Clonburris T3

Road Safety Audit Response Report

CLB-T3-ZZZ-SW-DTM-RP-DBFL-CE-0005

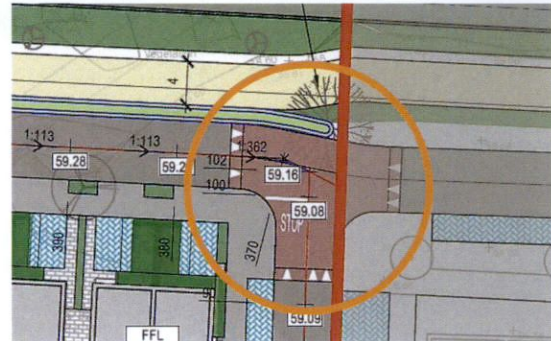
Location (G1) – Dropped Kerbs and Tactile Paving Problem

The drawings provided for the purpose of the RSA do not show provision of dropped kerbs and tactile paving at certain locations where pedestrian crossing points are proposed. This could lead to accessibility issues for road users, particularly wheelchair users and can cause confusion for partially sighted pedestrians who may encounter difficulties when crossing the road carriageway.

It is recommended that dropped kerbs and / or tactile paving in accordance with the appropriate design recommendations is provided at all key pedestrian travel desire lines that require a pedestrian to cross a road carriageway.

Pedestrian road crossing points and tactiles at all appropriate locations have been added to ensure safety of regular and disabled pedestrians. Key pedestrian desire lines have been considered at intersections and as close as possible to the middle of residential housing blocks.

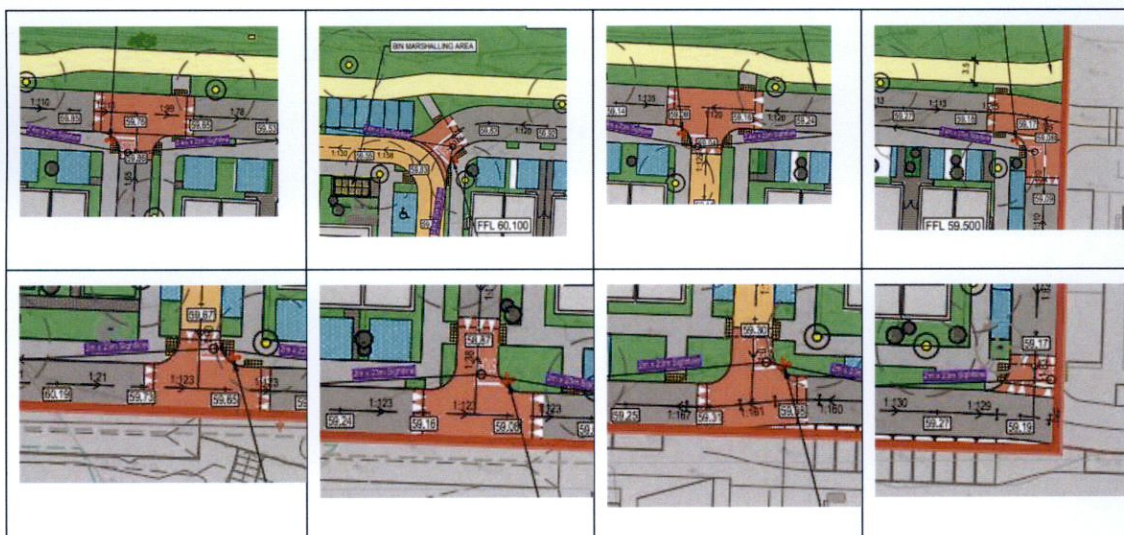
junctions which may lead to side impact collisions with vehicles travelling along the major arm through junctions.

It is recommended that appropriate road marking and signages are provided in accordance with the requirements of the Traffic Signs Manual.

Proposed signage has been added to the roads layout drawing CLB-T3-95-SW-DTM-DR-DBFL-CE-1201 in accordance with the Traffic Signs Manual.

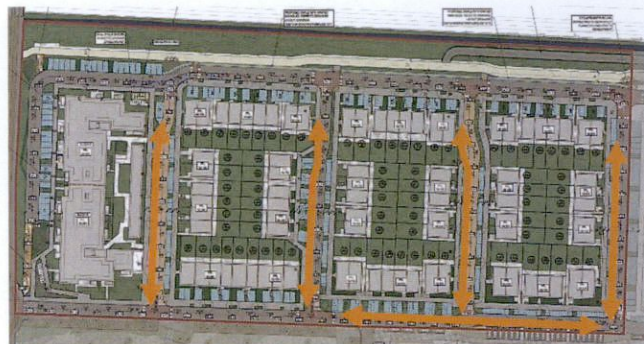
Location (G8) – Long Straight Sections of Carriageway

The internal local roads exhibit long straight sections with the carriageway lacking necessary traffic calming measures. This could lead to high excessive vehicle speeds. Higher speeds would lead to higher severity injury collisions should a driver lose control or come into contact with another road user.

The designers are requested to confirm the adopted design speed for each of the development streets. It is recommended that suitable traffic calming measures are provided to manage vehicular speeds along the local road/streets and ensure vehicle drivers do not exceed the adopted design speed. The measures should be in compliance with the principles set out in DMURS in regards to managing vehicle speeds.

The design speed of the development is 30km/h. Several bends in alignment have been introduced in Local Streets and different carriageway treatment utilised in Home Zones to manage vehicle speeds. Additional raised intersections and pedestrian crossings have also been introduced to

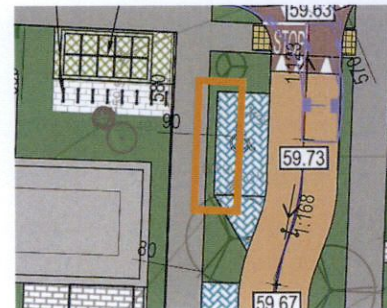
Location (S1) – Mobility Impaired Parking Bay

The mobility impaired parking bays are proposed to adjoin the landscaping area that does not provide a hardstanding area or dropped kerbs. A disabled person may find it difficult when entering / egressing the vehicle parked at this bay if a kerb is present which could result in a fall and cause an injury.

It is recommended that appropriate hardstanding areas with dropped kerb are provided to connect the parking bay with the footpath. The layout of 'parallel' disabled bay should respect the guidance outlined in the Traffic Signs Manual.

Dropped kerbs have been provided for all disable parking bays to allow users to access the adjacent footpaths as per the Traffic Signs Manual. Refer to the roads layout CLB-T3-95-SW-DTM-DR-DBFL-CE-1201.

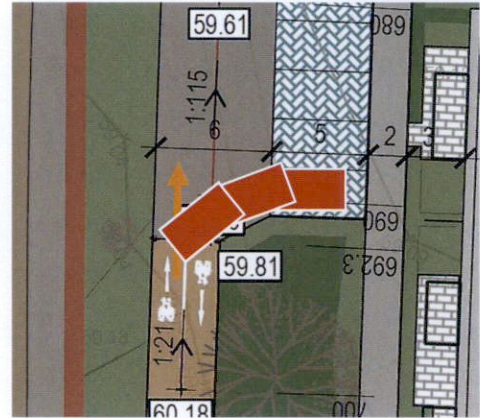
Location (S3) – Parking Bay Close to Two-Way Cycle Track

It is noted that the proposed two-way cycle track located to the south-west of the site is located very close to the car parking bay along the frontage of Block B. Vehicle reversing out from parking bay would encroach onto the two-way cycle track. A conflict could occur between a cyclist travelling northwards and a vehicle reversing at the same time.

The two-way cycle track could commence / terminate further south to ensure that a reversing vehicle does not need to drive onto the cycle track.

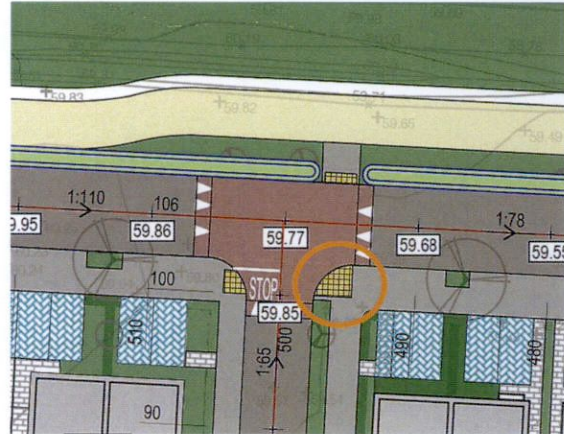
Location (S5) – Tactile Paving

The tactile paving on the eastern edge of the minor arm is misleading and would currently direct visually impaired pedestrians towards the carriageway resulting in collisions .

Ensure tactile paving is appropriately placed . A separate tactile paving should be provided for north-south movements at the eastern arm of this junction.

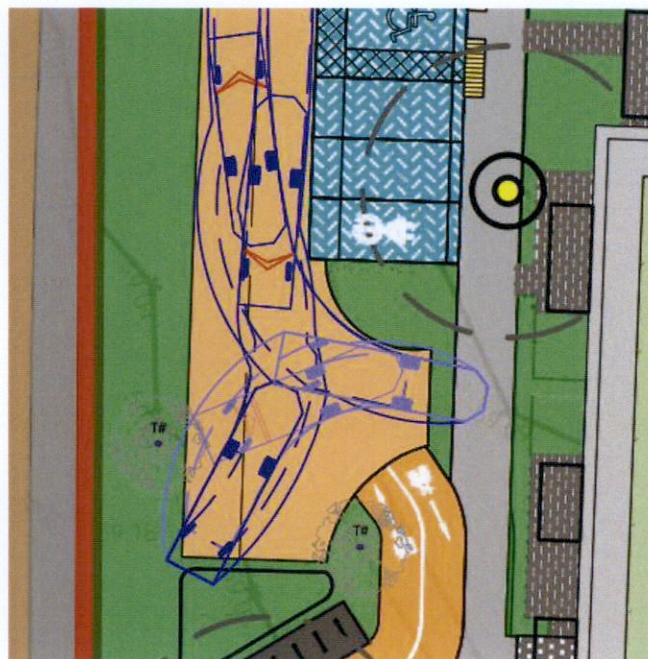
Location (S7) – Lack of Vehicle Turning Head

It is unclear how cars and large refuge vehicles will be able to access and undertaking u turn manoeuvre at the southern termination of the north-south street located immediately to the west of apartment block at the western edge of the site. The auditors request clarification regarding how large vehicles can be accommodated as the road terminates with a cul-de-sac.

To ensure a safe and convenient turning movement at this location, it is recommended to provide a turning head on this carriageway.

A turning head has been added to the end of Street 14 to allow sufficient turning space for a fire tender vehicle. Refer to drawing CLB-T3-95-SW-DTM-DR-DBFL-CE-1202 for further vehicle tracking details for the site.

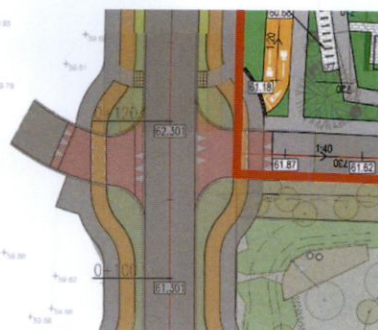
Comment (C1) – Junction Performance

The subject Tile 3 development is proposed to be accessed via a priority controlled junction located south-west of the site. This junction will also be used by other development Phases of Clonburris SDZ, therefore, the auditors feel that the priority arrangement of this junction, due to anticipated high traffic volume may result in the junction poor performance. The designer may consider signalised junction arrangement which could operate better in this case.

The Link Street adjacent to the proposed development has been granted planning under a separate planning application and has been deemed compliant.

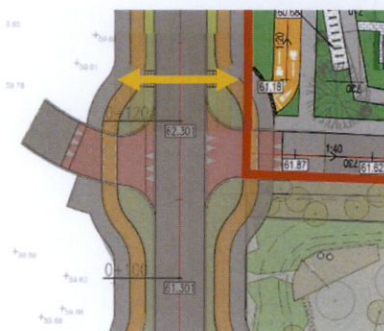
Comment (C2) – Need for Controlled Pedestrians Crossings

Further to C1, uncontrolled crossing is provided at the site access junction. The auditors feel that there is a need for controlled crossing for pedestrian and cyclists at this location due to anticipated high number of pedestrians and cyclists using the facility.

The Link Street adjacent to the proposed development has been granted planning under a separate planning application and has been deemed compliant.
