# Tree Survey Report

Coláiste Chilliain, Clondalkin, Dublin 22

Project No. TCOL002

Project name
 Coláiste Chilliain
 Primary School

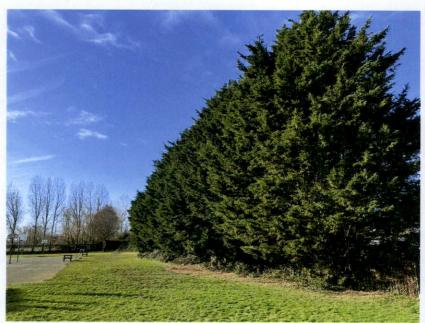
northern boundary. There are boundary hedges of beech and Leyland cypress (xCupressocyparis leylandii) which for the most part have been well maintained though a section of the latter on the northern boundary has become very large and has developed into a number of individual trees (refer to image 1).

Image 1. View of leyland cypress along the north-eastern boundary of site.

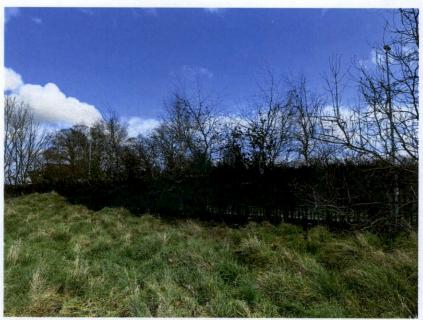
Image 2. Beech hedge along the Old Nangor road, south-western boundary of site.

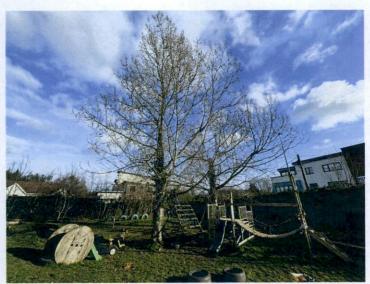
Image 3. Poplar #925 and #926 in the south eastern corner of the school.

926	Black Poplar Populus nigra	Mature	Poor	Upper crown lost at 9m	Remove Swings as unsafe /fell	U	0

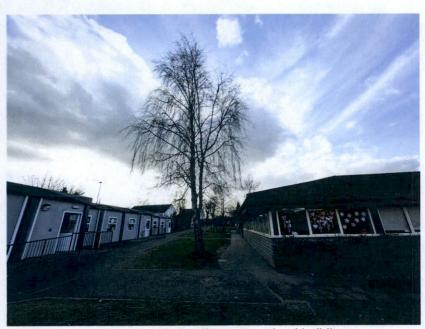
Image 4. View of internal birch adjacent to school buildings.

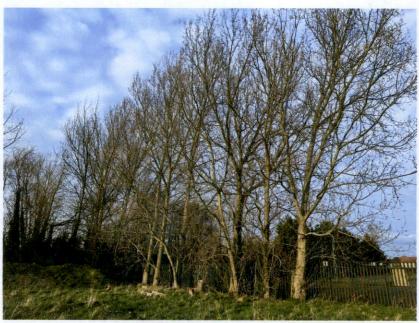
Image 5. View of the internal linear poplar planting in near the children's play area.

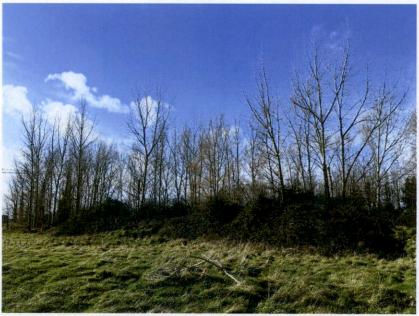
Image 6. Poplar adjacent to the northern boundary.
