**Arboricultural Assessment:
Notice of urgent
tree works required
Coláiste Chilliain School,
Old Nangor Road, Clondalkin,
Dublin 22**

Project No.	TCLO002	Date	10/02/23
Project Name	Coláiste Chilliain School	Revision	-

Notice of urgent tree works required

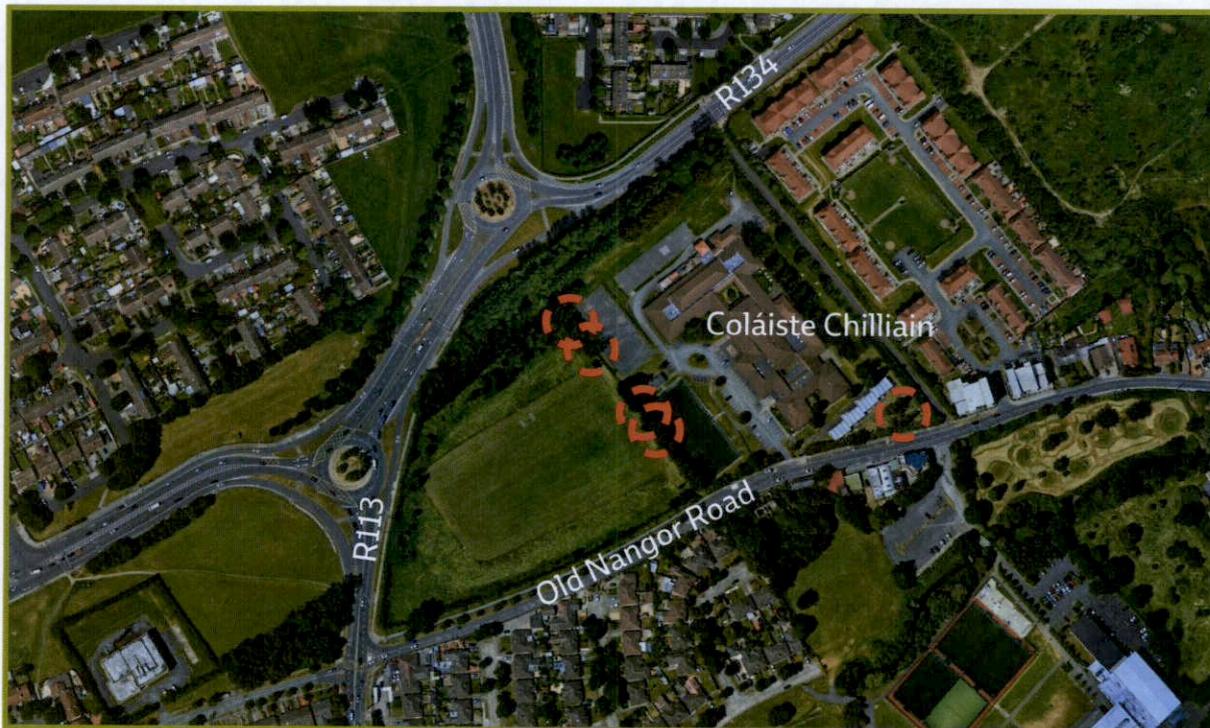
Image 1. Overview of locations of trees that require urgent attention within red rings (refer to drawings TCLO002 Tree Survey - urgent works 110-113).

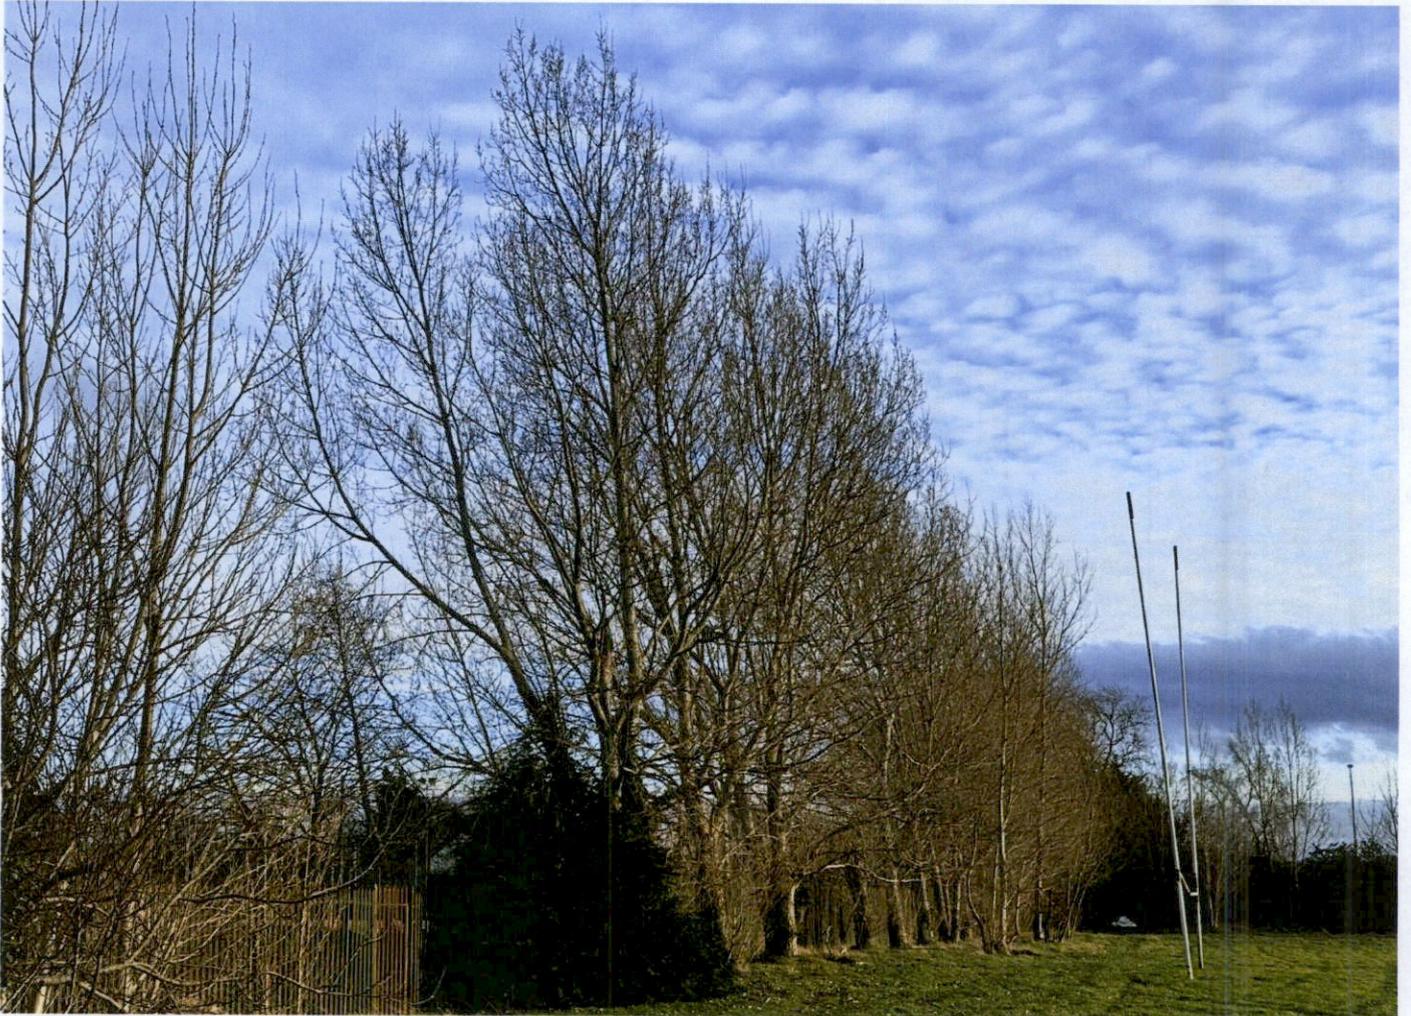
Image 2. Line of poplars trees #577-#590.

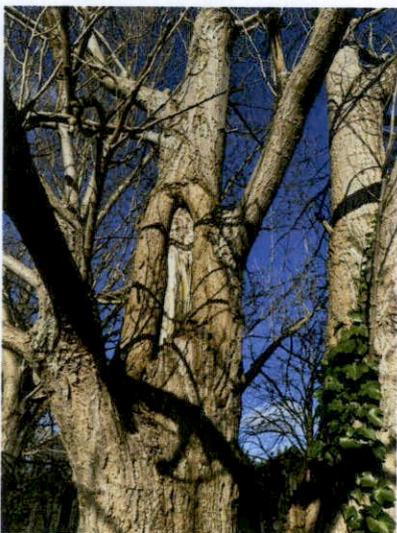
Image 3. Poplar tree #579 with a large limb failure at 3m south.

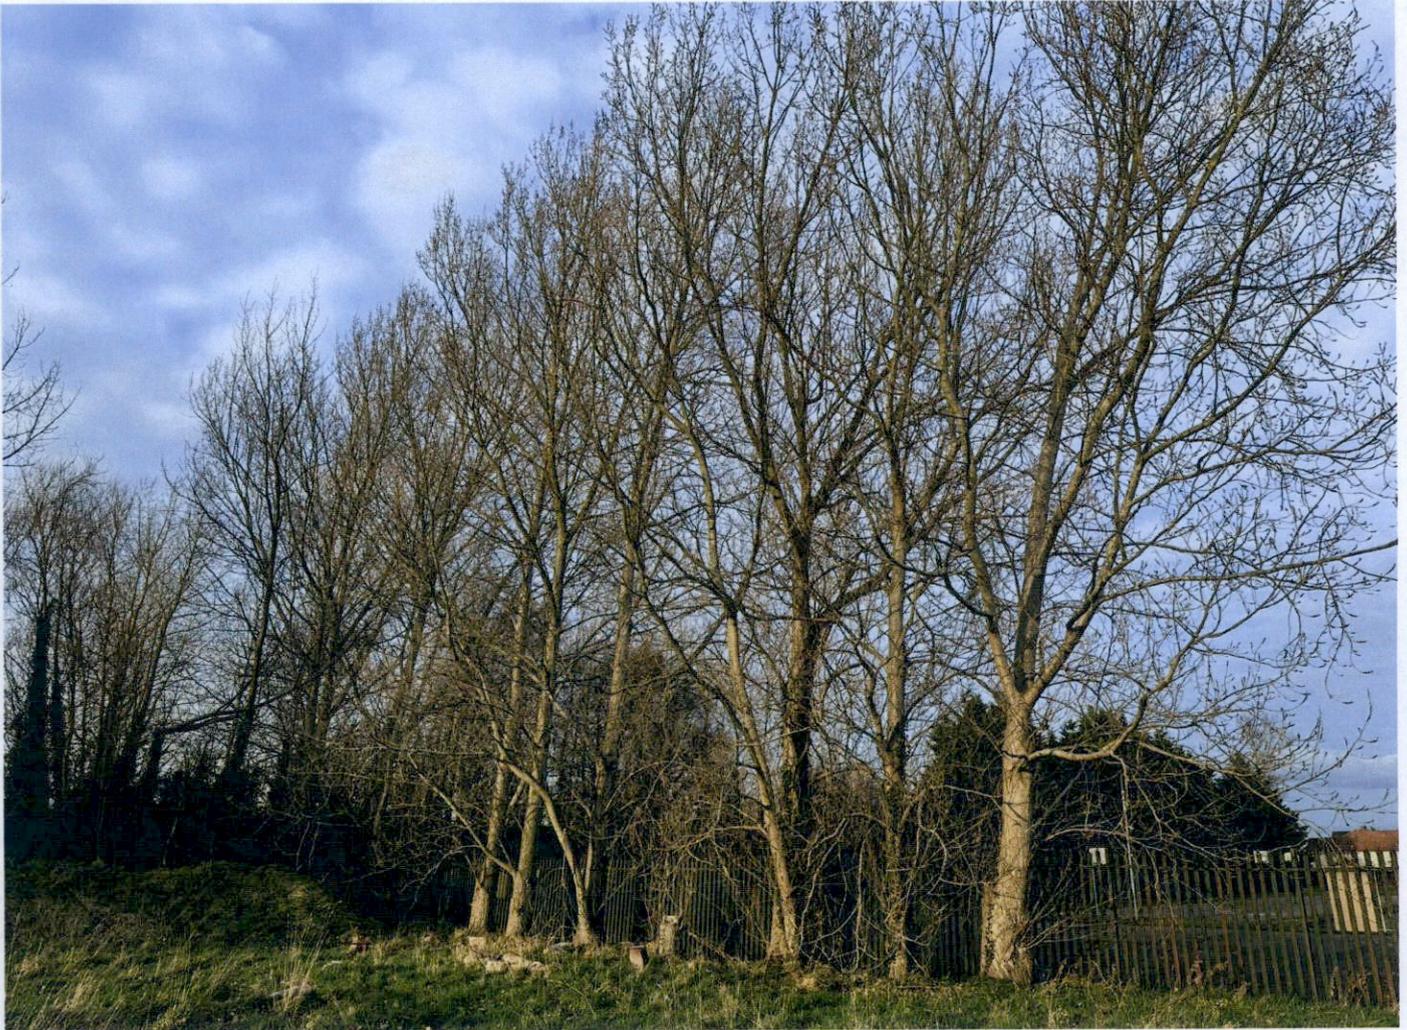
Image 4. Line of poplars trees #565-#576.

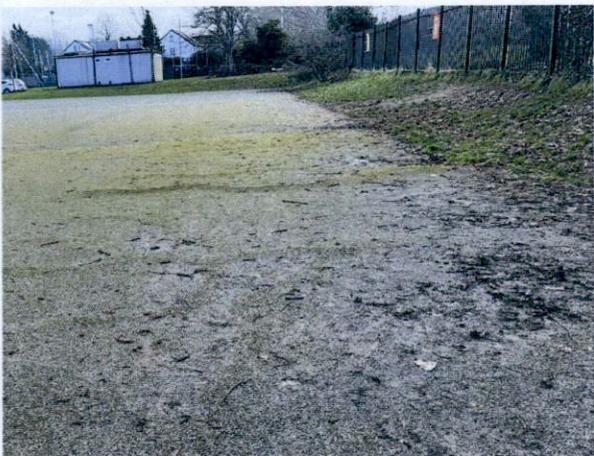
Image 5. Invasive roots from trees #565-#576 undermining the play area east of their location.

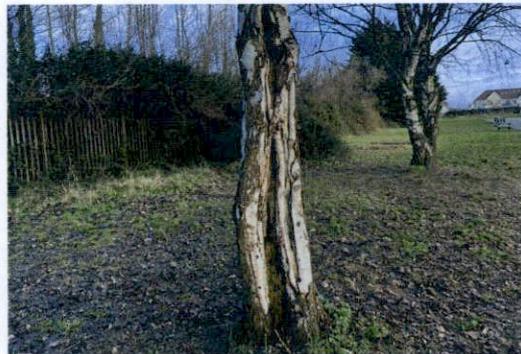
Image 6. Birch #594 with extensive cavity at base of tree.

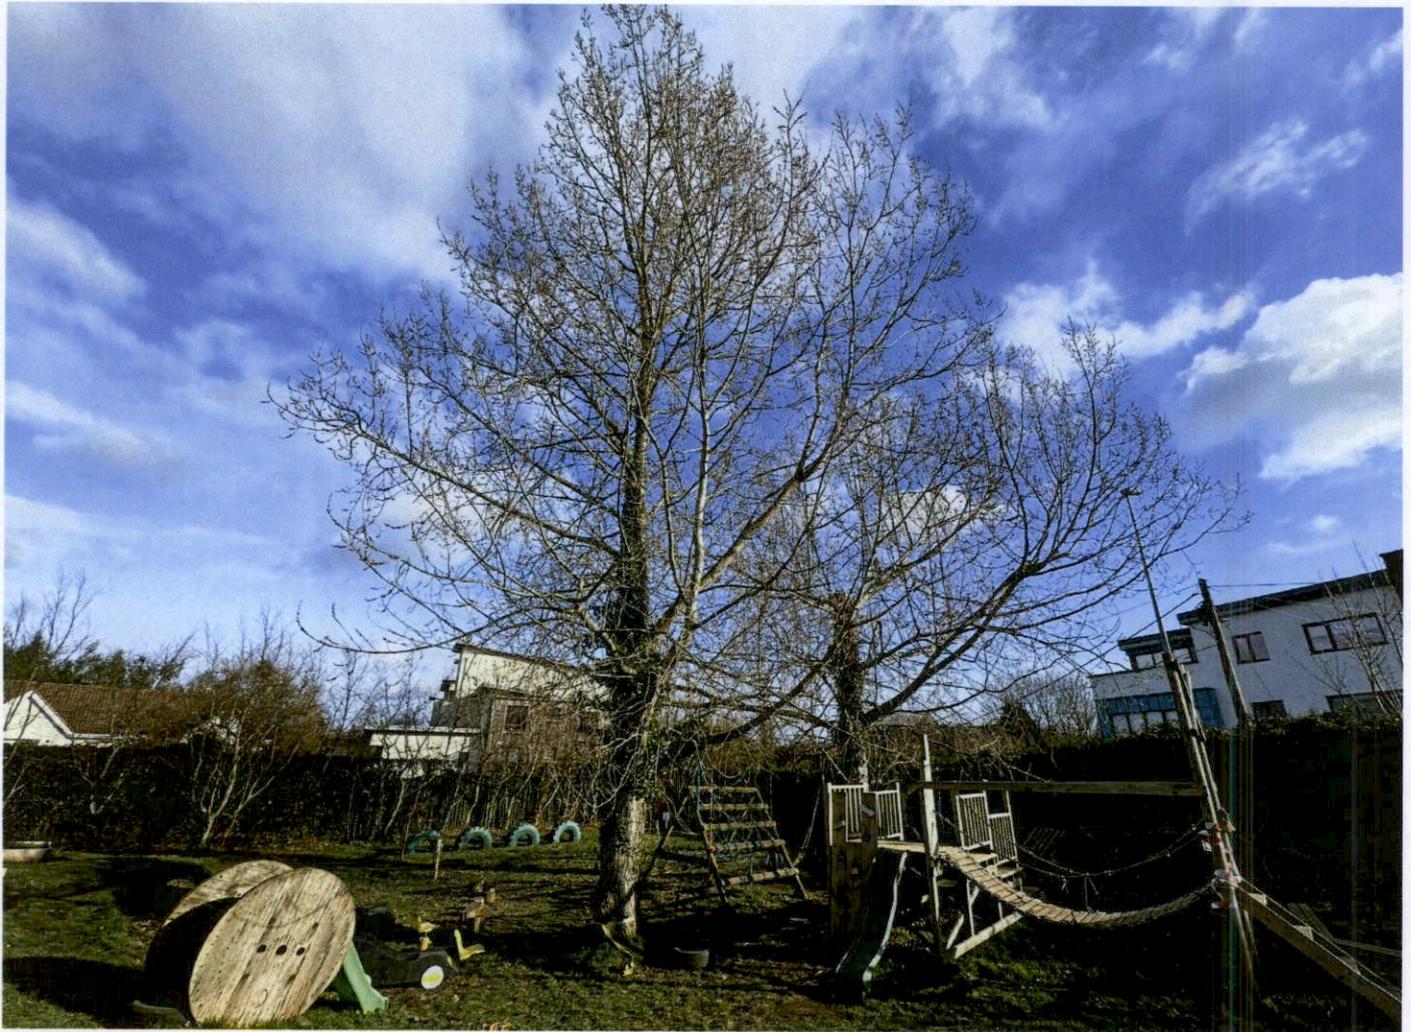
Image 7. Two mature poplars in the south east of the surveyed site. #925 (left) and #926 (right).

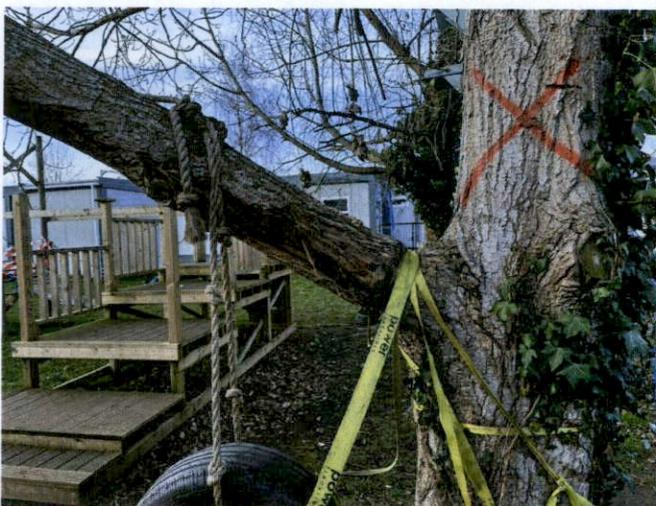
926	Black Poplar <i>Populus nigra</i>	Mature	Poor	Upper crown lost at 9m	Remove Swings as unsafe/fell	U	0

Image 8. Poplar tree #926 which is marked with a red x to signify a recommendation for immediate removal.
