PROJECT NAME:
Old Nangor Road Clondalkin

TITLE:
Exploratory hole location plan

Road Safety Audit Report

Stage 1/2 Road Safety Audit
Proposed school's development at Clondalkin, Co. Dublin
December 5th 2016

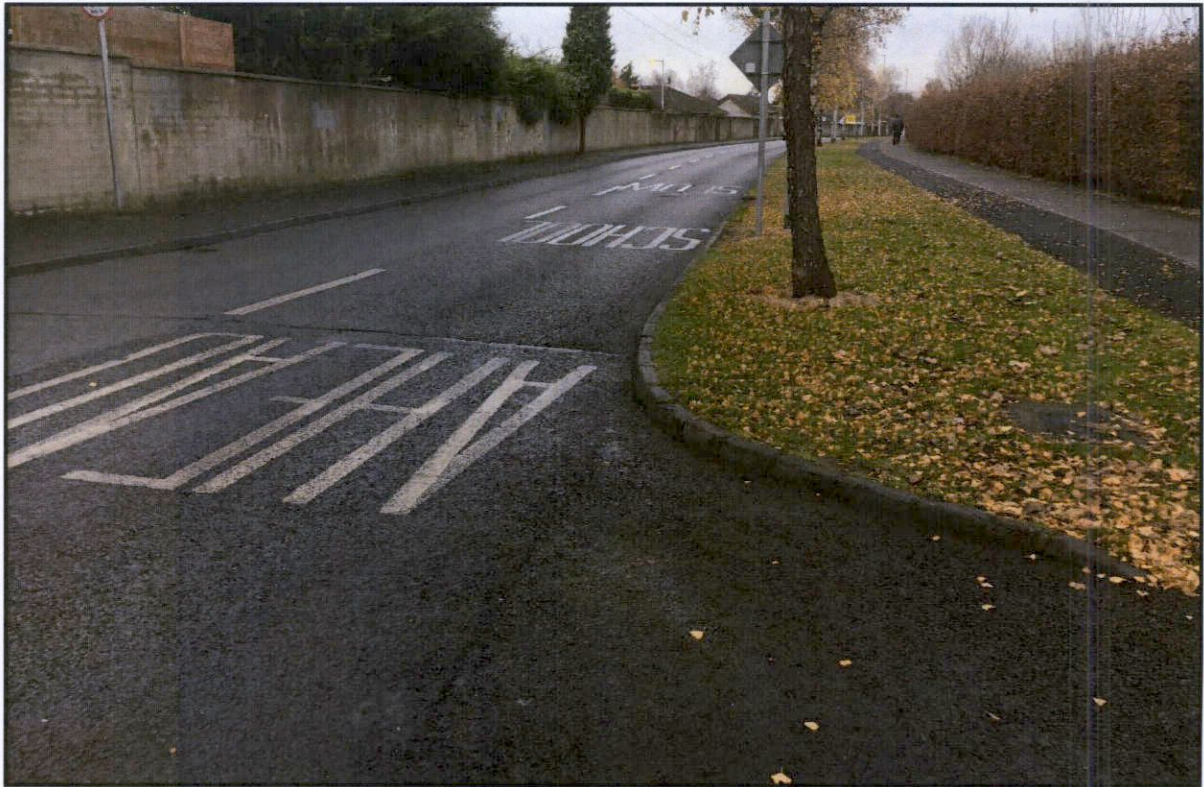
Photograph 1 – View from existing school access looking towards the R113

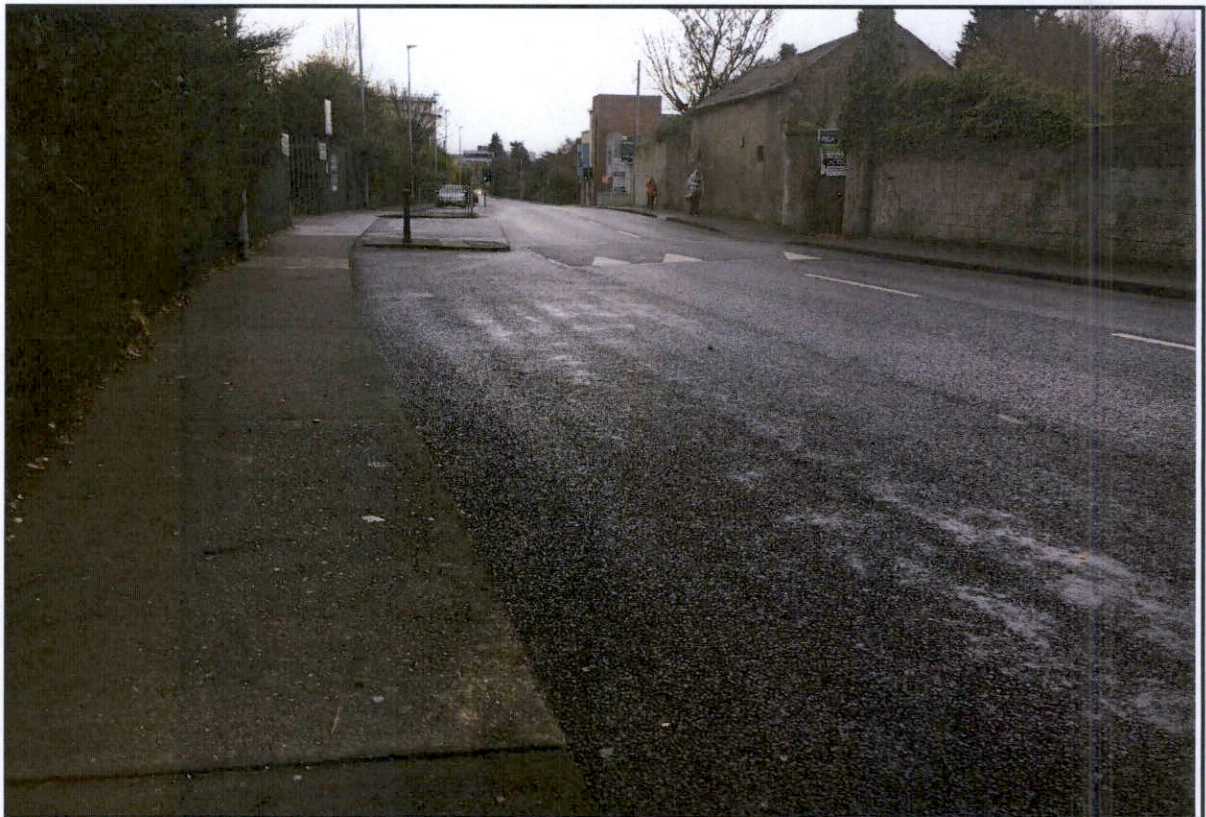
Photograph 2 – R113 approach to the school access from the Old Nangor Road

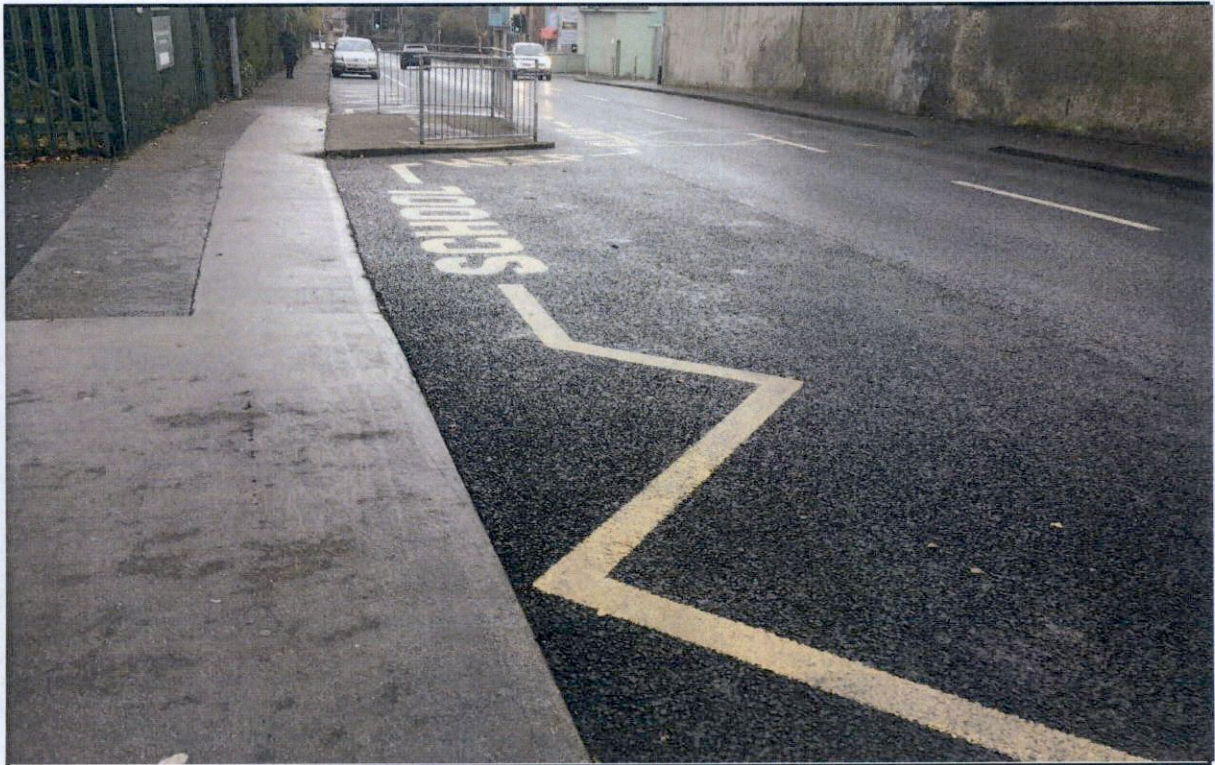
Photograph 3 – Existing road markings at the school access

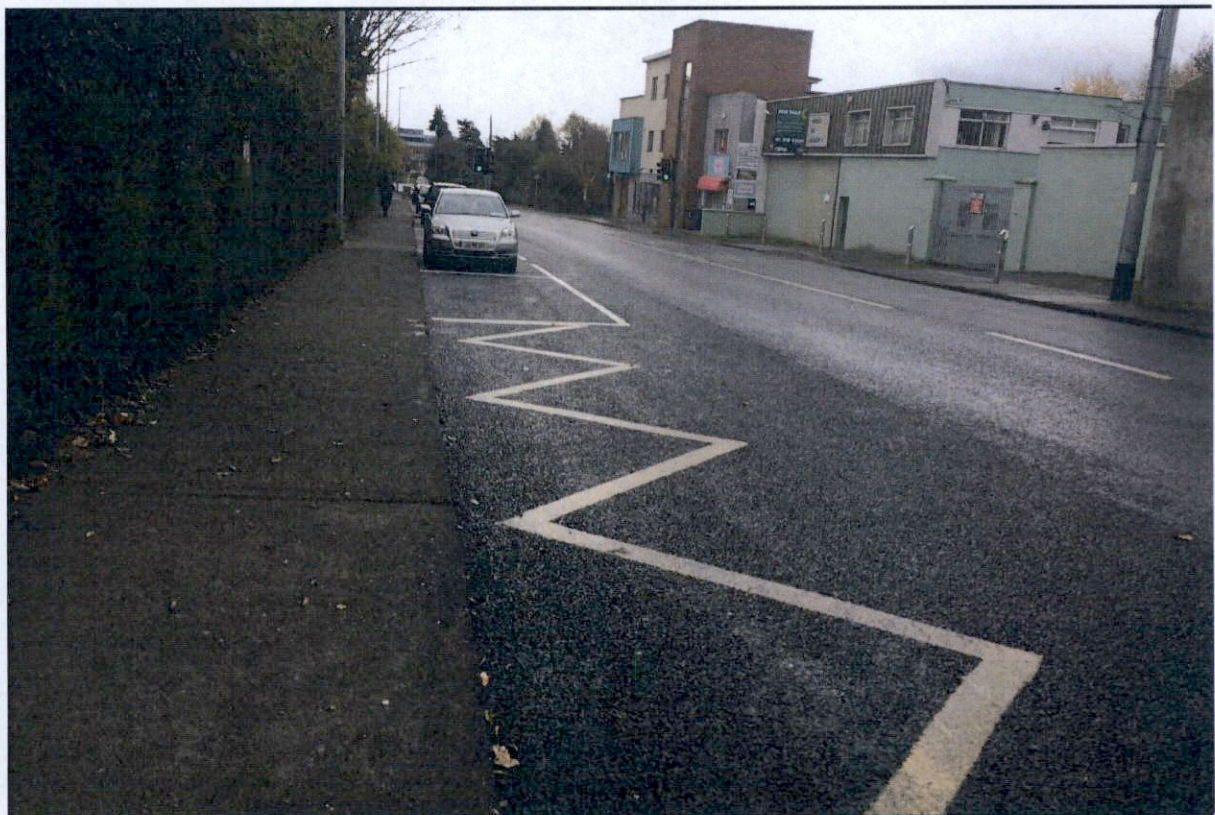
Photograph 4 – Existing parking facilities on Old Nangor Road at school access

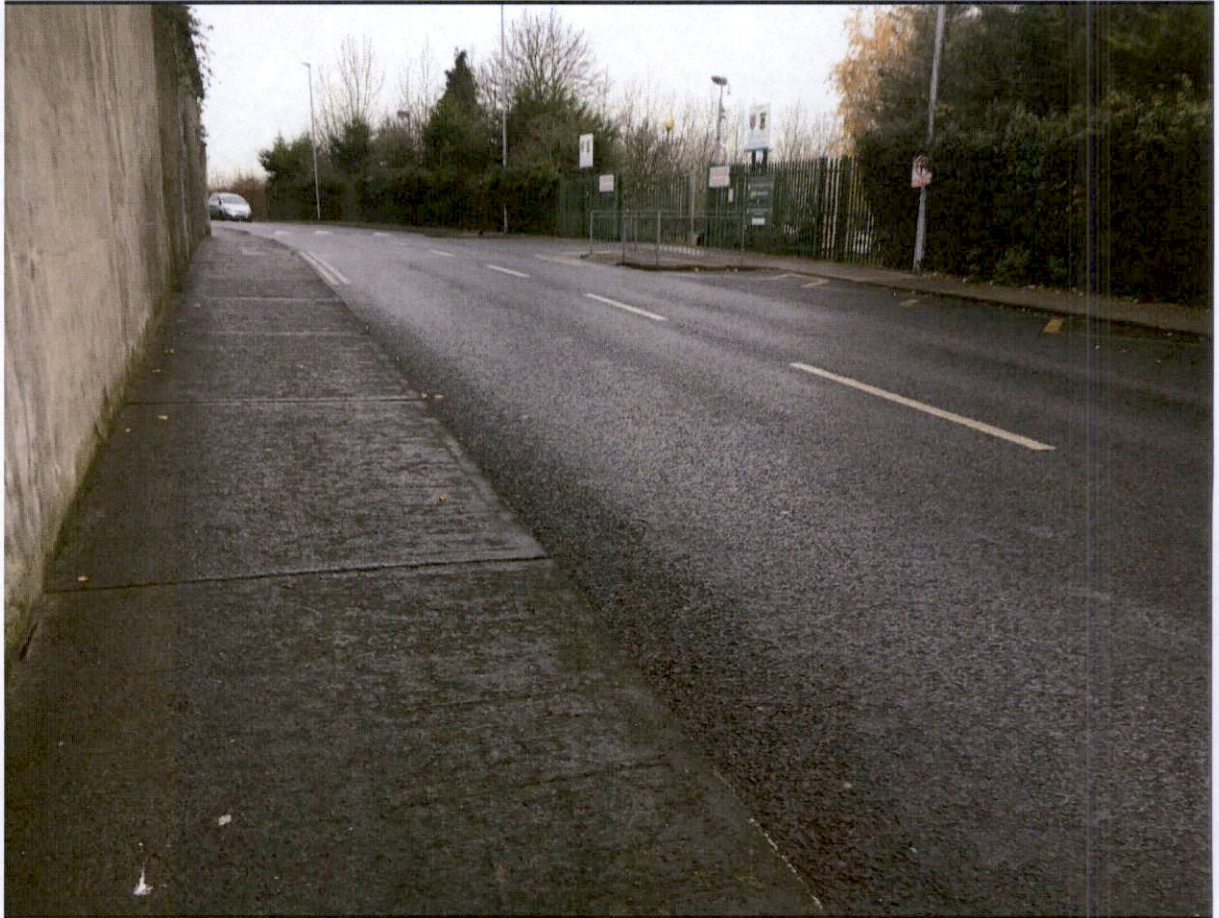
Photograph 5 – Existing gated school access
