Clonburris T3

Road Safety Audit Response Report

CLB-T3-ZZZ-SW-DTM-RP-DBFL-CE-0005

April 2023

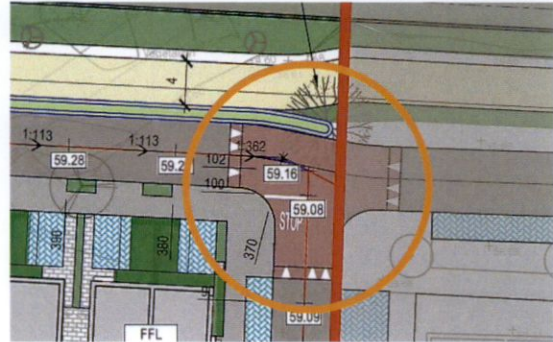
Location (G1) – Dropped Kerbs and Tactile Paving Problem

The drawings provided for the purpose of the RSA do not show provision of dropped kerbs and tactile paving at certain locations where pedestrian crossing points are proposed. This could lead to accessibility issues for road users, particularly wheelchair users and can cause confusion for partially sighted pedestrians who may encounter difficulties when crossing the road carriageway.

It is recommended that dropped kerbs and / or tactile paving in accordance with the appropriate design recommendations is provided at all key pedestrian travel desire lines that require a pedestrian to cross a road carriageway.

Pedestrian road crossing points and tactiles at all appropriate locations have been added to ensure safety of regular and disabled pedestrians. Key pedestrian desire lines have been considered at intersections and as close as possible to the middle of residential housing blocks.

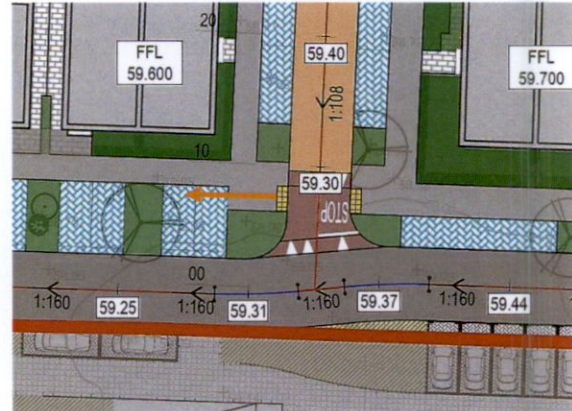
Location (G2) – Crossing Alignment with Footpath

The auditors note that proposed pedestrian crossings at some instances have not been aligned with footpaths on both sides of the crossings such as shown in the figure opposite. This may direct visually impaired pedestrians toward car parking bays resulting in a conflict between pedestrian and vehicles.

Ensure pedestrian crossings are appropriately aligned with the footways on both sides to safeguard the safety of visually impaired pedestrians.

All pedestrian crossing points, including the crossing at the junction of streets 12 and 18 have been aligned with footpaths to avoid any pedestrian confusion.

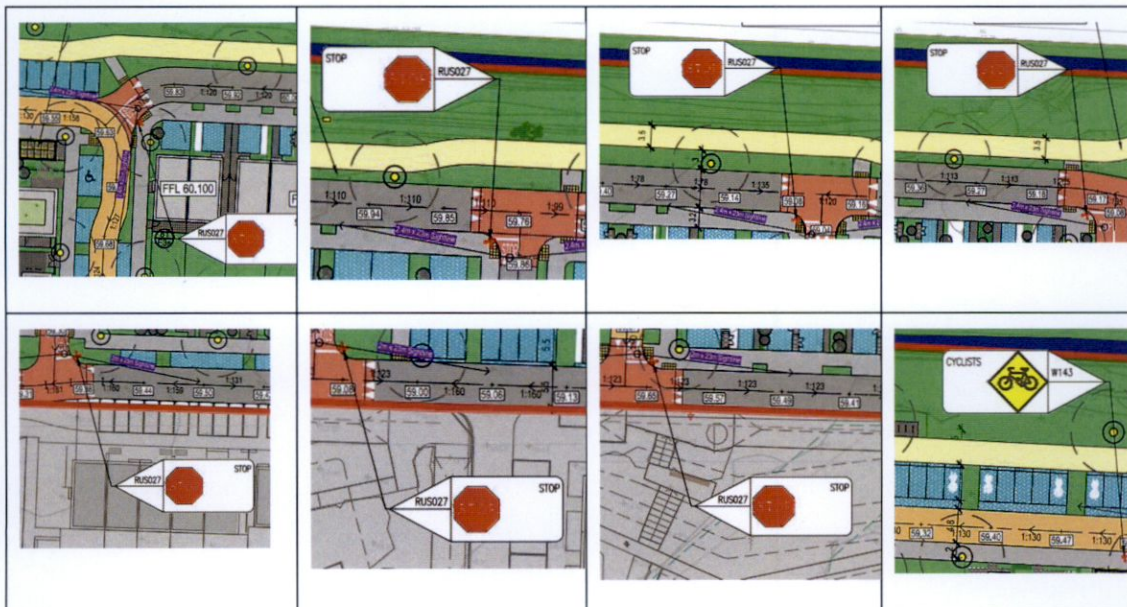
Location (G3) –Signage

The drawings provided for the purposes of the RSA do not show details of signage. Failure to provide the appropriate regulatory signs may result in vehicles failing to stop at the minor arm of

junctions which may lead to side impact collisions with vehicles travelling along the major arm through junctions.

It is recommended that appropriate road marking and signages are provided in accordance with the requirements of the Traffic Signs Manual.

Proposed signage has been added to the roads layout drawing CLB-T3-95-SW-DTM-DR-DBFL-CE-1201 in accordance with the Traffic Signs Manual.

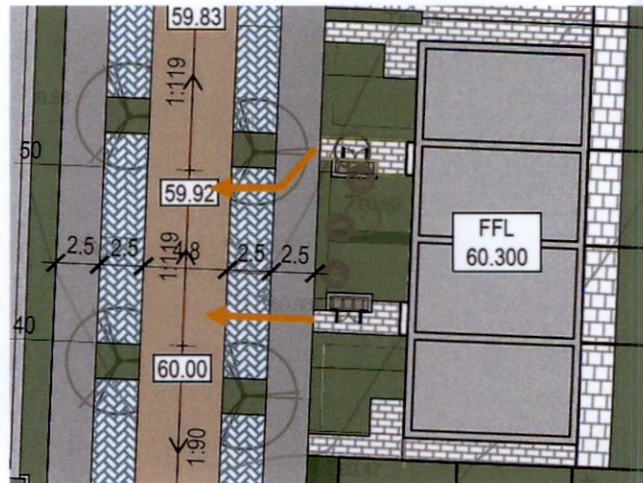
Location (G5) – Waste Bin Service Arrangement

The auditors note that the drawing illustrates the locations of waste bin storage areas within the site. However, the transfer arrangements for the waste bins between the carriageway and the house units is unclear. Should waste bins be inappropriately stored in the path of pedestrians, this could block pedestrian routes or limit the space available to pedestrians as they could

step onto the adjacent landscaping area or onto the parallel parking bays. This could result in pedestrian / vehicle conflicts. No consideration has been given to waste collection services requirements to transfer (e.g., manually pull the bins via the footpath and between the parallel parking bays) the waste from the storage area. If parking bays are occupied by vehicles, no route would be available when transferring bins to / from the waste collection vehicle on the carriageway.

Ensure appropriate bin transfer areas / locations and appropriate routes are be provided for waste bin transfer which do not result in the reduction of footpath widths to such an extent that pedestrian must leave the footpath to move around bins. Ensure a navigable route in the form of an appropriately designed pathway is provided that offers a route for waste collection activities on the carriageway.

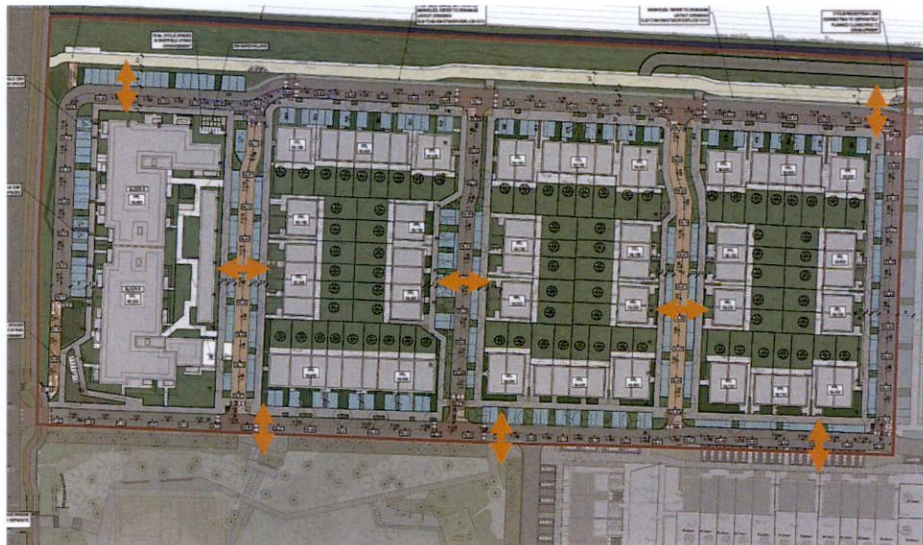
Location (G7) – Pedestrian Crossing Desire Lines

At some locations within the scheme, no provision has been made for pedestrians (and cyclists) that will be seeking to cross the road carriageway at key desire lines. This is noted between the house and the apartment units. No crossing has been provided along the entirety of the southern boundary of the scheme that connects to the park and the residential units as part of the Phase 1B Development to the south. Furthermore, no midblock crossing points are provided on the four internal north-south aligned streets. Absence of appropriate crossing provision could lead to trips and falls as pedestrians, children and particularly wheelchair users if trying to undertake crossing between parked vehicles and / or via landscaped or tree planting buffers. The issue could also lead to collisions with vehicles.

Appropriate pedestrian crossing facilities should be provided at all key pedestrian desire lines as indicated in the figure above to enable pedestrians safely crossing at key crossing desire lines along the internal roads as well as towards the adjacent proposed development.

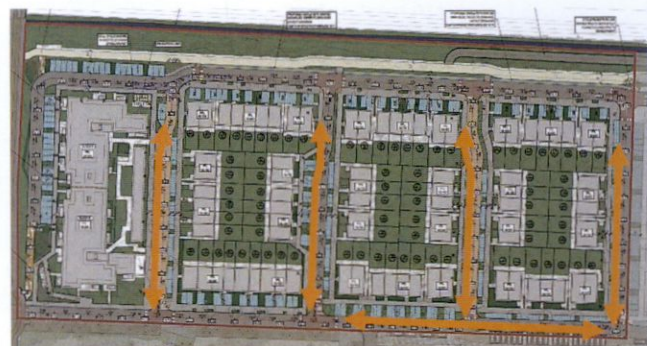
Location (G8) - Long Straight Sections of Carriageway

The internal local roads exhibit long straight sections with the carriageway lacking necessary traffic calming measures. This could lead to high excessive vehicle speeds. Higher speeds would lead to higher severity injury collisions should a driver lose control or come into contact with another road user.

The designers are requested to confirm the adopted design speed for each of the development streets. It is recommended that suitable traffic calming measures are provided to manage vehicular speeds along the local road/streets and ensure vehicle drivers do not exceed the adopted design speed. The measures should be in compliance with the principles set out in DMURS in regards to managing vehicle speeds.

The design speed of the development is 30km/h. Several bends in alignment have been introduced in Local Streets and different carriageway treatment utilised in Home Zones to manage vehicle speeds. Additional raised intersections and pedestrian crossings have also been introduced to

address auditors concerns. Traffic signage will also be used to mitigate speeds along the streets within the development.

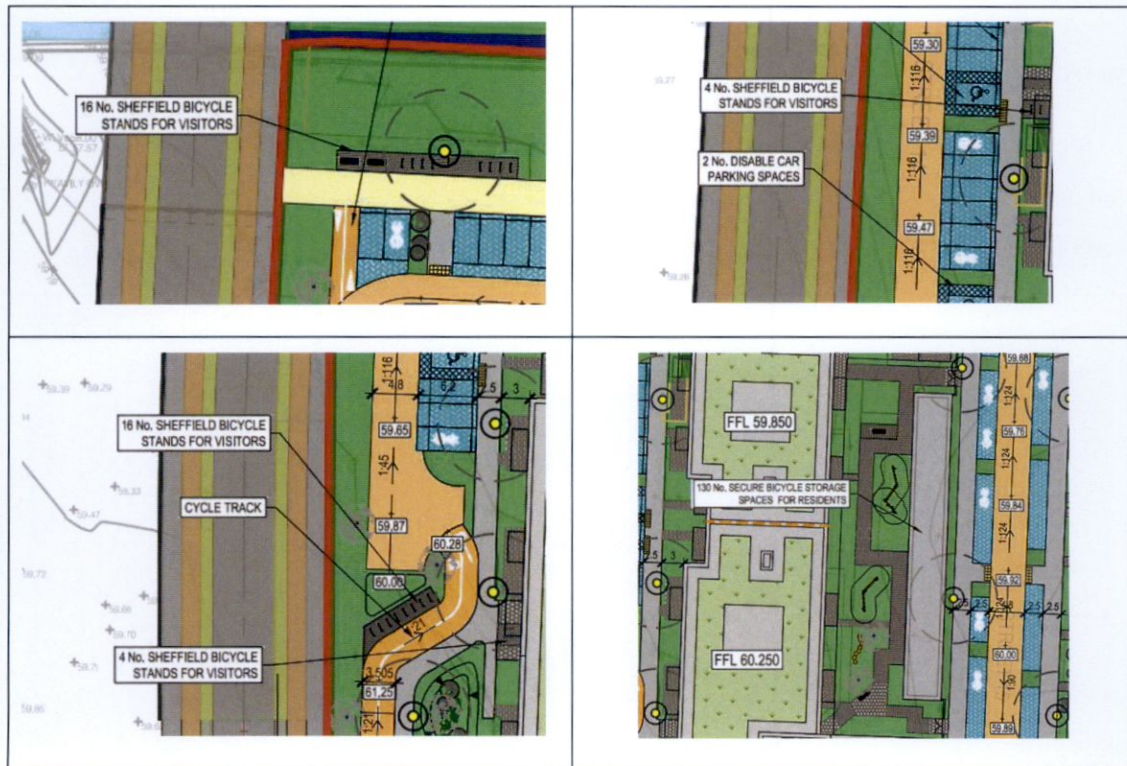
Location (G9) – Cycle Parking

The auditors note in reference to the drawing provided for the purpose of the audit that no long term (residents) or short term (visitors) bicycle parking has been provided. The auditors are concerned that in the absence of such facilities indiscriminate bicycle parking practices (eg. Light poles etc) may arise which have the potential to block the footpath and represent trip hazard for pedestrians.

The designer should ensure that the appropriate quantum of bicycle parking is provided for both resident and visitors. The design and location of the bicycle parking should respect the appropriate design guidance and safeguard pedestrian routes free from trip hazard.

Long term and short stay bicycle parking is now shown on the roads layout CLB-T3-95-SW-DTM-DR-DBFL-CE-1201 and corresponds with requirements as stated in the TTA.

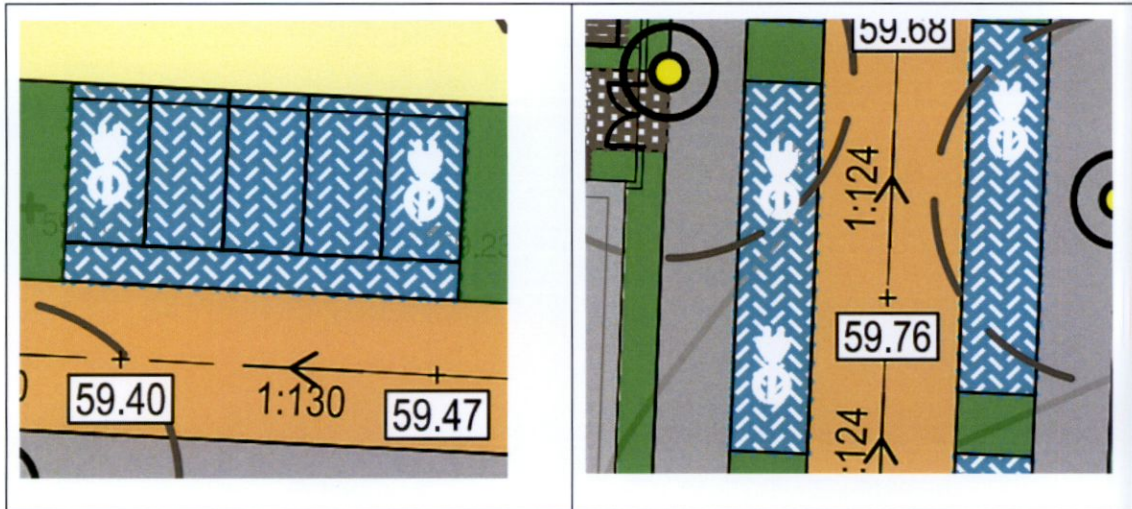
Location (G10) – EV Parking

It is noted upon review of TTA report that a minimum of 34 no. electric vehicle (EV) parking spaces will be provided. However, the scheme does not provide details of the location and size of EV parking bays or the location of EV charging points. The auditors are concerned that the proposed EV parking bays may be of a substandard size that could impact accessibility and result in cables encroaching to the public footpath which would represent trip hazard. Furthermore, the auditors are concerned that EV charge point may be located in either 1) the public footpath which could subsequently represent obstruction and /or 2) a grass landscaped area which, particularly in wet conditions, could be slip hazard for drivers seeking to access the charge point.

The designers are requested to confirm the location and size of all EV parking spaces meet best practice design guidance. EV charging points should be located in an area of hard standing, outside of the footpath area, and in close proximity to EV bays.

EV parking spaces are minimum 5.5m in length and are indicated on the roads layout CLB-T3-95-SW-DTM-DR-DBFL-CE-1201.

All footpaths proposed as part of the development have been increased to 2.5m wide if they were not previously. This would provide enough space for pedestrians on footpaths even if EV charging stations are placed on the edge of footpaths.

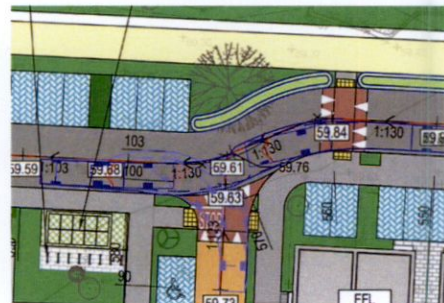
Location (G11) – Visibility Splays at Junction

The proximity of car parking bays adjoining a number of internal junctions throughout the site may obstruct driver's visibility. Failure to provide sufficient visibility for vehicle drivers at the junctions could result in overshoot incidents or side impact collisions with vehicles/cyclists travelling along the road.

Ensure sufficient visibility is provided at all junctions and vehicle access points as outlined in DMURS by ensuring car parking and tree species are located /specified such that unobstructed visibility splays safeguarded.

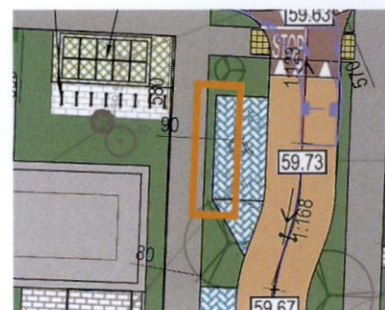
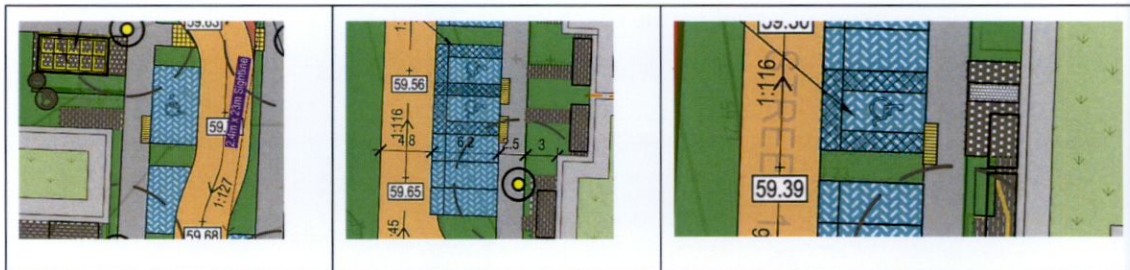
Location (S1) – Mobility Impaired Parking Bay

The mobility impaired parking bays are proposed to adjoin the landscaping area that does not provide a hardstanding area or dropped kerbs. A disabled person may find it difficult when entering / egressing the vehicle parked at this bay if a kerb is present which could result in a fall and cause an injury.

It is recommended that appropriate hardstanding areas with dropped kerb are provided to connect the parking bay with the footpath. The layout of 'parallel' disabled bay should respect the guidance outlined in the Traffic Signs Manual.

Dropped kerbs have been provided for all disabled parking bays to allow users to access the adjacent footpaths as per the Traffic Signs Manual. Refer to the roads layout CLB-T3-95-SW-DTM-DR-DBFL-CE-1201.

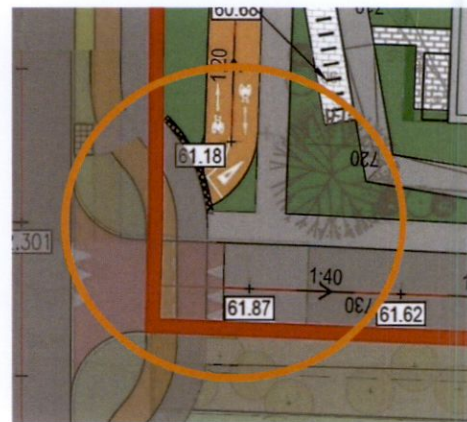
Location (S2) – Two-Way Cycle Track Link to Western Road

The auditors note that the proposed two-way cycle track located to the south-west of the site terminates with the pedestrian footway. Cyclists travelling to and from the two-way track could be travelling at high speed and will have to cross through the footway. This can be considered hazardous and could result in a conflict between pedestrians and cyclists.

It is recommended that a suitable transition be provided between the internal two-way cycle track and the external one-way cycle track facilities on the road to the west of the scheme to ensure the safety of all users and the appropriate level of integration between cycle links. The footpath area connecting both the internal cycle track and the external pedestrian / cycle facility could be converted into a 'shared-area' and could implement the corduroy tactile paving on either side of the pedestrian / cycle facilities to warn the vulnerable and the visually impaired. The designers should also confirm how cyclists are to travel to and from the northbound one-way cycle track located on the western side of the external road corridor.

As stated in the Road Safety Audit Responses, the Link Street in question is separately permitted and cannot be changed at this stage. However, discussions will be arranged with Local Roads Authority to raise the auditors concerns and agreed details how the cycle track can appropriately tie into the Link Street and associated cycle infrastructure and crossing desire lines.

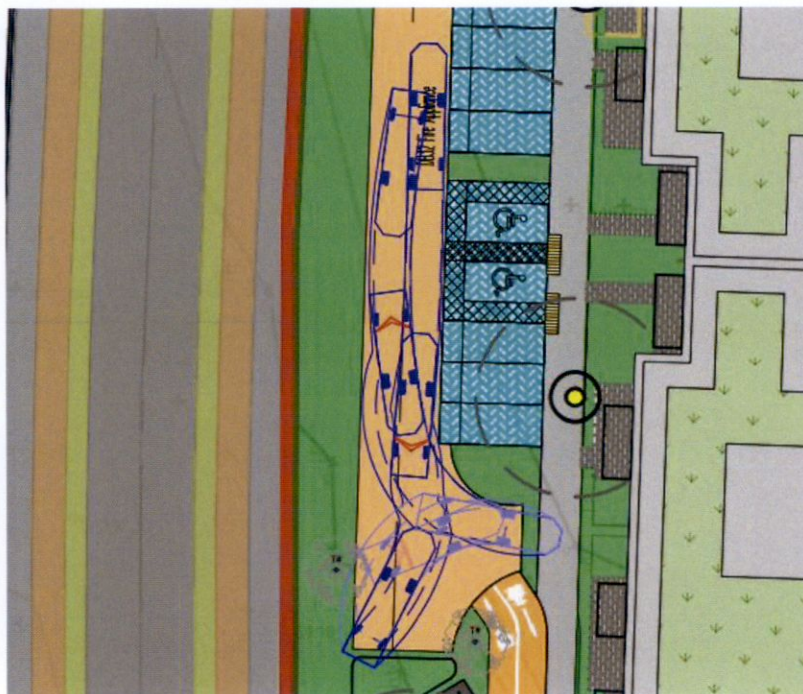
The two-way cycle track could commence / terminate further south to ensure that a reversing vehicle does not need to drive onto the cycle track.

The roadway could not be extended as suggested as the cycle link to the south would no longer meet part M gradient requirements. Parking bays were however moved farther north and a hammerhead has been introduced to assist vehicle turning and create a safe tie-in space for the cycle track to the roadway.

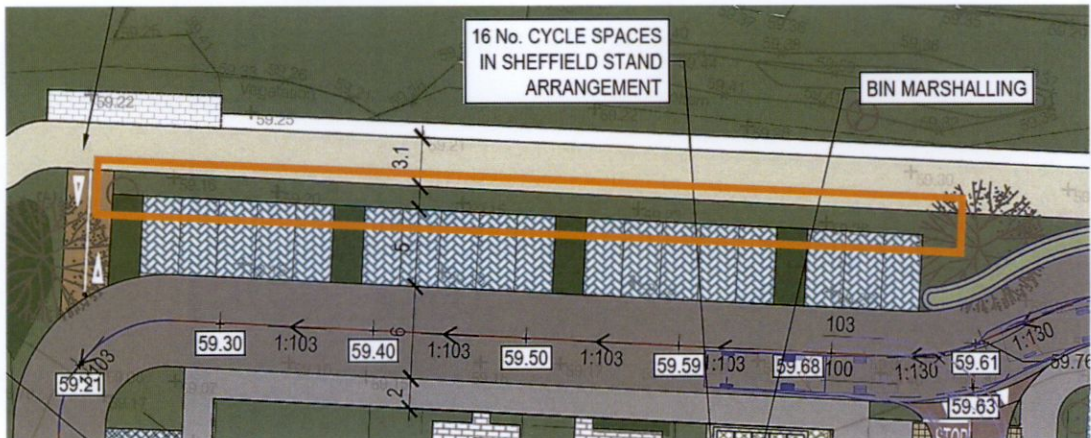
Location (S4) – Parking Bay and Pedestrian / Cycle Facility Connection

No connection has been provided between the parking bays (located north of Block B) and the continuous pedestrian / cycle link at the northern boundary of the site. The parking bay and the pedestrian / cycle link has been separated by a landscaping strip. The landscaping strip could be a trip hazard for pedestrians particularly during wet conditions.

It is recommended that a concrete handstand be provided to ensure the shared pedestrian / cycle link is easily accessible by individuals accessing / egressing their vehicles.

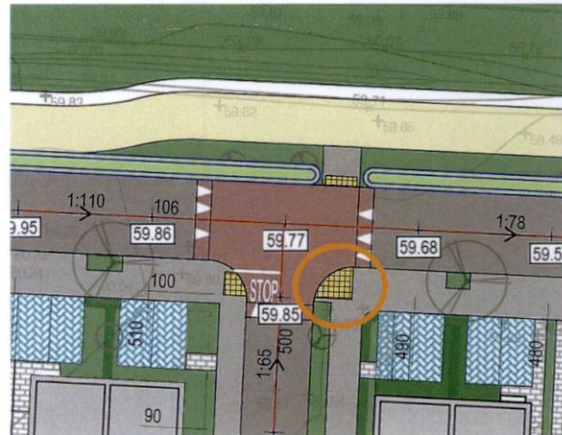
Location (S5) – Tactile Paving

The tactile paving on the eastern edge of the minor arm is misleading and would currently direct visually impaired pedestrians towards the carriageway resulting in collisions .

Ensure tactile paving is appropriately placed . A separate tactile paving should be provided for north-south movements at the eastern arm of this junction.

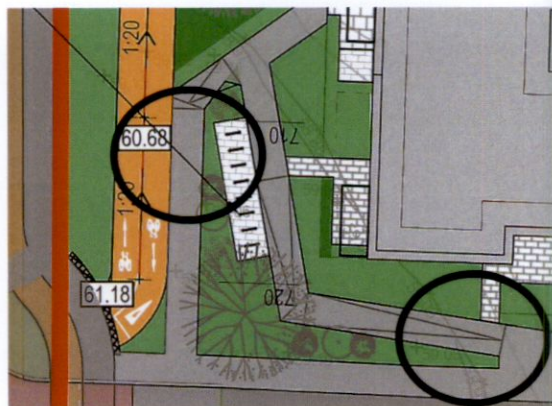
Location (S6) – Pedestrian Access / Bicycle Parking Access

The auditors have noted that there is a significant level difference between the bicycle parking spaces to the south-west of Block B and the dedicated cycle tracks to the west of the cycle parking. Ramped accesses from two locations towards this parking spaces have been provided, however, the auditors cannot ascertain if the proposed gradient is suitable for cyclists accessing these spaces to and from the cycle tracks as well as for pedestrians (particularly for wheelchair users).

The designer should confirm that the proposed pedestrians path and cycle facility access will have a suitable gradient for pedestrians and particularly for wheelchair users and cyclists.

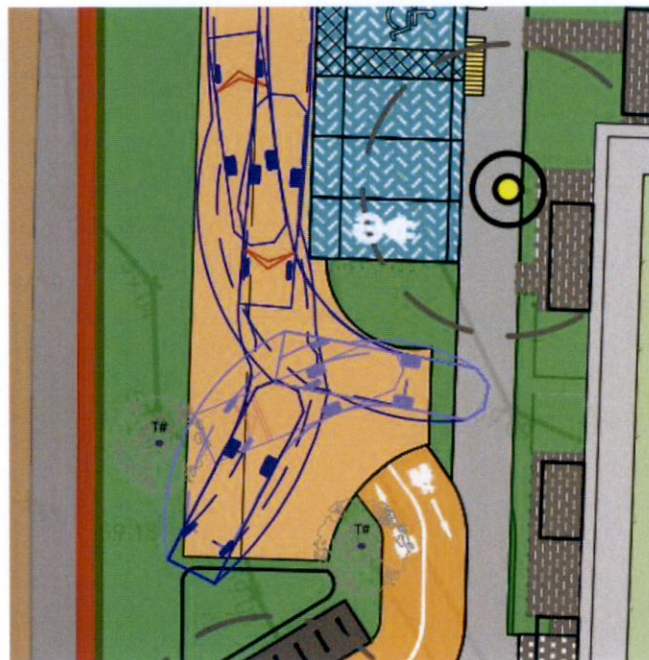
Location (S7) – Lack of Vehicle Turning Head

It is unclear how cars and large refuge vehicles will be able to access and undertaking u turn manoeuvre at the southern termination of the north-south street located immediately to the west of apartment block at the western edge of the site. The auditors request clarification regarding how large vehicles can be accommodated as the road terminates with a cul-de-sac.

To ensure a safe and convenient turning movement at this location, it is recommended to provide a turning head on this carriageway.

A turning head has been added to the end of Street 14 to allow sufficient turning space for a fire tender vehicle. Refer to drawing CLB-T3-95-SW-DTM-DR-DBFL-CE-1202 for further vehicle tracking details for the site.

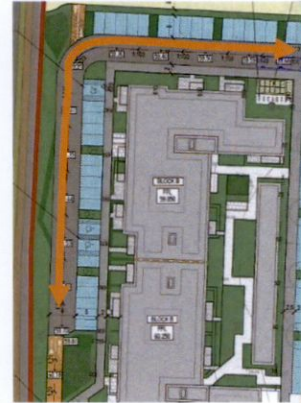
Location (S8) – Residential Local Street

The auditors are concerned that the proposed 6m width for the 'Local' residential street is excessive compared to DMURS recommendation and could result in higher vehicle speed. This a concern in the area as cyclists are likely to be present on the road carriageway in this general area when travelling between the segregated cycle track (to the south) and the shared ped/cycle path along the site's northern boundary.

The street should be narrow to meet the DMURS recommendations.

Consideration should also be given to implementing signage that would provide advanced cycle warning to the drivers of the presence of cyclists on the carriageway in this area.

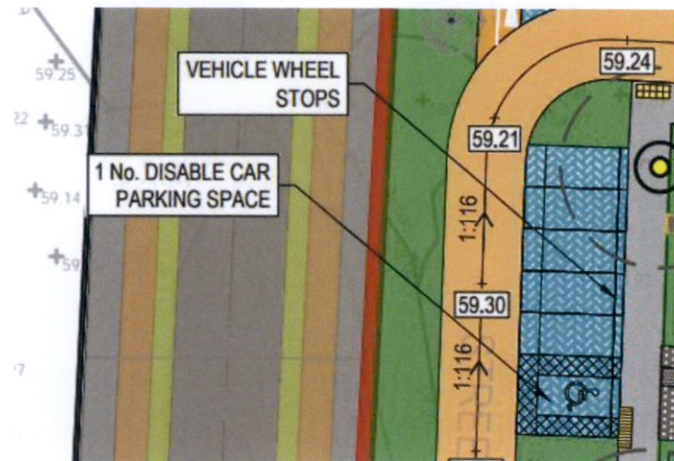
The auditors have noted that perpendicular car parking bays are provided immediately adjacent pedestrian walkways in several locations. It is noted that there are no physical barriers (e.g. bollards, wheel stops etc) between the parking bays and pedestrian walkway. There is a risk that drivers parking their cars (or worse case light goods vehicle such as vans) may cross over / encroach into the intended pedestrian footway resulting in pedestrian / vehicle collisions and / or pedestrian movements becoming obstructed.

Wheel stops have been provided on the roads layout to prevent vehicle overhangs encroaching on footpaths.

It is recommended that measures are implemented to prevent vehicles encroaching into the pedestrian footway.

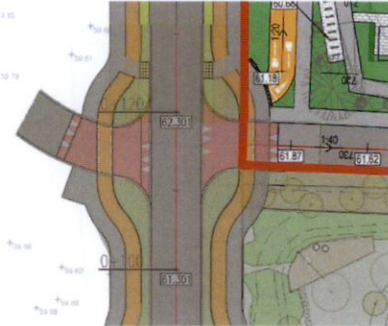
Comment (C1) – Junction Performance

The subject Tile 3 development is proposed to be accessed via a priority controlled junction located south-west of the site. This junction will also be used by other development Phases of Clonburris SDZ, therefore, the auditors feel that the priority arrangement of this junction, due to anticipated high traffic volume may result in the junction poor performance. The designer may consider signalised junction arrangement which could operate better in this case.

The Link Street adjacent to the proposed development has been granted planning under a separate planning application and has been deemed compliant.

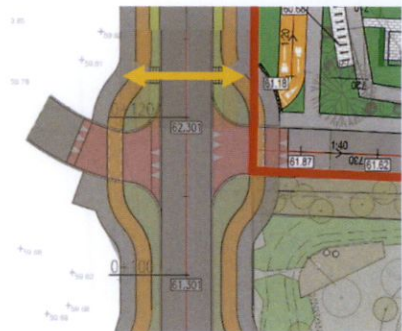
Comment (C2) – Need for Controlled Pedestrians Crossings

Further to C1, uncontrolled crossing is provided at the site access junction. The auditors feel that there is a need for controlled crossing for pedestrian and cyclists at this location due to anticipated high number of pedestrians and cyclists using the facility.

The Link Street adjacent to the proposed development has been granted planning under a separate planning application and has been deemed compliant.

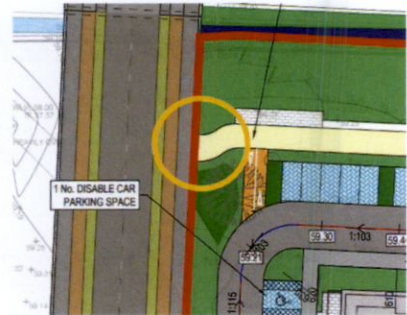
Comment (C3) – Pedestrian/Cycle Link to T4

The auditors are not sure about how the shared pedestrian/cycle route will connect to T4 development. If it connects to T4 via a tunnel, ensure sufficient lighting and headroom are provided for cyclists.

The bridge shown on the proposed drawings are indicative only and proposals will be lodged under a separate planning application. The lighting layout drawing SES 15522 for the proposed development is enclosed.
