Proposed Extension to Educate Together School at Esker, Lucan, Co. Dublin

ROAD SAFETY AUDIT STAGE 1/2

April 2023

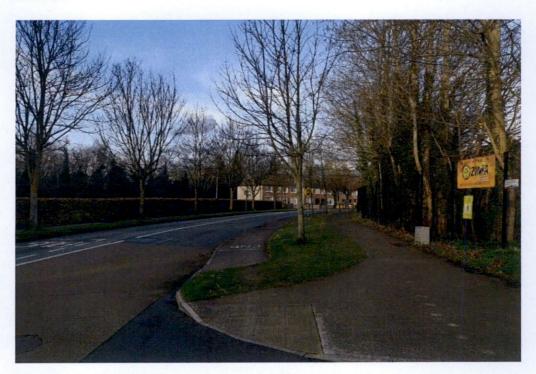
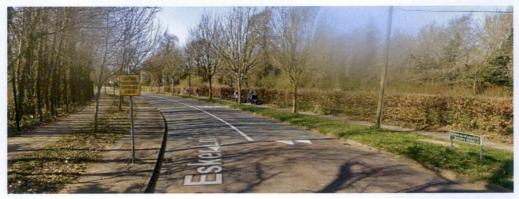
2.1 Problem

The visibility splay to the right from the retained access onto Esker Lane is partially obstructed by a tree (or trees) located within the roadside verge. At the time of the site visit the trees were without foliage, the trunks were small diameter and the impact on the sightline was minimal. In addition, the speed of traffic is slow due to the presence of ramps on Esker Lane. However, the presence of a sign beside the eastbound lane warning drivers of a concealed entrance ahead would indicate that there was concern at some time in the past in relation to the safe operation of the access.

Road safety risk is increased in situations where inter-visibility between drivers turning at an access and drivers approaching on the mainline is restricted. This may increase the likelihood of collisions at the access.

Ideally the trees within the visibility splay would be removed. If that is not feasible, they should be maintained in a condition such that they do not cause greater obstruction to sightlines.

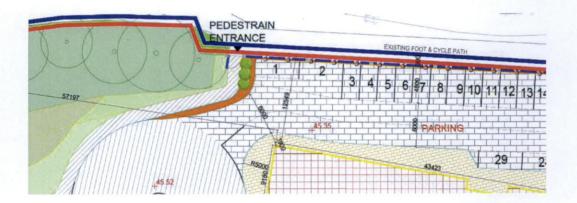
2.4 Observation

Given the tight horizontal curvature it may be difficult for opposing vehicles to pass with ease were they to meet on the bend at the entrance to the teacher car park. It may be beneficial to provide some additional road width on the bend by moving, to the north, the proposed northern kerb line.
