**ARBORICULTURAL ASSESSMENT
&
IMPACT REPORT**

**FORGEFIELD
STOCKING LANE
FIRHOUSE
NEWTOWN
DUBLIN 16**

Project No.	Project name	Date	Revision
TFOR001	Forgefield	22/08/23

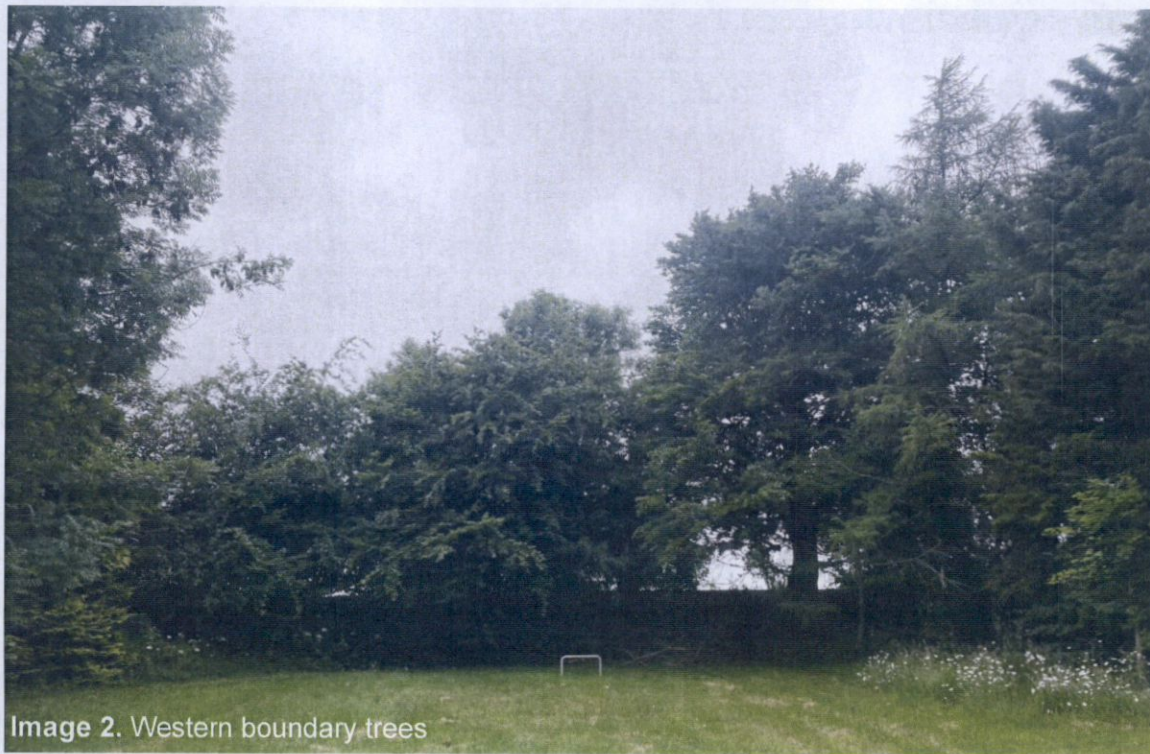
mature sycamore (*Acer pseudoplatanus*) and beech (*Fagus sylvatica*). These trees form a cohesive group and a strong screen to the site (images 2 & 3) and are well developed overall. There is strong competition between individual specimens with decay and defects consistent with their age and proximity prevalent.

Image 2. Western boundary trees

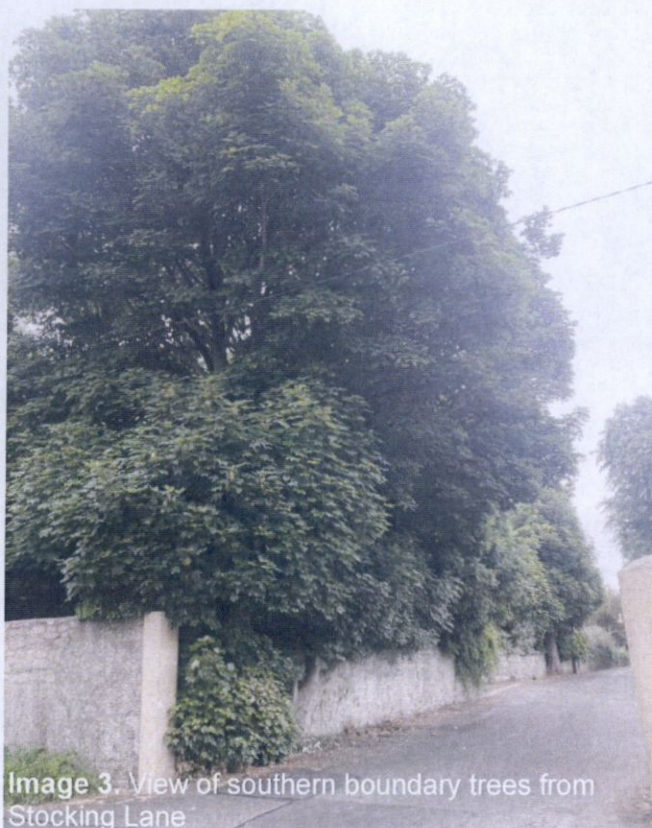
Image 3. View of southern boundary trees from Stocking Lane

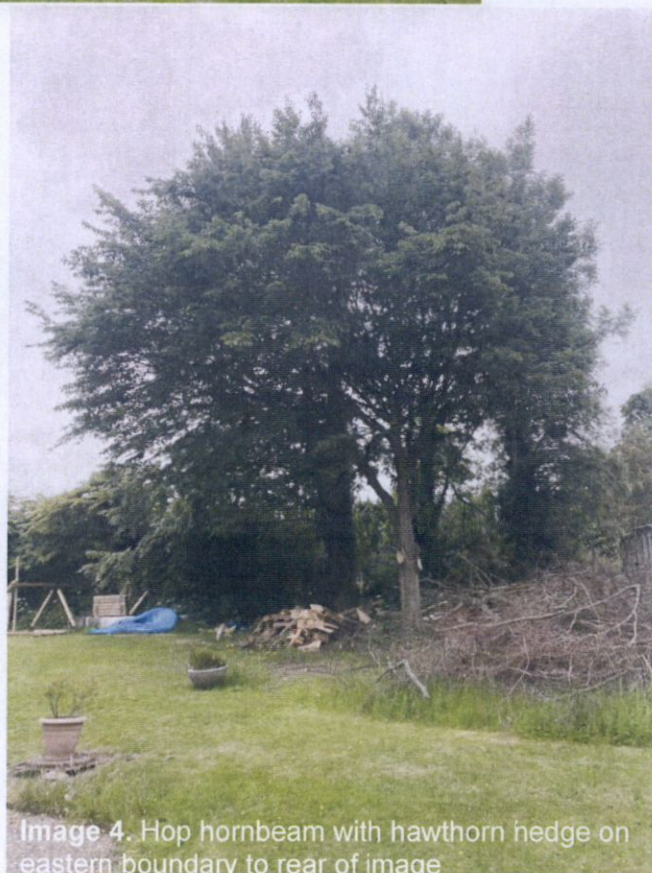
Image 4. Hop hornbeam with hawthorn hedge on eastern boundary to rear of image

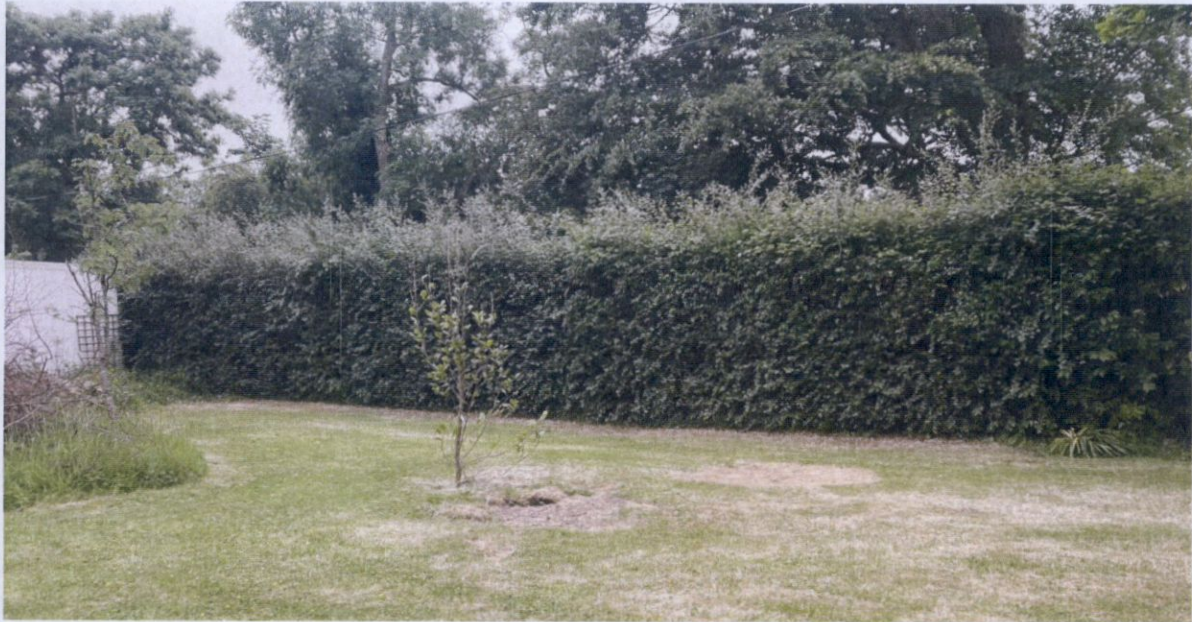
Image 5. Cotoneaster hedge on boundary with access road to golf course
