PROPOSED DEVELOPMENT SITE, OLD NANGOR ROAD, DUBLIN 22

EXISTING CULVERT HYDRAULIC ASSESSMENT REPORT

Document No:	IE1978-4525
Issue No:	01-ISSUE
Project No:	IE1978
Date:	27 th March 2020
Revision:	2.0
Prepared By:	N O'Malley BE CEng MIEI

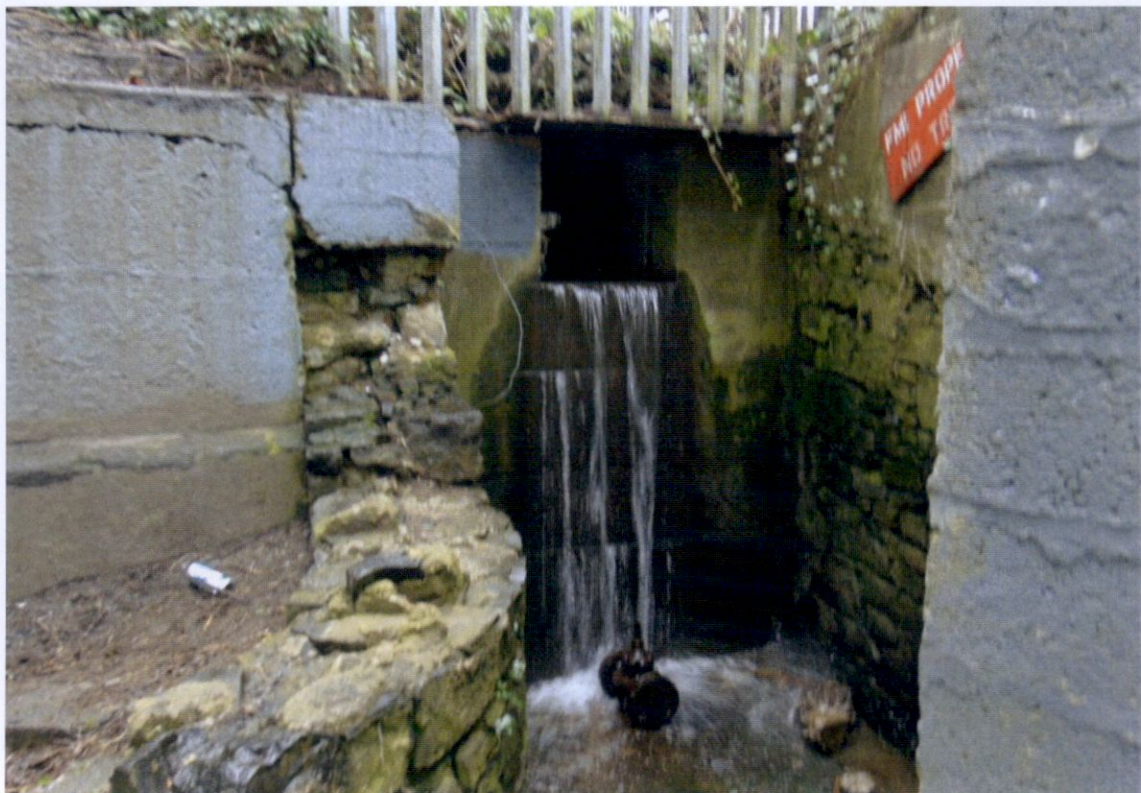
Figure 2 – Concrete Tank Outlet

The culvert was originally constructed as part of a paper mill, which is no longer in existence. It does however provide a hydraulic conveyance function to allow waters that spill into the Mill Pond from the Camac River to flow back into the river downstream. The rate of discharge from the pond is limited by an opening in the side of the concrete tank located upstream of the culvert inlet as shown in *Figure 2* below.

The flow limiting factor into the culvert is likely to be the Concrete tank outlet, which was assessed by increasing the flow into the hydraulic model until such time that the water levels surcharge above the top of the concrete tank roof level.

A peak flow of $0.695\text{m}^3/\text{s}$ was determined to be the peak flow that may discharge from the outlet of the concrete tank.

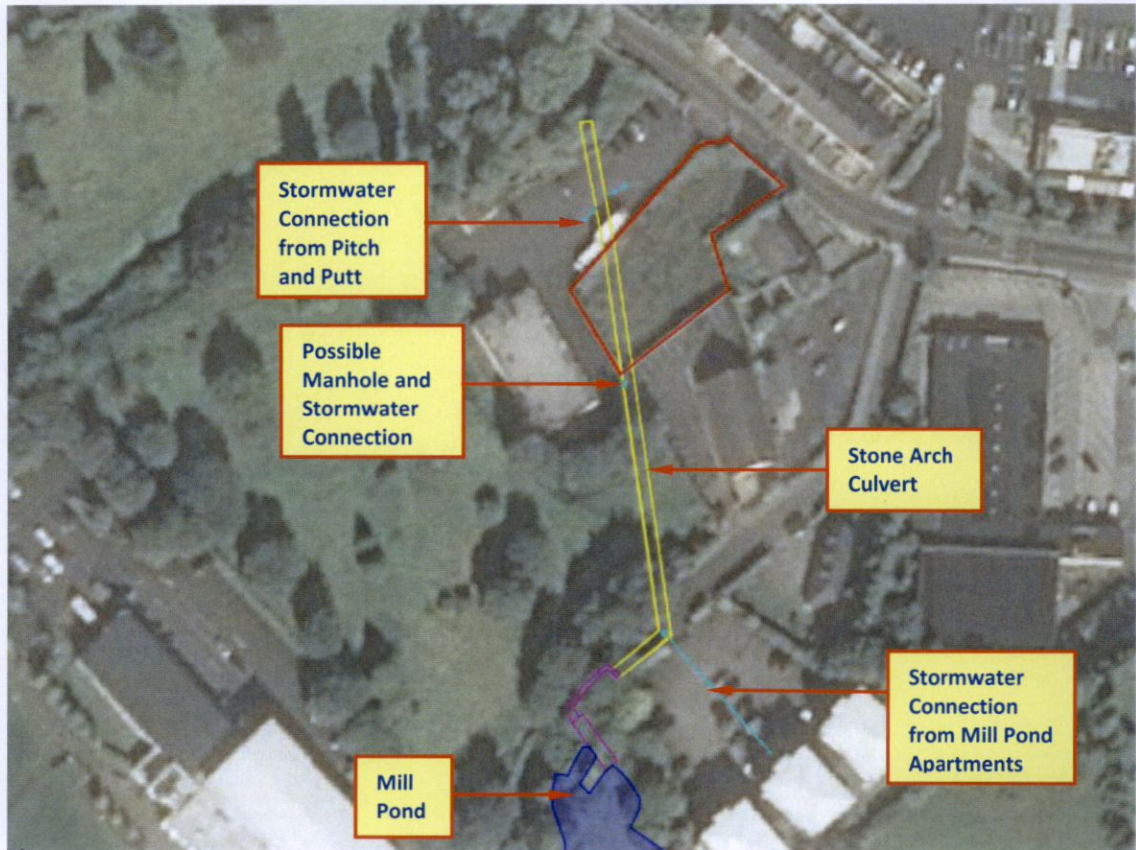
Figure 5 – Potential Stormwater Connections

The culvert inspection survey was not able to determine the location of any stormwater connections discharging to the culvert from adjacent properties due to significant blockage at the culvert inlet. It is likely however that the Mill Pond Apartments and the Pitch and Putt facility may have a stormwater connection to the culvert. The manhole identified within the culvert is likely to be the connection point from the Mill Pond apartments. There are also two stormwater gullies located within the car park of the Pitch and Putt. It is possible given their location that these are connected to the stone arch culvert. The anticipated location of these connections is shown in *Figure 5* below. Although the stormwater connection from the Pitch and Putt is likely to be located downstream of the proposed development site for the purposes of this assessment it is assumed to be located upstream of the site as a possible manhole was identified upstream of the site as shown in *Figure 5* below.

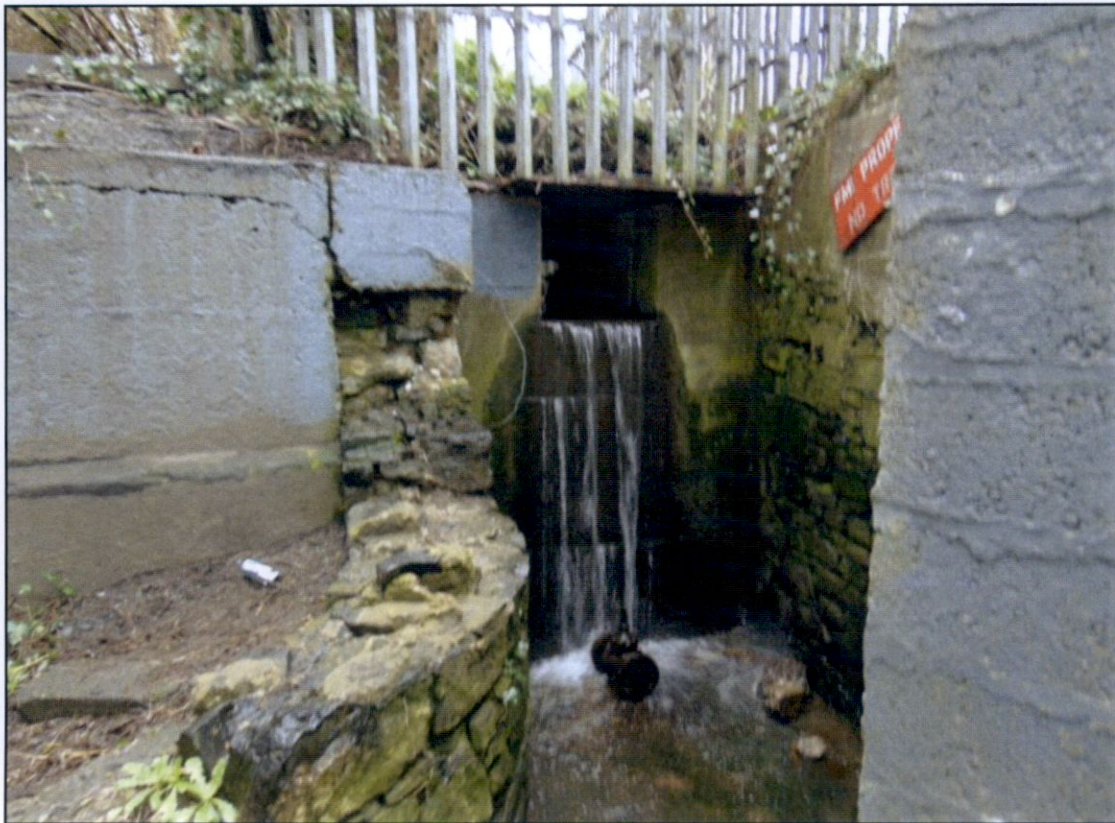
Photo 3: Concrete Tank Outlet

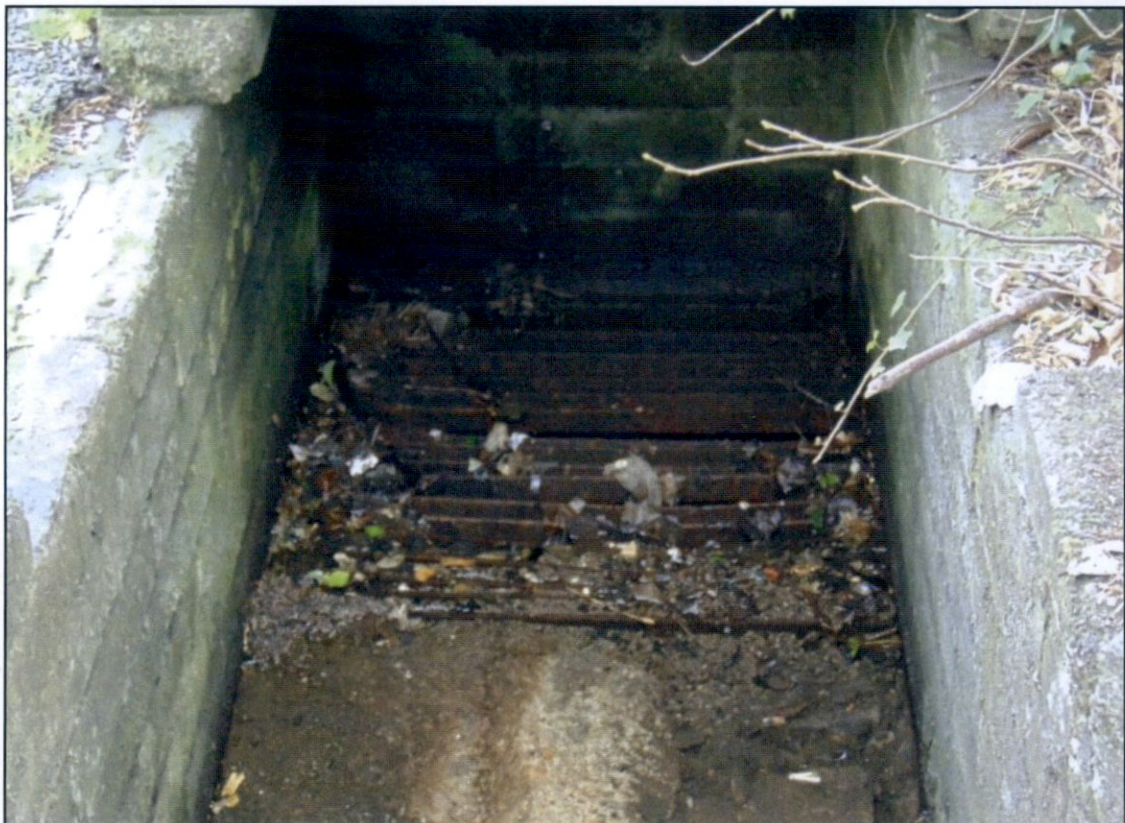
Photo 6: Sump Inlet & Grill

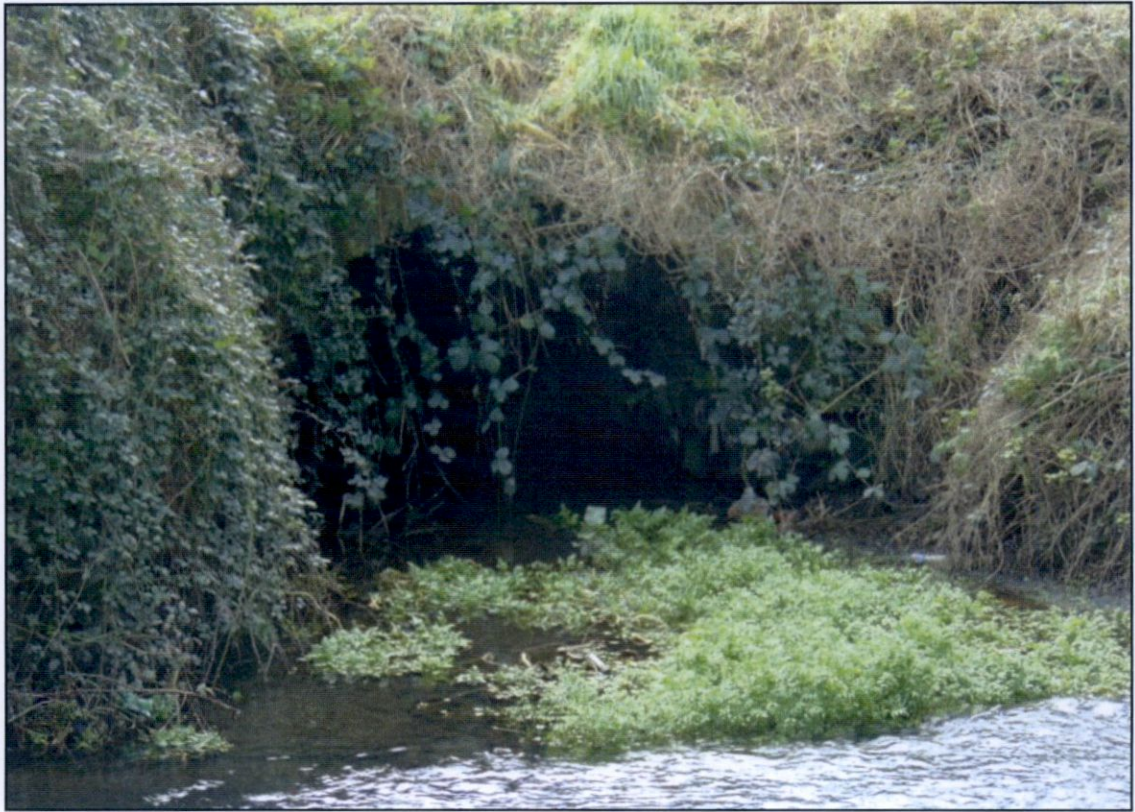
Photo 7: Culvert Outlet to Camac River

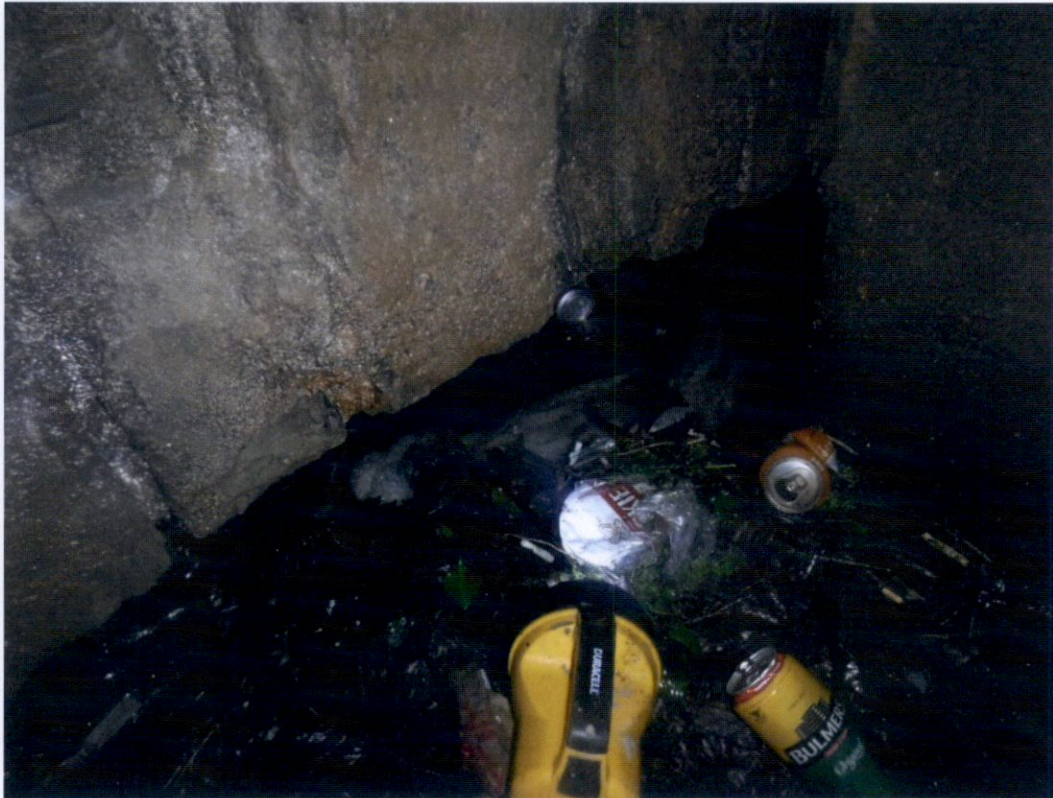
There is a small sized chamber between the steel grate and what appears to be the fascia of an old masonry arch bridge. The water level is up to approximately 300 mm of the arch barrel soffit. A build up of coarse gravel material and debris is present at the old bridge fascia. This blockage, and high-water level prevented progress further downstream. There is a block chamber approximately 8m downstream from the

Photograph No. 1 Upstream end. Old bridge fascia.

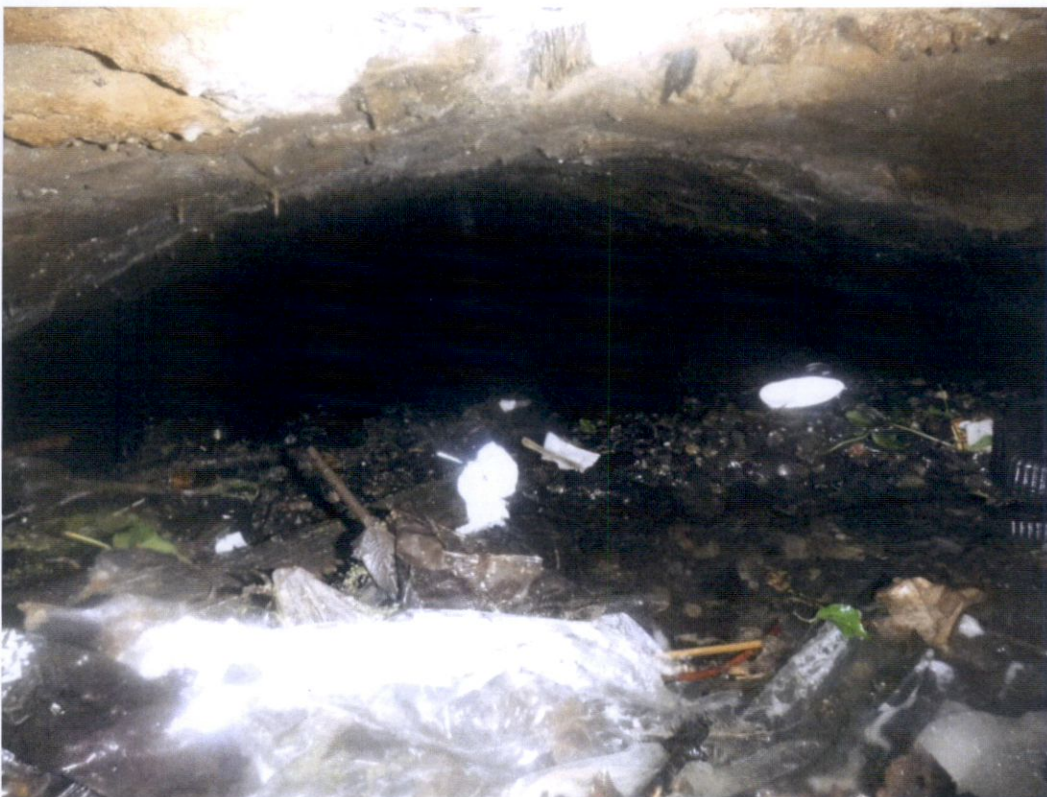
Photograph No. 2 Upstream End @ 2 m. Blockage in Arch Barrel

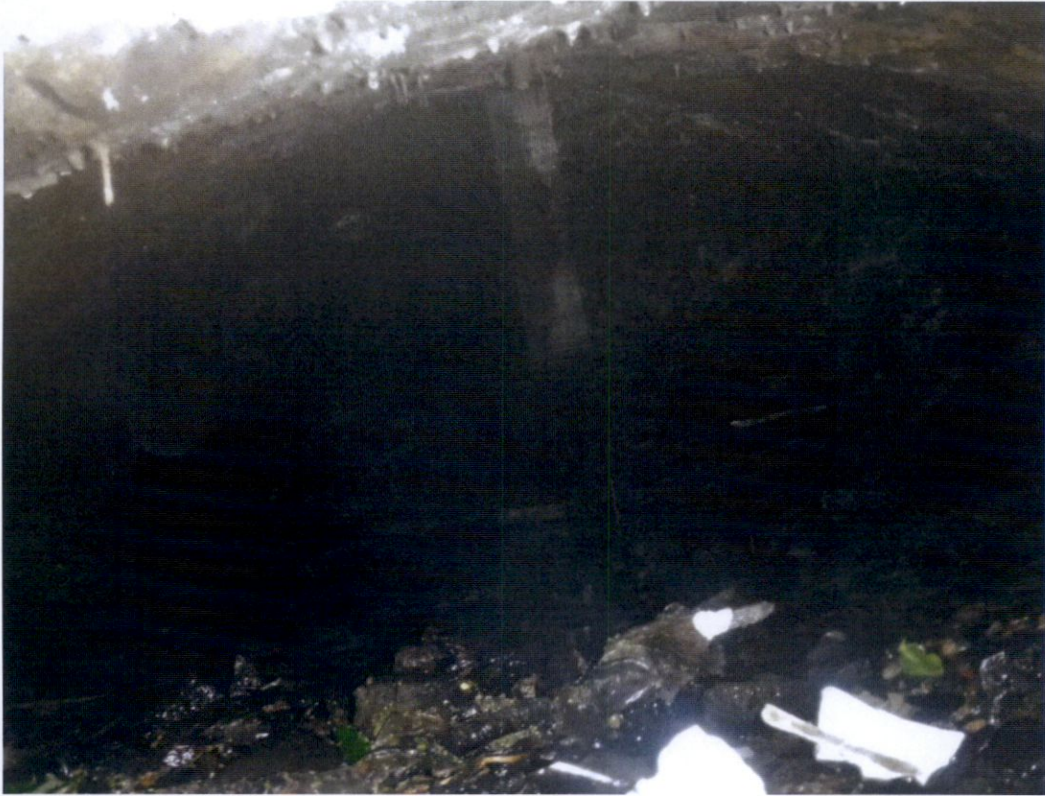
upstream fascia of the culvert. The chamber can be seen in photograph number three below. South Dublin County Council stated they were going to go back and scan the road, to see if they can find a manhole lid under the road carriageway.

Photograph No. 3 Upstream End @ 2 m. Arch Barrel

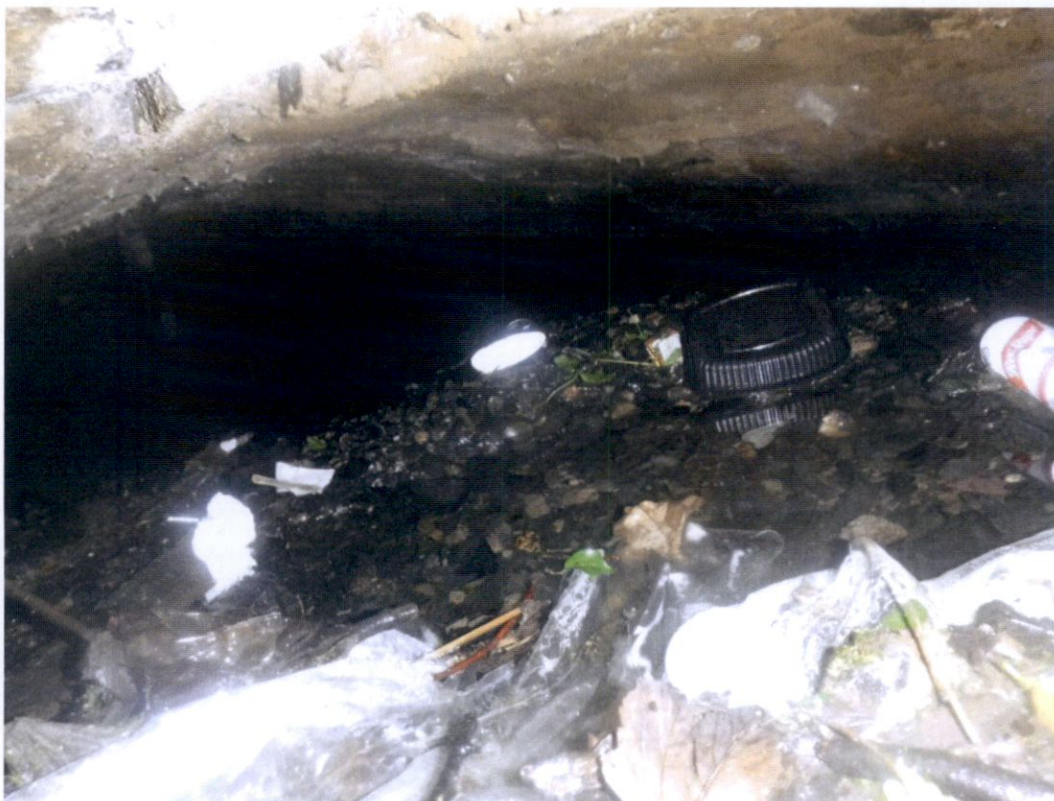
Photograph No. 4 Upstream End @ 2 m. Arch Barrel
