DUBLIN SIMON COMMUNITY

PROPOSED DEVELOPMENT SITE, OLD NANGOR ROAD, DUBLIN 22

PROPOSED CULVERT HYDRAULIC DESIGN REPORT

Document No:	IE1978-4571
Issue No:	02-ISSUE
Project No:	IE1978
Date:	15 th August 2023
Revision:	2.0
Prepared By:	N O'Malley BE CEng MIEI

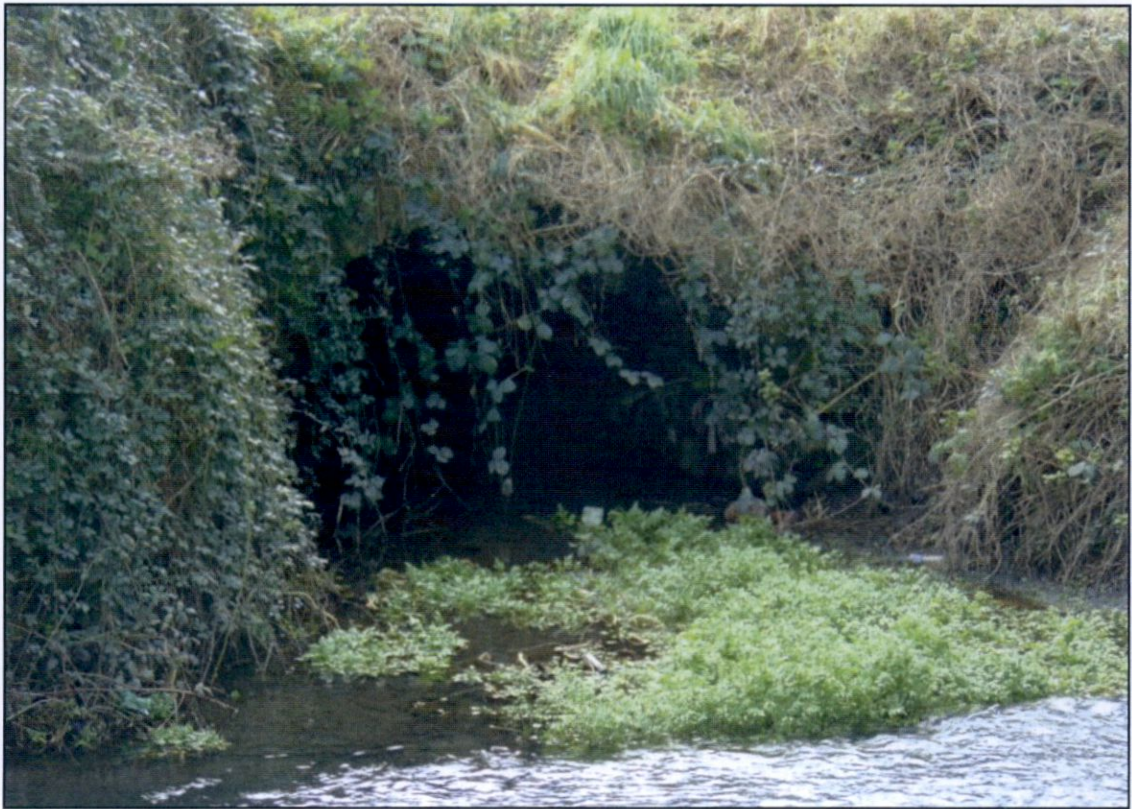
Figure 2 - Culvert Outlet to Camac River

The existing stone arch culvert is approximately 125m in length from the inlet adjacent to the Mill Pond apartments to outlet where it discharges to the Camac River. The culvert outlet is shown in *Figure 2* below.

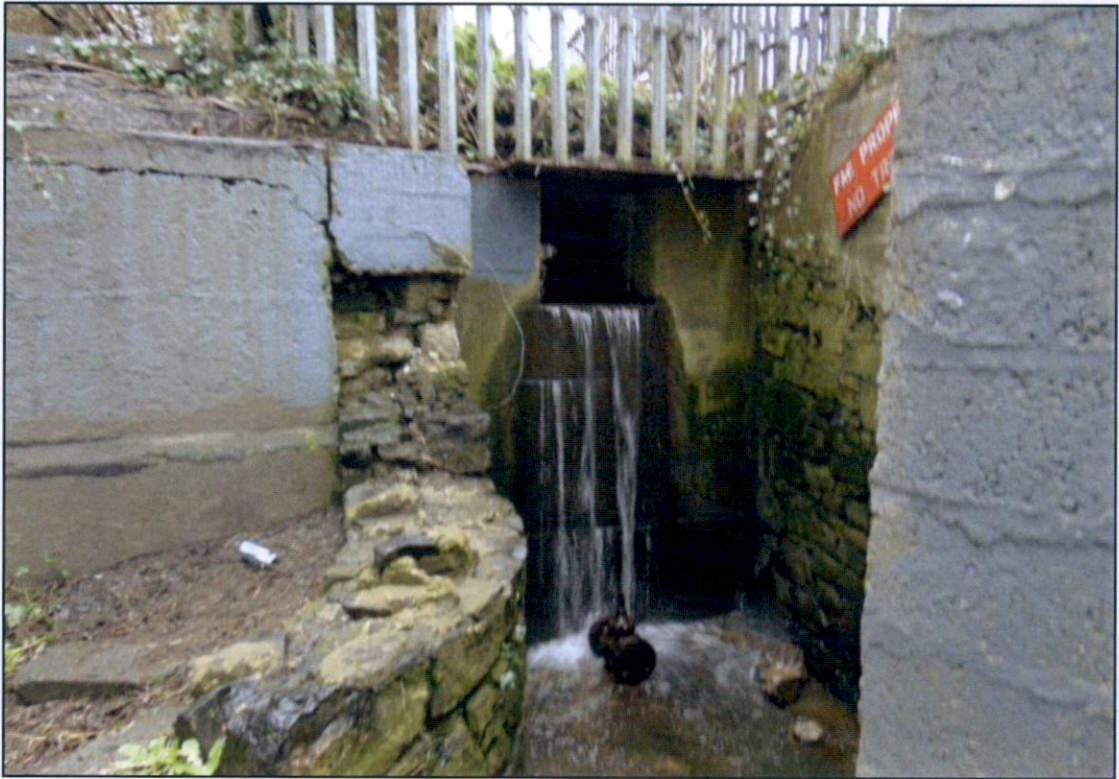
Figure 3 – Concrete Tank Outlet

The flow limiting factor into the culvert is the concrete tank outlet, which was assessed by increasing the flow into the hydraulic model until such time that the water levels surcharge above the top of the concrete tank roof level.

A peak flow of 0.695m³/s was determined to be the peak flow that may discharge from the outlet of the concrete tank.

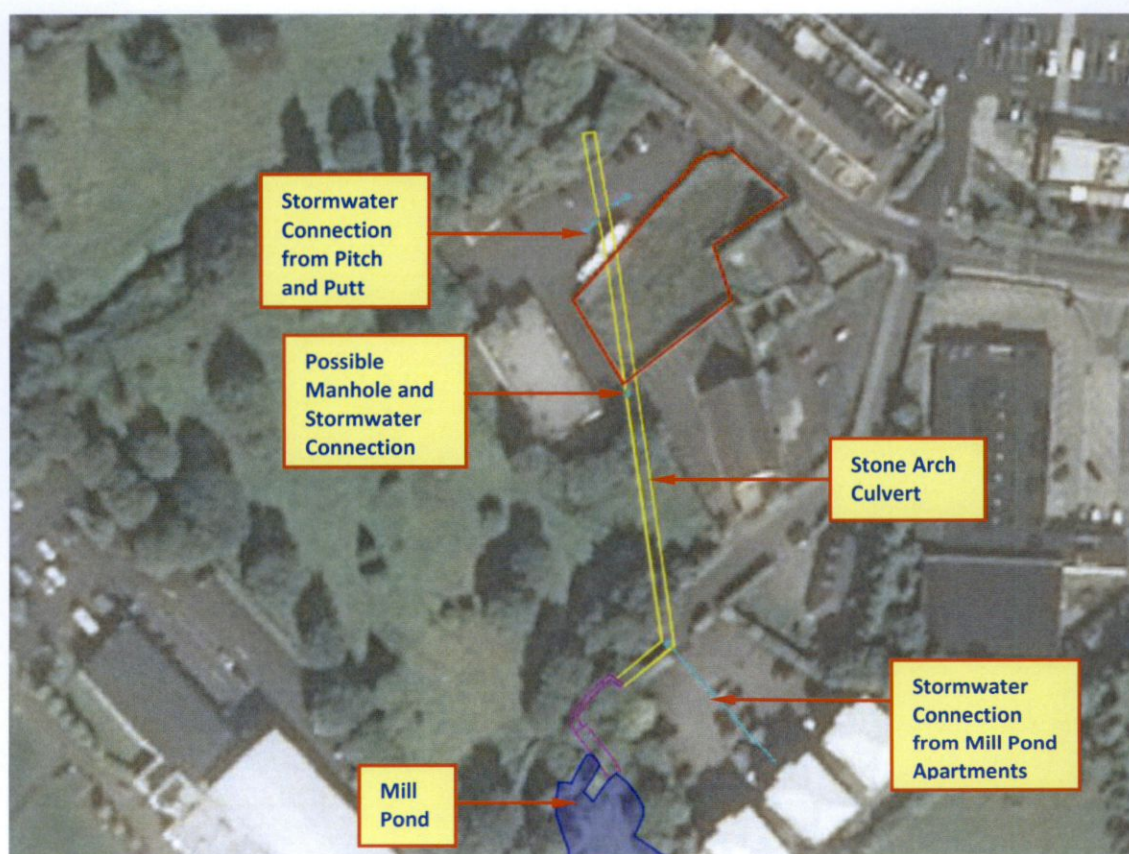
Figure 8 – Potential Stormwater Connections

Council identifies a pipe connection emanating from the direction of the Mill Pond apartments and therefore it is likely the surface water runoff from this development discharges to the stone arch culvert. It is also likely that the Pitch and Putt facility may have a stormwater connection to the culvert. The manhole identified within the culvert is likely to be the connection point from the Mill Pond apartments. There are also two stormwater gullies located within the car park of the Pitch and Putt. It is possible given their location that these are connected to the stone arch culvert. The anticipated location of these connections is shown in *Figure 8* below. Although the stormwater connection from the Pitch and Putt is likely to be located downstream of the proposed development site for the purposes of this assessment it is assumed to be located upstream of the site as a possible manhole was identified upstream of the site as shown in *Figure 8* below.

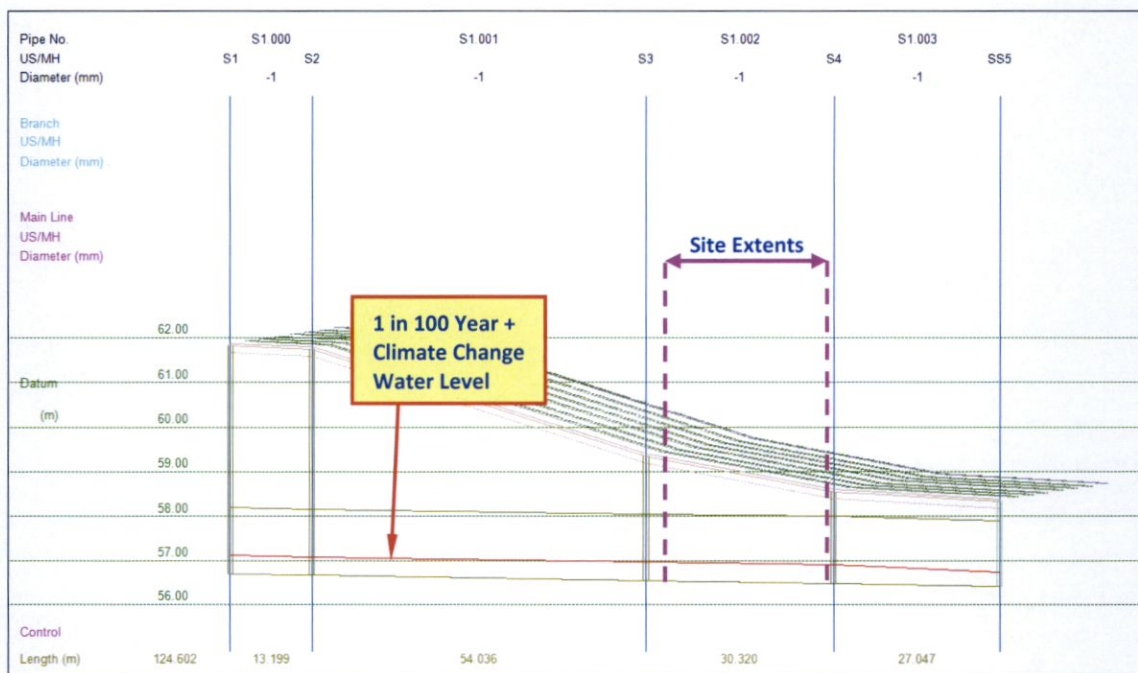
Figure 10 – Existing Scenario: 1 in 100 Year + 20% Longitudinal Profile

The peak 1 in 100 year + climate change flow rate that may discharge from the culvert into the Camac River is 1.02m³/s.

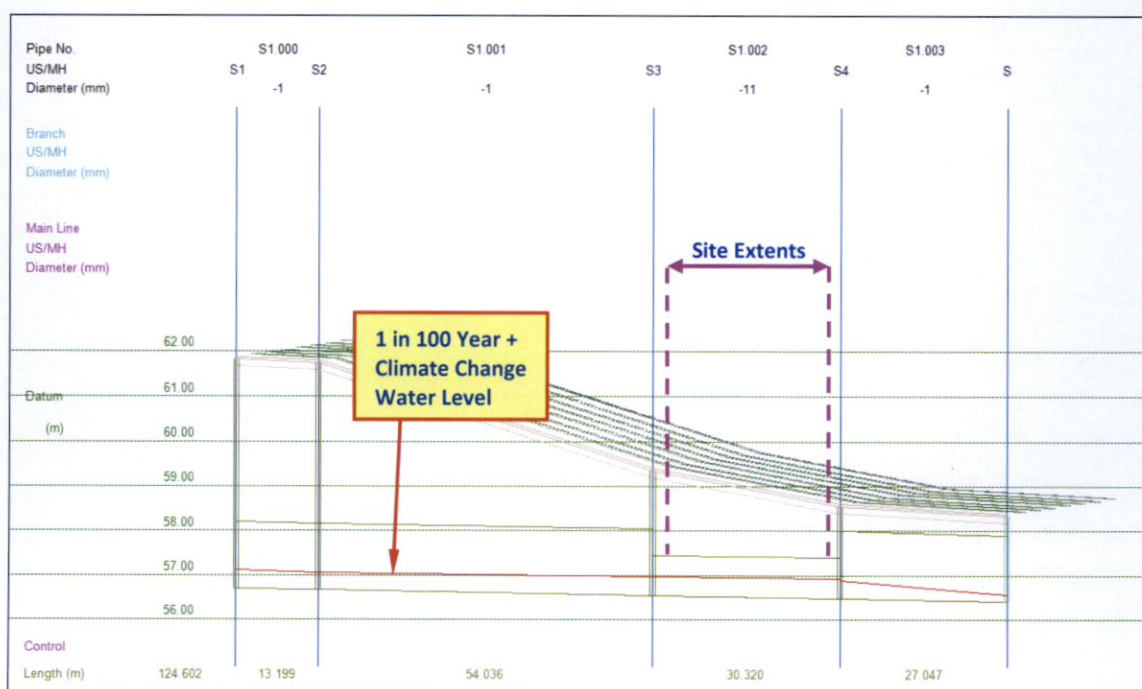
Figure 11 – Proposed Scenario: 1 in 100 Year + 20% Longitudinal Profile

The proposed three 900mm pipe culverts have sufficient hydraulic capacity to convey the 1 in 100 year + 20% climate change flow. The depth of freeboard is 445mm at the upstream end and 411mm at the downstream end of the culverts respectively. The proposed culvert plan and section details are shown on drawing number *IE1978-001-A, Appendix E*.

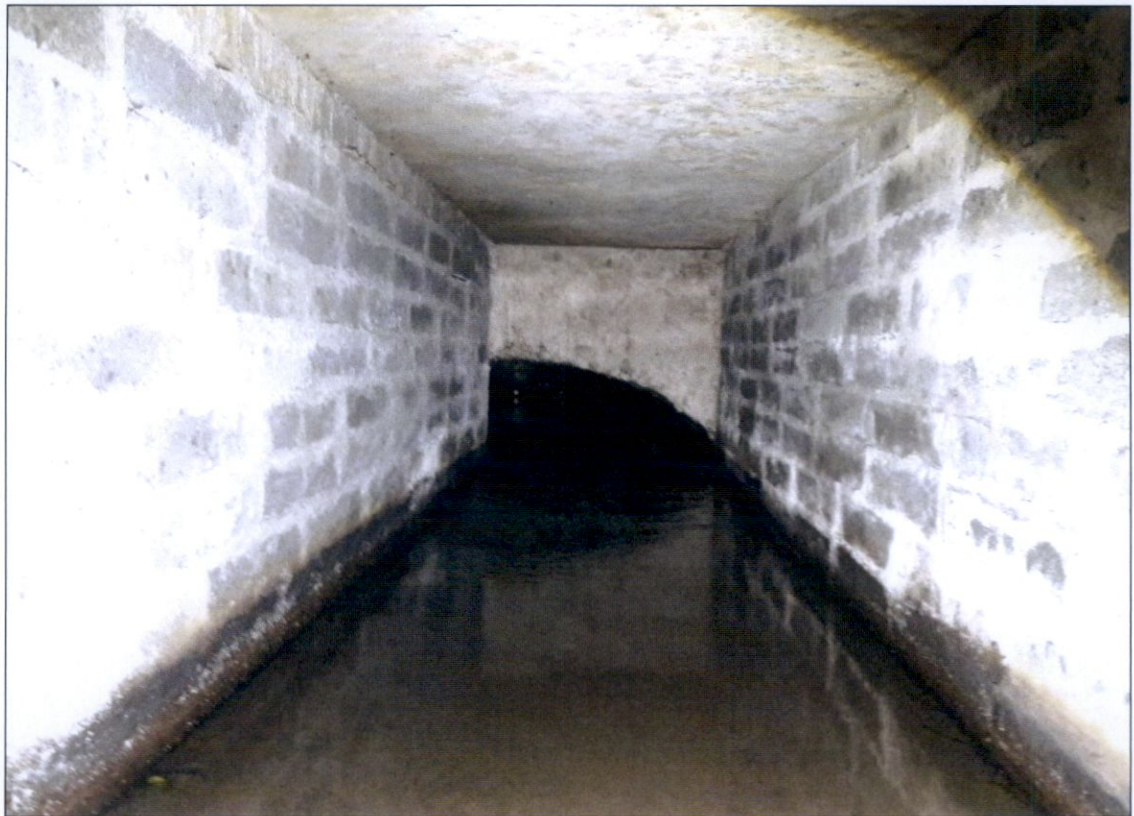
surface with a metal detector and had the cover exposed and raised to road level. A further inspection of the culvert was carried out in this location by SDCC in May 2020. This identified a pipe connection emanating from the direction of the Mill Pond Apartments. The existing culvert in this location appears to have been rebuilt with concrete blocks, which has substantially reduced the aperture of the existing stone arch culvert. It is estimated that this opening has reduced the existing culvert capacity by more than 50%. This is believed to be the reason for the substantial blockage at the culvert inlet.

The existing full bore capacity of the stone arch is no longer required or appropriate as the paper mill is no longer in existence. There is also a substantial in the reduction of the culvert aperture location at the culvert inlet in front of the Mill Pond Apartments. The existing culvert in this location appears to have been rebuilt with concrete blocks, which has substantially reduced the existing culvert capacity by more than 50%.

Photo 8: Rebuilt Culvert Outside Mill Pond Apartments Looking Upstream

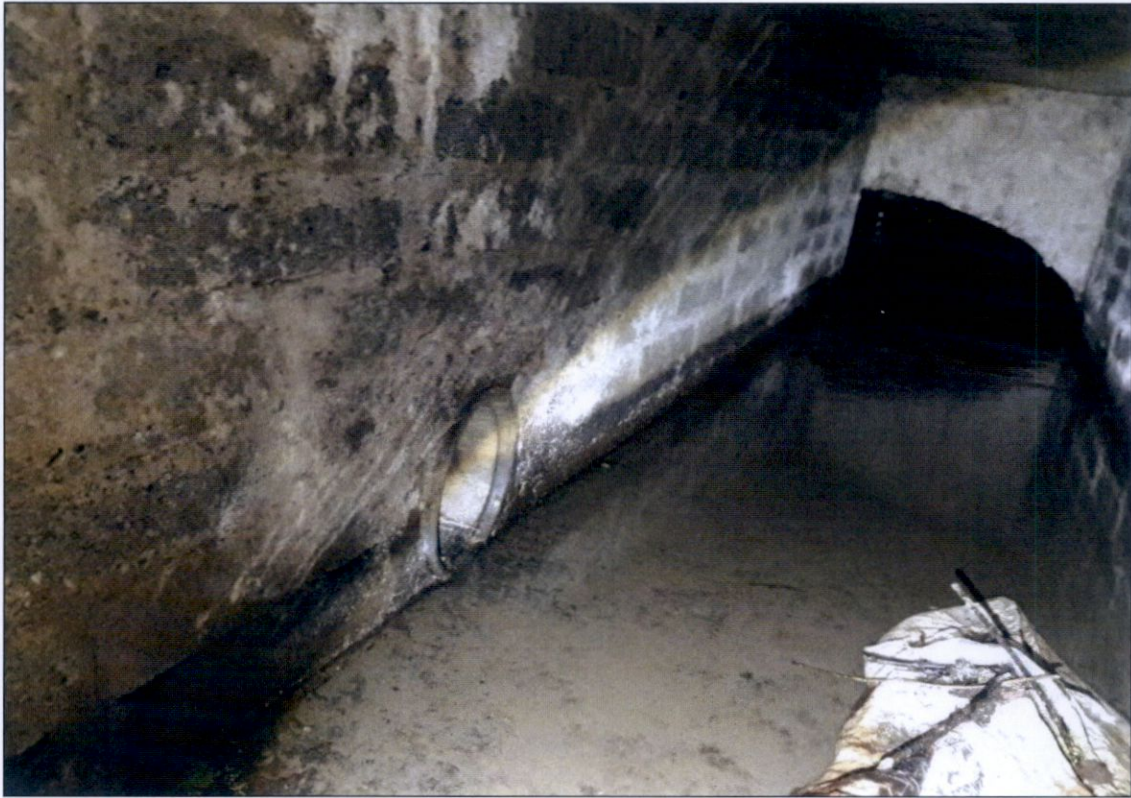
Photo 9: Stormwater Connection from Mill Pond Apartments

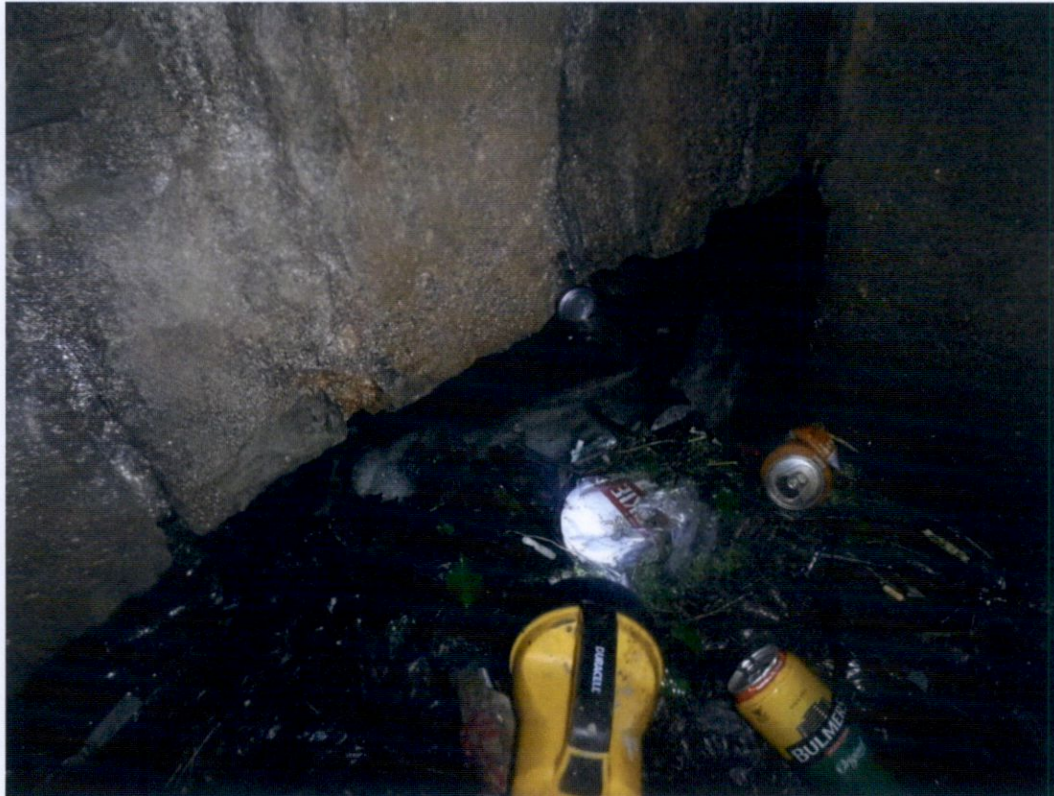
Photograph No. 1 Upstream end. Old bridge fascia.

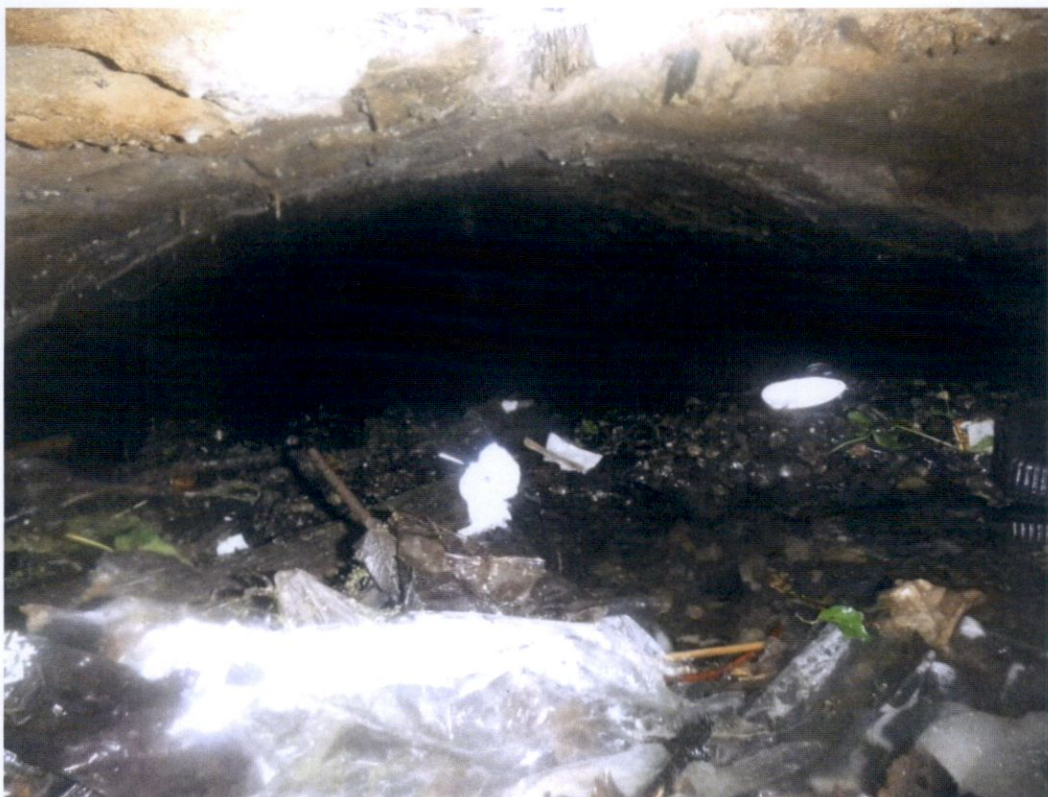
There is a small sized chamber between the steel grate and what appears to be the fascia of an old masonry arch bridge. The water level is up to approximately 300 mm of the arch barrel soffit. A build up of coarse gravel material and debris is present at the old bridge fascia. This blockage, and high-water level prevented progress further downstream. There is a block chamber approximately 8m downstream from the

Photograph No. 2 Upstream End @ 2 m. Blockage in Arch Barrel

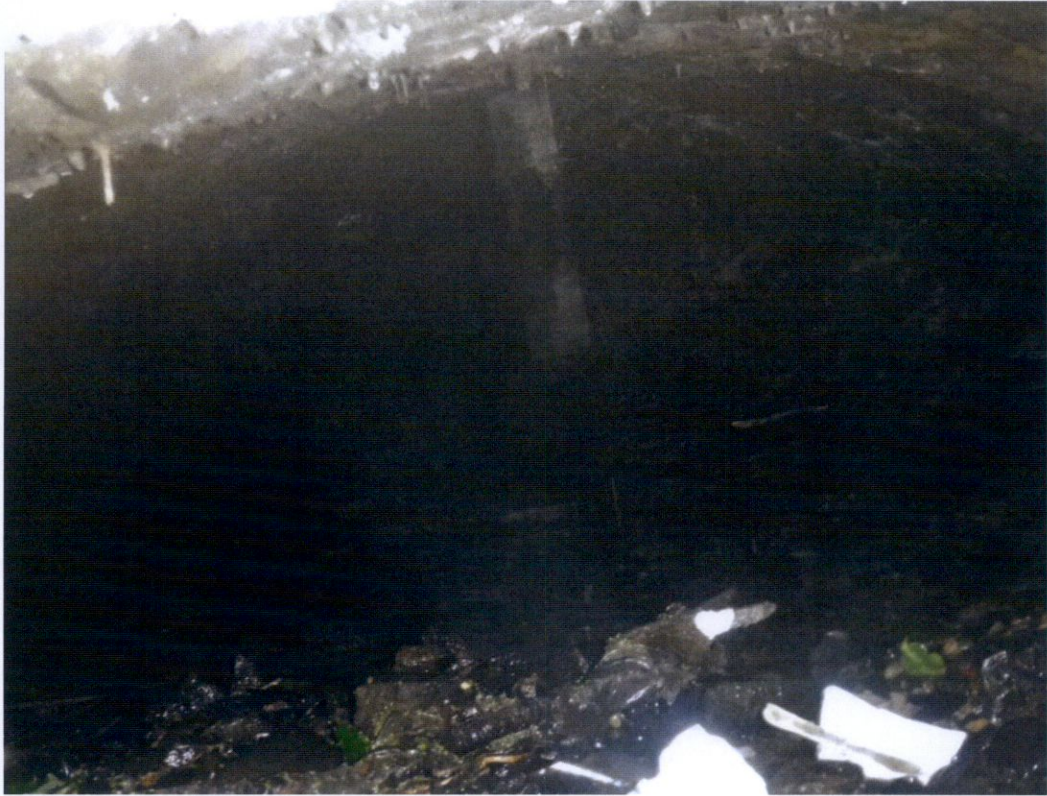
upstream fascia of the culvert. The chamber can be seen in photograph number three below. South Dublin County Council stated they were going to go back and scan the road, to see if they can find a manhole lid under the road carriageway.

Photograph No. 3 Upstream End @ 2 m. Arch Barrel
