Title: STAGE 2 ROAD SAFETY AUDIT

**Proposed Self Storage Warehousing Facility at Liffey Valley,
Lucan, Dublin 22.**

Date: December 2023

Report reference: 2107R01

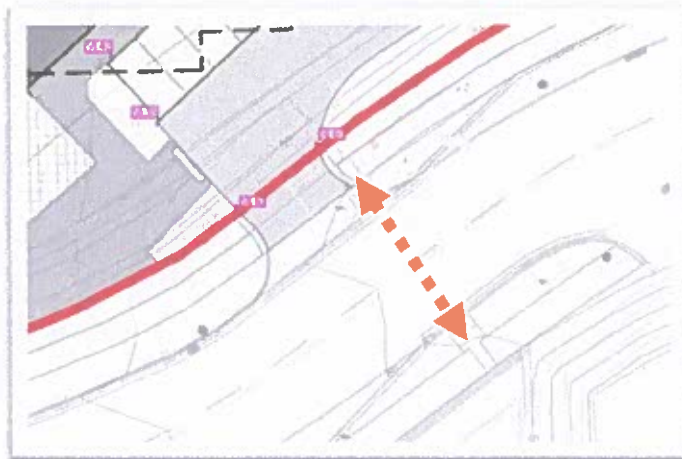
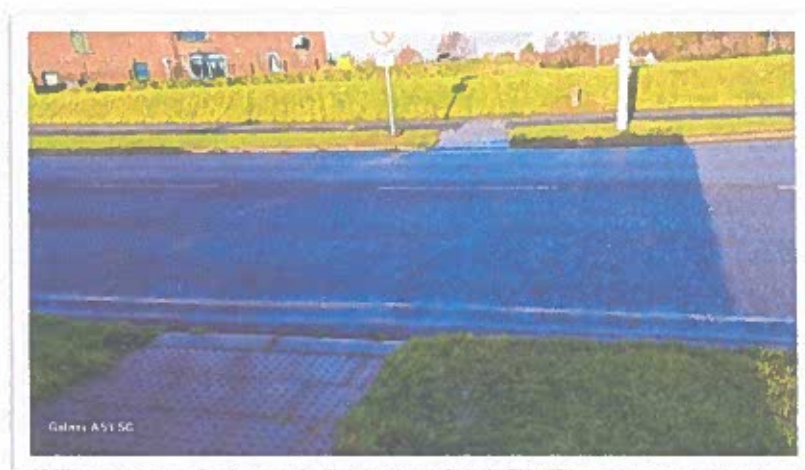
Drawing USLV-GDE-ZZ-DR-C-0006 Rev T, GDCL, Motor Hall Road.

The new access to the development off Motor Hall Road is at the existing uncontrolled pedestrian crossing which is strategically located to serve the bus stops/laybys. A lack of crossing facilities could lead to trips on the high kerbs and interaction between turning vehicles and pedestrians.

It is recommended that a new crossing be provided for pedestrians.

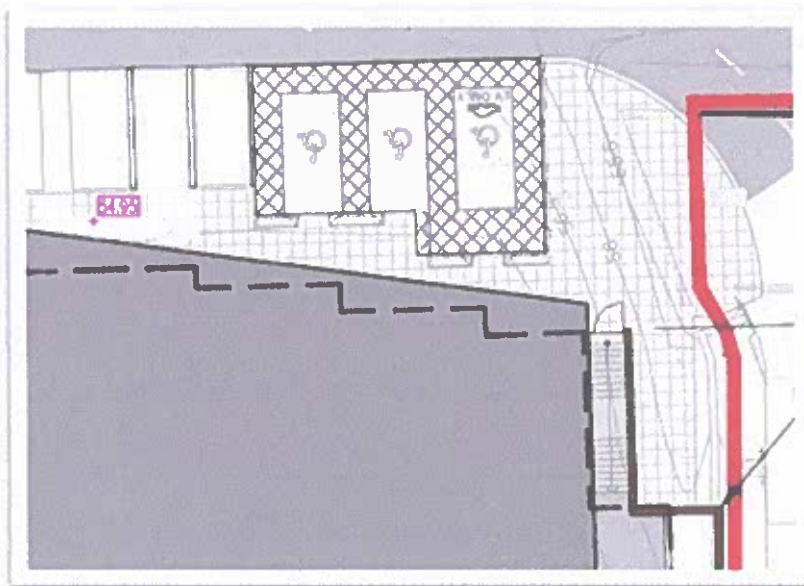
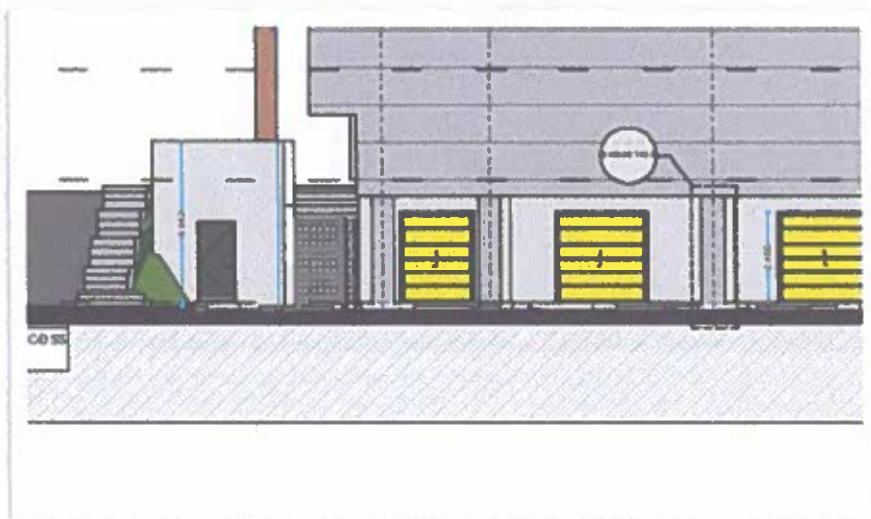
Drawing USLV-GDE-ZZ-DR-C-0006 Rev T, GDCL, Disabled parking spaces.

It is unclear if the mobility impaired using the disabled parking spaces to the rear of the building will be able to access the building from the spaces without having to travel up steps. A lack of facilities for the mobility impaired could lead to falls or inaccessibility.

Ensure all parts of the building can be accessed by disabled users of the rear parking spaces.

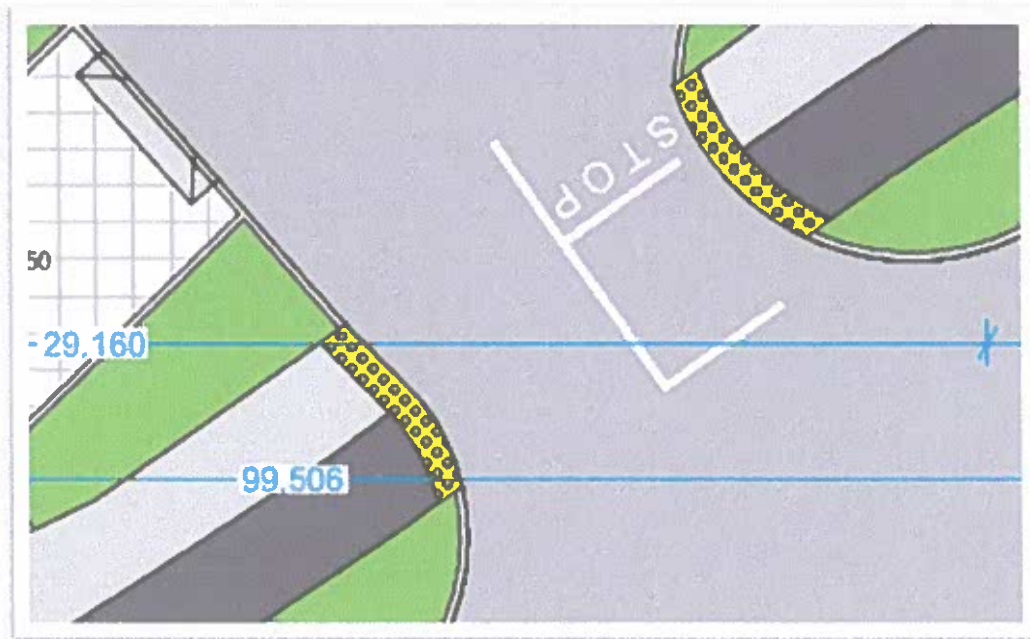
Drawing USLV-CKA-401 Rev -, Carew Kelly Architects, New access.

Some tactile paving is shown at the new access where the cycle track and footpath are intersected. The proposed depth of the tactile paving is unclear. The crossing is an in-line crossing and if the tactile paving is not deep enough then blind or partially sighted pedestrians may not detect it under foot which could result in collisions with turning vehicles.

It is recommended that a suitable depth of tactile paving be provided for an inline crossing. Suitable depth dropped kerbs should also be used to avoid trip hazards and not prevent accessibility.

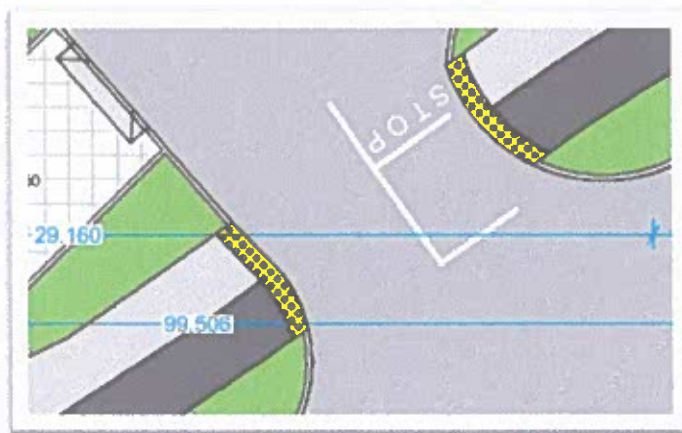
USLV-CKA-401 Rev -, Carew Kelly Architects, New access.

There is an usual double stop line at the proposed egress. The stop lines are relatively close and may lead to confusion. It is also unclear if a stop sign is proposed. The layout may not give enough prominence to cyclists and pedestrians leading to collisions especially with fast moving e-scooters and electric bikes.

It is recommended that a single stop line be provided in advance of the footpath, that a stop sign be provided and that some warning road markings and coloured surfacing be provided to highlight the potential presence of crossing cyclists to drivers exiting the development.

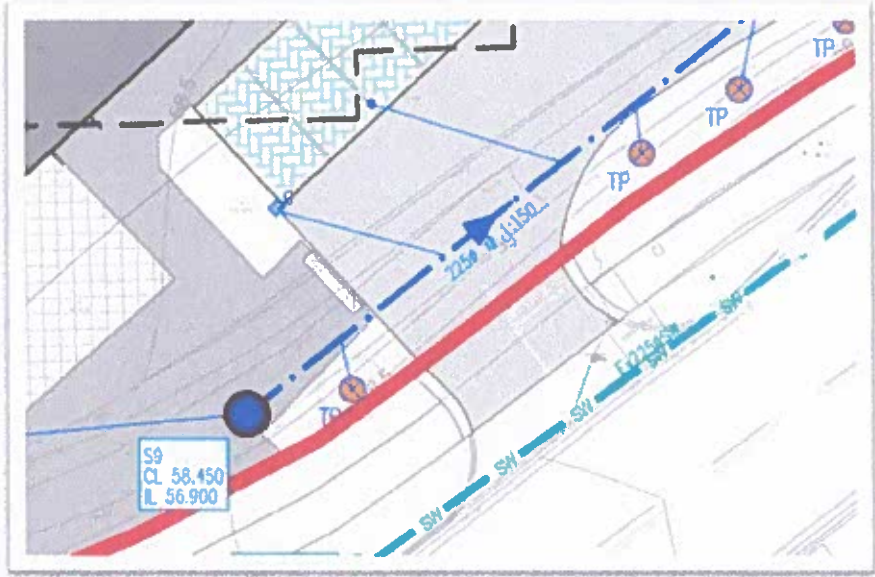
USLV-GDE-ZZ-DR-C-0004 Rev T, GDCL, Motor Hall Road, Drainage.

There is a risk of surface water ponding at the dropped kerbs of the new access which could lead to slips and falls for pedestrians and loss of traction and loss of control for cyclists.

It is recommended that gullies be provided immediately upstream of the dropped kerbs

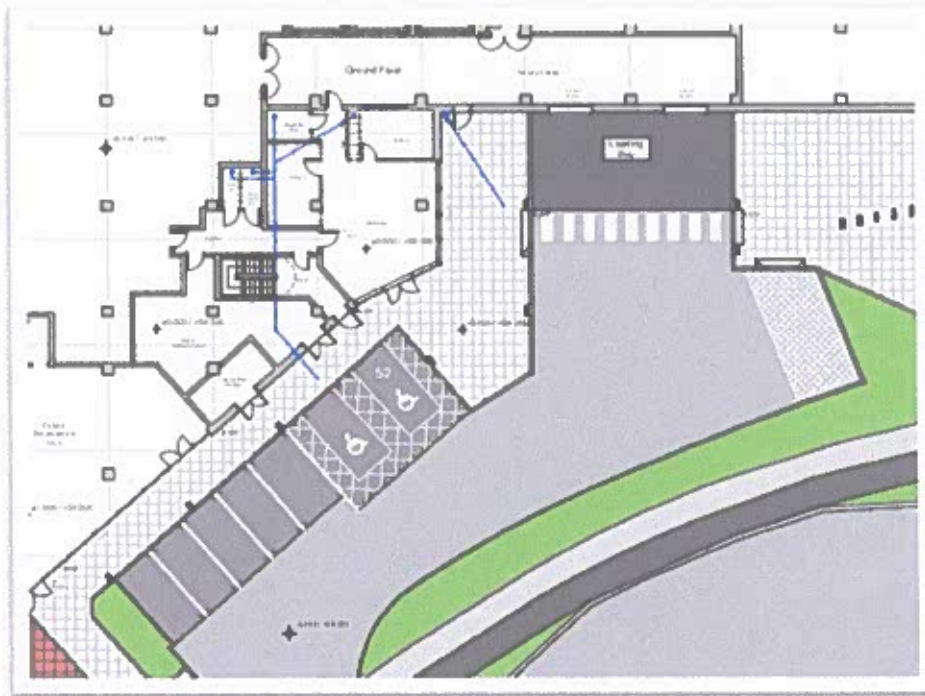
Location.
Loading Bay.

It is unclear if the loading area will be capable of allowing large HGVs to turn without striking street furniture, parked vehicles or other features of the development. A lack of space could lead to damage.

It is recommended that a swept path analysis be carried out for the largest vehicles to use the development to ensure that adequate space is provided.
