**Refer: Non-Compliance of Condition No 35 (iii) of Grant of Permission
No. SDZ22A/0007.**

**Prepared for: Adamstown Station & Boulevard Limited – The
Applicant.**

Re: Non-compliance letter from SDCC for Condition No. 35 (iii) at Adamstown Boulevard.

I have been instructed by Adamstown Station & Boulevard Ltd. to prepare a response to SDCC Non-compliance letter of 8th May 2024 for tree and hedgerow within the site area at Adamstown Boulevard Phase 1 as per Condition 35 under planning reference SDZ22A/0007:

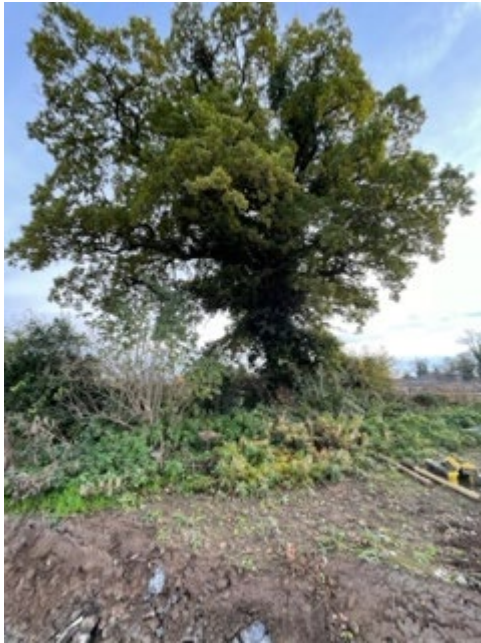
Tree number 1529 – Mature Oak tree prior to remedial works.

- All scrub has been carefully removed manually from around the base of this specimen tree back to ground level.
- A 2m strip of ivy has been removed from the base of the main stem. Ivy adds weight and windsail to a tree.
- All major deadwood has been removed from the crown of this specimen oak tree.
- Stagnant water has been removed from the drain adjacent to the tree and the open drain has been back filled with good quality topsoil.
- Good quality topsoil has been spread manually all around the RPA of the tree. This will protect surface roots and provide a medium for sowing grass seed at a later date.

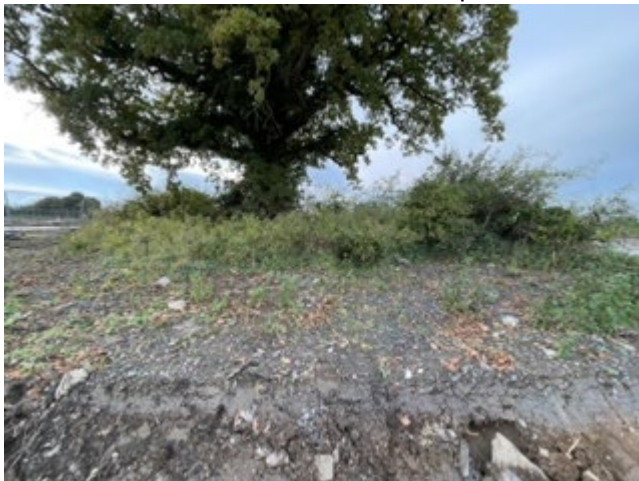
Light ground scrub vegetation prior to removal.

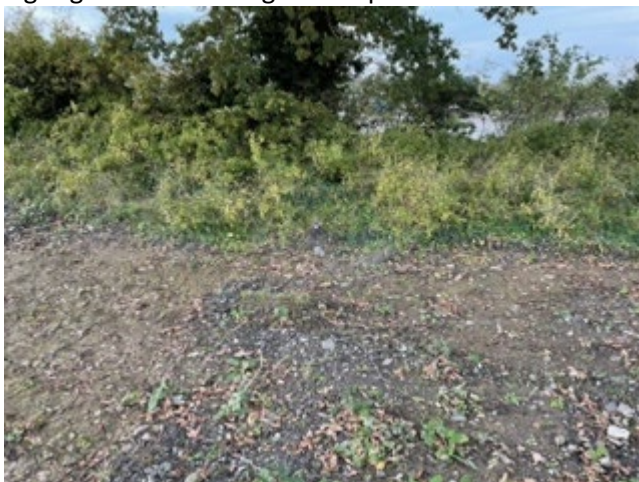
Tree laden with ivy prior to removal.

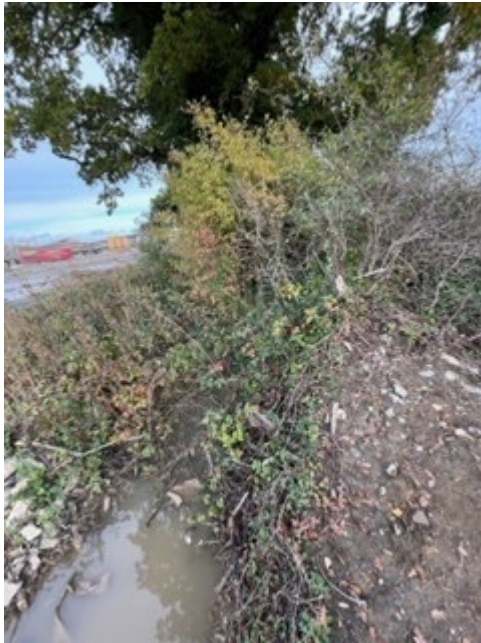
Open field drain full of stagnant water, prior to removal and backfilling.

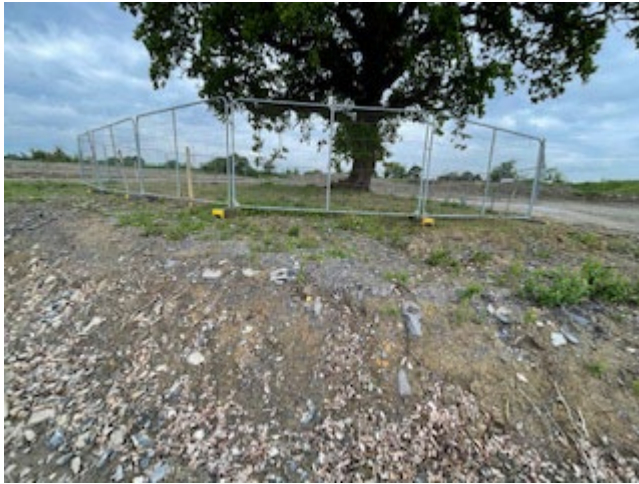
Scrub removed, ivy severed and removed, open drain backfilled and temporary protective fencing in place during enabling works.

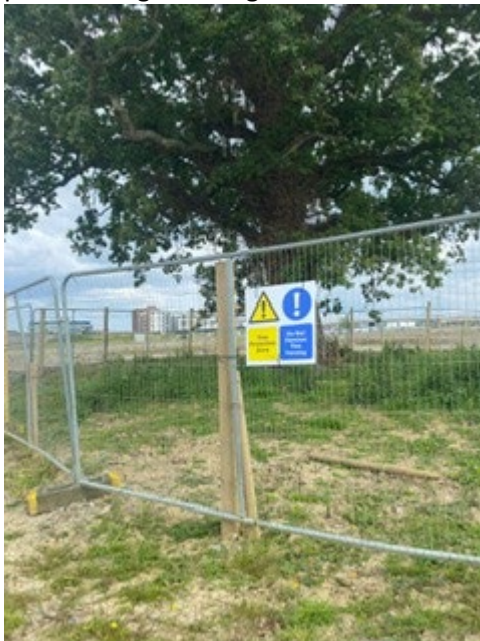
Protective fencing now in place around oak tree. Note signage also in place.

I can confirm that the protective fence is now complete to a higher specification, reinforced with timber stakes, and will be maintained as such for the entire duration of the development.

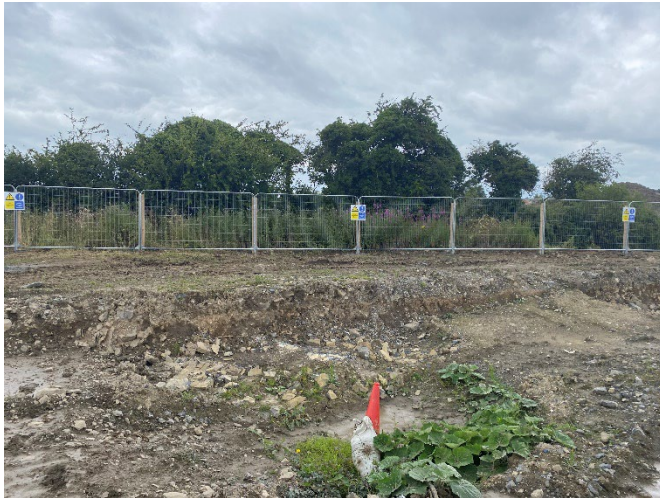
Hedgerow protection and signage now in place 1

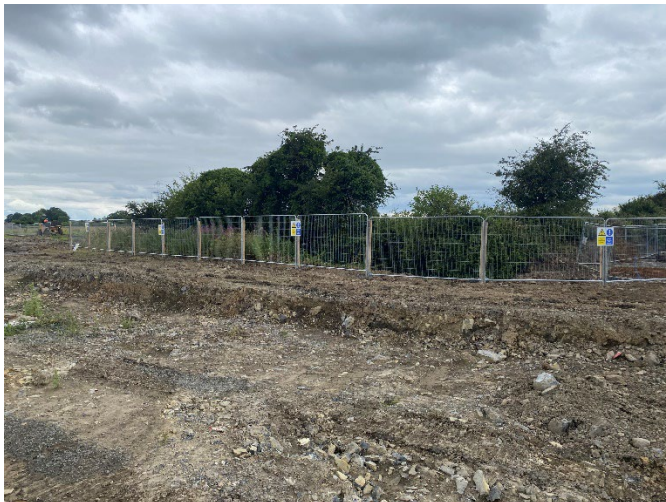
Hedgerow protection and signage now in place 2

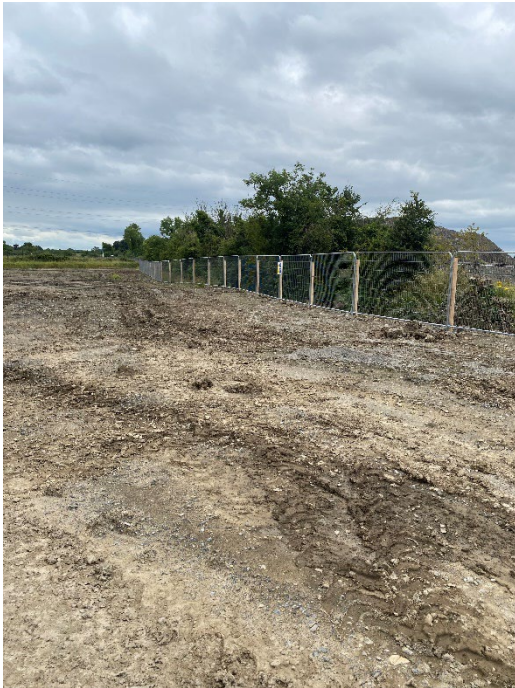
Hedgerow Protection and signage now in place 3

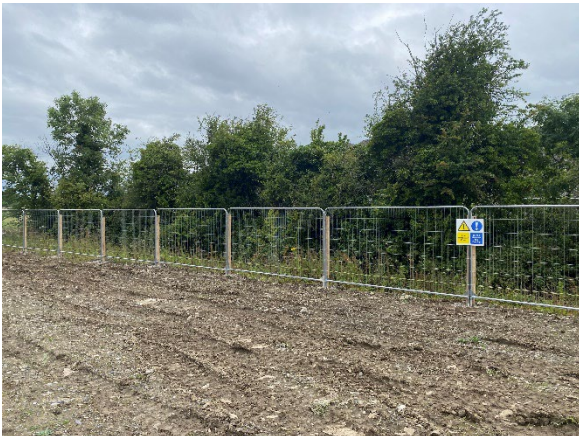
Line of protective fencing reinforced with timber stakes and concrete base

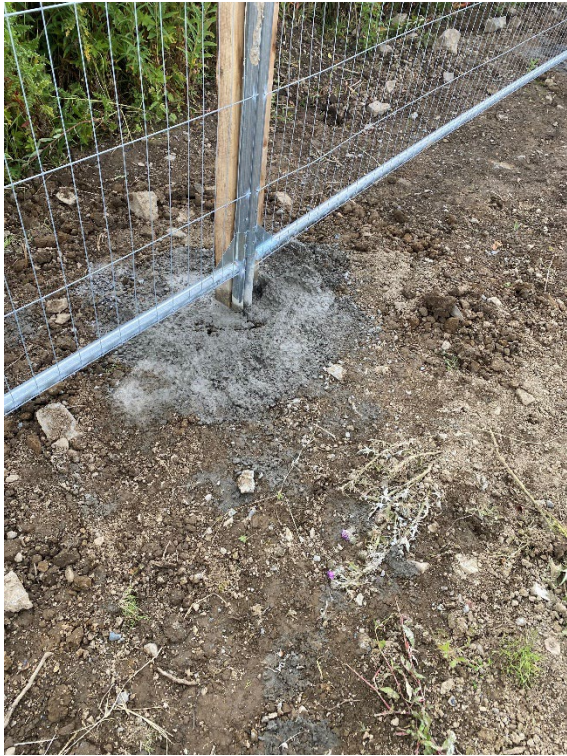
Fencing reinforced with timber stakes and concrete base in parts to ensure robustness and stability during construction phase
