Arboricultural Report

Tree Survey,
Arboricultural Impact Assessment &
Arboricultural Method Statement

Griffeen Community College
Lucan
Co. Dublin

200319-PD-11

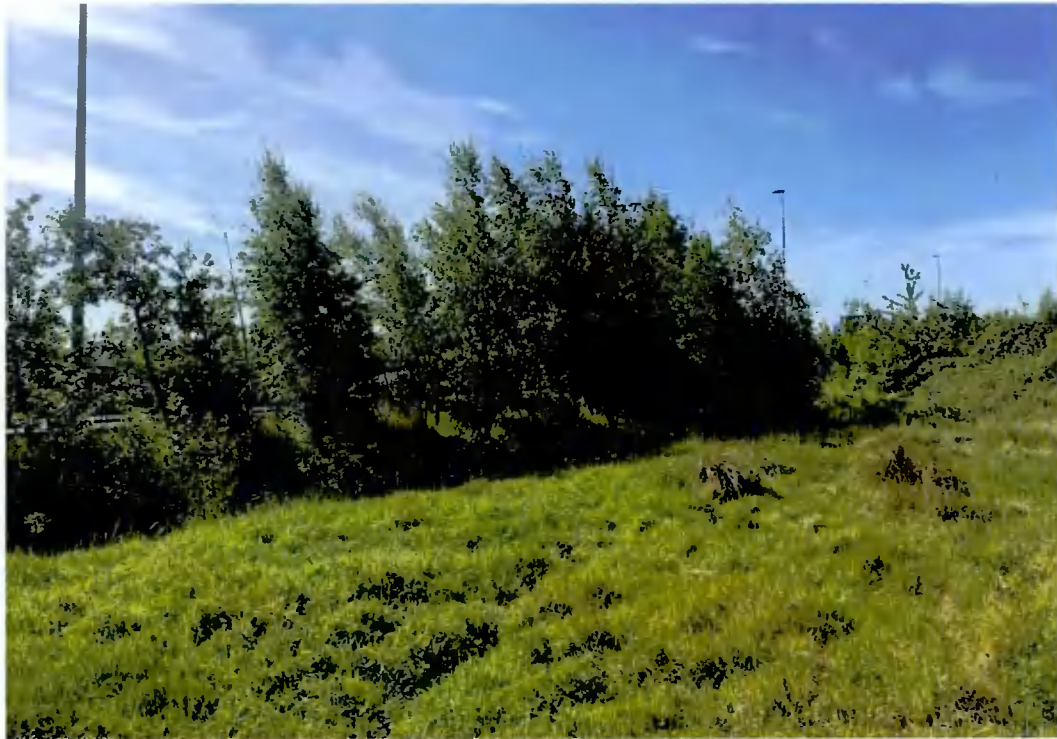
Photo 1: View of the eastern boundary semi-mature tree group G184.

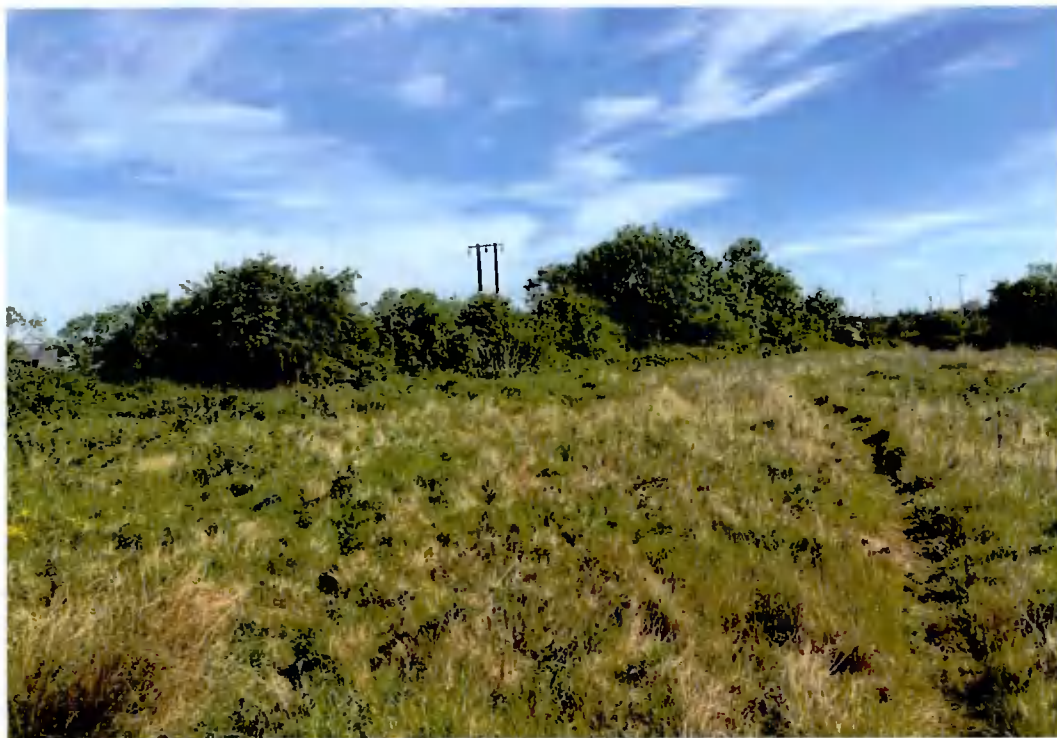
Photo 2: View central hedge (G202) and tree line (T189 to T201) looking north from the eastern side of the site.

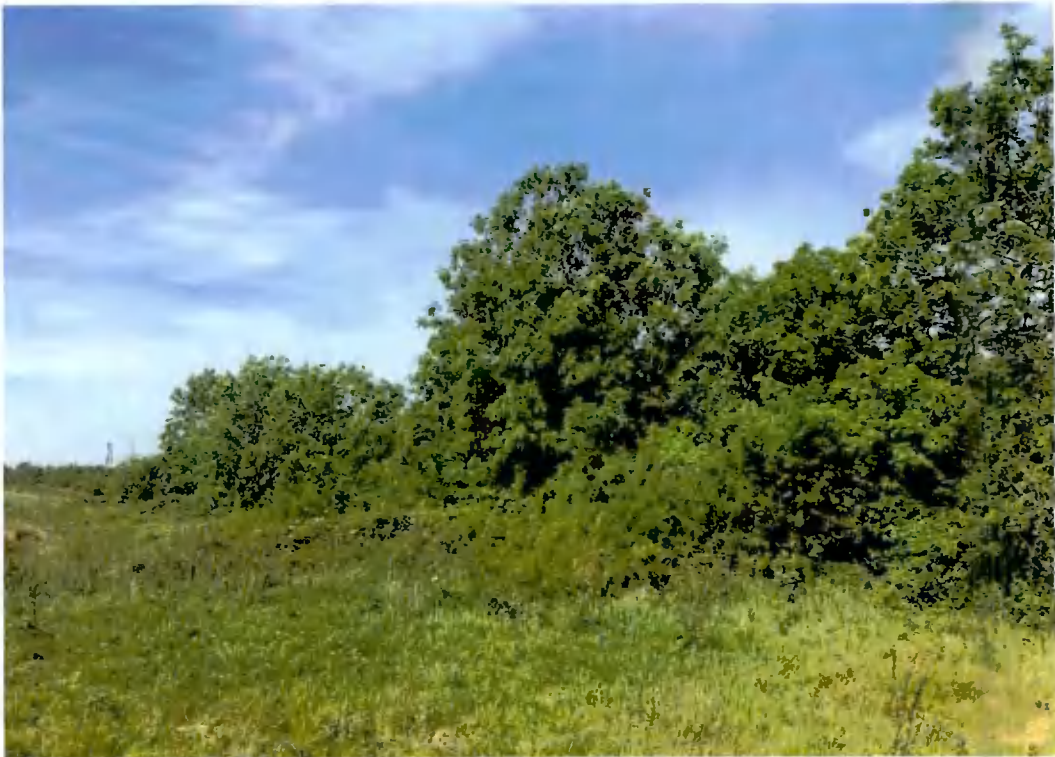
Photo 3: Second view of the central hedge (G202) and tree line (T189 to T201) looking south from the eastern side of the site.

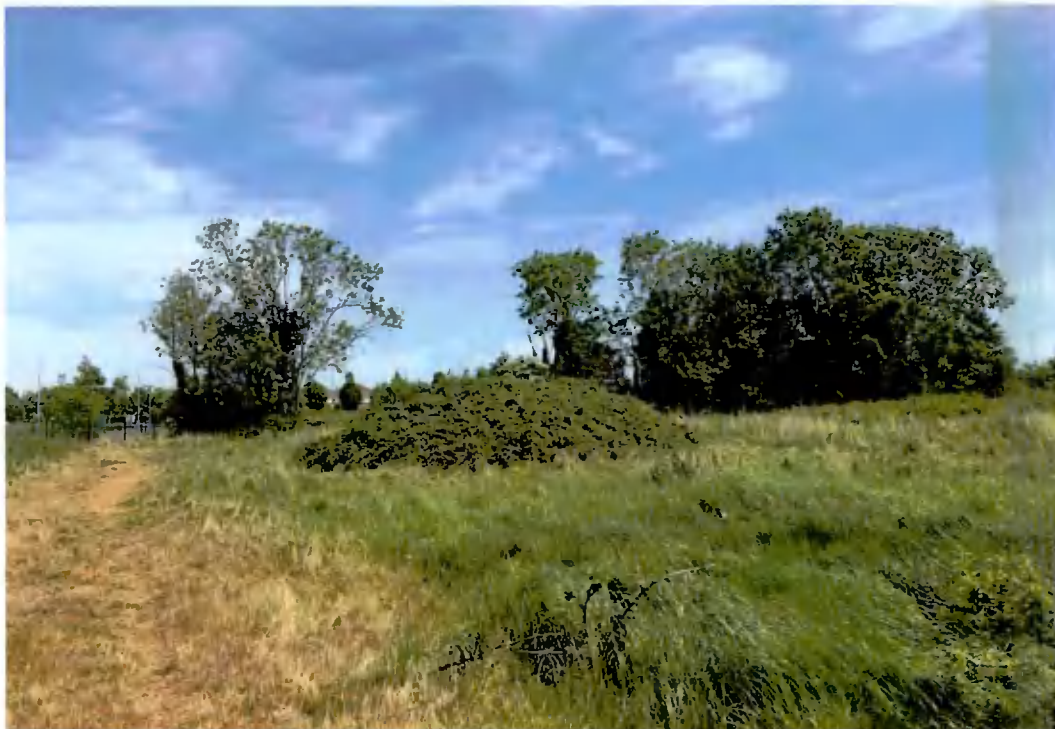
Photo 4: View of trees T215 to T223 and hedge groups G195, G196, G197.

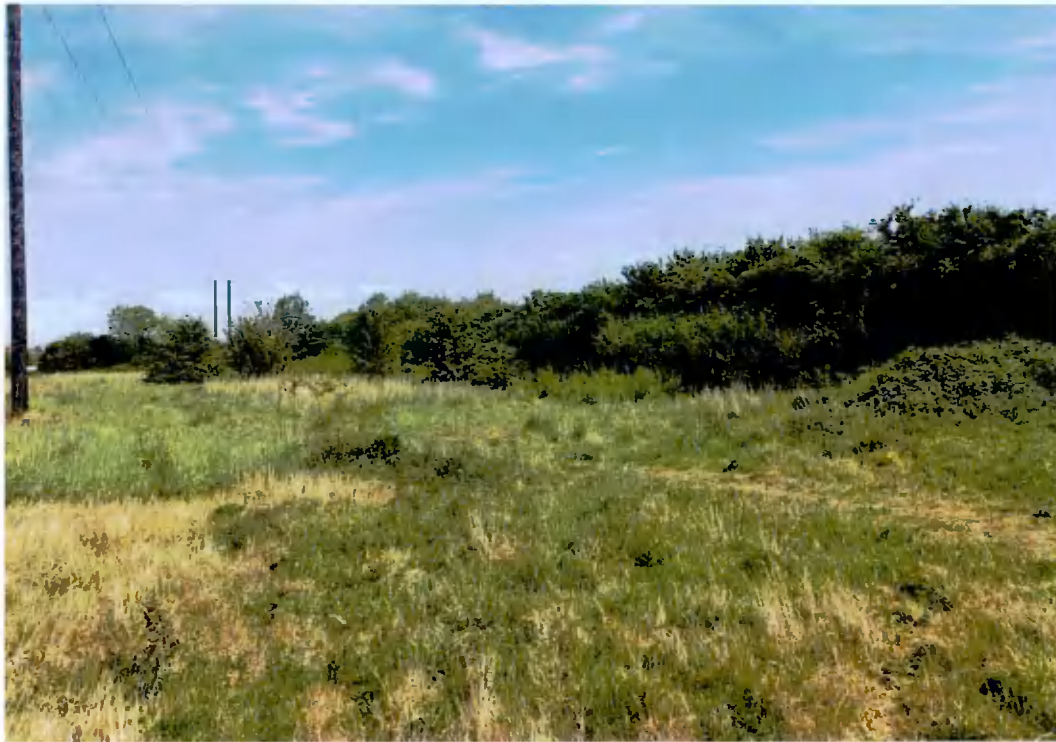
Photo 5: View of central hedge G202 and hawthorn trees T225 to T229 looking north from the western side of the site.

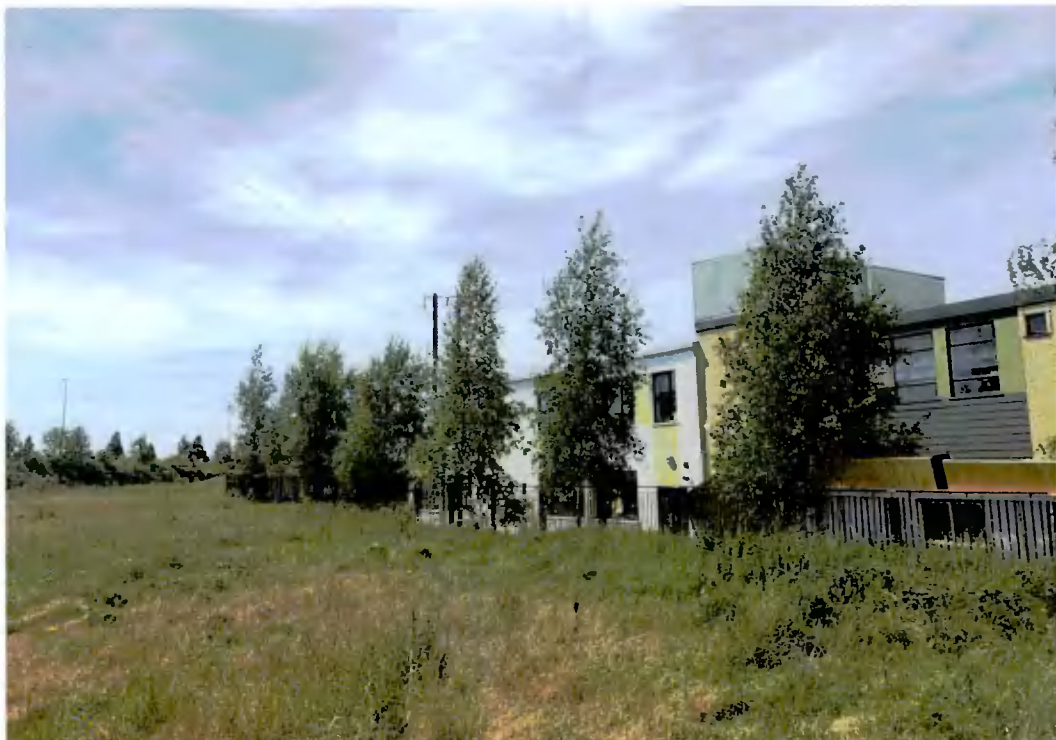
Photo 6: View of the neighbouring silver birch trees T230 to T237 located within the Lucan East Educate Together National School.
