Aboricultural Assessment Report

Microsoft Ireland Lands
Grangecastle Business Park
Dublin 22

27 October 2020

DOCUMENT:
Tree Survey Report

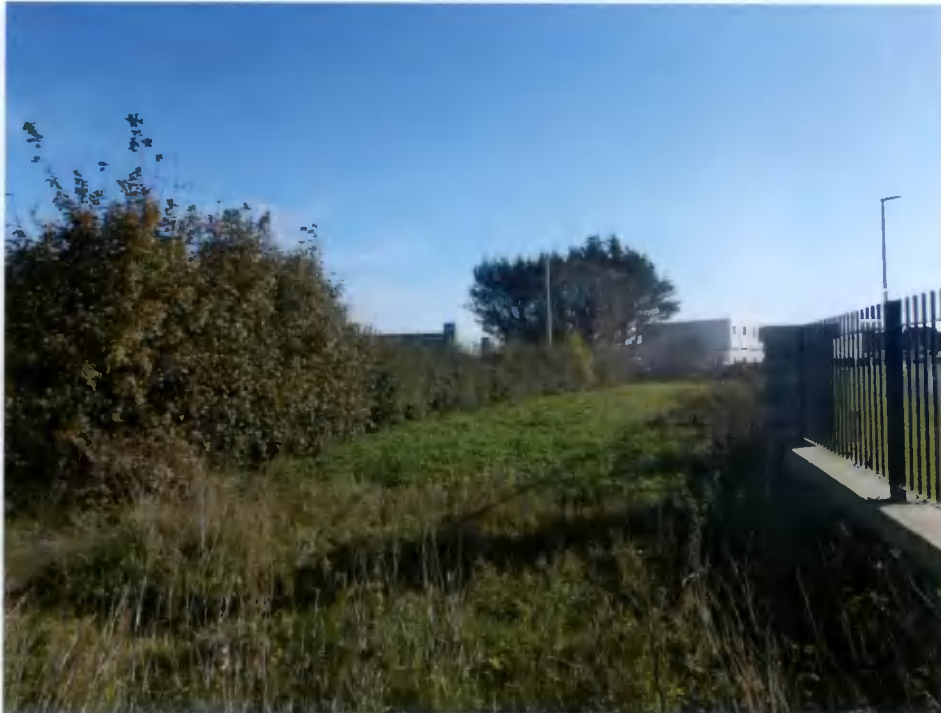
Photo 1. Hedge H2 and conifer group G1 viewed from the west

H	2	Acer pseudoplatanus (Sycamore) Crataegus monogyna (Hawthorn) Fraxinus excelsior (Ash) Prunus spinosa (Blackthorn) Sambucus nigra (Elder)	EM	3	100	1	0	1	1	1	1	10+	Fair	Fair. Remnant section of hedgerow. Clipped to maintain a compact form.	No urgent works needed.	1.2	C2

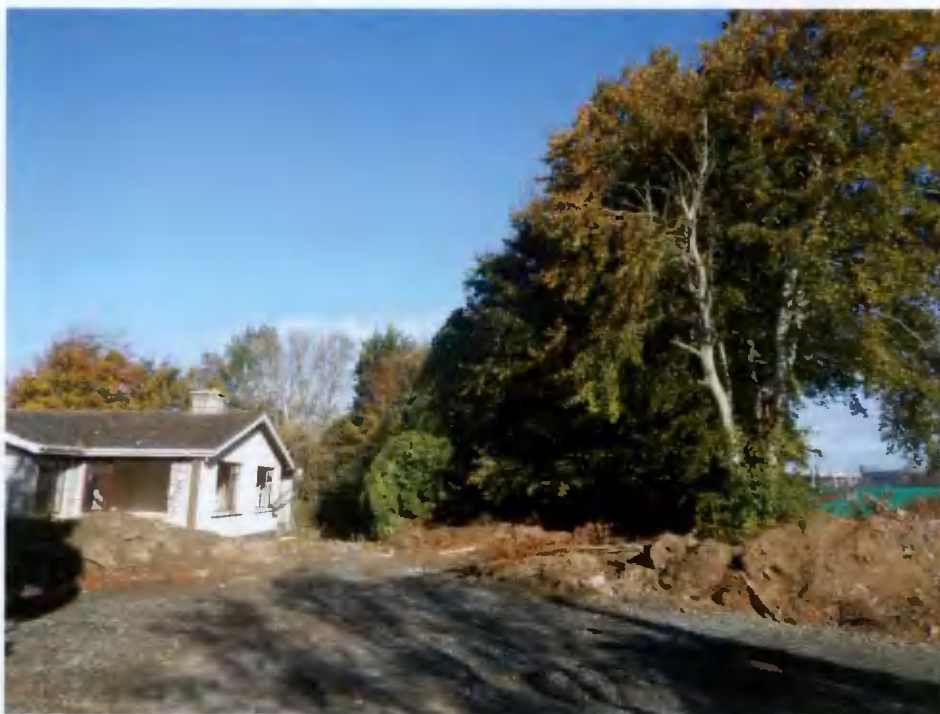
Photo 2. Trees of groups G3 and G4 next to the derelict house in the southern part of the site

G	4	Fagus sylvatica (Beech) Fraxinus excelsior (Ash) Prunus cerasifera (Cherry Plum) Sorbus aucuparia (Rowan) Chamaecyparis lawsoniana (Lawson Cypress)	SM EM	6	200	1	1	2	2	2	2	10+	Fair/Poor	Fair. Smaller garden trees/bushes established inside the larger hedge. Trees have been partially suppressed by the hedge and are of limited value. The Cherry Plum is now in poor condition.	Prune back adjacent hedge.	2.4	C2

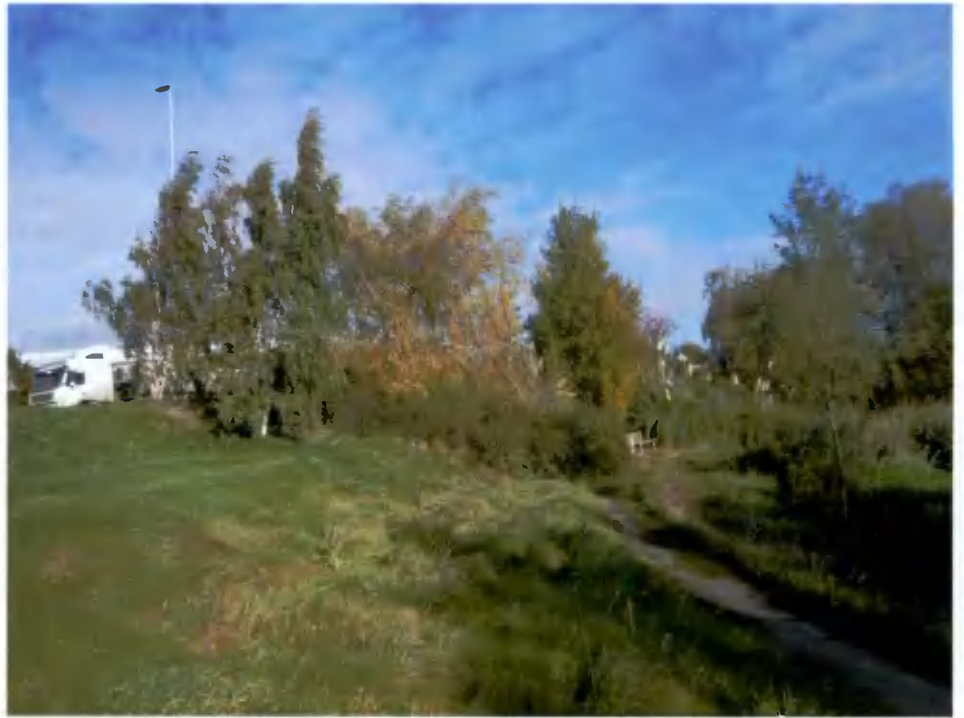
Photo 3. Willow, Birch and Poplar trees planted around the landscape scheme next to the river channel in the far west of the site

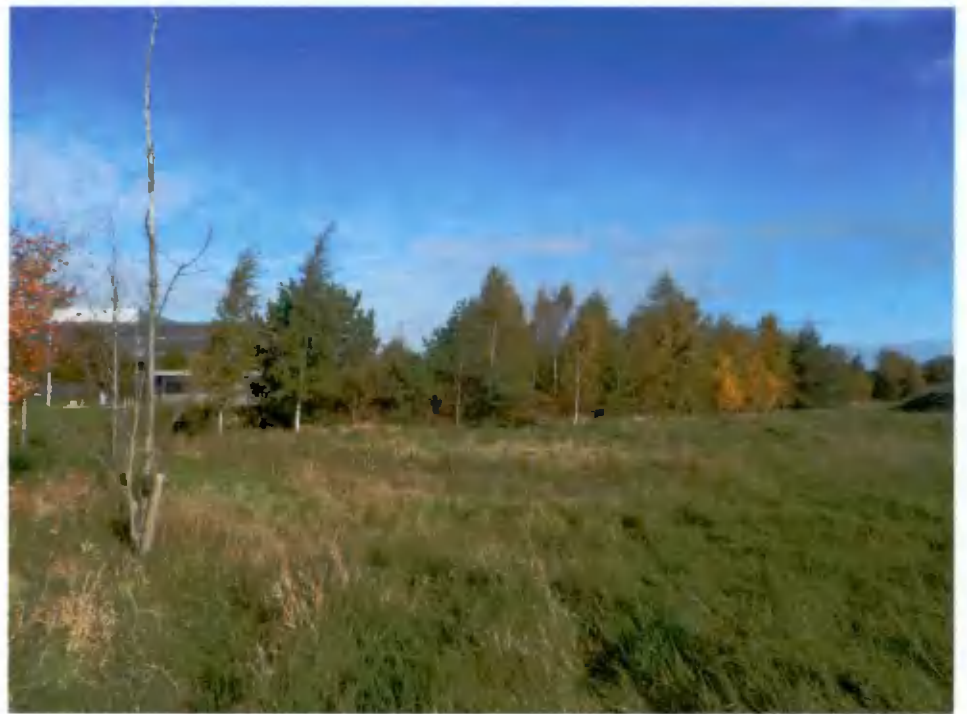
The young mixed plantation (G11) established along the Griffeen River channel now provides a valuable landscape screen into the property from the northwest, as well as a developing riparian habitat area.

Photo 4. Young plantation (G11) along southern side of river channel

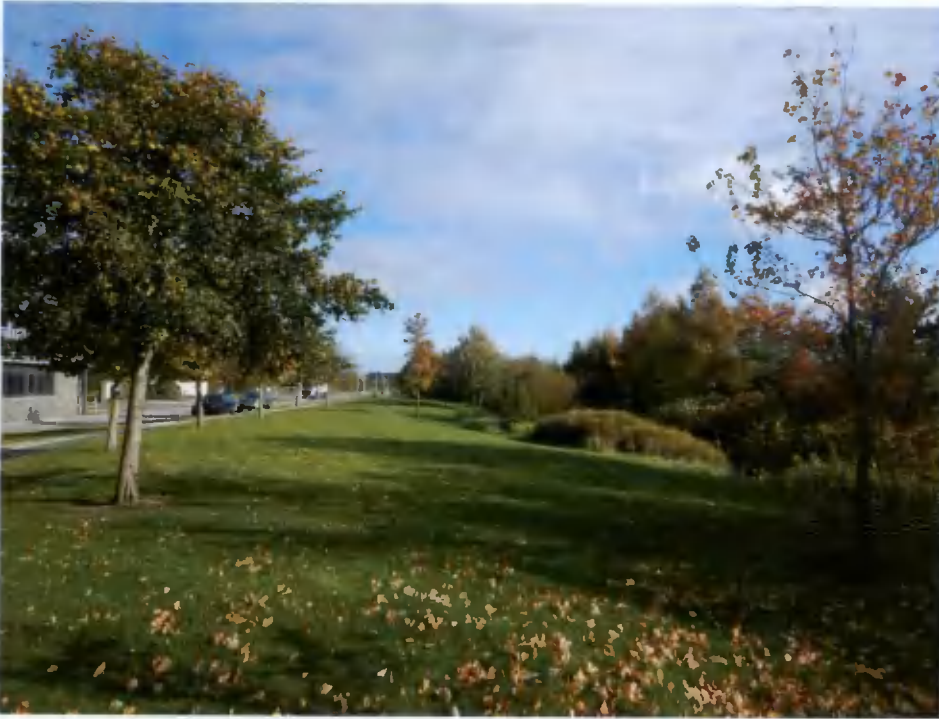
Photo 5. Landscape planting between entrance road and river channel in western part of site

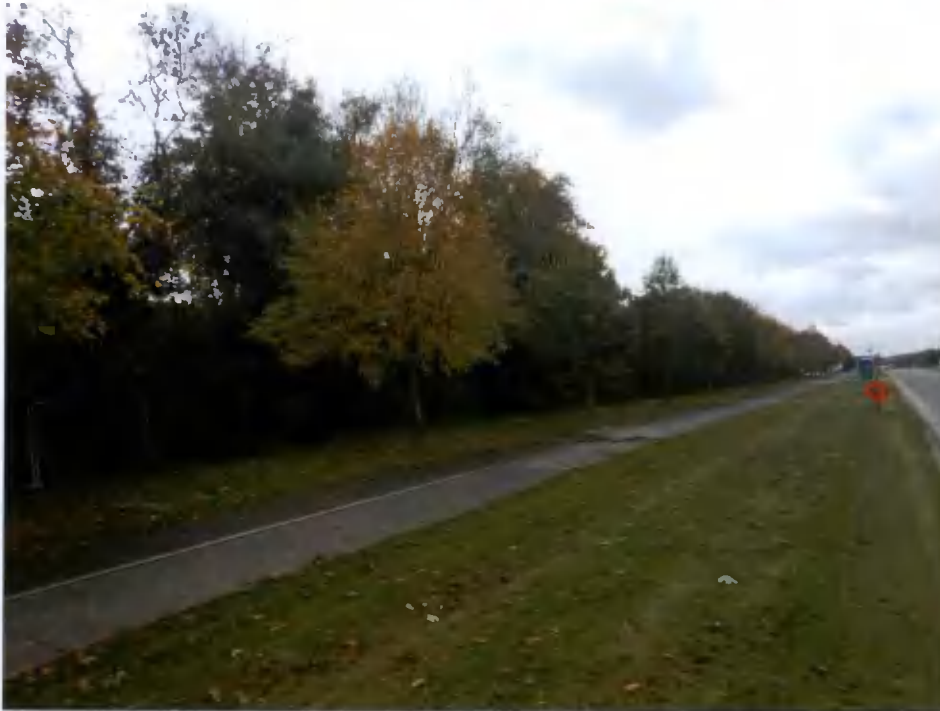
Photo 6. Hedgerow H5 and young Lime trees (Group G13) along the north western edge of the site (viewed from the north east)

G	13	Tilia cordata (Small-leaved Lime)	SM	5	200	1	2	2.5	2.5	2.5	2.5	10+	Fair	Fair. Smaller sized street trees planted in verge. Good shape/form. Some bark wounds to lower stem.	No urgent works needed.	2.4	C2
G	14	Tilia cordata (Small-leaved Lime)	SM	5	100	1	2	2	2	2	2	10+	Fair	Fair. Smaller sized street trees planted in verge. Good shape/form. Some bark wounds to lower stem.	No urgent works needed.	1.2	C2
G	15	Betula pendula (Silver Birch) Quercus robur (Common Oak) Prunus avium (Wild Cherry)	Y	4	100	1	1	1	1	1	1	10+	Fair	Fair. Young plantations along sections of raised mounds/berms.	No urgent works needed.	1.2	C2
H	1	Crataegus monogyna (Hawthorn) Fraxinus excelsior (Ash) Prunus spinosa (Blackthorn) Sambucus nigra (Elder)	M	6 to 15	300	1	0	4	4	4	4	10+	Fair	Fair. Mature agricultural hedgerow between two heavily modified sites, with topsoil stripped and compacted. Emergent Ash stems to 15m. with majority of hedge Hawthorn and Blackthorn bushes 6-8m. No recent hedgerow management evident.	Cut back into shape if retained.	3.6	C2

The northern section of hedgerow H1 and the old hedge H5 will be retained and enhanced through improved management and additional infill planting, ensuring their long-term survival as landscape features.
