**Bat survey of Newbrook House and grounds,
Ballyboden, Co. Dublin**

For Panther Environmental Solutions Ltd.

July 2021

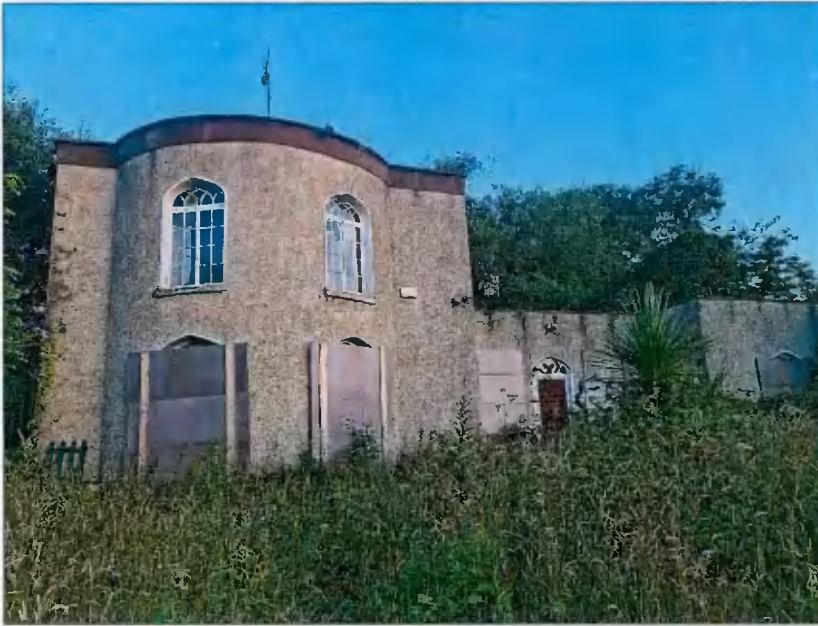
No bats were observed emerging from Newbrook House. The building is considered as having a low potential for bat roosts however the solid masonry structure may provide suitable winter hibernation roost conditions. No bats were observed emerging or re-entering the derelict sheds and they are all considered to have negligible potential for bat roosts.

The main part of the Newbrook House is flat roofed (the wing building has a low-pitched slated roof) and has no wooden fascias or soffit boards. With the exception of a split in the masonry at the front and broken windows to the rear, there were few other obvious access / egress points into the building that bats could potentially use.

Plate 1. View of the front of Newbrook House

If renovation works on Newbrook House have not commenced by November 1st, 2021, a winter roost survey of the interior is recommended (the provision of safe access into the house will be required). If works have not commenced by May 1st, 2022, then fresh bat surveys of the house are required. This is to ensure that bats have not taken up residence in the property in the period following these current surveys.

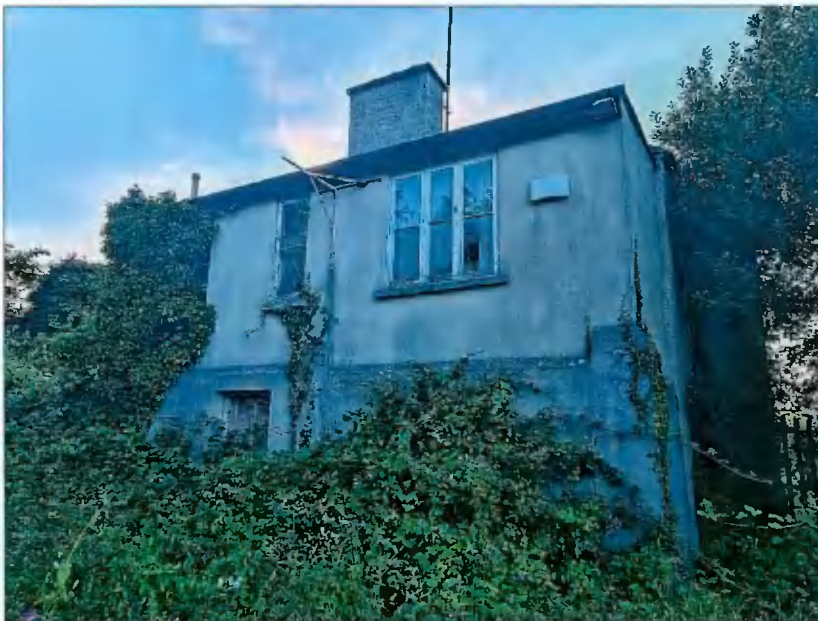
Plate 2. Rear view of Newbrook House

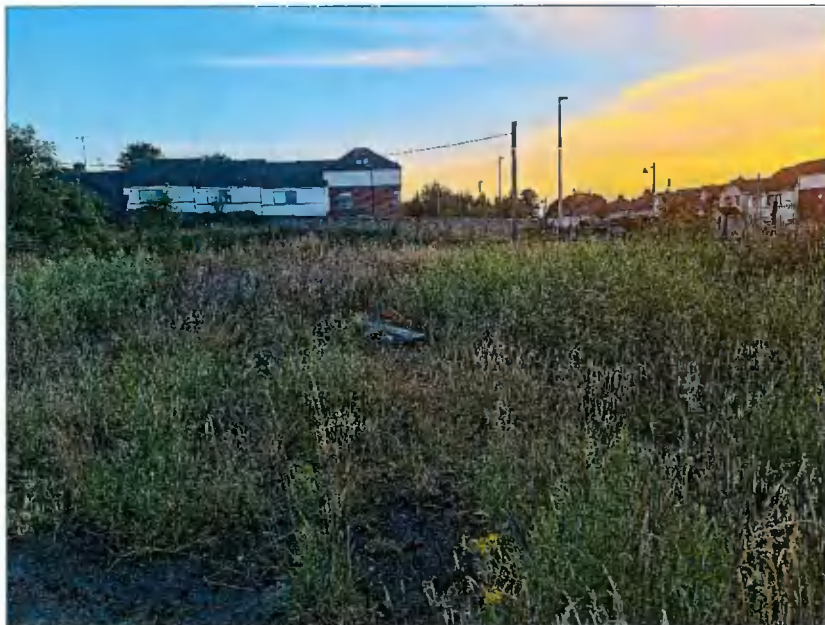
The front section of the site, including the frontage of Newbrook House is impacted by streetlight illumination originating from the R113 road. This is a likely contributing factor to the low levels of bat activity recorded on the site. A petrol station to the immediate east also creates light overspill, particularly along the eastern section of the site.

Plate 3. View of the front of the site, looking westwards. The R113 road is to the right.

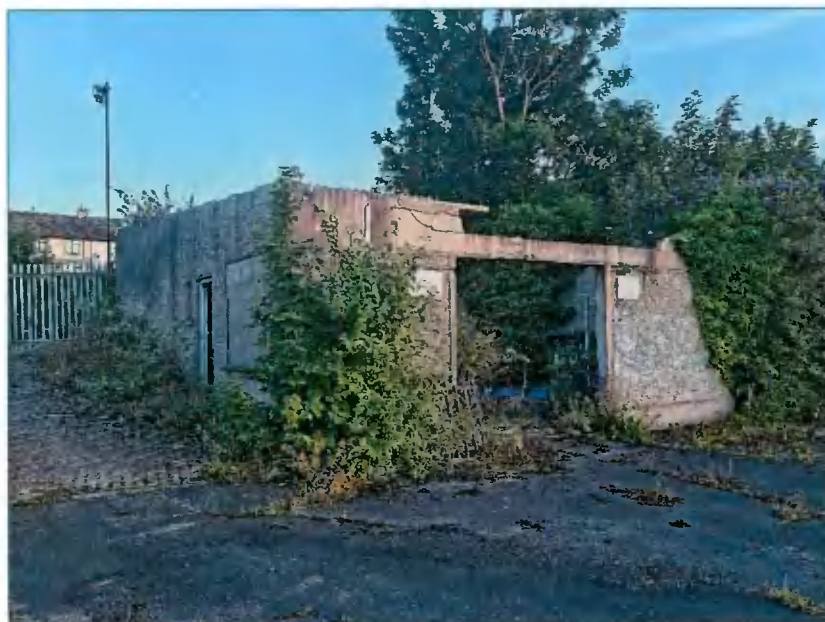
The derelict sheds provide few, if any, suitable features that bats could potentially use. The sheds are in a poor structural condition with one shed without a roof and the two others having rotting timber and corrugated iron sheeting roofs with large gaps, resulting in the buildings being exposed to the elements. Illumination from lighting in the adjacent petrol station also reduces the suitability of these sheds as roost sites.

Plate 4. Derelict shed with no roof. Negligible bat roost potential.

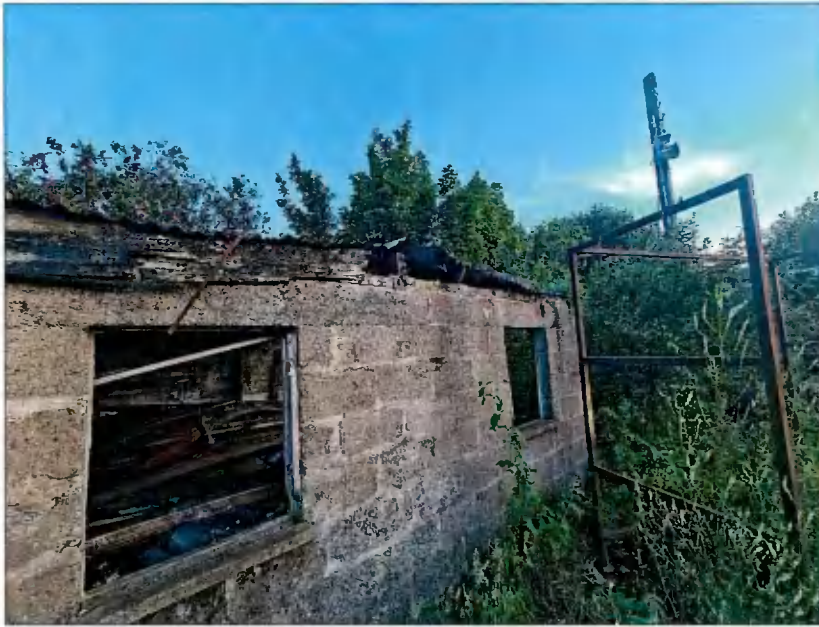
Plate 5. Second derelict shed on site with large gaps in the roof and rotting timberwork. Unsuitable for roosting bats.

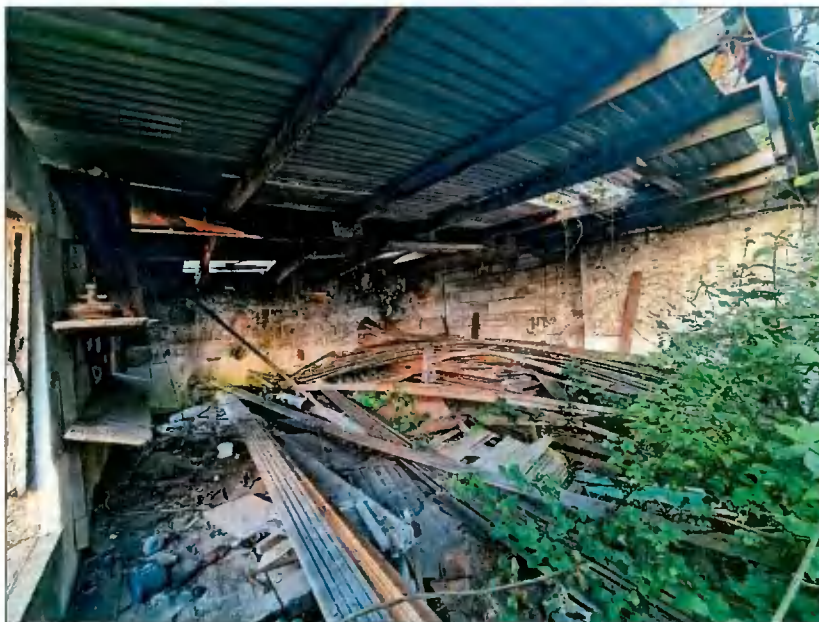
Plate 6. Interior of shed. Unsuitable for roosting bats.

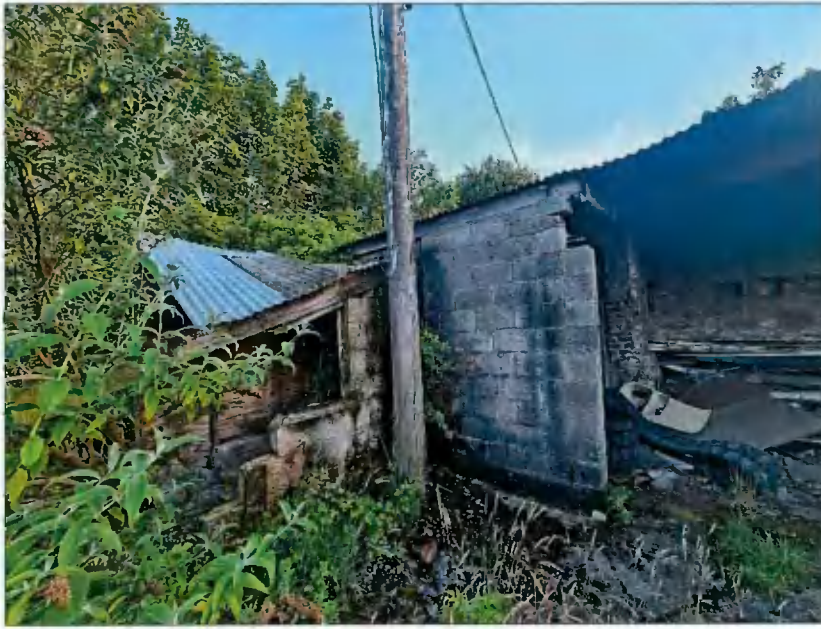
Plate 7. The third derelict shed. Unsuitable for roosting bats.

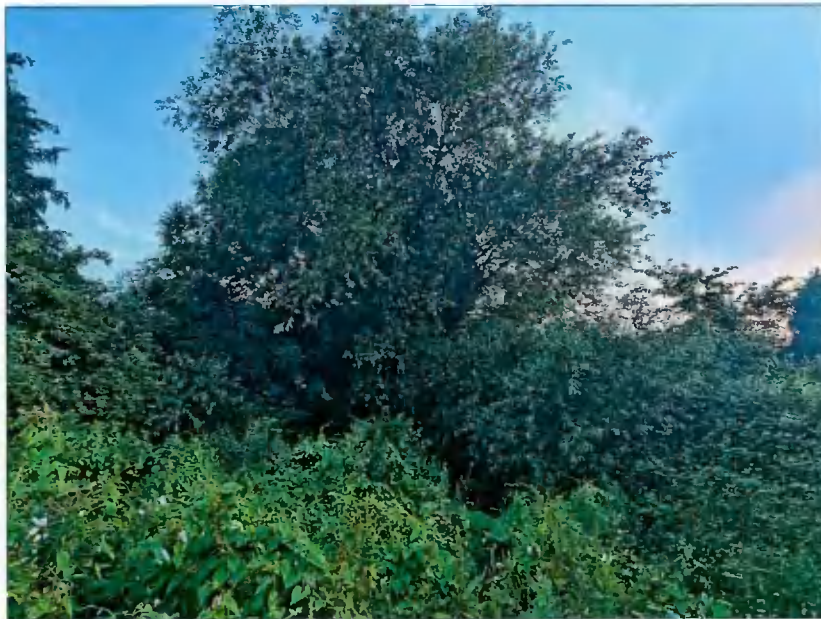
The scrub and trees to the rear of Newbrook House provide a small area of darkness and suitable foraging area however bats were not detected in this area during the three site surveys. None of the trees have features that could potentially be used as bat roosts. It is likely that bats in the area are concentrated in locations such as Marley Park to the east and St. Enda's to the northwest, which provide superior feeding grounds and suitable buildings and trees for roosting.

Plate 8. Overgrown area to the rear of Newbrook House.

Based on the results of the three site surveys and the building assessments, the site does not appear to be important for the local bat population. However, the trees along the southern boundary provide foraging areas and also provide some connectivity in the local area by serving as a linear feature. The existing trees should be retained and supplemented with the planting of native species, in keeping with what grows locally in the area.
