## TECHNICAL NOTE

**Project** EdgeConnex Ireland Limited

**Subject** Additional Information Response  
Item no. 7 & 11

**Ref.** LB/20/11901TN01

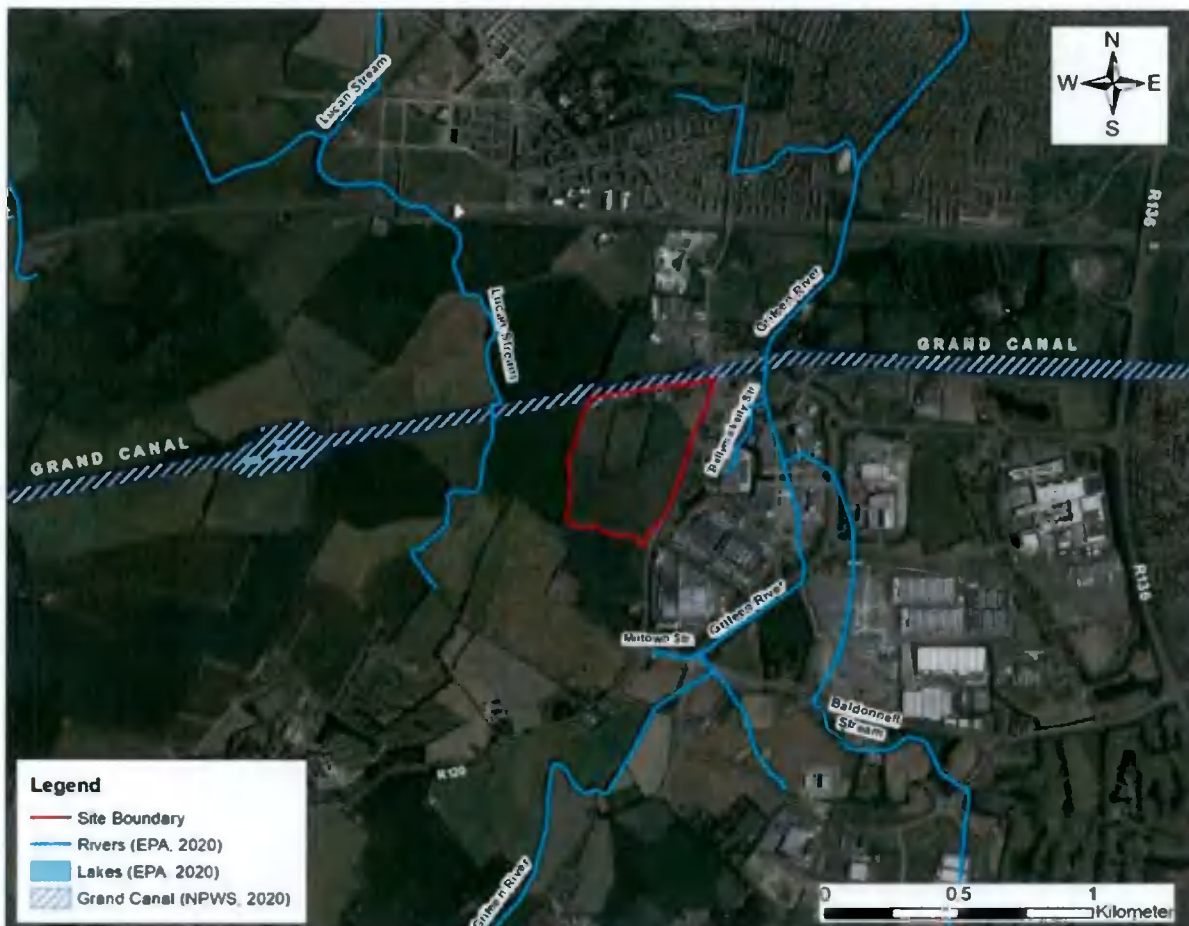
Figure 1 Hydrology (Source: EIA Chapter 6 Hydrology (AWN, 2021))

There are no mapped surface water courses on or bordering the site as seen in Figure 1 below. below taken from the EIAR Hydrology chapter submitted to as part of the EIA.

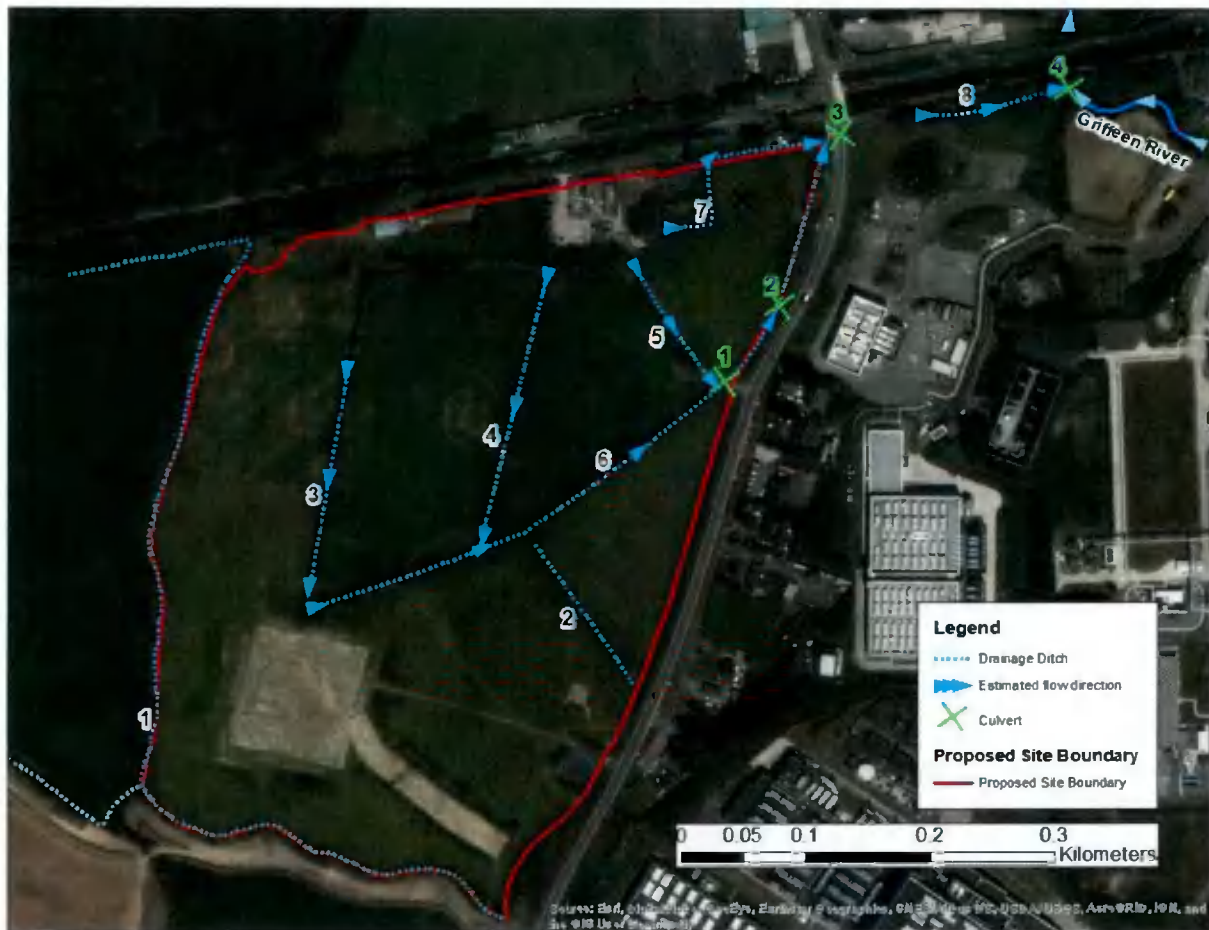
Figure 2 Drainage Layout

Field Drain	Flow direction	Condition
1	No apparent flow direction.	Land ditch marking field boundary overgrown with vegetation, shallow banks. Located to the west and South the proposed development site boundary. Overgrown vegetation, no outfall within the proposed development site boundary.
2	No flow direction visible.	Land ditch marking field boundary overgrown with vegetation, shallow banks. No water present at time of visit. Ditch is not connected to any other features, assumed discharge to ground.
3	Contour suggests a southern flow direction and connection to Field drain 6.	Land ditch marking field boundary overgrown with vegetation, shallow banks. No water present at time of visit.
4	Contour suggests a southern flow direction and connection to Field drain 6.	Land ditch marking field boundary overgrown with vegetation, shallow banks. No water present at time of visit.
5	Flow is directed south towards Field Drain 6.	Stagnant water visible. Located alongside an old access to dilapidated buildings.

6	North and North-East to Griffeen River.	No water present in upstream of Culvert 1, with some flowing water visible before and after Culvert

Field Drain	Flow direction	Condition
		2; at very low flow rate. Generally overgrown with vegetation.
7	East to Griffeen River.	No water present at time of visit. Shallow dish drain for stormwater collection for dilapidated buildings.
8	East to Griffeen River.	Steep sites, Flowing water visible; very low flow rate.

Overall internal ditches shown in Figure 2 are predominantly artificial ephemeral drainage ditches, most of which were dry during the time of the visit so flow direction is assumed. These are manmade ditches to drain the fields and generally marking the field boundaries.

Ditch 1 is not located within the site on the western boundary and is located on the boundary line along the south. It is likely that the ditches (2, 3, 4, 5) primarily drain to ground, or during extended periods of heavy rainfall drain into Field Ditch 6 which flows through the centre of the site and adjacent to the R120 as shown on Figure 2. Ditch 7 connects directly with Culvert 4.

These field drains (6 & 7) are hydraulically linked through a series of culverts to drainage Ditch 8 and ultimately the Griffeen River. The Griffeen combines with drainage Ditch 8 at Culvert 4 before flowing north and converging with the River Liffey which then flows east to the Liffey Estuary c. 15 km downstream of the site.

The RFI Response prepared by Pinnacle Consulting Engineers addresses how these ditches will be modified as part of the Proposed Development.
