CONSERVATION / METHOD STATEMENT

RE: The development consisting of: (i) Partial demolition and reconstruction of a two storey corner extension to the rear, provision of a new flat roof with roof-light to this extension, (ii) Demolition of the two storey extension at the centre of the back (east) of the house and the construction of a new flat roofed two storey extension with roof-light(s), (iii) Repairs to windows with replacements where necessary or appropriate. Construction of single storey bay extension with pitched roof to the south elevation at lower ground floor/basement level, (iv) Minor internal alterations, general refurbishment, provision of maintenance access to centre valley, addition of photovoltaic panels, repairs to plasterwork, increase in height of rear garden boundary wall to the north, (v) Outbuilding to the Rear: internal alterations, roof repairs, new doors and window and general refurbishment, (vi) Minor hard and soft landscaping works including parking area to the North-East and all ancillary site works above and below ground. At **Oak Lodge**, New Road, Clondalkin, Dublin 22, D22 F516. The property is a **Protected Structure, RPS No. 156**.

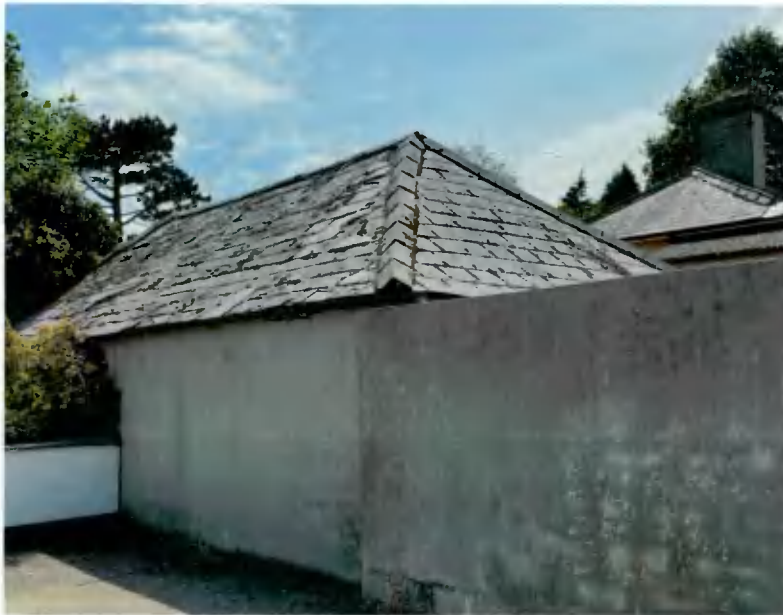
The slates over the east side of the out-building facing onto the property behind have failed, see photograph below. Having been previously painted with bitumen to address a leak at some time in the past these slates on the eastern façade are damaged beyond repair and need to be replaced/re-slatted, new battens. This is a common problem and is noted in A Guide to the Repair of Historic Roofs: (2010) states on Page 54 which states:

*“The external roof slopes may have been painted with a bituminous liquid, either on its own or with a hessian base, as a ‘quick fix’ to resolve slate slippage and leaks. These types of repair essentially stick the slates together and make it impossible to carry out local repairs. If this treatment, known as ‘turnerising’, has been applied to a roof and there are further leaks, complete replacement of the slates is the only option. Furthermore, slates subjected to turnerising are not fit to be salvaged and reused.”**

It is proposed to re-slate this section of roof using a slate of a similar colour to the existing.
