Arboricultural Report

Tree Survey,
Arboricultural Impact Assessment &
Arboricultural Method Statement

**Palmyra
Whitechurch Road
Rathfarnham
Dublin 16**

191013-PD-21

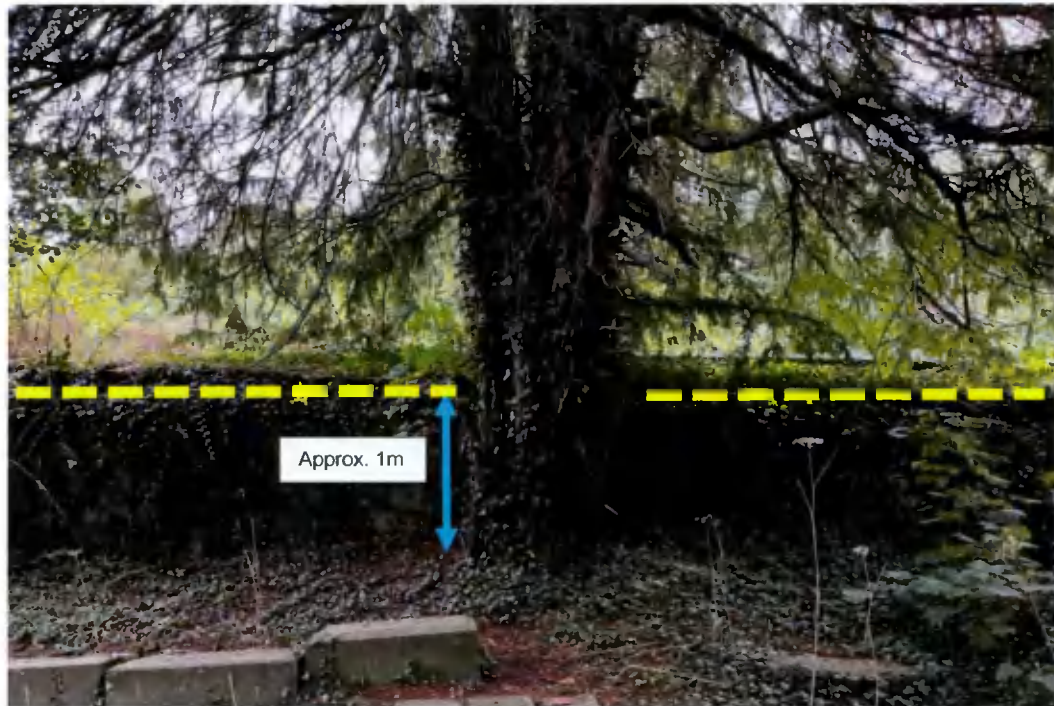
Photo 1: View of the main stem of the mature A Category yew (T643) tree from within the graveyard. The yellow line indicates the top of the wall which is also the top of the adjacent shed to be demolished. This is a retaining wall and is restricting root growth into the Application Site.

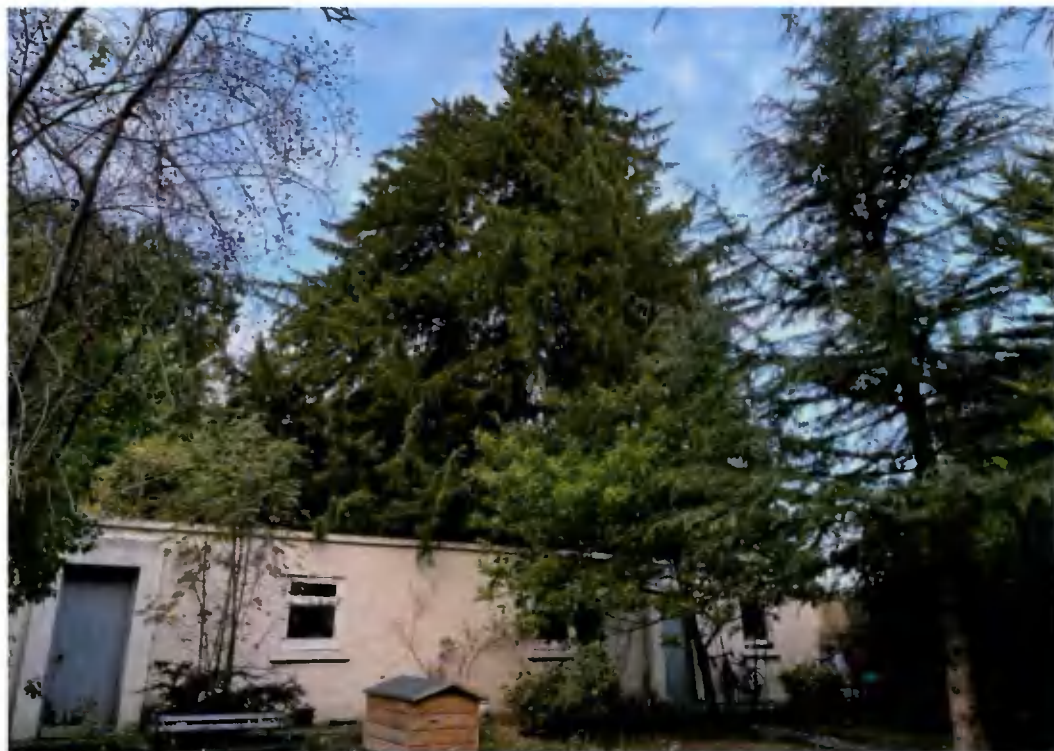
Photo 2: View of Shed 1 from within the Application Site and the A Category yew tree (T643) behind. The yew tree is required to be crown lifted as part of the works.

- 6.14 Once Shed 1 has been demolished, a series of trial holes are required to be manually excavated to establish the depth of rooting. This will help guide the special engineered foundation that will be necessary to construct the carport / home office and minimise any damage on the tree. An example of such foundations would include a mini pile, pad or raft foundation which sits above the existing rooting profile of the tree. A final engineered design must be approved by the arboricultural consultant prior to the main construction works commencing.

- 6.15 All excavation works for the trial holes and to install foundations are required to be carried out under arboricultural supervision. Manual excavation with the use of hand tools will be carried out unless otherwise agreed by the arboricultural consultant.

- 8.5 Engineering details of the proposed foundations within the RPA of the yew (T643) must be designed in accordance with BS5837:2012 following the trial investigate works. These must be reviewed and agreed in advance of any construction works commencing by the arboricultural consultant.

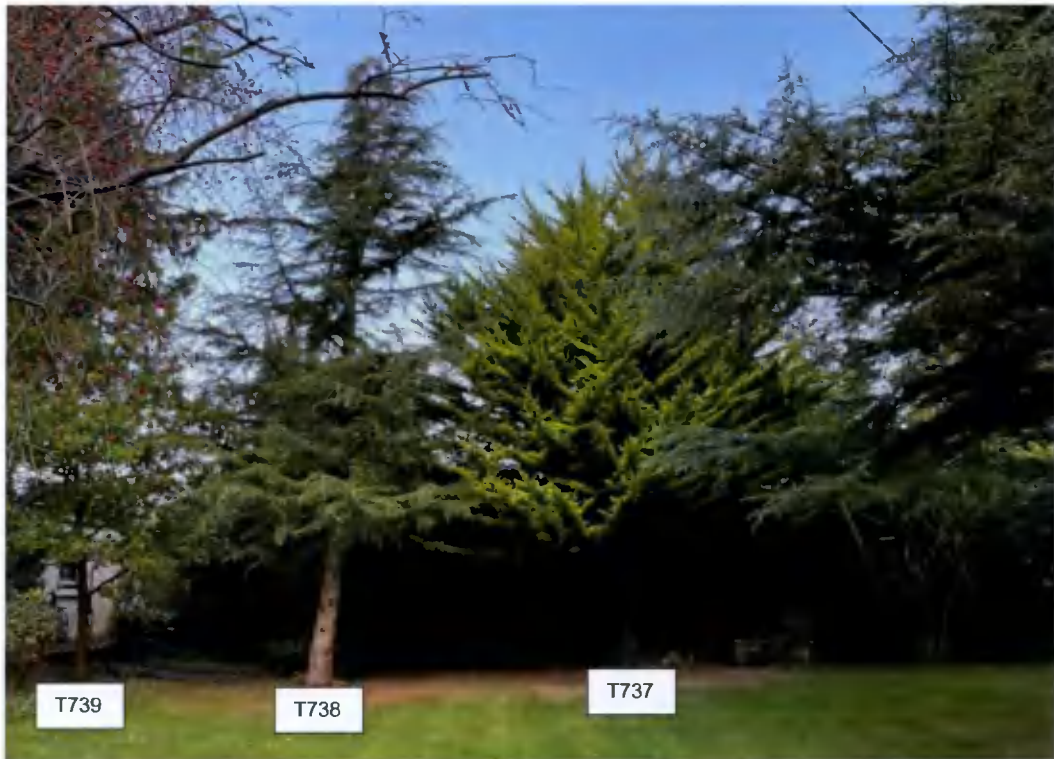
Photo 3: View of trees T737, T738, T739 that are required to be removed as part of the development works. The trees are small in size and have no public amenity value.

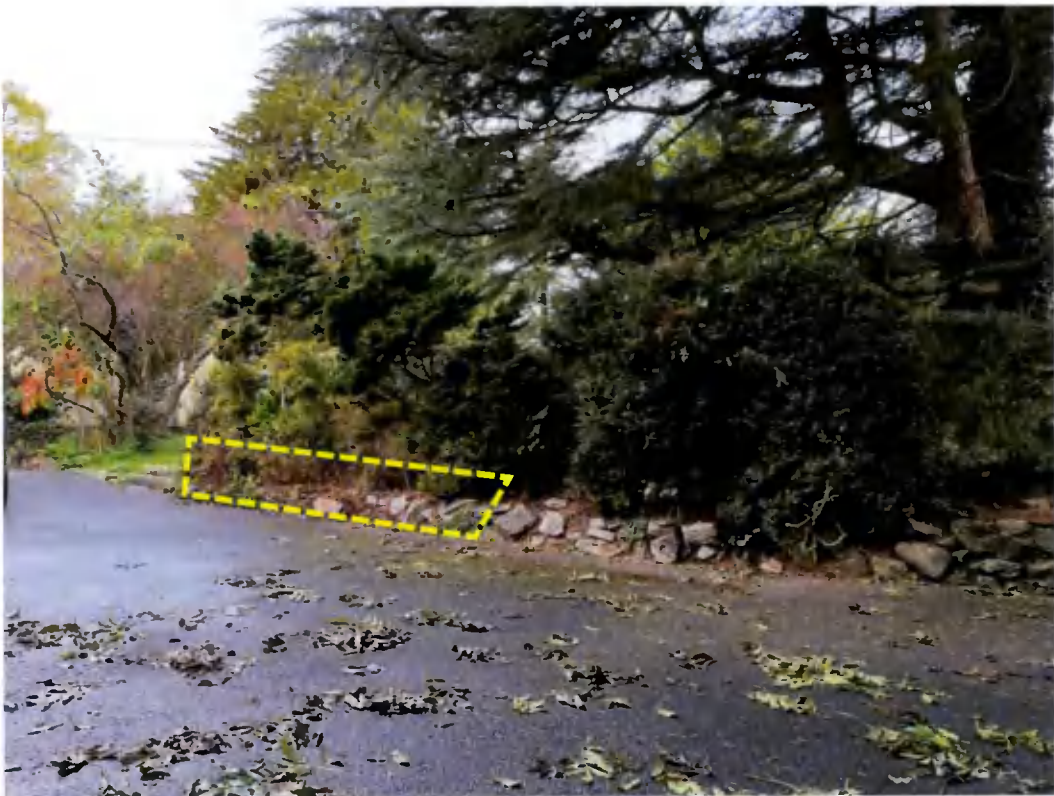
Photo 4: View showing the area within the RPA of the mature cedar (T734) that is required to be reduced in order to construct the proposed driveway and tie in with the existing driveway.

- 6.19 The excavation works are most significant at the point closest to the existing driveway. It is likely that in order to tie in levels, some root loss in this area will be unavoidable. This is approximately 6.5m from the stem of the tree, which is unlikely to have a detrimental impact on its health or structural condition.

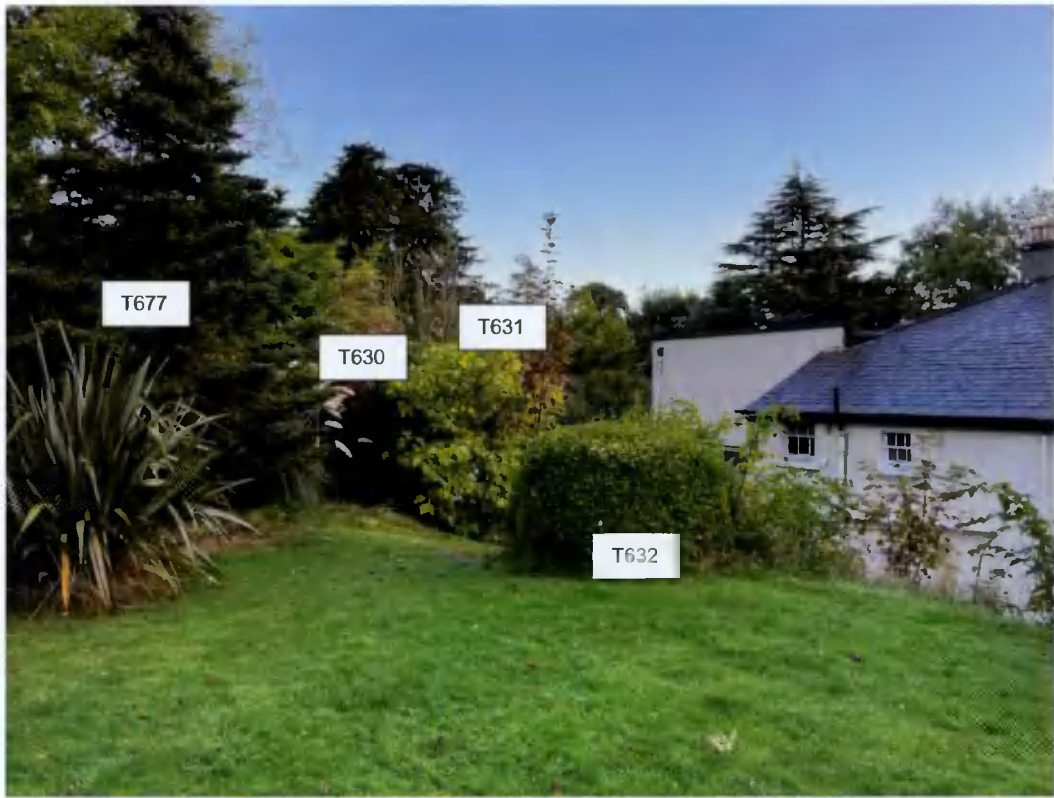
Photo 5: View of the small trees to the rear of the existing dwelling that are required to be removed to facilitate the proposed extension. The trees are small in size and have no public amenity value.
