SOIL CHARACTERISATION AND
SITE SUITABILITY ASSESSMENT REPORT
TE REF: 21/712A TE

BRIAN DUNNE
LYNBROOK
WHITECHURCH RD
RATHFARNHAM
DUBLIN 16
SITE A

IN ACCORDANCE WITH
EPA CODE OF PRACTICE
WASTEWATER TREATMENT AND DISPOSAL
SYSTEMS SERVING SINGLE HOUSES 2021

SITE CHARACTERISATION FORM FOR AN ON-SITE WASTEWATER TREATMENT SYSTEM

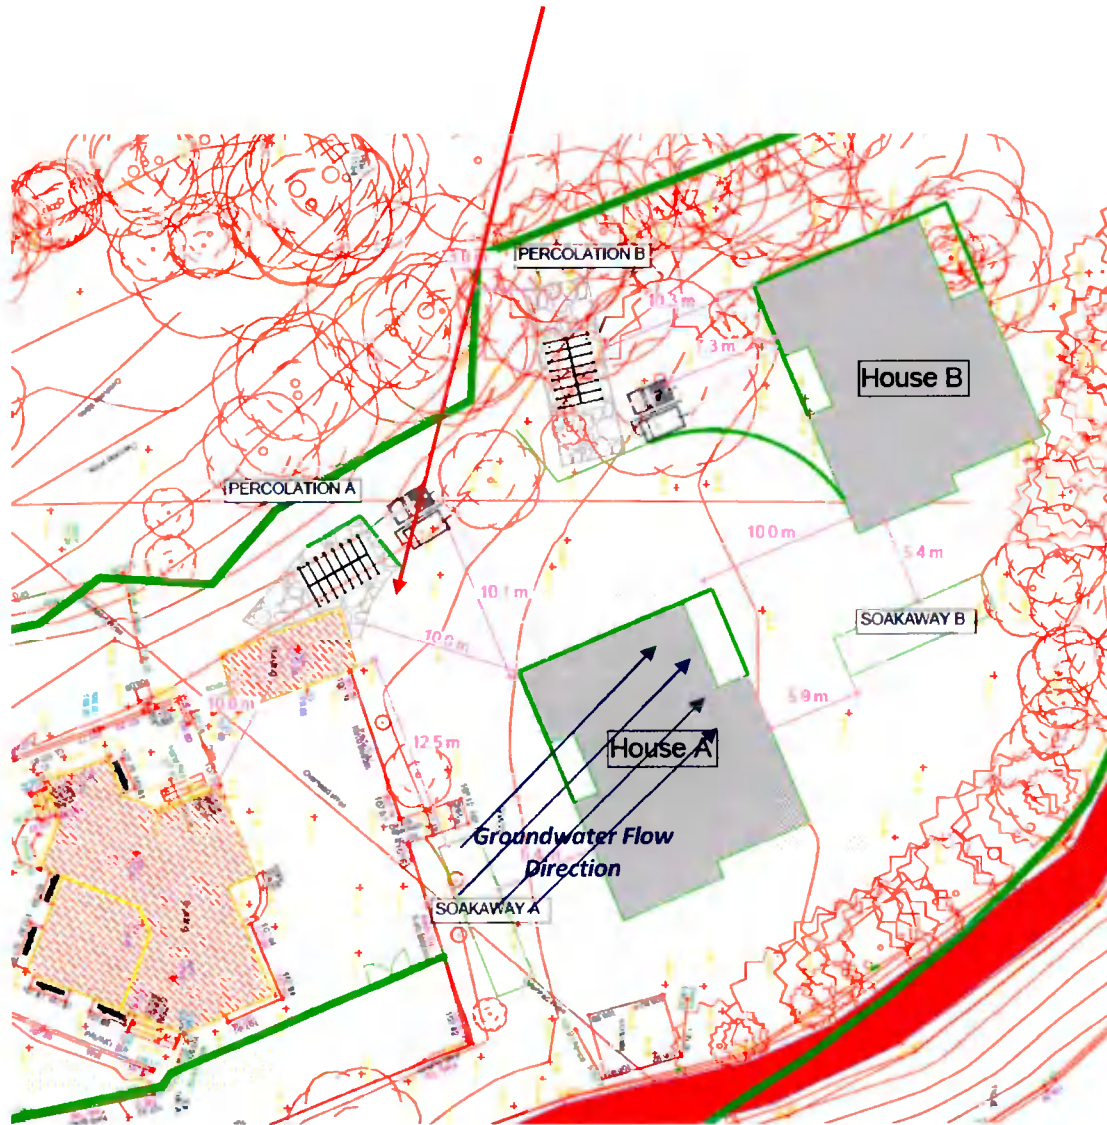
*Approximate Location of Trial Hole & Percolation
Test Holes Examined on 24.09.21*

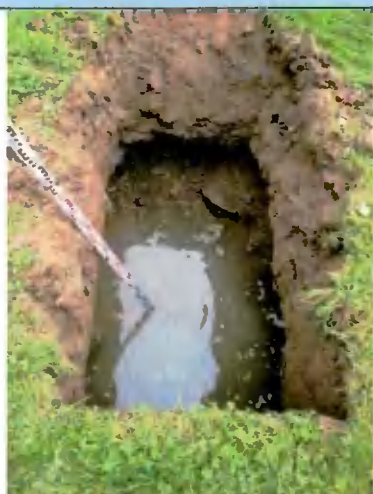
Trial Hole – Front View

Groundwater was encountered in the trial hole at a depth of 1.40m BGL. Winter Groundwater was encountered in the trial hole at a depth of 1.10m BGL. Bedrock was not encountered in the trial hole.

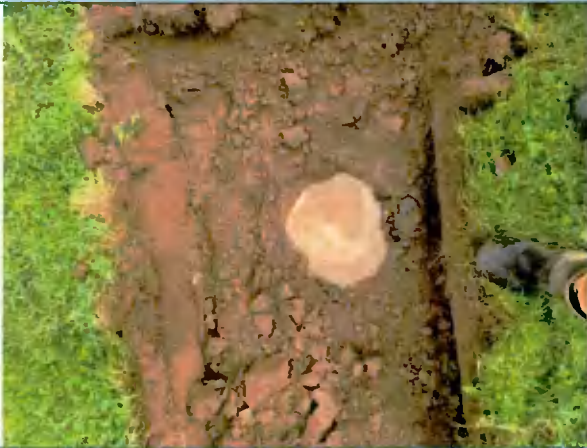
Percolation ("Sub-surface") Test 1

Result of Test: Subsurface
Percolation Value: 28.57 min/25mm

Comments
Result of Subsurface Percolation: 28.57min/25mm. Good Percolation Characteristics of the Surface Material.

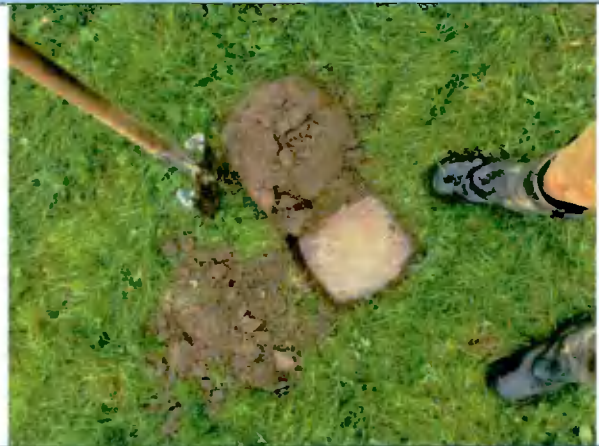
Percolation ("surface") Test 1

**Result of Subsurface Percolation: 21.04min/25mm.
Good Percolation Characteristics of the Surface Material.**

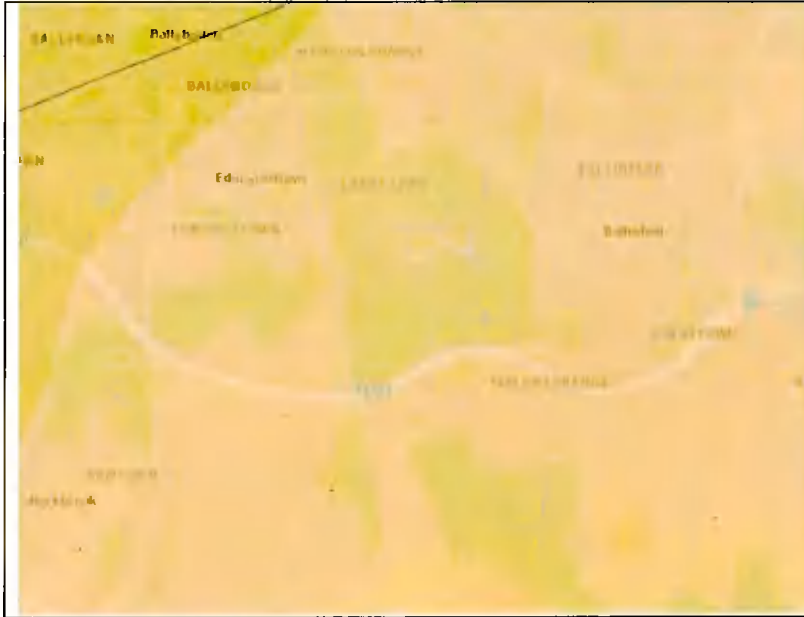
Groundwater/Aquifer Map

*From the GSI Groundwater
Aquifer Map Site is
classified as P1- Poor
Aquifer - Bedrock which is
Generally Unproductive
except for Local Zones*

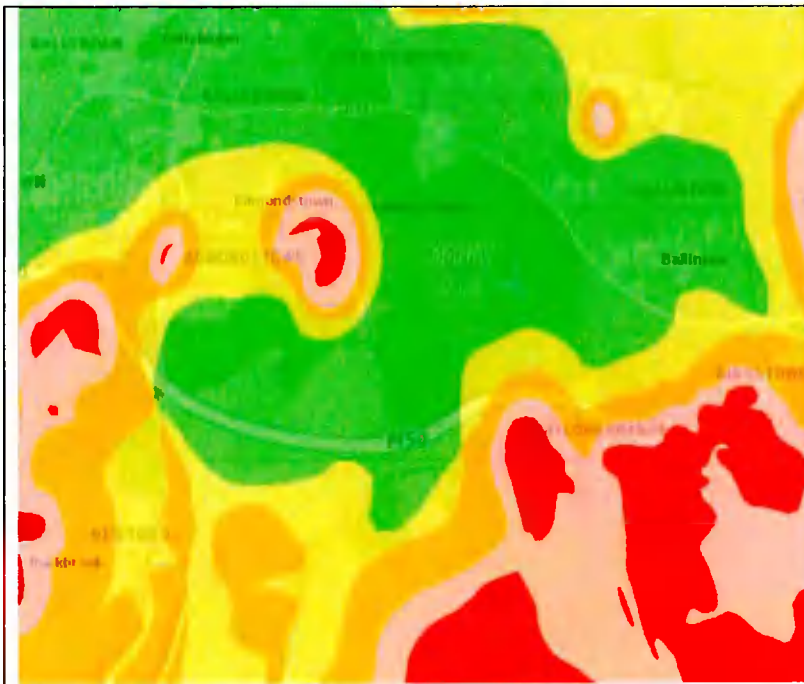
*From the GSI Vulnerability
Map Site is classified as
Low*

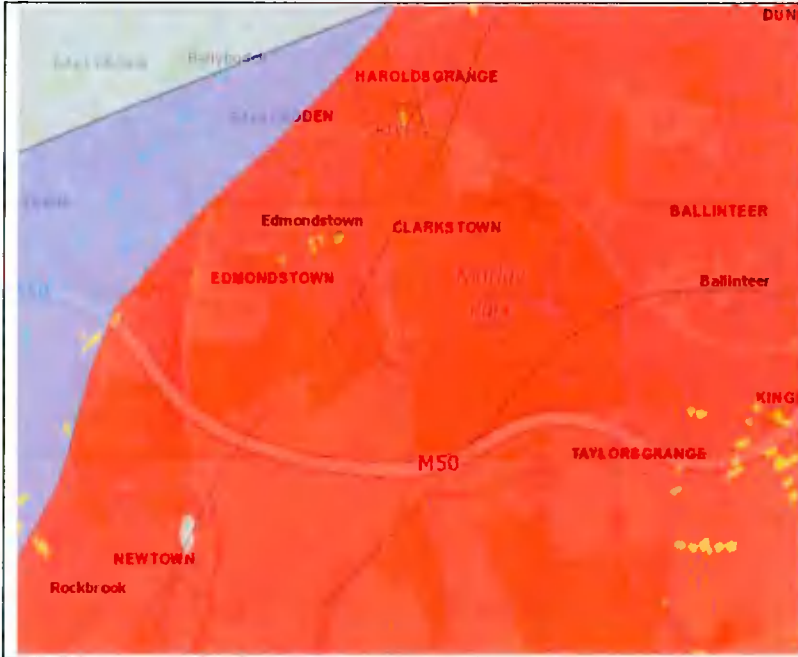
*From the GSI Bedrock Map
the Site is classified as GII-
Granites & other Igneous
Intrusive rocks*

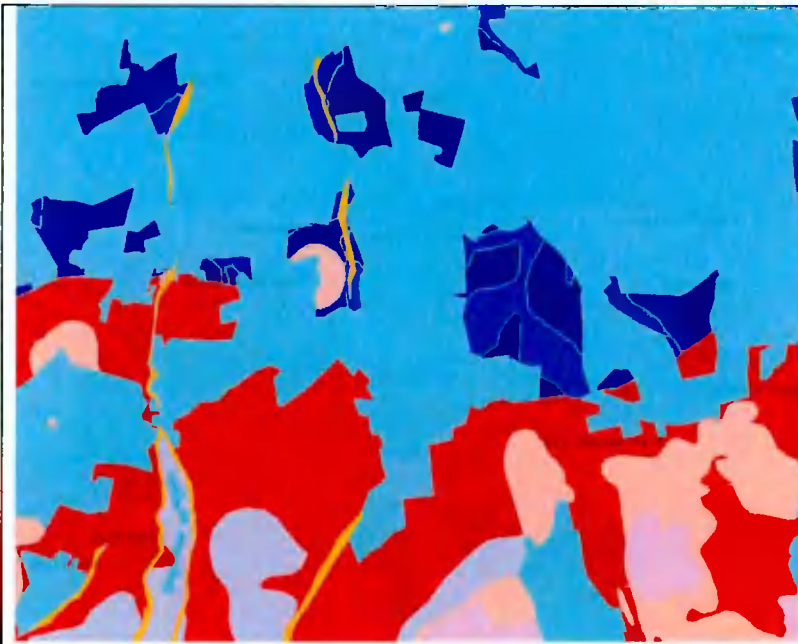
*From the GSI Teagasc
Subsoil Map Site is
classified as Fine loamy
drift with siliceous stones*
