# Tree report and survey

FOR  
PROPOSED WAREHOUSE DEVELOPMENT  
AT  
MAGNA AVENUE  
MAGNA BUSINESS PARK  
DUBLIN 24

18 February 2022

Rockface Developments

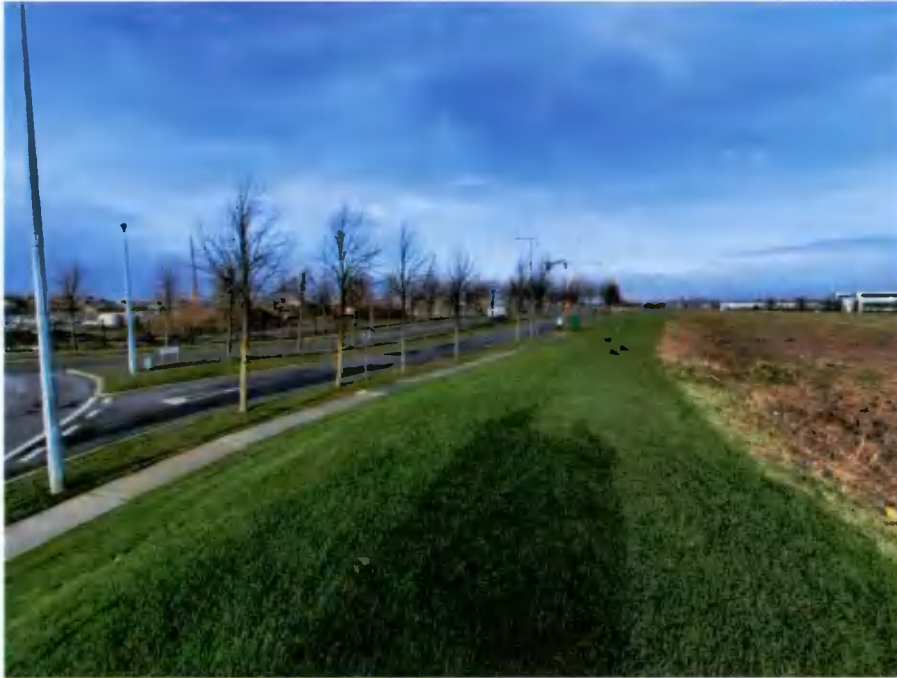
The 61 lime trees (Tree group 1) were classed as of moderate value as they appear to not be growing vigorously and suffering from the harsh conditions of the surrounding environment and /or poor ground conditions. They do provide landscape value as a soft edge to the west and north boundaries.

1. Tree group 1 forming soft landscape edge to site.

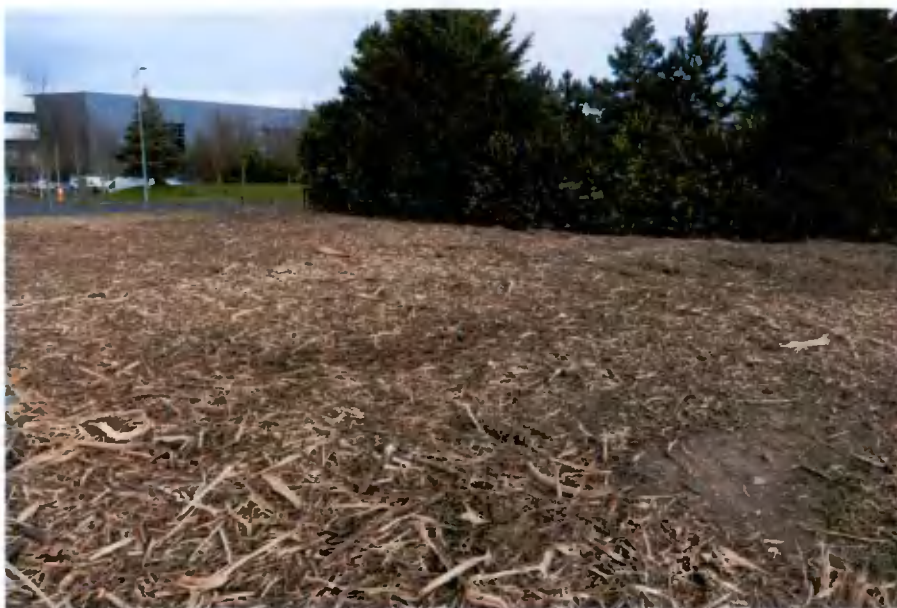
The 8 pine, 1 leylandii cypress and a number of cherry laurel are offset approximately 2 to 3m along a c. 45m section of the boundary of the site in the north east corner. This planting is essentially an over grown evergreen screen between the two sites and is classed as low value due to the very tight spacing of the individual trees, their deformed growth and also given their location. They are positioned directly on top of a 3 to 4 m high gabbion retaining wall in the adjoining site. Their long term suitability and safety for this location is questionable given the proximity to the retaining structure and their eventual expected size.

2. Tree group 2 in north east corner of the site.

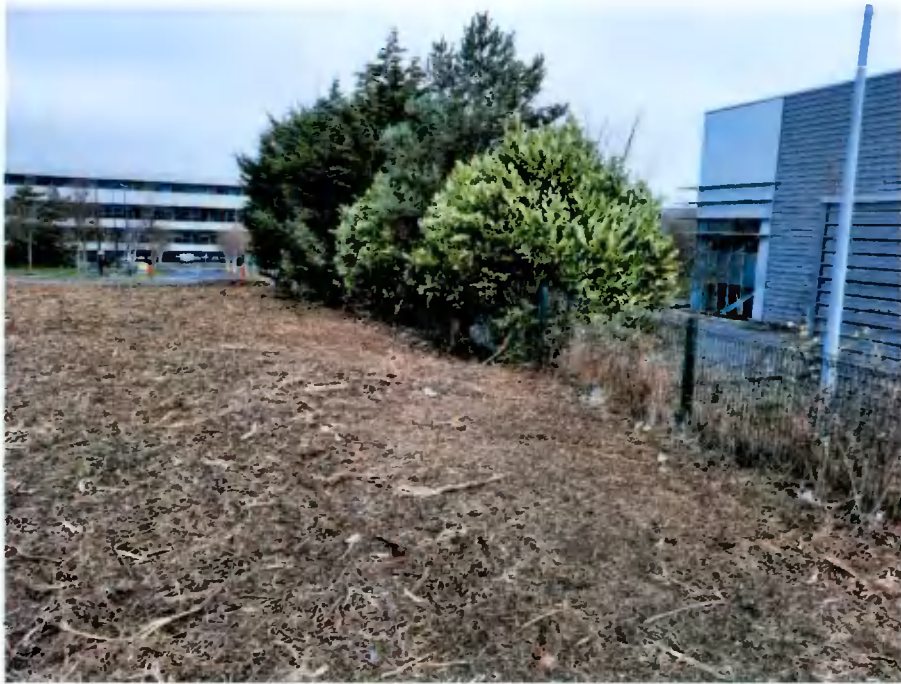
*3. Tree group 2 in north east corner of the site.*
