CUNNANE STRATTON REYNOLDS

TREE SURVEY

**Haydens Lane,
Adamstown, Lucan,
Co Dublin.**

December 2021

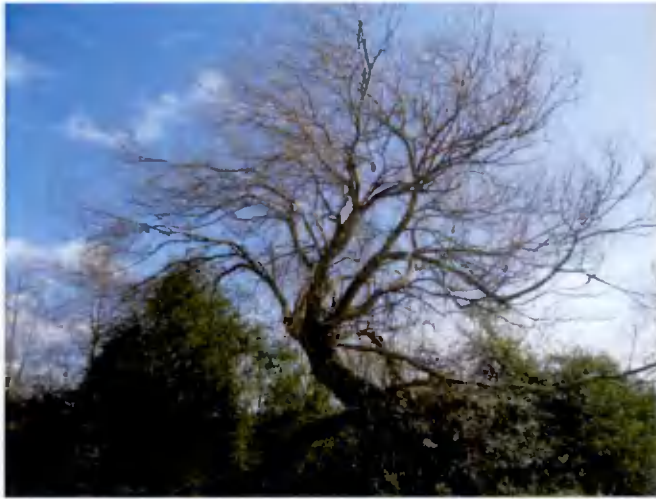
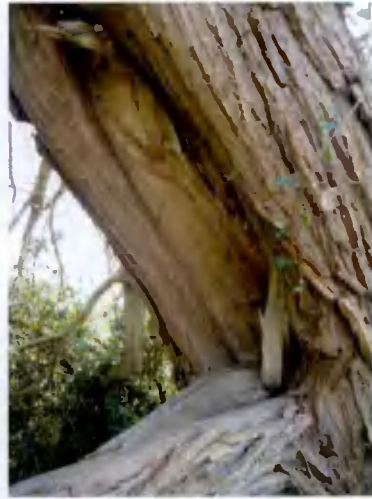
T013

10	Cupressus x cupressocyparis leylandii	9	2/2/2/2	490	5.88	3	MA	20+	Good	Good		C1	
11	Prunus avium	7	4/2/3/3	375	4.50	1m all	MA	20+	Good	Fair	Remove Ivy	B2	
12	Prunus avium	8	4/3/4/4	400	4.80	1m all	MA	20+	Good	Fair	Remove Ivy	B2	
13	Salix alba	9	8/7/6/6	900	10.80	3m n	M	10+	Fair	Poor	Monolith	B2	branch break / decay
14	Quercus robur	7	3/3/3/3	240	2.88	2m all	Y	40+	Good	Fair		A2	
15	Quercus robur	6	2/2/2/2	150	1.80	2m all	Y	40+	Good	Fair		A2	remove stake ties
16	Quercus robur	6	2/2/2/2	200	2.40	2m all	Y	40+	Good	Fair		A2	remove stake ties
17	Betula utilis	6	2/2/2/2	180	2.16	2m all	Y	40+	Good	Good		C1	
18	Betula utilis	4	2/2/2/2	150	1.80	2m all	Y	10<	Poor	Poor		C1	
19	Betula utilis	4	1/1/1/1	80	0.96	2m all	Y	40+	Good	Good		C1	
20	Prunus sp.	5	2/2/2/2	140	1.68	1m all	Y	20+	Fair	Good		C1	
21	Betula pendula	6	2/2/2/2	200	2.40	2m all	MA	20+	Good	Fair		C1	Youngii
22	Acer platanoides	11	4/4/5/4	450	5.40	1m s	MA	40+	Good	Fair	Remove Ivy	B1

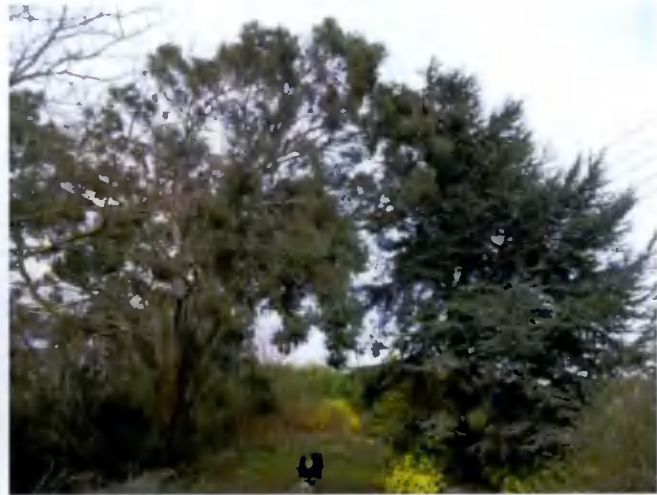
T024 & T025

23	Eucalyptus viminalis	14	9/3/4/6	460x4	11.04	1m w	MA	10+	Fair	Fair	Remove Ivy	B1	
24	Eucalyptus viminalis	15	5/5/6/5	840	10.08	3m all	M	20+	Good	Fair	Remove Ivy	B1	power line conflict
25	Cedrus atlantica	11	3/3/3/2	460	5.52	2m all	MA	40+	Good	Fair		B1	power line conflict
26	Acer platanoides	8	3/3/3/2	340	4.08	2m e	MA	40+	Good	Fair		B1	
27	Acer platanoides	9	4/4/4/2	420	5.04	2m s	MA	40+	Good	Fair		B1	
28	Acer platanoides	8	2/2/2/3	150x3	3.12	1m all	MA	40+	Good	Fair		B2	
29	Acer platanoides	8	3/3/3/3	270	3.24	1m all	MA	40+	Good	Fair		B2	
30	Cedrus atlantica	8	2/2/2/2	300	3.60	1m all	MA	40+	Good	Fair		B1	
TG1	Cupressus x cupressocyparis leylandii & Prunus avium	6		Av 135	1.62	0m all	MA	20+	Good	Fair		C2	
TG2	Cupressus x cupressocyparis leylandii	5		300	3.60	0m all	MA	20+	Good	Fair		C2	
TG3	Cupressus x cupressocyparis leylandii	5		300	3.60	0m all	MA	20+	Good	Fair		C2
