EDMONDSTOWN SHD
KILMASHOGUE
DUBLIN 16

Project No.	Project name	Date	Revision
TEDM001	Edmonstown SHD	28/10/21	-

Report Prepared by

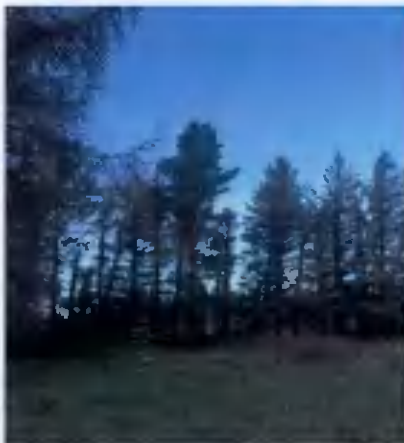
The main group of trees are those on the southern and western boundaries (images 2 & 3). These are screen / shelter-belt plantings mainly composed of coniferous species including Douglas fir (*Pseudotsuga menziesii*), Larch (*Larix decidua*), Sitka spruce (*Picea sitchensis*). There are also occasional poplar (*Populus spp*) with a now mostly dead or poorly developed element of birch (*Betula pendula*) within the mix. Monterey cypress (*Cupressus macrocarpa*) is also represented within the shelter-belt planting and as individual trees and small groups in various locations. There has been no effective management of these trees with the result that their condition is mixed with competition causing the poor development of some specimens (image 4). The planting provides screening, shelter and acts as a noise buffer so is a valuable resource overall. However it requires appropriate management to improve its quality and effectiveness.

Image 2. Section of shelter-belt on southern boundary

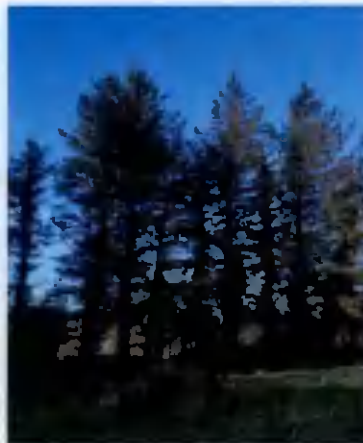
Image 3. Section of shelter-belt on western boundary

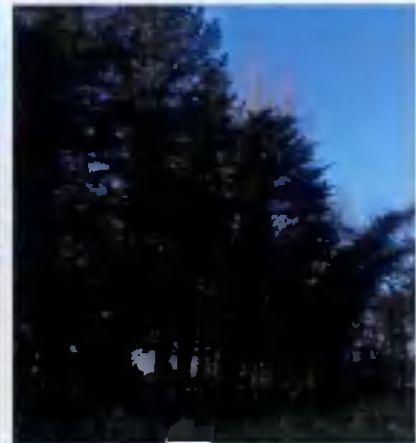
Image 4. Southern and western sections of shelter-belt. Note larch in a state of collapse

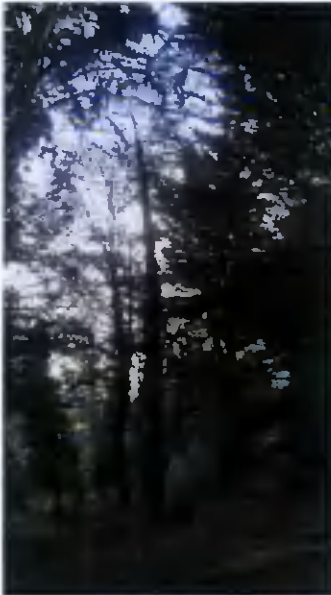
Monterey cypress form the main species along the upper section of the southern edge of the access road (image 5). Again, these trees provide a valuable resource in terms of screening and shelter but due to the dense nature of the planting are in need of management to thin out poorer specimens. This species is also noted for limb failure during storm events therefore appropriate management is crucial for their long-term potential.

Image 5. Monterey cypress along the southern edge of access road

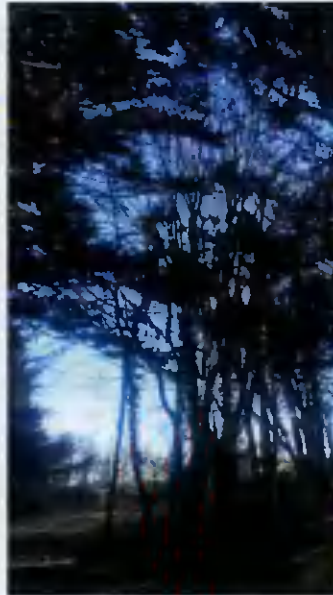
A beech hedge at the entrance to the house has long been allowed to develop without appropriate management with the result that the individual trees are generally drawn and poorly formed due to competition between specimens (image 6). To the east of the house a planting of Leyland cypress (*xCuprocyparis leylandii*) appears to have been planted as a screen (image 7). It is composed of 4 specimens which are developing into trees. None are of particular merit with one specimen in decline.

Image 6. Beech hedge near house. Note competition induced form.

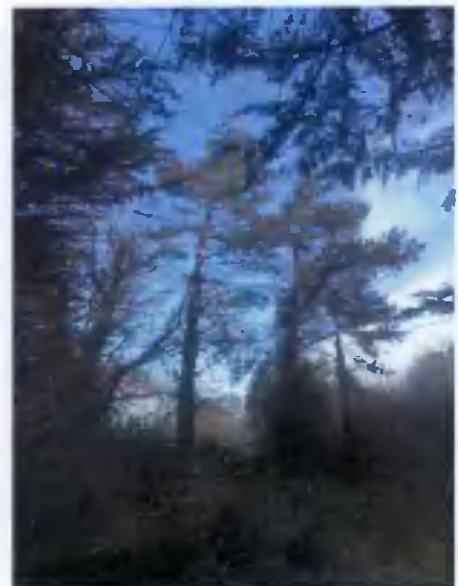
Two Scots pine (*Pinus sylvestris*) are located on sloping ground to the east of the site. These trees have landscape value within an appropriate setting and are in keeping with the upland nature of the site (image 8).

Image 8. Scots pine #2065 & 2066

2066	Scots pine <i>Pinus sylvestris</i>	Mature	Good	A well developed specimen. Very heavy ivy growth obscuring view for assessment.	Cut ivy and re-assess	B2	30-40	17	420	2;5;5;4	10n
2067	Beech <i>Fagus sylvatica</i>	Young	Very Poor	Sub-dominant to neighbouring trees	Fell	U	<10	6.5	170	0;3;1;1	NA

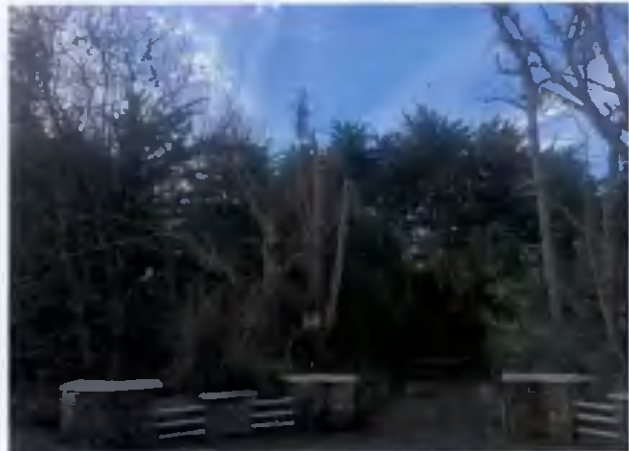
There are a number of trees on the section of the site the borders Whitechurch Road. These are a mixture of native / naturalised self-seeded deciduous species and a section of the screen / shelter-belt coniferous planting. The quality of the trees is generally poor with the deciduous trees #2045 & 2046 low value (category C) with structural issues and elements of decay which limit their long-term potential. The section of coniferous planting in this area is in very poor condition and mostly in a state of collapse or decline due to lack of management (category U).

Image 9. Entrance to site. Note poor quality of blue moss cypress trees #2049 and storm damage to Monterey cypress #2046
