# Arboricultural Assessment & Impact Report

## The Arboury

Project No.	Project name	Date	Revision
TABB001	The Arboury	20/04/22	B

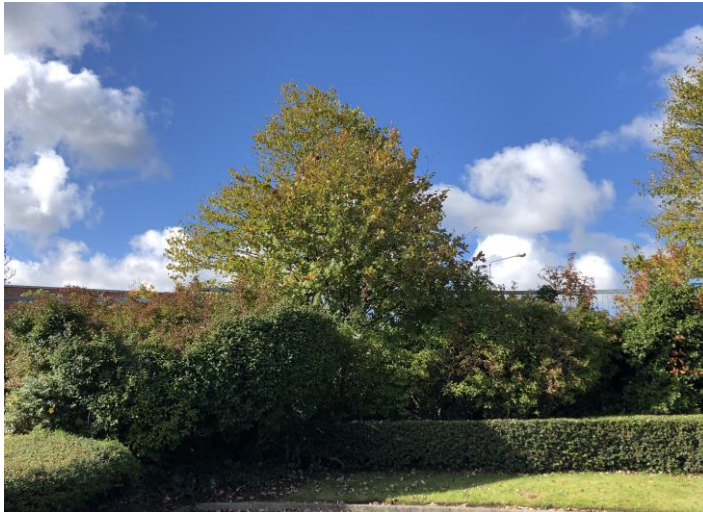
There are also a range of shrubs including lilac, hebe and potentilla present. In the main they have been tightly clipped (image 2) and are of low to moderate landscape value as a result.

**Image 2.** Whitebeam on western boundary

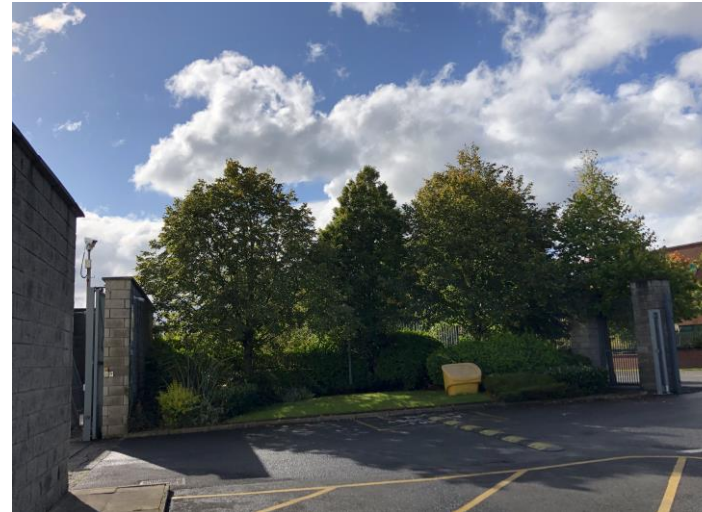
**Image 3.** Alder on southern boundary

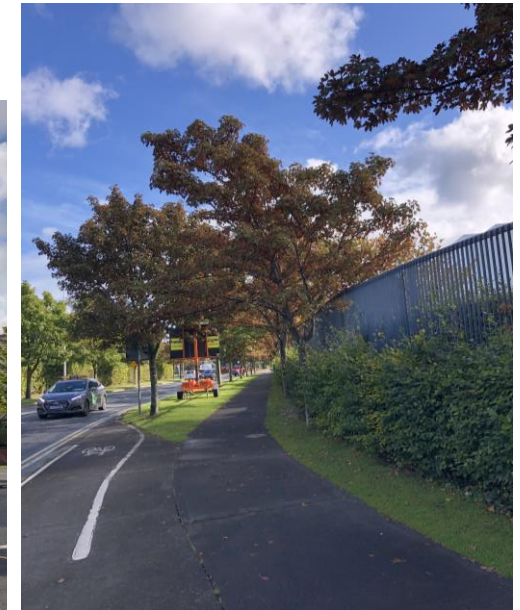
A number are growing close to or just overhanging the ABB site (image 4). They are very unlikely to have roots which extend into the site as a boundary wall and fence delineates the boundary and would restrict root movement into the site.

**Image 4.** Trees on Belgard Square North

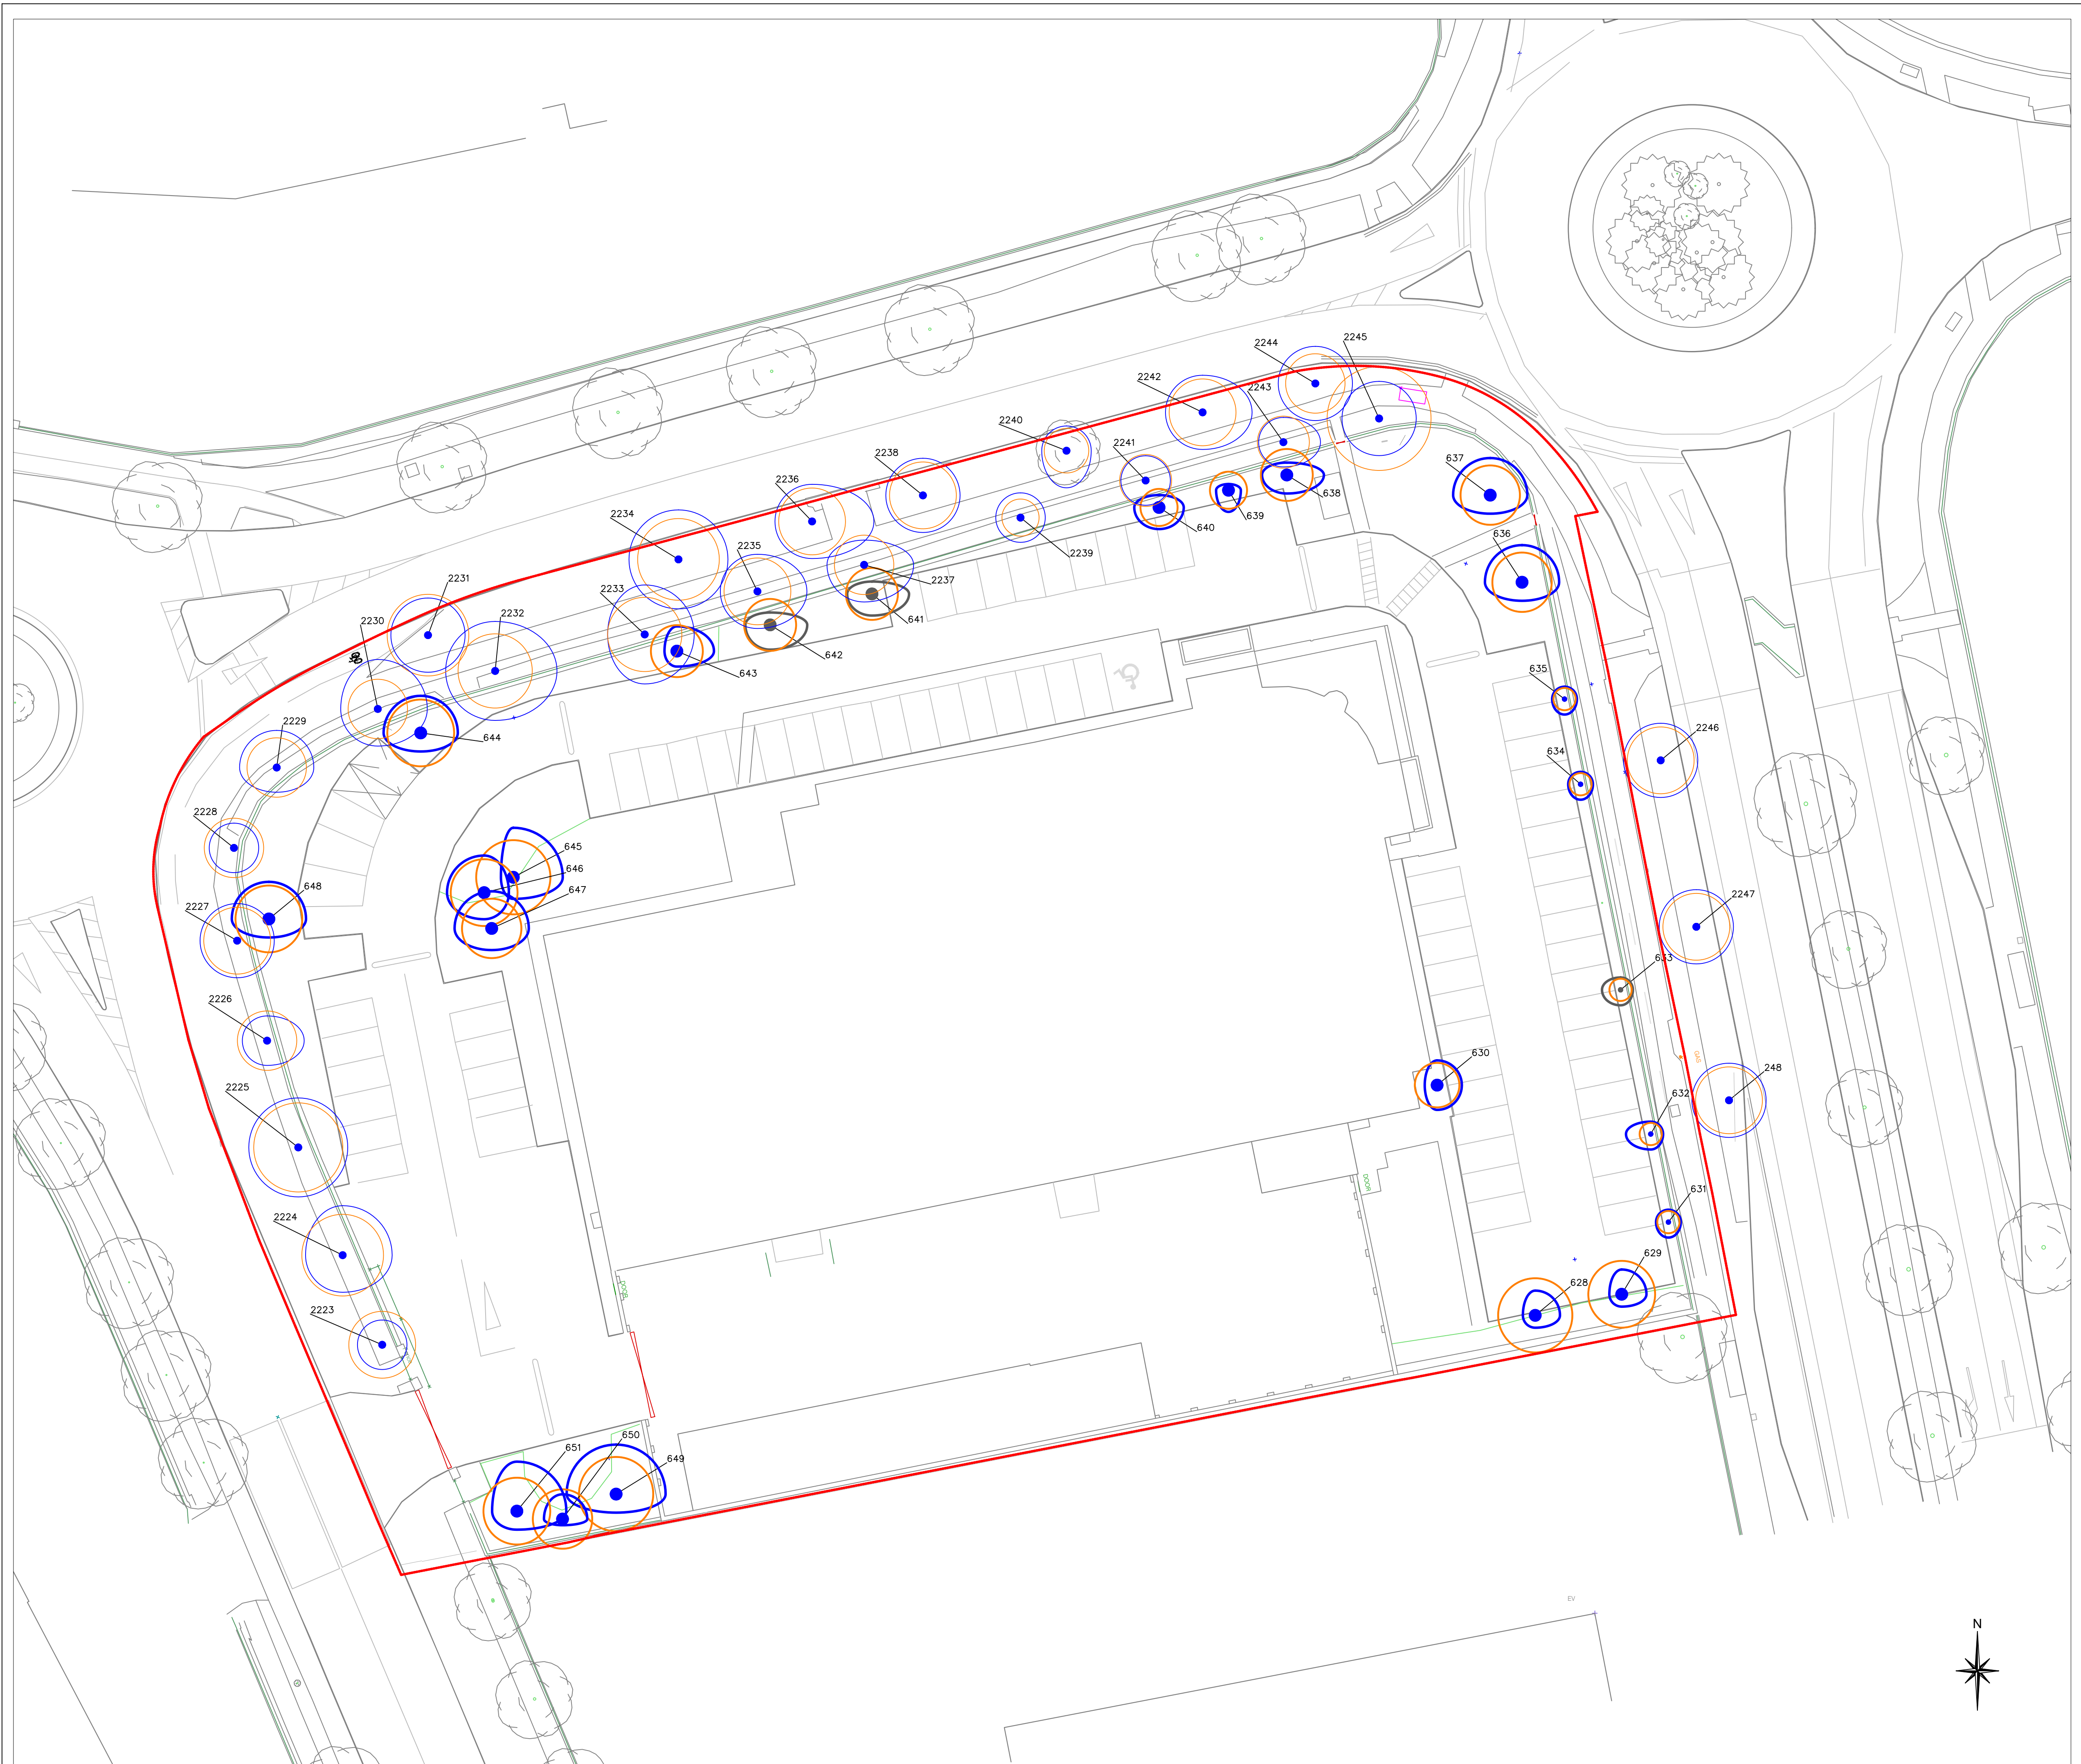
CLIENT: Landmarque Belgard Development Company Limited	PROJECT: The Arbours		
DRAWING: ARBOCULTURAL ASSESSMENT	DATE: 06-04-21	SCALE: 1:250 @ A1	DRAWING NO: 101
DRAWN BY: CURRAN KEATING		CK	REVISION
STATUS: PLANNING		DETAILS

There has been minimal management of trees to date. The quality of the trees are good overall (table 1) with the vast majority of the trees within category B which gives them a moderate quality categorisation (BS5837 2012) with those within category C of low value overall.

A total of 26 trees within the public realm on Belgard road and Belgard Square North & East were assessed (for locations refer to drawing TABB001 101). They are composed of small leaved lime (*Tilia cordata* cv), Turkish hazel (*Corylus avellana*) and Norway maple (*Acer platanoides*) (Chart 2). The trees are early-mature though range considerably in terms of size. They are generally well developed (refer to Appendix II for a detailed description of individual trees) and all have been categorised as B.

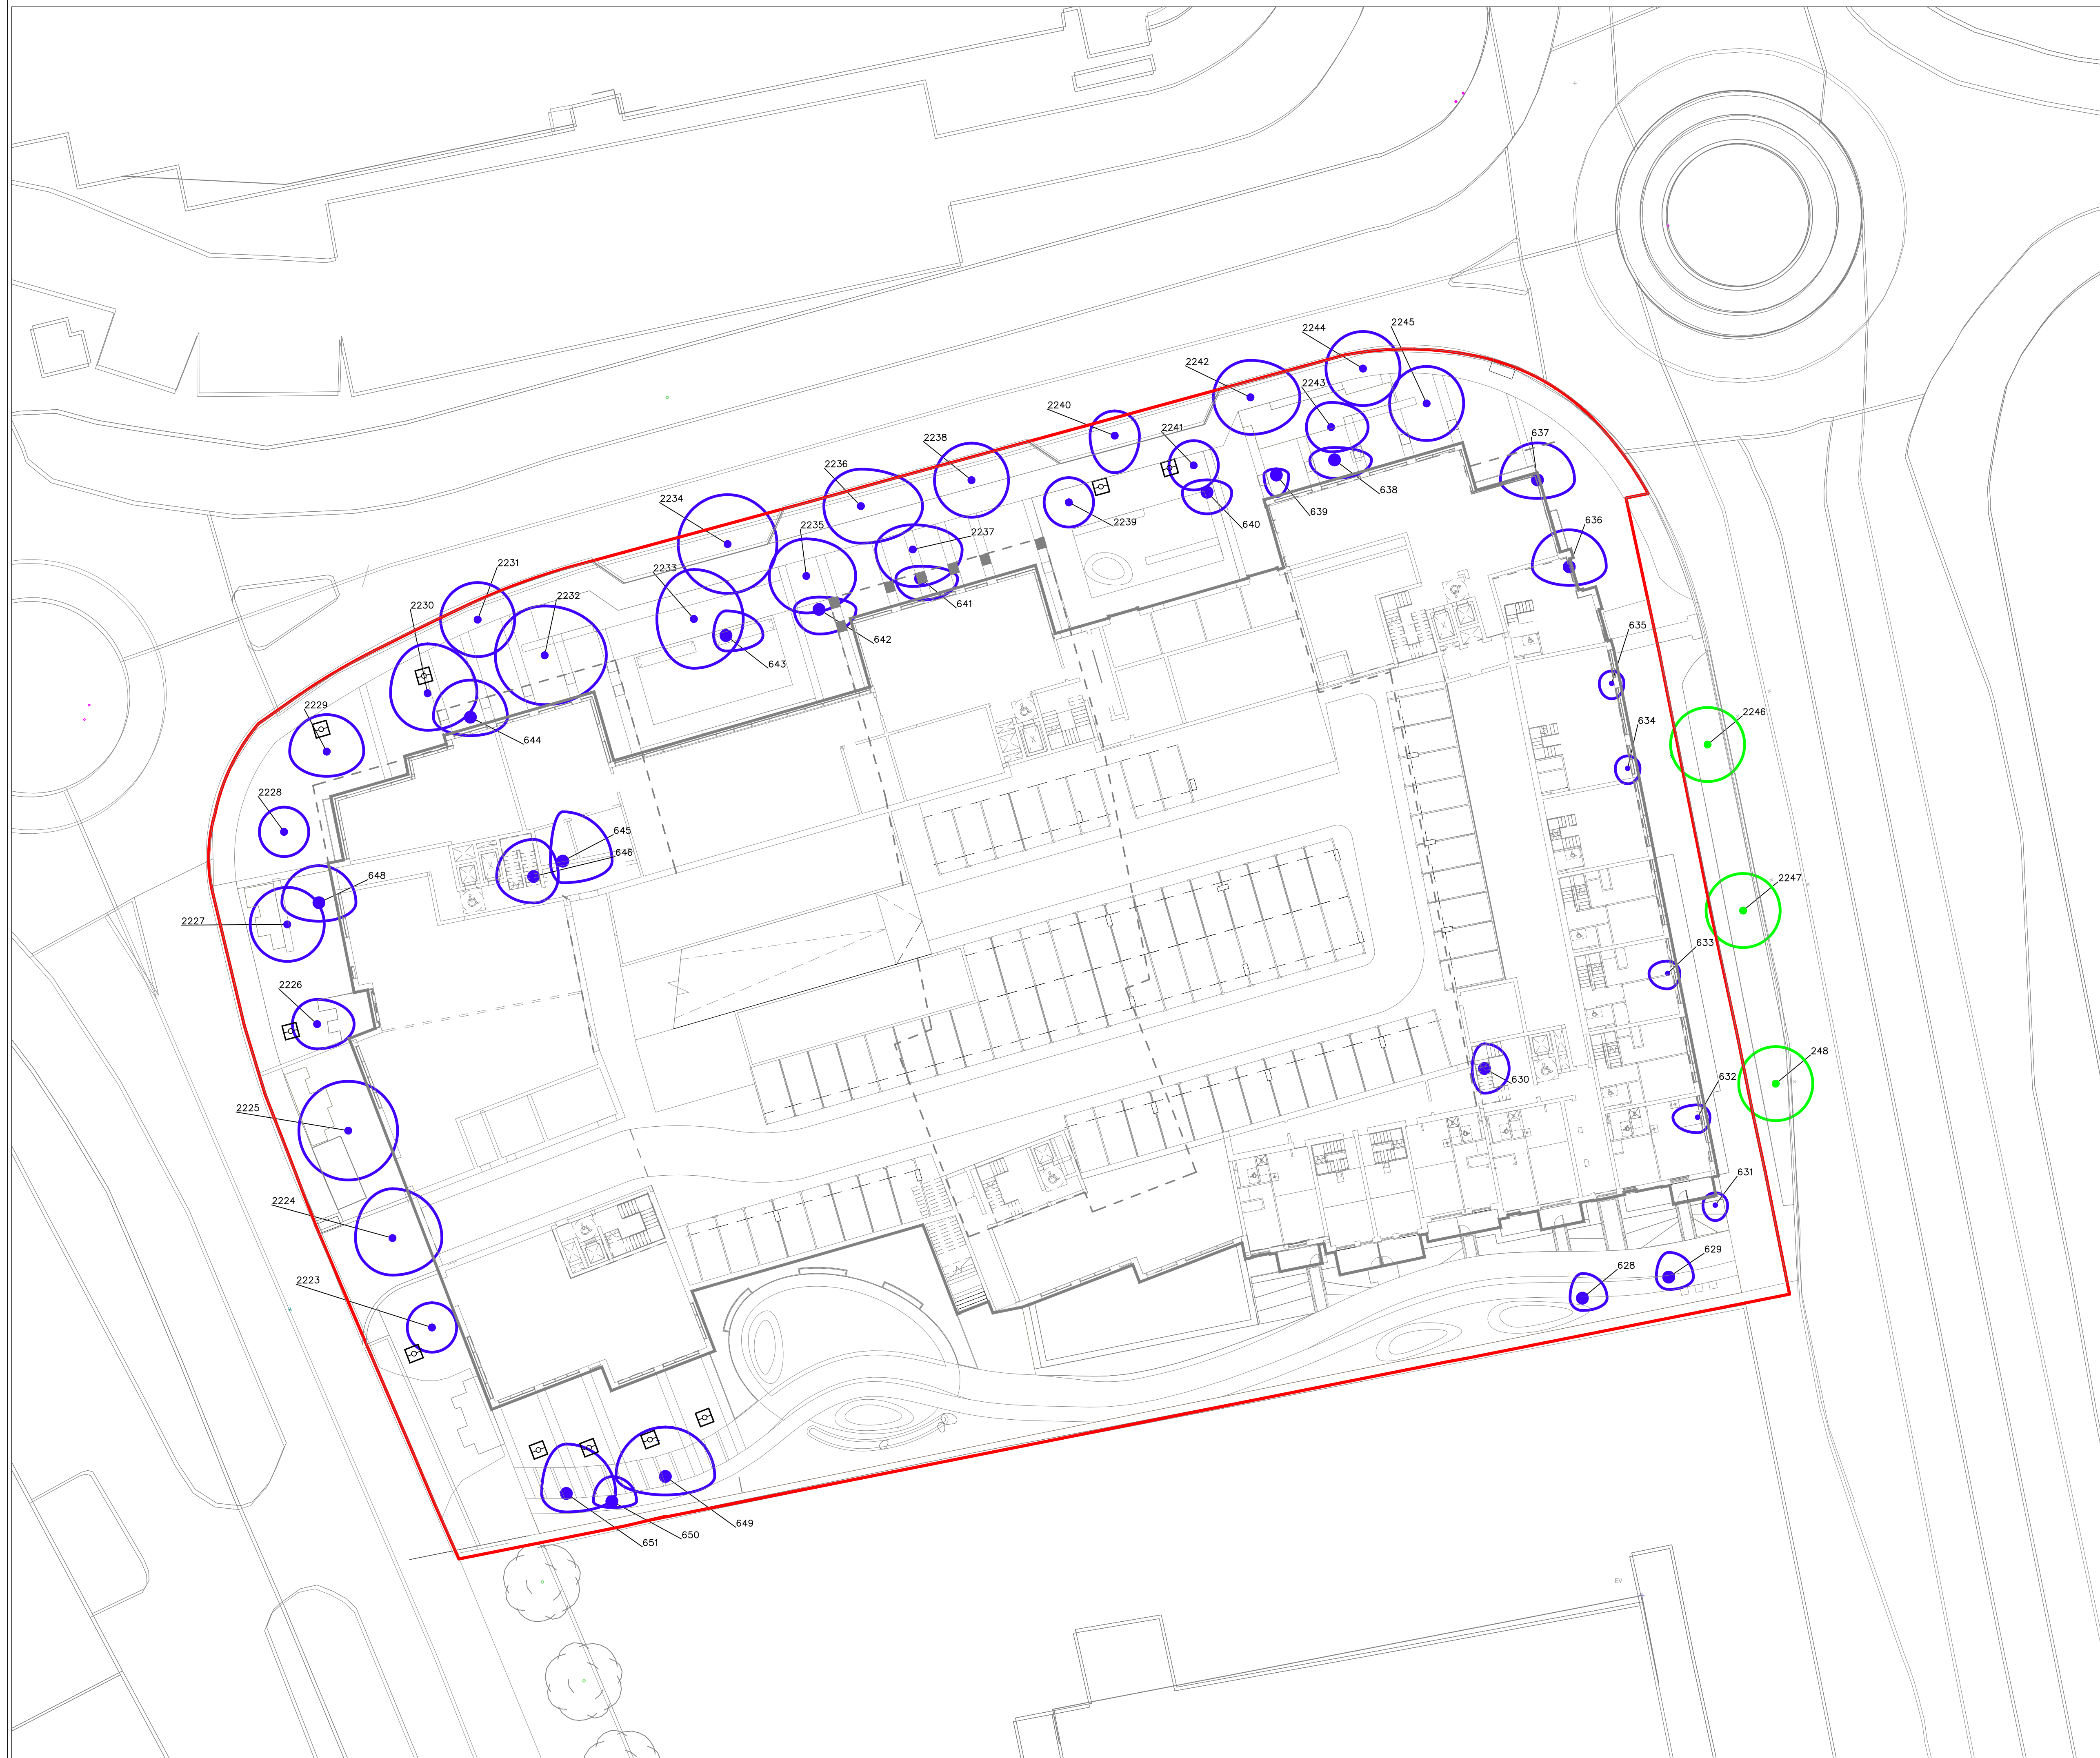
CLIENT: Landscape Belgard Development Company Limited	PROJECT: The Attery
DRAWING: ARBORICULTURAL IMPACT	DATE: 20.04.22
DRAWN BY: CARRIVALLING	SCALE: 1:250 @ A1
STATUS: PLANNING	REVISION: A

The proposed development will necessitate the demolition of all existing structures on site (and the construction of a mixed-use residential development set out in 3 No. blocks including a podium over a basement, ranging in height from 2 to 13 storeys. The proposed development will necessitate the removal of all existing trees within the site (table 1) plus a total of twenty three early-mature category B trees within the public realm on Belgard Square North & East.

The impact of the proposed development on trees is shown on drawing TABB001 102 Rev B and is considered significant in terms of tree loss in this area. Proposed new tree and other associated plantings are outlined within the Landscape Strategy provided by Cameo & Partners. They have shown a total of 86 trees planted over the site.
