Additional Information- Tree report and survey

PROPOSED WAREHOUSE DEVELOPMENT

MAGNA AVENUE

And MAGNA DRIVE, CITYWEST, DUBLIN 24

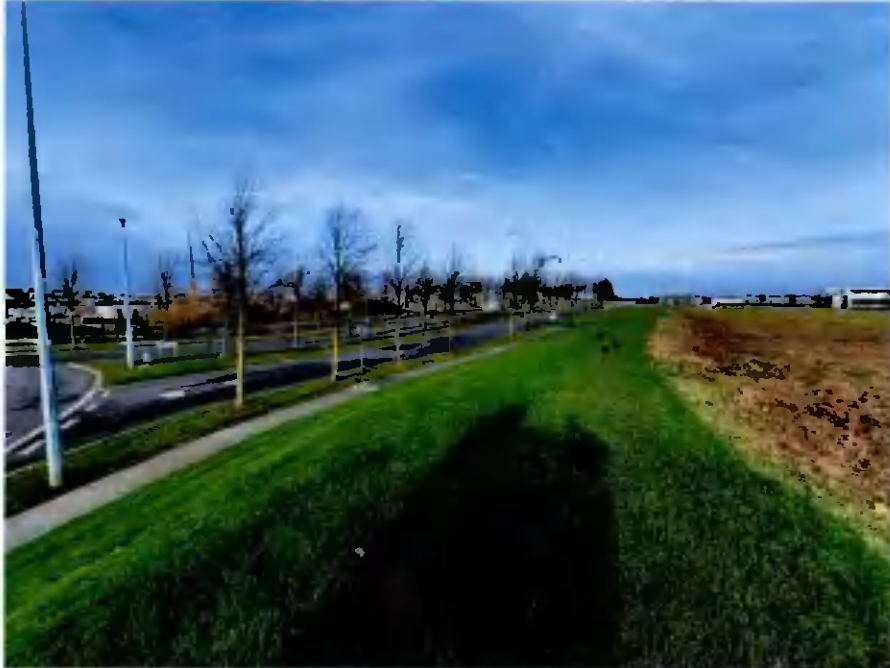
The 61 lime trees (Tree group 1) were classed as of moderate value as they appear to not be growing vigorously and suffering from the harsh conditions of the surrounding environment and /or poor ground conditions. They do provide landscape value as a soft edge to the west and north boundaries.

1. Tree group 1 forming soft landscape edge outside the site.

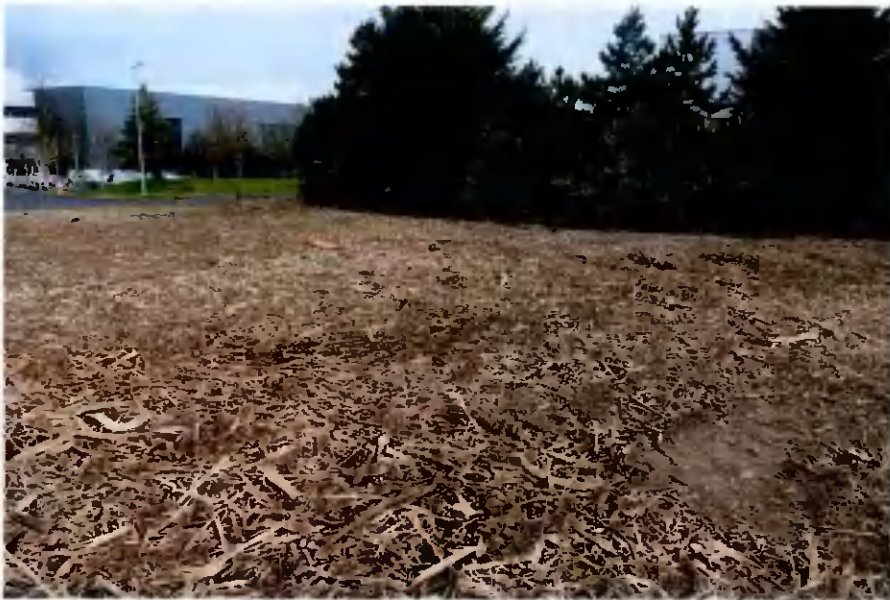
The 8 pine, 1 leylandii cypress and 4 cherry laurel are offset approximately 2 to 3m along a c. 45m section of the boundary of the site in the north east corner. This planting is essentially an over grown evergreen screen between the two sites and is classed as low value due to the very tight spacing of the individual trees, their deformed growth and also given their location on a steep level change. They are positioned directly on top of a 3 to 4 m high gabbion retaining wall in the adjoining site. Their long term suitability and safety for this location is questionable given the proximity to the retaining structure and their eventual expected size.

2. Tree group 2 outside north east corner of the site.

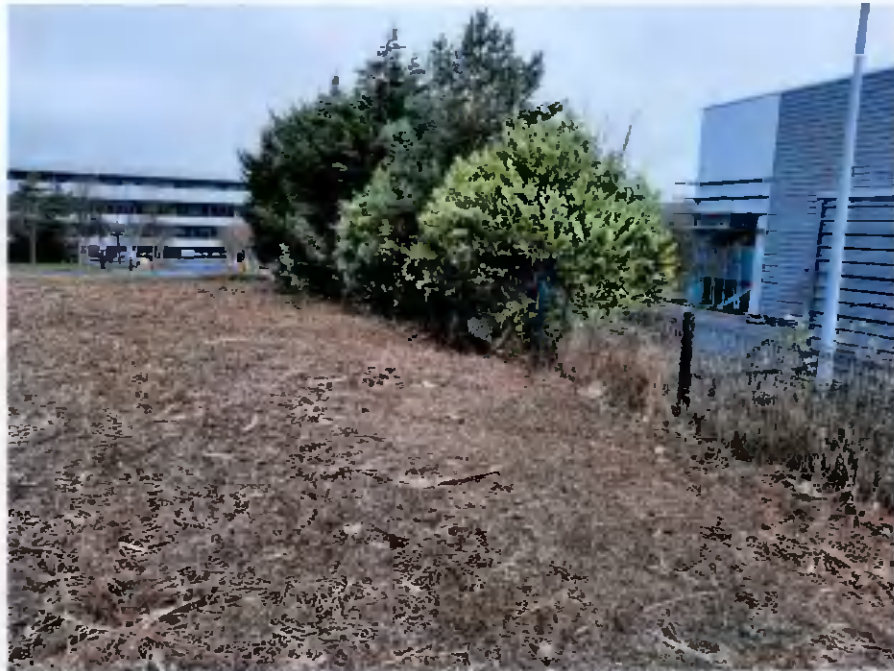
3. Tree group 2 outside north east corner of the site.
