Bat Roost Survey Report

Kiltipper Woods Care Home, Tallaght,
Dublin

Planning Application Ref: SD21A/0287

March 2022

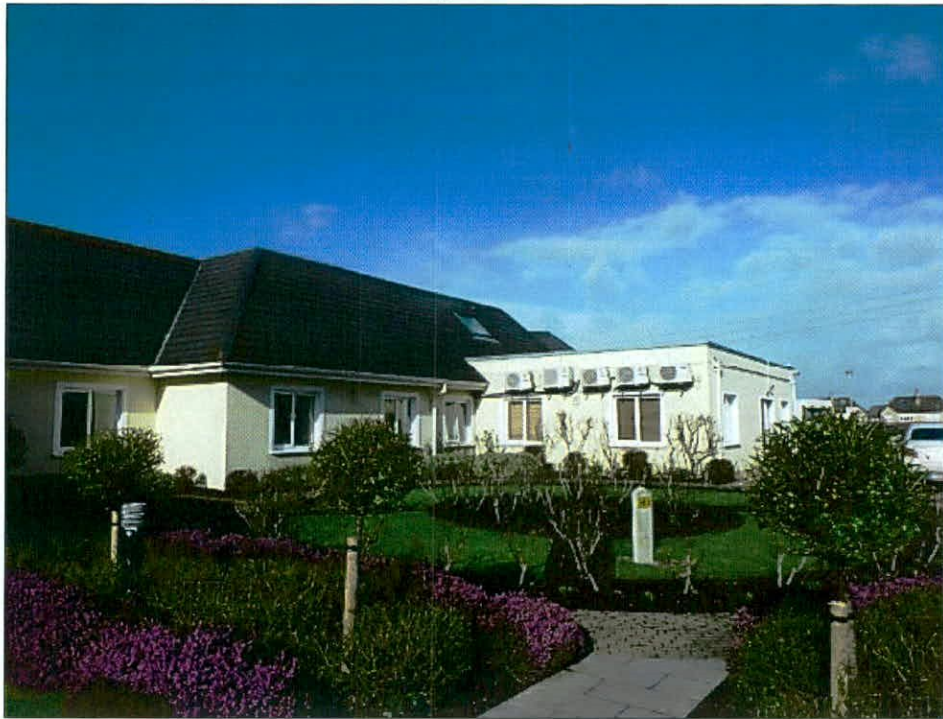
- 4.2 The building is a typical modern rendered block wall construction, which has been maintained to a high standard. There are no notable gaps between the roof slates and ridge tiles while the PVC fascia boards and soffits are generally in excellent repair and fit tightly to the walls and roof. The PVC window frames are also in good repair with no cracks or cavities between frame and walls.

Figure 1 Building exterior

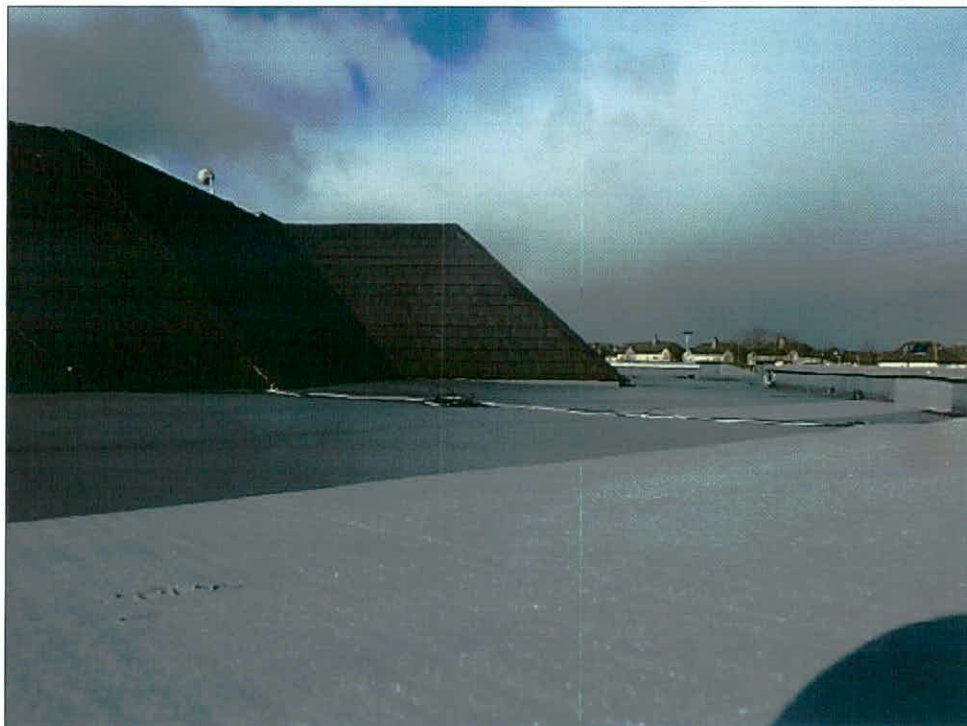
- 4.1 The Kiltipper Woods Care Centre is a modern purpose-built facility which opened in 2004 (Figure 1). The proposed extension will affect only a small part of the building as illustrated in Appendix 2 of this report. A significant section of the area affected is a flat roofed area which houses the current reception area (Figure 2), although there are also sections of pitched fibre-slate roof within the extension area.

Figure 2 Flat roof at front of building

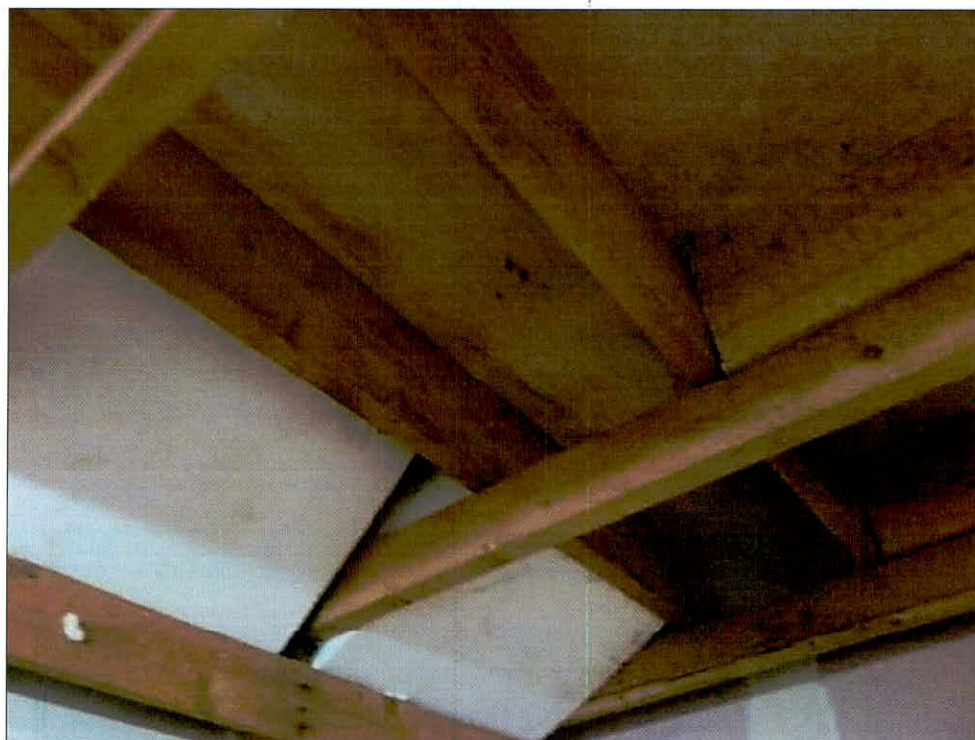
- 4.4 There were no obvious access points to the building's roof voids which were extremely well-insulated and maintained. The roof-void ceilings were lined with plywood-faced boarding and insulation panels preventing access by bats into the roof space area (Figure 3). Roof timbers are treated and intact with no cracking, gappy joints or holes. Many sections were partially floored, fitted with electric lighting and used as storage space (Figure 4).

Figure 3 Typical roof void area

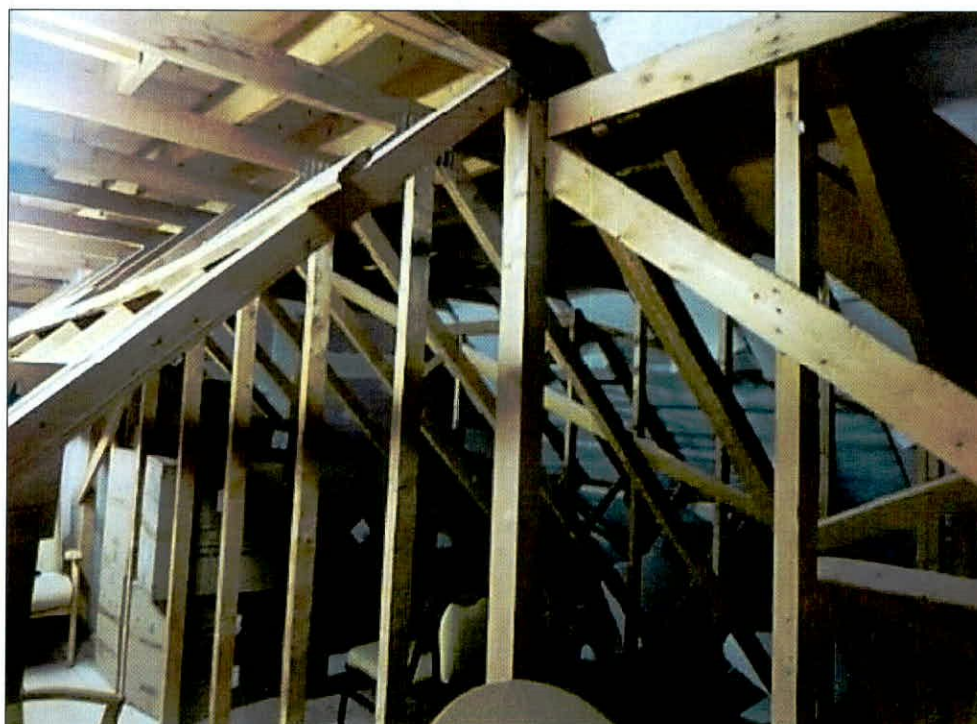
Figure 4 Roof void used for storage

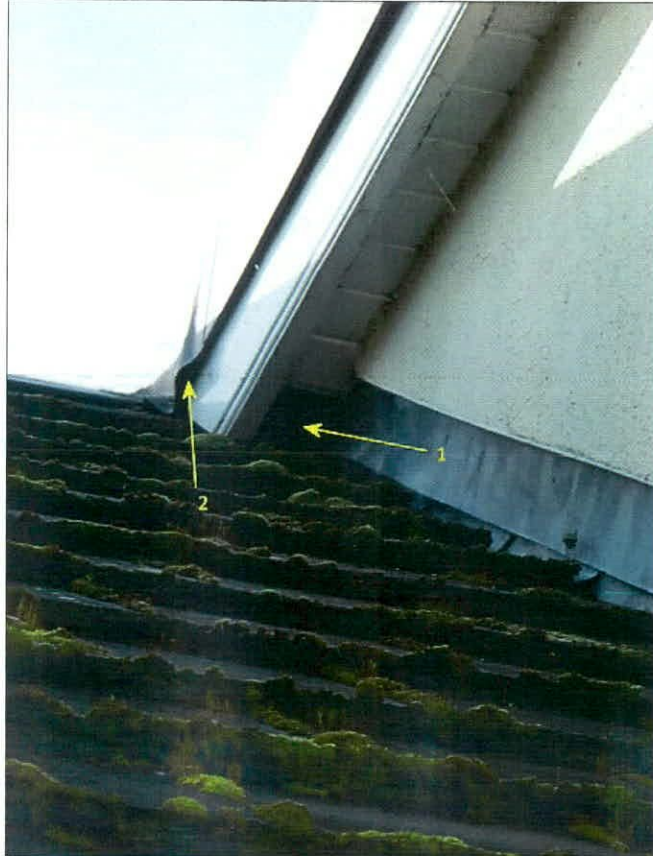
1. Large gap in PVC fascia;
 2. Lifted lead flashing;
 3. A gap in a roof valley between lead flashing and guttering;
 4. a gap where flat roof meets the sloped roof tiles.

Photo 1 Potential roost features 1 & 2

- 6.4 In light of this assessment it is recommended that before construction work begins, a single dusk emergence survey should be undertaken at an appropriate time of year (May to August) to confirm the presence or absence of roosting bats at the potential roost features identified. Two personnel would be required to ensure coverage of these features.

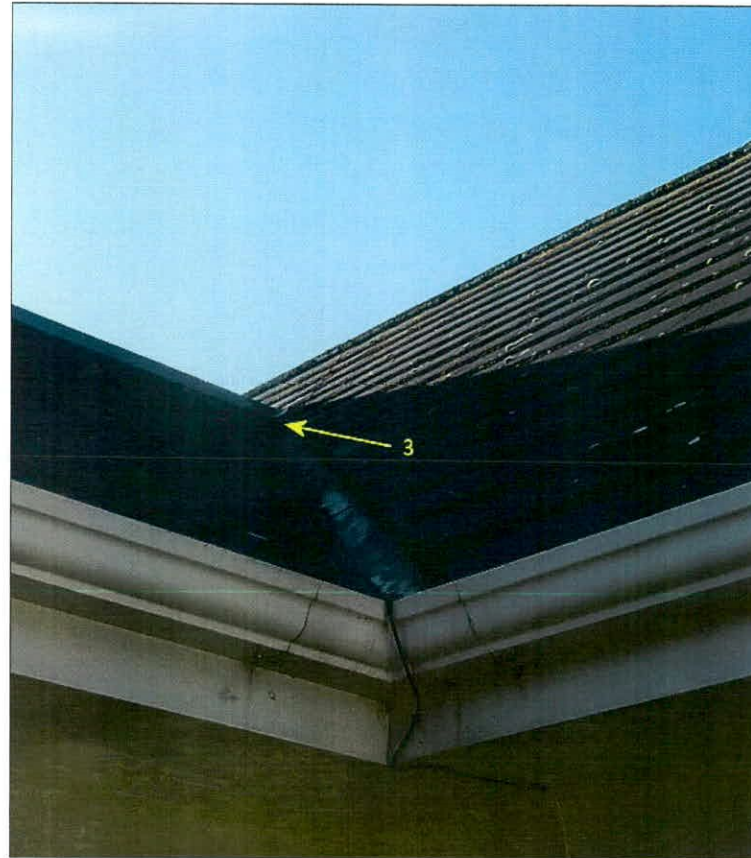
Photo 2 Potential roost feature 3

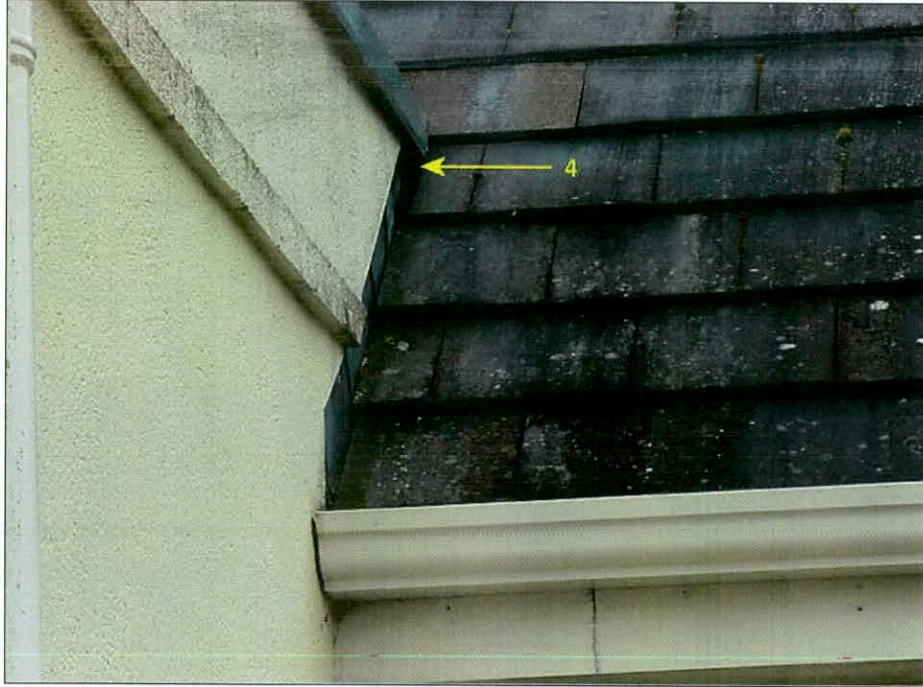
Photo 3 Potential roost feature 4

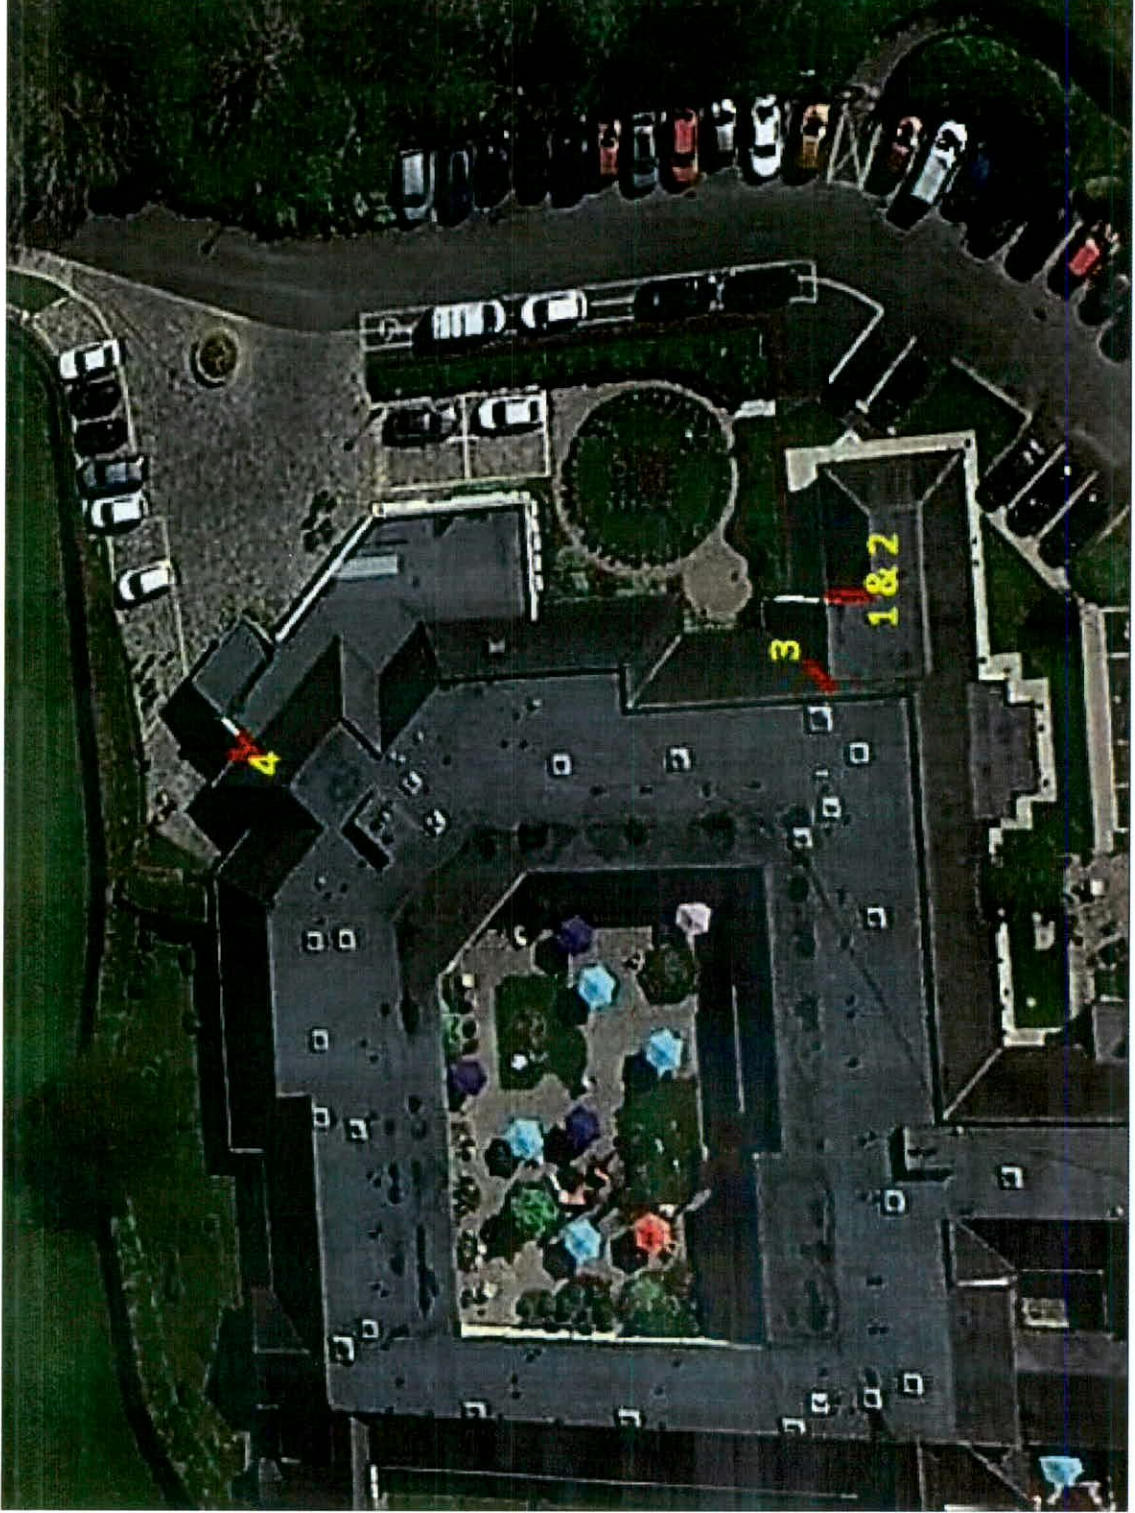
Appendix 6 Location of potential roost features

- 5.9 A small number of potential entry points were identified on the exterior roof. As access to the roof void appears highly unlikely, any roosting bats would be restricted to the space between the roof tiles and roof lining, or small gaps between the roof tiles and lead flashing. The potential roost features (PRFs) identified were as follows:
