# Arboricultural Report

Tree Survey,  
Arboricultural Impact Assessment &  
Arboricultural Method Statement

**Belgard Square East**  
**Belgard Road and Blessington Road**  
**Tallaght**  
**Dublin 24**

**210812-PD-11-A**

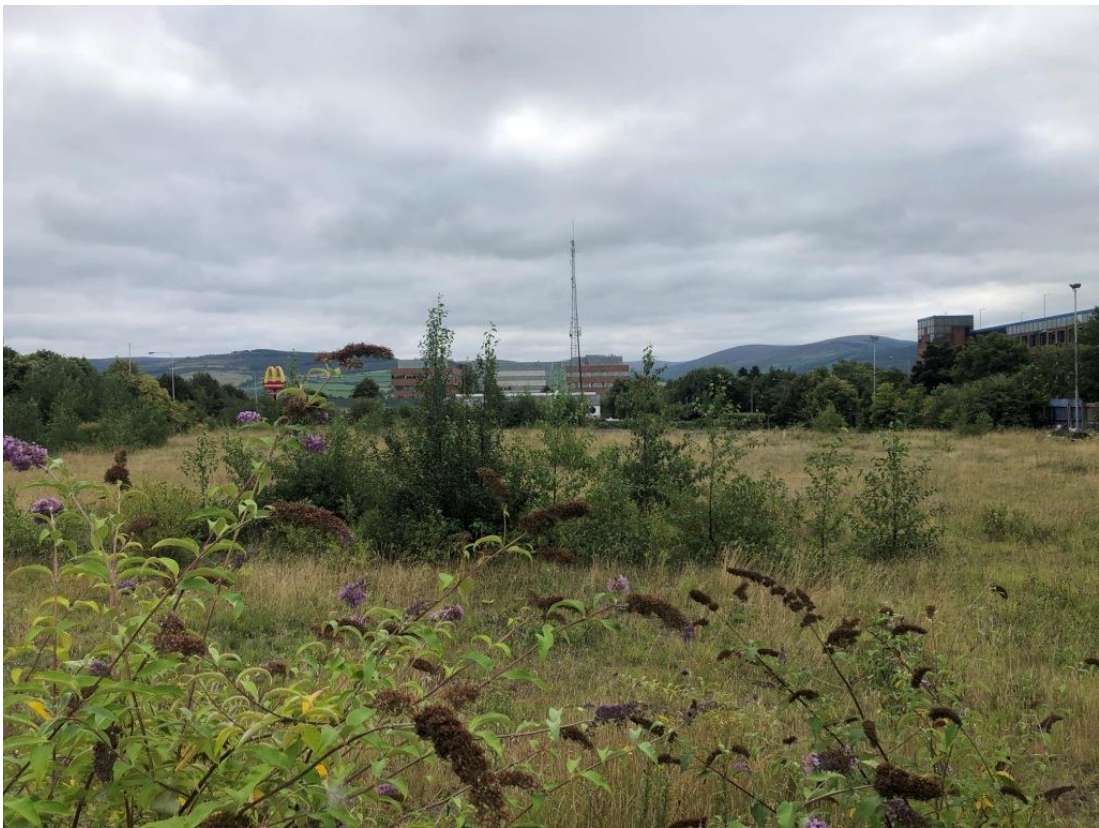
**Image 1:** View from within the site from the northern boundary. This area contains naturally regenerated Italian alder, silver birch and buddleja.

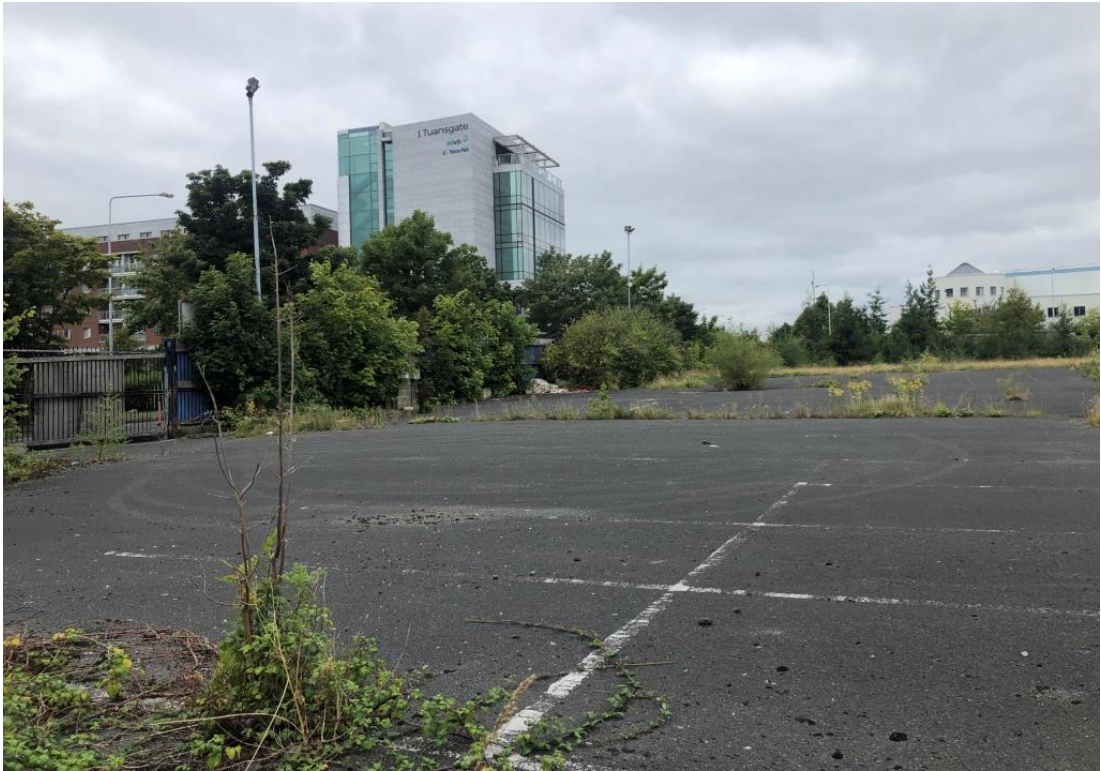
**Image 2:** View from within the site from the southern boundary.

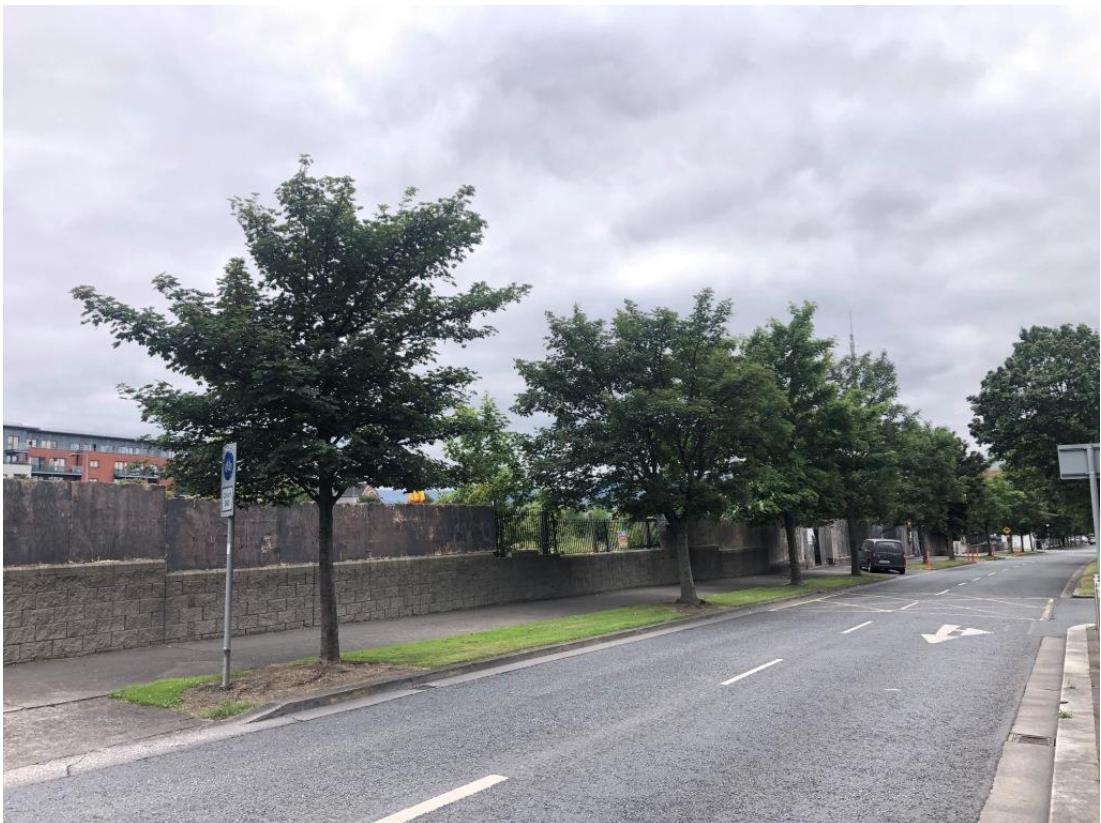
**Image 3:** View of the sycamore trees (T2 to T7) located along Belgard Square East, adjacent to the western boundary of the site.

Tree ID	No. Species	Height (m)	Stem diameter (cm)	No. of Stems	CROWN SPREAD (m)								Crown clearance (m)	L.B. (m)	Life stage	Condition Notes	Survey date	RPA (m <sup>2</sup> )	RPR (m)	Life expectancy (yrs)	BS Category
					N	NE	E	SE	S	SW	W	NW									
Tree T1	1 Acer pseudoplatanus (Sycamore)	9.0	26	1	4.0	4.5	4.5	4.0				2.5		Early Mature	Structural condition Good. Physiological condition Good. Root environment - Restricted. Root damage - Mower.	30/08/2021	30.6	3.1	20-40	B2	
Tree T2	1 Acer pseudoplatanus cv. (Sycamore cv.)	10.5	33	1	3.5	3.0	3.0	3.0				3.0		Early Mature	Structural condition Good. Physiological condition Good. Root environment - Restricted. Root damage - Mower.	30/08/2021	49.3	4.0	20-40	B2	
Tree T3	1 Acer pseudoplatanus (Sycamore)	9.0	28	1	4.0	3.5	3.5	3.5				3.0		Early Mature	Structural condition Good. Physiological condition Good. Root environment - Restricted. Root damage - Mower.	30/08/2021	35.5	3.4	20-40	B2

Tree T4	1 Acer pseudoplatanus (Sycamore)	9.0	31	1	5.0	5.0	5.0	5.0				2.0		Early Mature	Structural condition Fair. Physiological condition Fair. Fork - Weak with included bark. Root environment - Restricted. Root damage - Mower.	30/08/2021	43.5	3.7	20-40	C2	
Tree T5	1 Acer pseudoplatanus (Sycamore)	9.0	30	1	5.0	4.5	4.5	4.0				2.0		Early Mature	Structural condition Poor. Physiological condition Fair. Decay / structural defect - Localised. Fork - Weak with included bark. Root environment - Restricted. Root damage - Mower.	30/08/2021	40.7	3.6	10-20	C2	
Tree T6	1 Acer pseudoplatanus (Sycamore)	8.0	30	1	4.0	3.5	3.5	3.5				2.0		Early Mature	Structural condition Fair. Physiological condition Fair. Girdling roots - Minor. Root environment - Restricted. Root damage - Mower.	30/08/2021	40.7	3.6	20-40	B2	
Tree T7	1 Acer pseudoplatanus (Sycamore)	6.0	19	1	3.5	2.5	3.0	3.0				2.0		Semi Mature	Structural condition Fair. Physiological condition Fair. Girdling roots - Minor. Root environment - Restricted. Root damage - Mower.	30/08/2021	16.3	2.3	20-40	C2

ID	No. / Species	BS5837 Category	Purpose of works Recommended works	Status
T1	1 <i>Acer pseudoplatanus</i> Sycamore	B2	To facilitate development Fell - Ground level.	Proposed
T3	1 <i>Acer pseudoplatanus</i> Sycamore	B2	To facilitate development Fell - Ground level.	Proposed
T6	1 <i>Acer pseudoplatanus</i> Sycamore	B2	To facilitate development Fell - Ground level.	Proposed
T9	1 <i>Acer pseudoplatanus</i> Sycamore	U	To facilitate development Fell - Ground level.	Proposed
T10	1 <i>Acer pseudoplatanus</i> Sycamore	C2	To facilitate development Fell - Ground level.	Proposed
T11	1 <i>Acer pseudoplatanus</i> cv. Sycamore cv.	C2	To facilitate development Fell - Ground level.	Proposed
H22	1 <i>Fagus sylvatica</i> Common Beech	C2	To facilitate development Fell - Ground level.	Proposed
H23	1 <i>Fagus sylvatica</i> Common Beech	C2	To facilitate development Fell - Ground level.	Proposed
T24	1 <i>Tilia</i> sp. Lime sp.	C2	To facilitate development Fell - Ground level.	Proposed

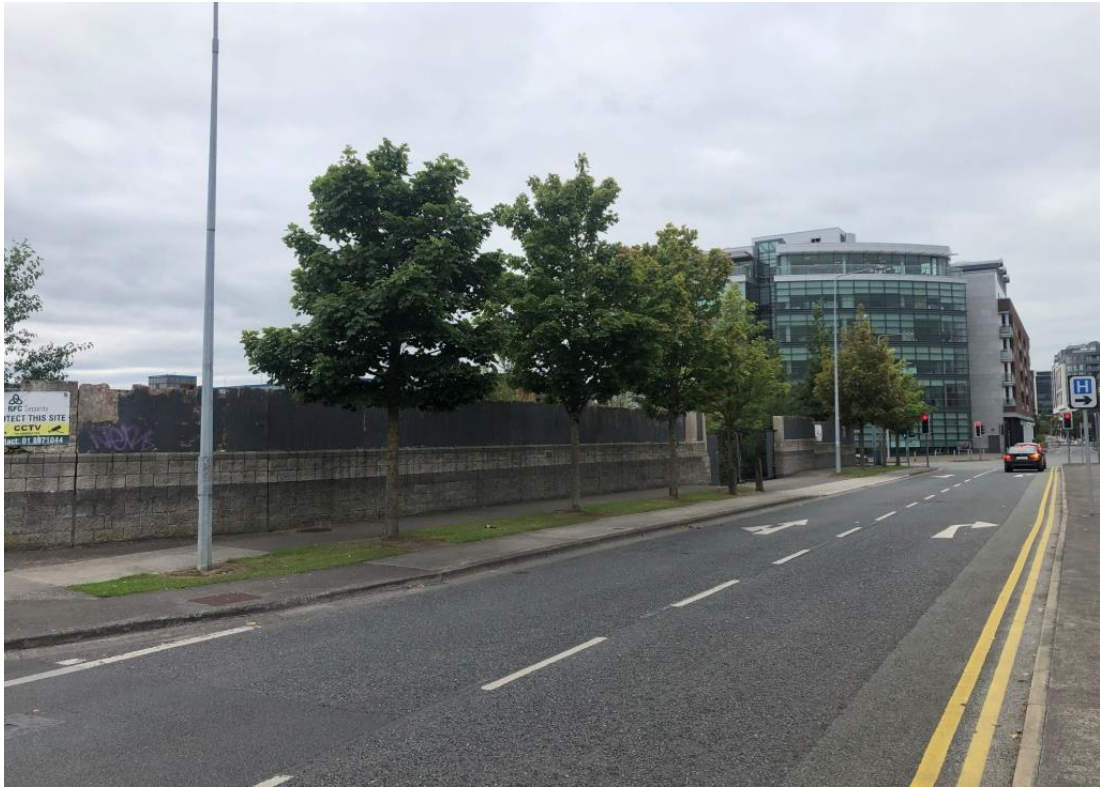
**Image 4:** View of the sycamore and Norway maple trees (T8 to T15) located along Blessington Road, adjacent to the northern boundary of the site.

Tree T8	1 Acer pseudoplatanus (Sycamore)	6.0	18	1	2.5	2.5	2.5	2.5				2.0		Semi Mature	Structural condition Fair. Physiological condition Fair. Root environment - Restricted. Root damage - Mower.	30/08/2021	14.7	2.2	20-40	C2

Tree ID	No. Species	Height (m)	Stem diameter (cm)	No. of Stems	CROWN SPREAD (m)								Crown clearance (m)	L.B. (m)	Life stage	Condition Notes	Survey date	RPA (m <sup>2</sup> )	RPR (m)	Life expectancy (yrs)	BS Category
					N	NE	E	SE	S	SW	W	NW									
Tree T9	1 Acer pseudoplatanus (Sycamore)	6.0	14	1	2.5	2.5	2.0	2.0	2.5					Semi Mature	Structural condition Fair. Physiological condition Poor. Die-back - Throughout crown. Decline - Evident / observed. Root environment - Restricted. Root damage - Mower.	30/08/2021	8.9	1.7	0-10	U	
Tree T10	1 Acer pseudoplatanus (Sycamore)	7.0	16	1	2.0	2.0	2.0	2.0	2.5					Semi Mature	Structural condition Fair. Physiological condition Fair. Root environment - Restricted. Root damage - Mower.	30/08/2021	11.6	1.9	10-20	C2	
Tree T11	1 Acer pseudoplatanus cv. (Sycamore cv.)	8.0	22	1	3.0	3.0	2.5	2.5	2.5					Early Mature	Structural condition Fair. Physiological condition Fair. Root environment - Restricted. Root damage - Mower.	30/08/2021	21.9	2.6	20-40	C2

Tree T12	1 Acer pseudoplatanus (Sycamore)	7.0	18	1	2.0	2.0	2.0	2.0	2.5					Semi Mature	Structural condition Fair. Physiological condition Fair. Root environment - Restricted. Root damage - Mower.	30/08/2021	14.7	2.2	20-40	C2	
Tree T13	1 Acer platanoides (Norway Maple)	8.0	20	1	2.5	2.5	2.5	2.5	3.0					Early Mature	Structural condition Fair. Physiological condition Fair. Root environment - Restricted. Root damage - Mower.	30/08/2021	18.1	2.4	20-40	B2	
Tree T14	1 Acer platanoides (Norway Maple)	8.0	21	1	3.0	2.5	2.5	2.5	3.0					Early Mature	Structural condition Fair. Physiological condition Good. Root environment - Restricted.	30/08/2021	20.0	2.5	20-40	B2	
Tree T15	1 Acer pseudoplatanus (Sycamore)	7.0	20	1	2.5	2.5	2.5	2.5	2.0					Early Mature	Structural condition Good. Physiological condition Good. Root environment - Restricted.	30/08/2021	18.1	2.4	20-40	B2	
Tree T16	1 Tilia sp. (Lime sp.)	10.0	29	1	4.0	4.0	3.5	3.0	2.0					Early Mature	Structural condition Good. Physiological condition Good. No significant faults observed.	30/08/2021	38.0	3.5	40+	A2

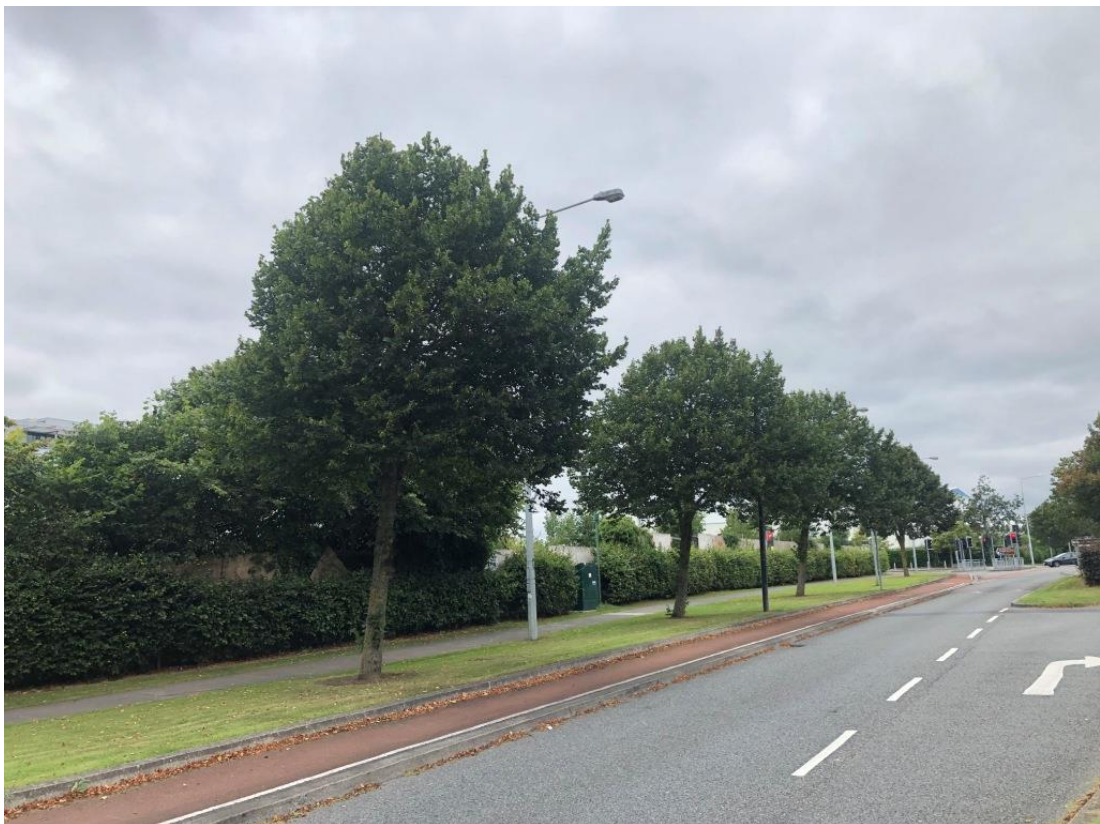
**Image 5:** View of the lime trees (T16 to T21) located along the R113, adjacent to the eastern boundary of the site.

Tree T17	1 Tilia sp. (Lime sp.)	9.0	30	1	4.5	4.5	4.0	3.0	2.5					Early Mature	Structural condition Fair. Physiological condition Good. Leaning trunk - Minor.	30/08/2021	40.7	3.6	40+	B2	
Tree T18	1 Tilia sp. (Lime sp.)	9.0	30	1	4.5	4.5	4.5	3.0	2.5					Early Mature	Structural condition Fair. Physiological condition Good. Leaning trunk - Minor.	30/08/2021	40.7	3.6	40+	B2
