TREE SURVEY

**Mountpark Baldonnell Phase 2,
Baldonnell Business Park,
Baldonnell,
Dublin 22.**

**New Link Road
May 2022**

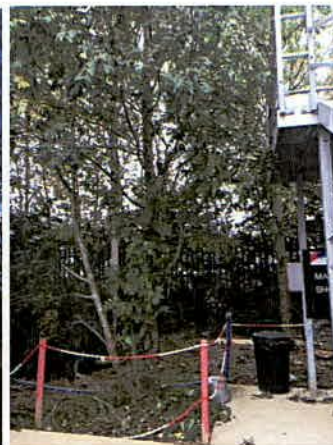
Tree Group 1

Tag No	Tree Species	Tree Class	Number of trees
TG1	Fraxinus excelsior	B2	3
TG2	Betula pendula & Fraxinus excelsior	B2	5
