Tree Report and Survey

PROPOSED WAREHOUSE DEVELOPMENT

Kingswood Road and Kingswood Avenue, Citywest
Business Campus, Dublin 24

June 2022

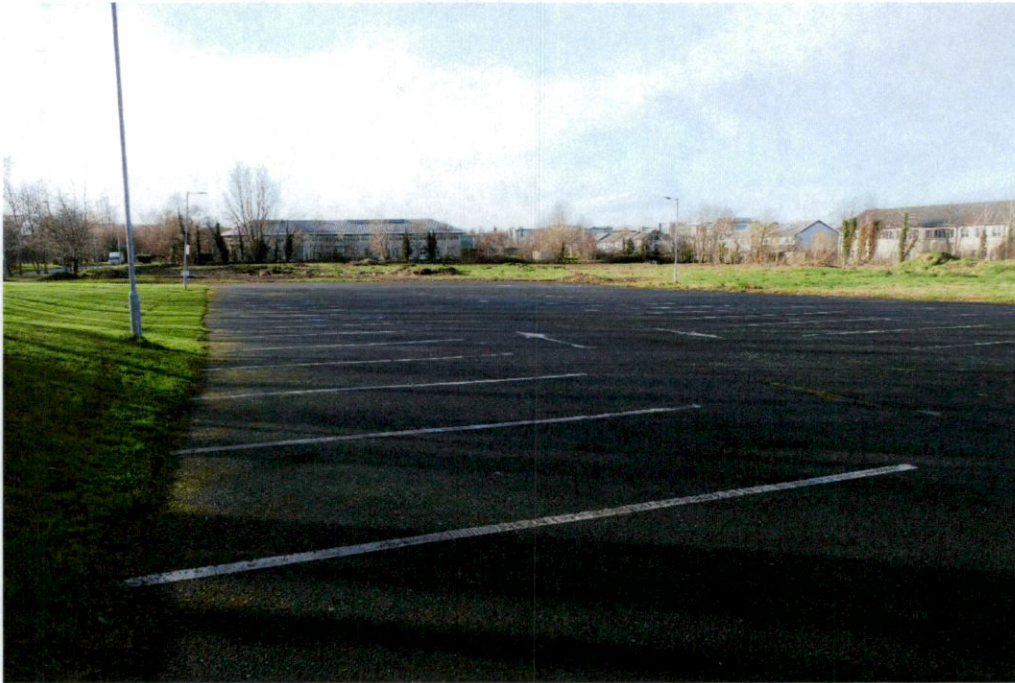
Fig. 1. Looking towards the south west boundary.

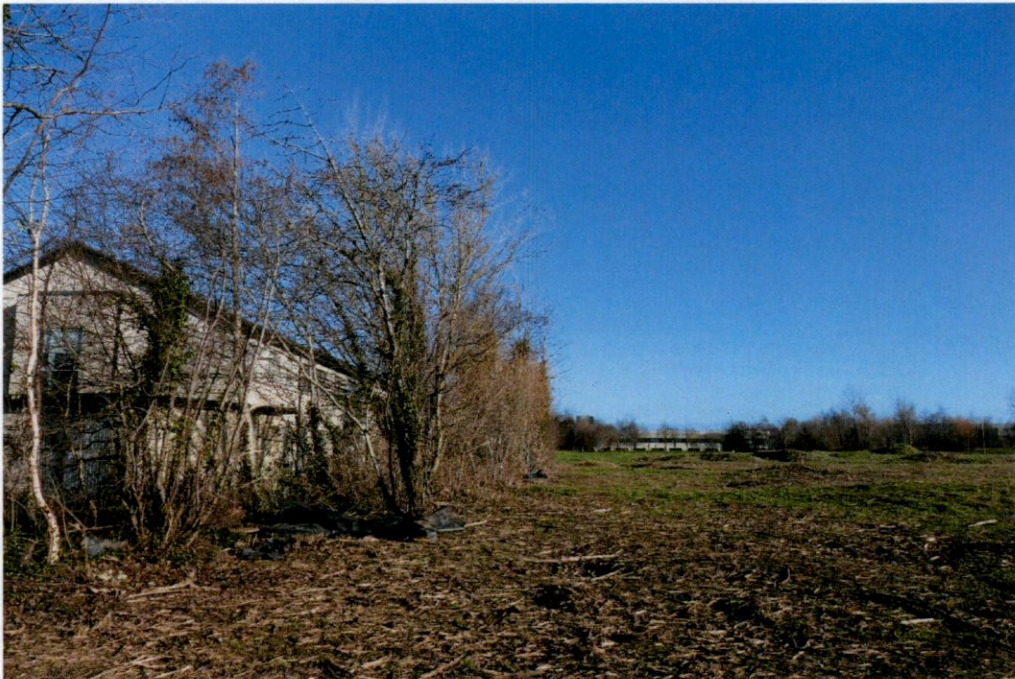
Fig. 2. From the south west boundary looking north east.

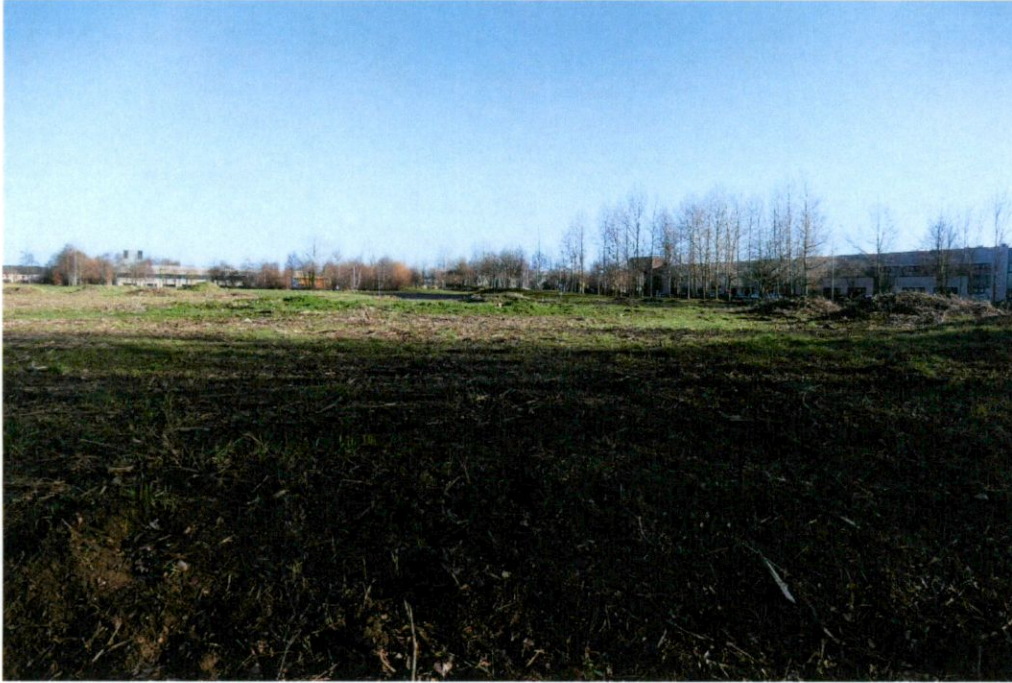
Fig. 3. From the south west boundary looking north east.

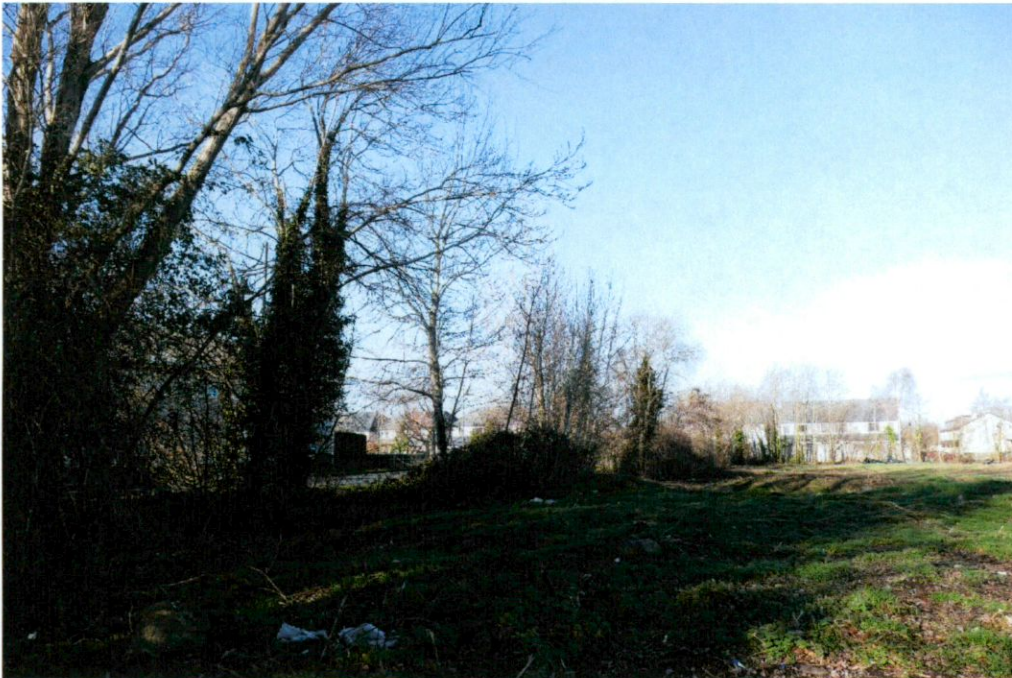
Fig. 4. Looking along the south west boundary from the southern corner of the site.

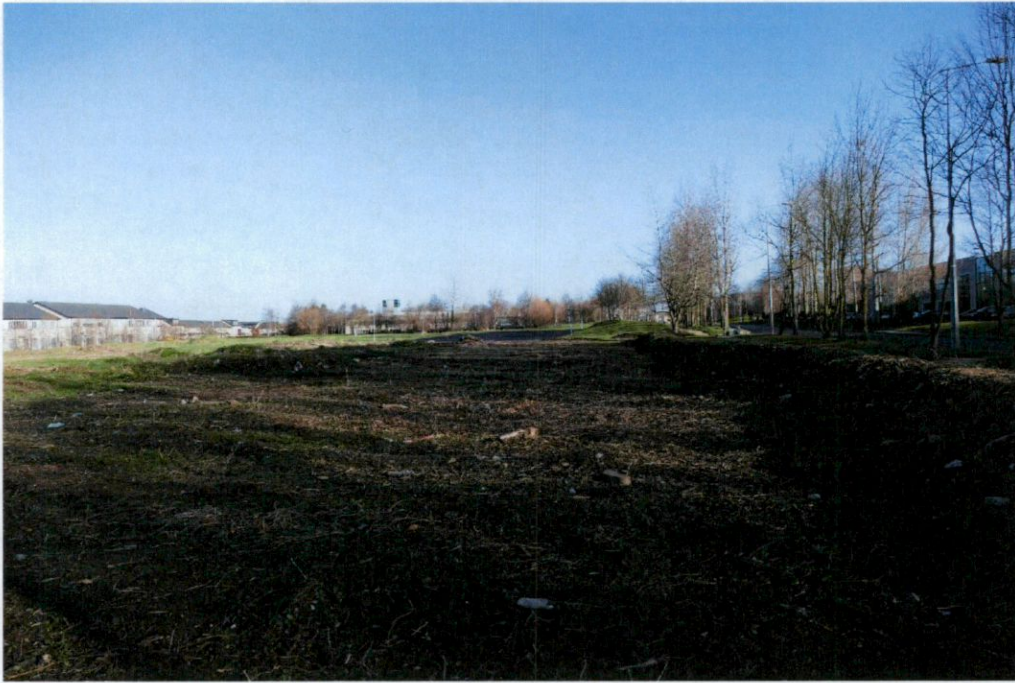
Fig. 5. Looking along the south east boundary from the southern corner of the site.
