An Arboricultural Assessment of the Site Area at the Junction of 'Kingswood Drive and Kingswood Road', Citywest Business Campus, Dublin 24.

Prepared for: K2 Strategic Infrastructure Ireland Ltd.

Prepared by: Felim Sheridan F. Arbor. A, RFS Dip, Nat. Dip & NCH in
Arboriculture

Date: 1st July 2022

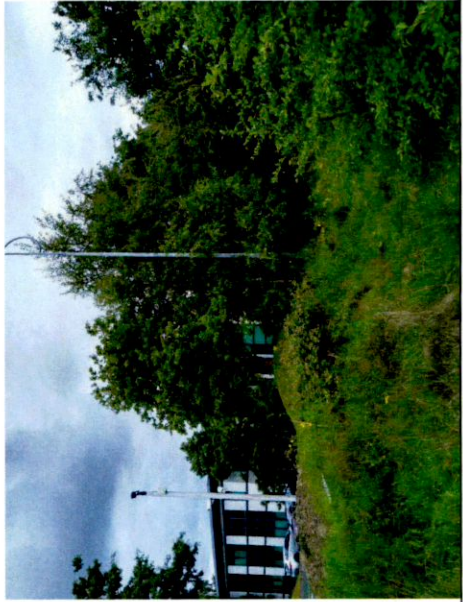
Tree No.	Tree Species	Ht. (m)	Stem Dia. (mm)	Branch Spread (m)	C-Ht. (m)	Age Class	Phys. Con.	Structural Condition Other Comments	Preliminary Recommendation	Remain Contribute In Years	Cat. Grade
								N-north S-south E-east W-west Phys.-physiological.	A- average,		
		<p>A Condition Assessment of the tree vegetation within the site area at the junction of 'Kingswood Drive' and 'Kingswood Road', Citywest Business Campus, Naas Road, Dublin 24. The assessment starts in the north-eastern corner and works clockwise around the site area. The tree vegetation is located around the perimeter of the site area along the southern and eastern boundaries.</p>									
Tree Group No.1	Birch <i>Betula pendula</i> Oak <i>Quercus robur</i>	<p>It is a small tree group located within the north-eastern corner of the site with the adjoining property to the north. It consists of some tree planting growing on a soil berm/mound and these are of a semi -mature age class in fair condition both physiologically and structurally. The trees were planted most likely as whips and at close spacing and they have grown up together competing for light and space which is affecting the development and structure of some trees. Those growing up around the public light standard have been topped/cut back previously to prevent shading and these are developing multi-stemmed crowns from these pruning points. They are of some value for screening within this area.</p>

This belt of trees would benefit from some light selective thinning to reduce density and allow the better quality trees more space to grow and develop.	20+	C2

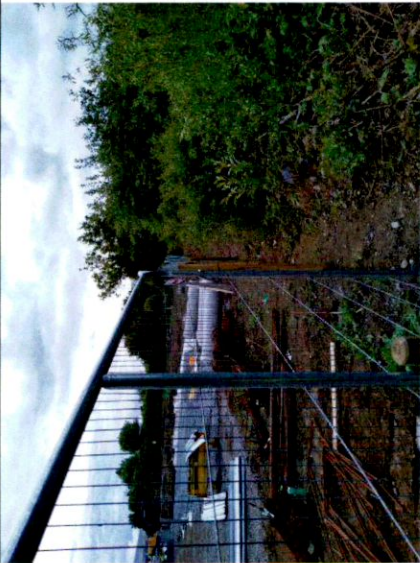
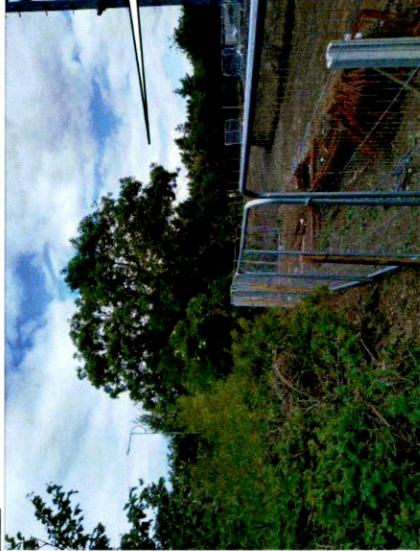
</div> <p style="text-align: center;">Tree No. 1018</p> <p style="text-align: center;">The following two trees are located within this hedge.</p>												A4	--	A3E/ 1W	--
A4	--	A3E/ 1W	--

Tree No.	Tree Species	Ht. (m)	Stem Dia. (mm)	Branch Spread (m)	C-Ht. (m)	Age Class	Phys. Con.	Structural Condition Other Comments	Preliminary Recommendation	Remain in Years	Cat. Grade
								N-north S-south E-east W-west Phys.-physiological.	A- average,		
1018	Ash <i>Fraxinus excelsior</i>	10	510	4N 5S 5E 4W	3	Mature	Fair/ Poor	Poor It is growing up out of Hedge No.1 at the northern end. Heavy Ivy cover on the main trunk is extending up into its crown causing suppression and increasing its crown windsail. It has suffered a large decay wound on the lower trunk near to ground level creating a structural weakness at this point. Construction works on the site to the east have come close to the base, impacting its rootzone. Part of the lower crown also appears to have suffered recent damage on the east side. The crown is showing signs of infection by 'Ash Dieback' (<i>Hymenoscyphus fraxineus</i>).	Retain at present, but due to its condition physiologically and structurally and in particular the infection by 'Ash Dieback', this tree will need to be removed in the short-term.	<10	U

1019	Ash <i>Fraxinus excelsior</i>	9	320/ 220/ 200	3N 4S 4E 4W	1.5	Mature	Fair/ Poor	Poor It forms part of the hedge bulking and is being suppressed by Ivy. It is multi-stemmed from base and has suffered limb failure from its base. Construction works on the site to the east have come close to the base, causing root damage that will impact upon its stability. The crown is showing signs of infection with 'Ash Dieback' (<i>Hymenoscyphus fraxineus</i>).	I would recommend its removal as part of management due to root damage caused by construction works.	<10	U

The two trees (Nos.1018 & 1019) along this boundary will not be directly impacted upon by the proposed development layout, but are being recommended for removal as part of management due to physiological and structural issues and also due to root damaged that has been caused by the removal of the surrounding hedge, and particularly Tree No.1019. The stumps of these two trees could be retained and incorporated into the new boundary hedge line.

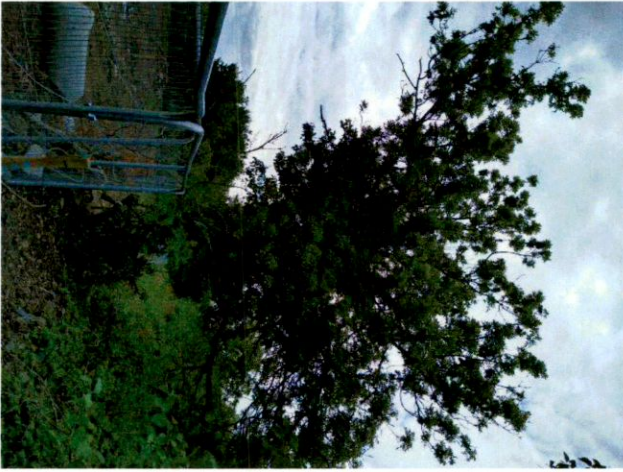
A- average,	20+	C2
<p>It is of a young age class in fair/ good condition physiologically and in fair condition structurally. It consists of Field Maple and Alder and is c:2.5m wide with trees planted in a staggered line at close spacings. There are also a number of self-seeded Ash trees developing along the line. The trees were planted most likely as whips, at close spacing and they have grown up together competing for light and space which is affecting the development and structure of some trees. They form a good screen barrier along the boundary fence. Soil alterations have occurred on the site side. Construction works have also been carried out on the eastern side on the adjacent site which have come close to the base of this tree belt. The Ash trees are showing signs of infection with 'Ash Dieback' (<i>Hymenoscyphus fraxineus</i>).</p>							<p>This tree belt would benefit from some selective thinning to reduce density and to allow the better quality trees the space to grow and develop.</p>

'Tree Belt No.1' along the eastern boundary will be tidied up and trimmed in to accommodate the boundary treatment which will be of a fence type structure.

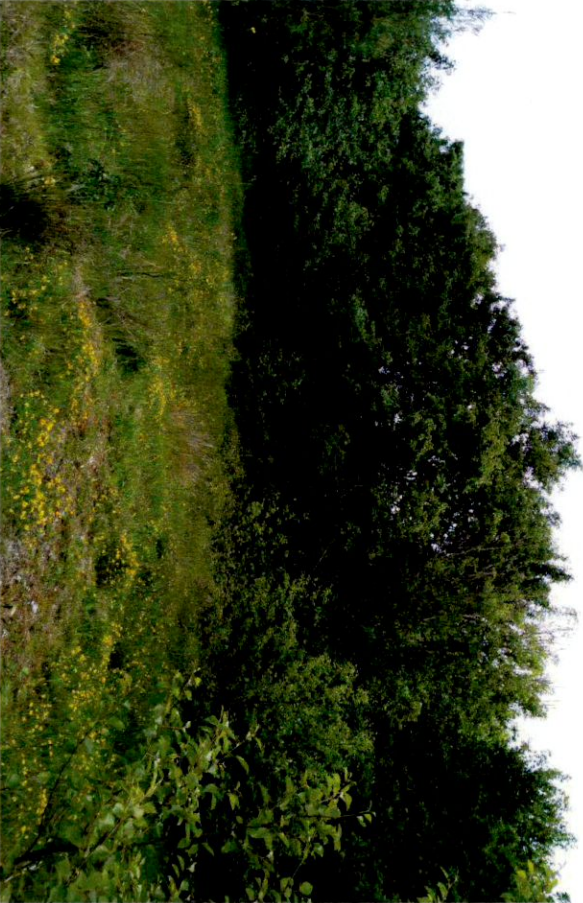
Tree No.	Tree Species	Ht. (m)	Stem Dia. (mm)	Branch Spread (m)	C-Ht. (m)	Age Class	Phys. Con.	Structural Condition Other Comments	Preliminary Recommendation	Remain Contribute in years	Cat. Grade						
								N-north S-south E-east W- west Phys.-physiological.	A- average,								
		<table border="1"> <tr> <td>A8</td> <td>A200</td> <td>A3N/ A3S/ A3E/ A3W</td> <td colspan="2">A0.5</td> </tr> </table>					A8	A200	A3N/ A3S/ A3E/ A3W	A0.5							
A8	A200	A3N/ A3S/ A3E/ A3W	A0.5														
Tree Belt No.2	Field Maple <i>Acer campestre</i> Oak <i>Quercus robur</i>	<p>It runs in an east-west direction along the southern boundary of the site area.</p>

<p>It is of a semi-mature age class in fair/ good condition physiologically and in fair condition structurally. They have been planted on top and mainly on the southern side of a soil mound/ berm. They are planted</p>									They would benefit from some selective thinning as they grow in size in order to reduce competition and to allow the better quality tree	20+	C2

Along the southern boundary, 'Tree Belt No.2' will require the trimming of the lower branches on some trees to facilitate the boundary treatment which will be of a fence structure.

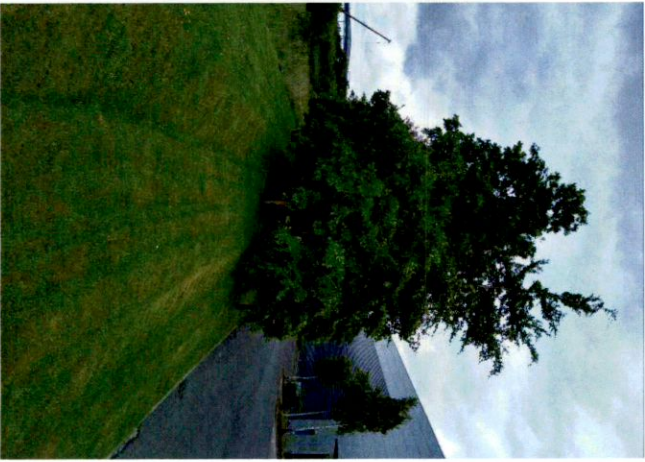
Tree No.	Tree Species	Ht. (m)	Stem Dia. (mm)	Branch Spread (m)	C-Ht. (m)	Age Class	Phys. Con.	Structural Condition Other Comments	Preliminary Recommendation	Remain Contribute in years	Cat. Grade	
	Poplar <i>Populus sp.</i> Birch <i>Betula pendula</i> Beech <i>Fagus sylvatica</i> Ash <i>Fraxinus excelsior</i> Crab Apple <i>Malus sylvestris</i>							N-north S-south E-east W-west Phys.-physiological.	A- average, species more space to grow and develop.			
Scrub Area No. 1	Birch <i>Betula pendula</i> Alder <i>Alnus sp</i>

<p>It covers most of the eastern half of the site area.</p> <p>It is of a young age and has established here naturally as a result of the site area being derelict. They are self-sown into this area and are developing across the site with occasional open areas. Bramble and other</p>			<p>This area would benefit from general tidying works.</p>		-	C2

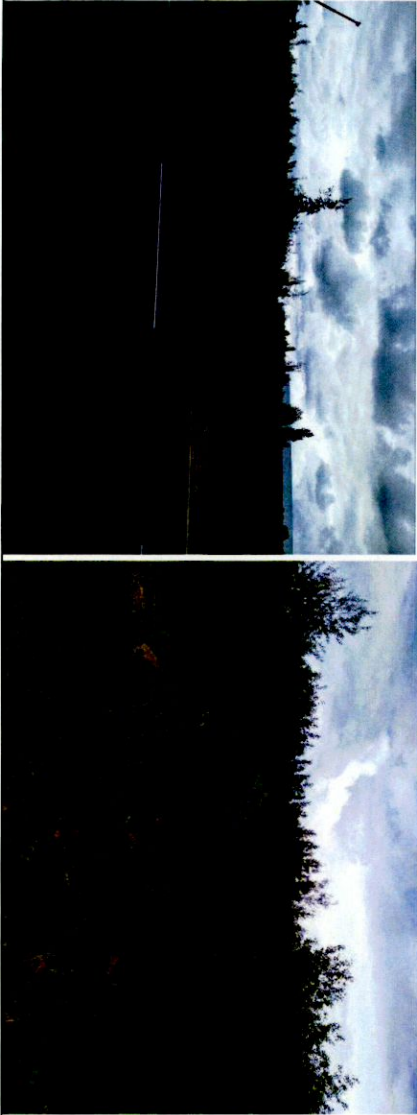
Tree No.	Tree Species	Ht. (m)	Stem Dia. (mm)	Branch Spread (m)	C-Ht. (m)	Age Class	Phys. Con.	Structural Condition Other Comments	Preliminary Recommendation	Remain Contribute in years	Cat. Grade
	Goat Willow <i>Salix caprea</i> Oak <i>Quercus robur</i> Mountain Ash <i>Sorbus aucuparia</i> .							N-north S-south E-east W-west Phys:-physiological.	A- average,		
		coarse weeds are beginning to colonise the edge areas. They are beginning to grow strongly but their structure is being impacted due to the density of plants.									
		A3	A.50	A0.5N/ S/ E/ W			A0
