TREE & VEGETATION SURVEY, ASSESSMENT, MANAGEMENT & PROTECTION
MEASURES
FOR

Lidl Newcastle

CLIENT: Lidl Ireland GmbH

July 2022

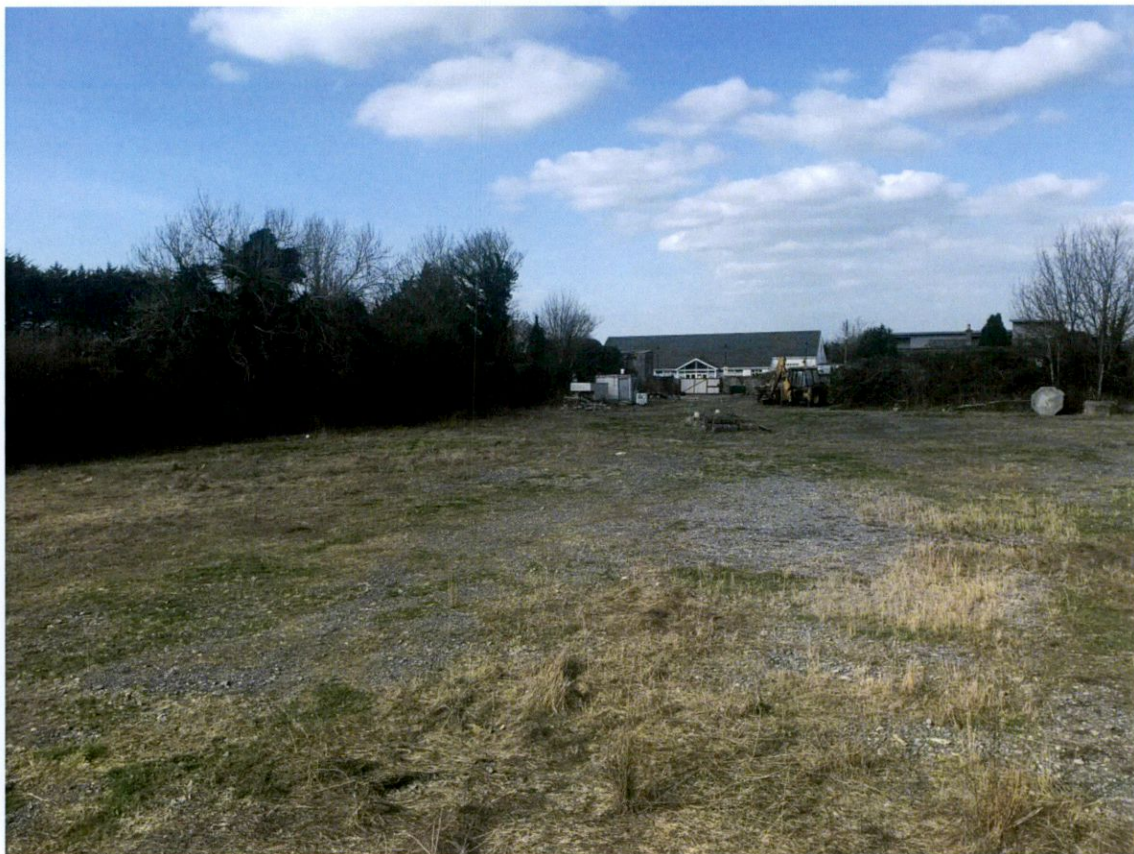
Figure 1: northern part of the site looking north across the yard, the western hedgerow, hedgerow 03 is visible to the right-hand side of the image

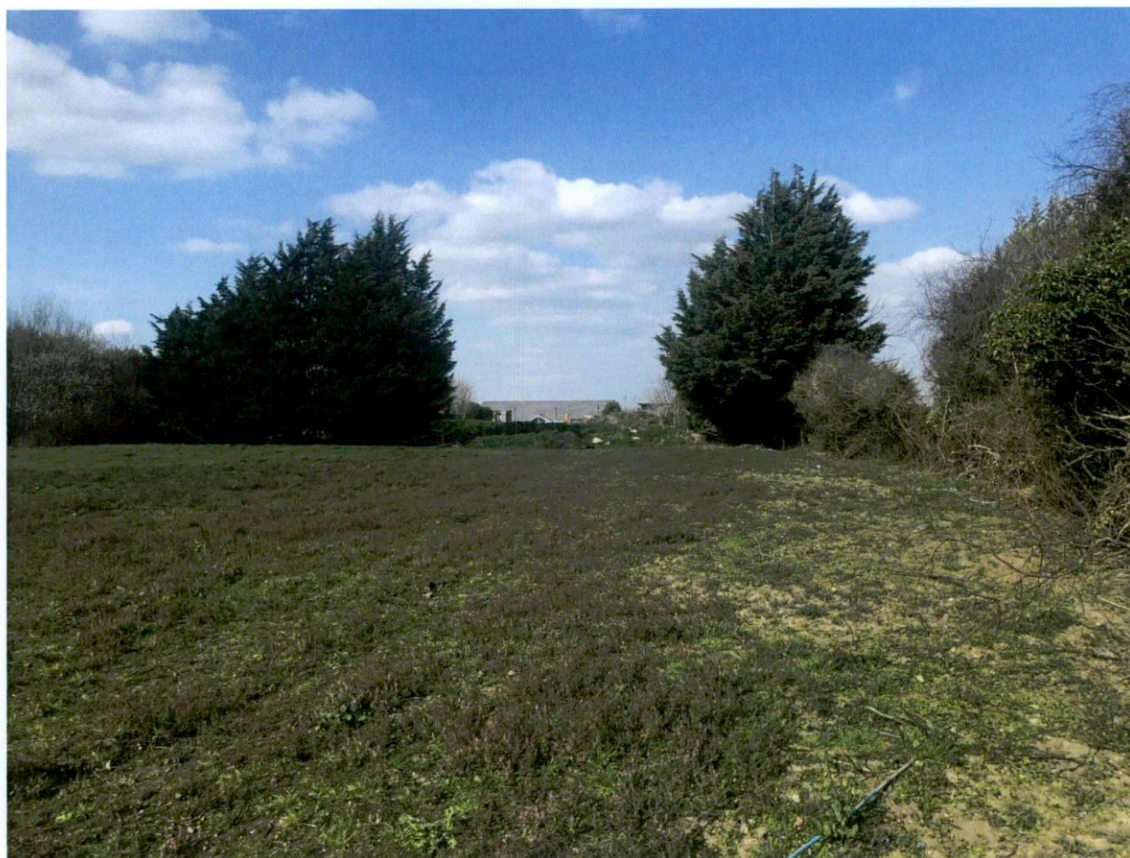
Figure 2: Southern part of the site looking north, Leyland Cypress X Cuprocyparis visibly, mound partially visible between the Leyland Cypress X Cuprocyparis leylandii

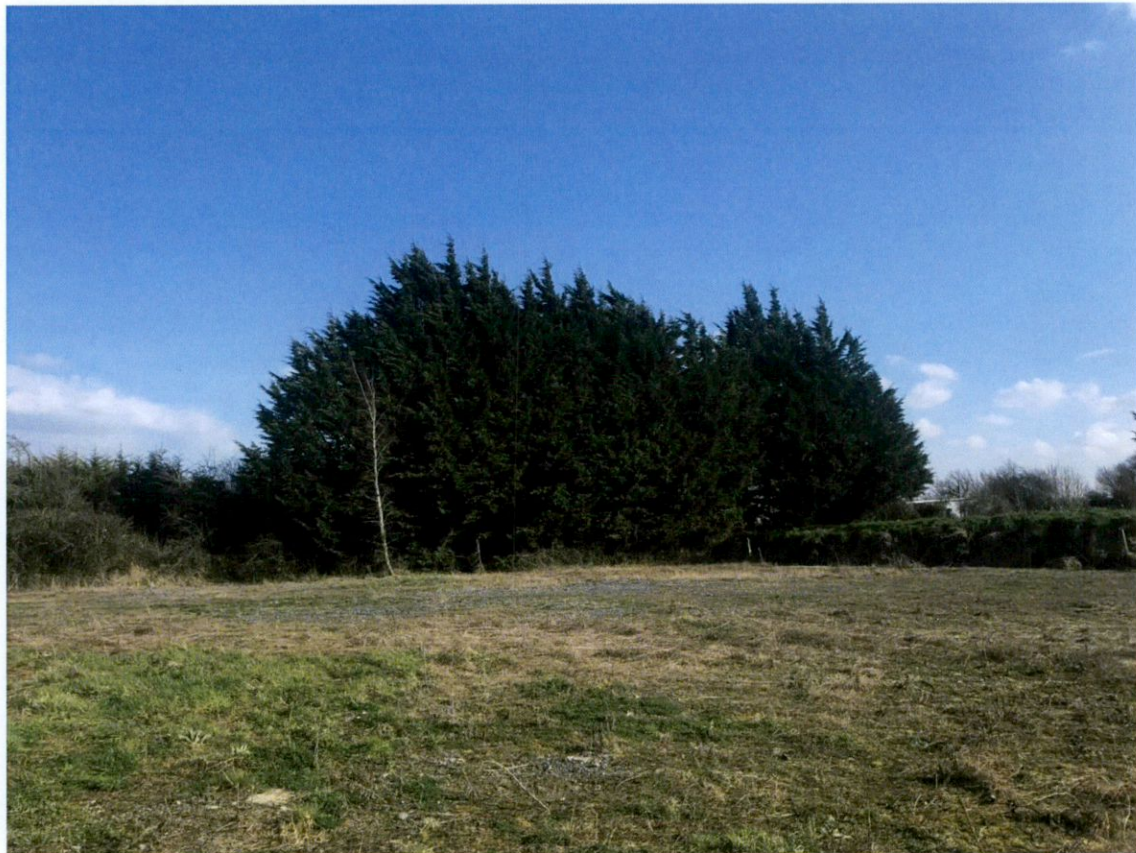
Figure 3: *Leyland Cypress X Cuprocypris* Tree Group 01 on the eastern boundary

The eastern boundary of the site, to the northern end is formed by a mish mash of self-seeded planting and *Leyland Cypress X Cuprocypris leylandii*. To the southern part of this boundary, there is some better hedgerow, hedgerow 02. Though this is quite weak and needs augmentation with suitable native hedgerow species.

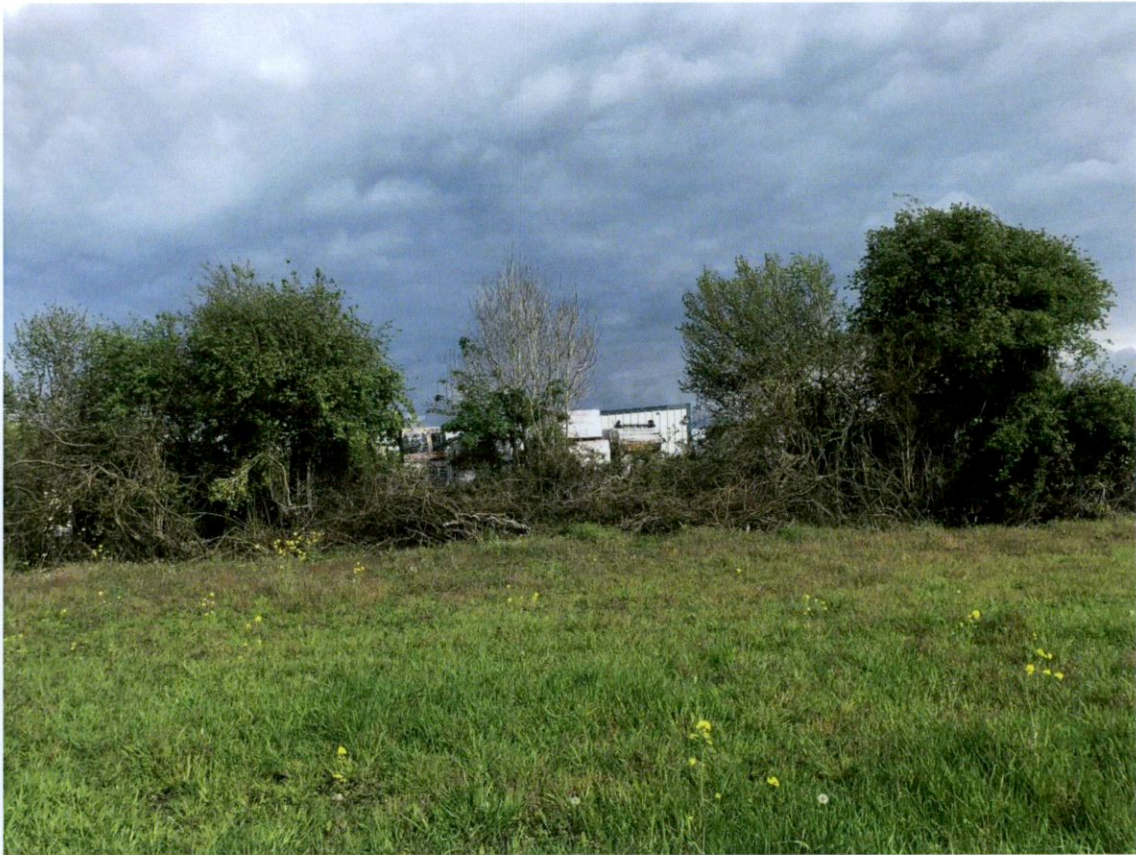
Figure 4: Eastern boundary, southern part, hedgerow 02, this hedgerow is somewhat scraggy with cut brush in the hedgerow, it needs to be cleaned out and augmented with supplementary native planting

Hedgerow 03 is located on the Southern part of the Eastern boundary. Species are *Fraxinus excelsior* Ash and *Crataegus monogyna* Hawthorn and Blackthorn *Prunus spinosa*. The hedge is quite sparse in places and needs augmentation.

- Tree protective fencing will be placed to prohibit access within the RPA of the hedgerow and protect the above and below ground parts of the hedgerow.
- The excavations for building foundations and building construction will be supervised on site by the project Arborist.
- Any local removal of hedging will be supervised by the project Arborist and suitable replacement planting will be planted.
