TREE & HEDGEROW SURVEY, ASSESSMENT, MANAGEMENT, MITIGATION & PROTECTION MEASURES

PROPOSED CHANGE OF USE OF RESIDENTIAL UNITS
AT
WESTPARK CRESCENT, GARTERS LANE, SAGGART, Dublin 22

Suites Hotel Management CLG.

July 2022

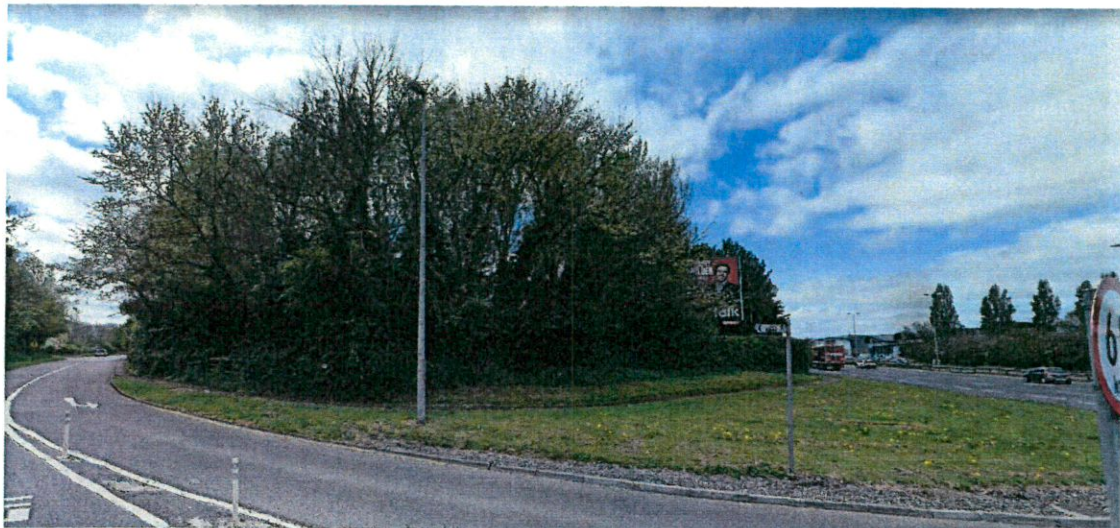
Figure 2 Northern boundary

4.2 The most prominent trees located on the site are located along the northern boundary with the Nass Road N7 and along the Eastern Boundary with Garters Lane. These trees provide dense visual screening of the exiting development and are a prominent feature of the site and are significant to the wider receiving environment. There are two tree groups located within this boundary and they are Group 1 along the northern boundary and Group 2 along the eastern boundary.

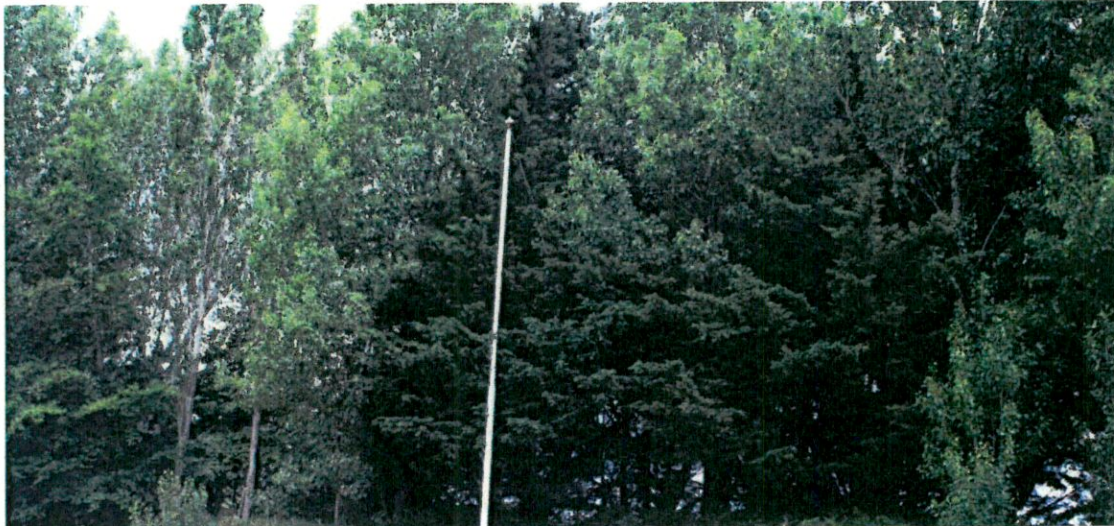
Figure 3 Group 1 - Black Poplar and Leyland Cypress

4.3 Group 1 is a dense woodland screening edge that is planted on part of an existing earthen berm along this boundary. The trees in this boundary contain a 50/50 mix of the deciduous *Populus nigra* (Black Poplar) and *Cupressus Leylandii* (Leland cypress). A total of c.52 trees were identified in this group and are all in good condition at present providing a robust visual and noise screening with the motorway to the north. The depth of this tree belt is approx. 10m and the trees rise to a height of c. 18ms tall. These trees shall be retained and protected.

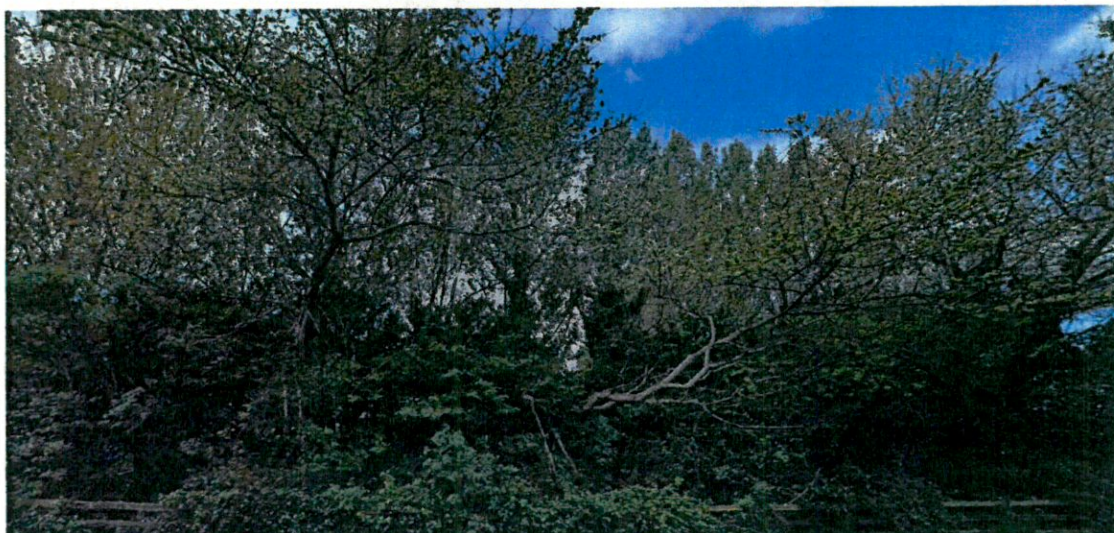
Figure 4 Group 2 - Black Poplar and Common Oak

4.4 Group 2 is a similarly dense woodland screening edge that is found along the site's eastern boundary providing a strong visual screening element between the site and Garter Lane. This group comprises of 50% *Populus nigra* (Black Poplar), 25% *Cupressus Leylandii* (Leland cypress) and 25% *Quercus robur* (Common Oak). A total of approx. 20 trees are found along this boundary with a total height of 12-18ms. The understorey is planted with some *Crataegus monogyna* (Hawthorn), *Rubus idaeus* (Bramble) and *Hedera helix* (Ivy). These trees shall be retained and protected.

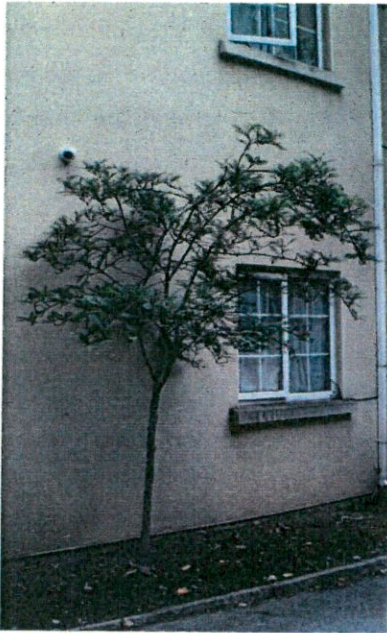
Figure 6 Ash trees around the building

4.5 The remaining specimen trees outlined on our survey sheets as numbers T01 – T08 are a mixed collection of multi-stem *Betula pubescens* (Birch) and *Fraxinus excelsior* (Ash). These trees are in reasonable condition and can remain for approx. 10 -20 years in their current condition. Due care and reasonable attention should be offered to the *Fraxinus excelsior* specimens which are suffering from mild Ash dieback and may need to be removed at some stage and a suitable replacement specimen planted in its stead.

T08	Tree	Ash, <i>Fraxinus excelsior</i>	7.5	570	2,2,1,1	2	Y	Good	Fair tree suffering from mild Ashdieback, monitor for future removal.	10-20	B2
G00	Group 01	Black Poplar, <i>Populus nigra</i> and Leyland cypress, <i>Cupressus x leylandii</i>	13 - 18m	inaccessible	N/a	0	M	Good	Good condition / Shared canopy / Combined canopy form / Crown lift / Monitor roadside branches for removal where necessary / Remove dead ivy	40+	B1
G01	Group 02	Tree: Black Poplar, <i>Populus nigra</i> <i>Quercus robur</i> , Oak; Shrubs: Bramble Bush, <i>Rubus idaeus</i> , Hawthorn, <i>Crataegus monogyna</i>	13 - 18m	inaccessible	N/a	0	M	Good	Leyland cypress showing dead/poor branches. Good condition / Shared canopy / Combined canopy form / Crown lift / Monitor roadside branches for removal where necessary / Remove dead ivy	40+	B1
S1	Shrubs	Common Box, <i>Buxus sempervirens</i>	0.5	N/A			M	Good	Good hedge condition	10-20	B1
