# Arboricultural Report

Tree Survey,  
Arboricultural Impact Assessment &  
Arboricultural Method Statement

**No. 1 Adamstown Boulevard**

**220722-PD-11**

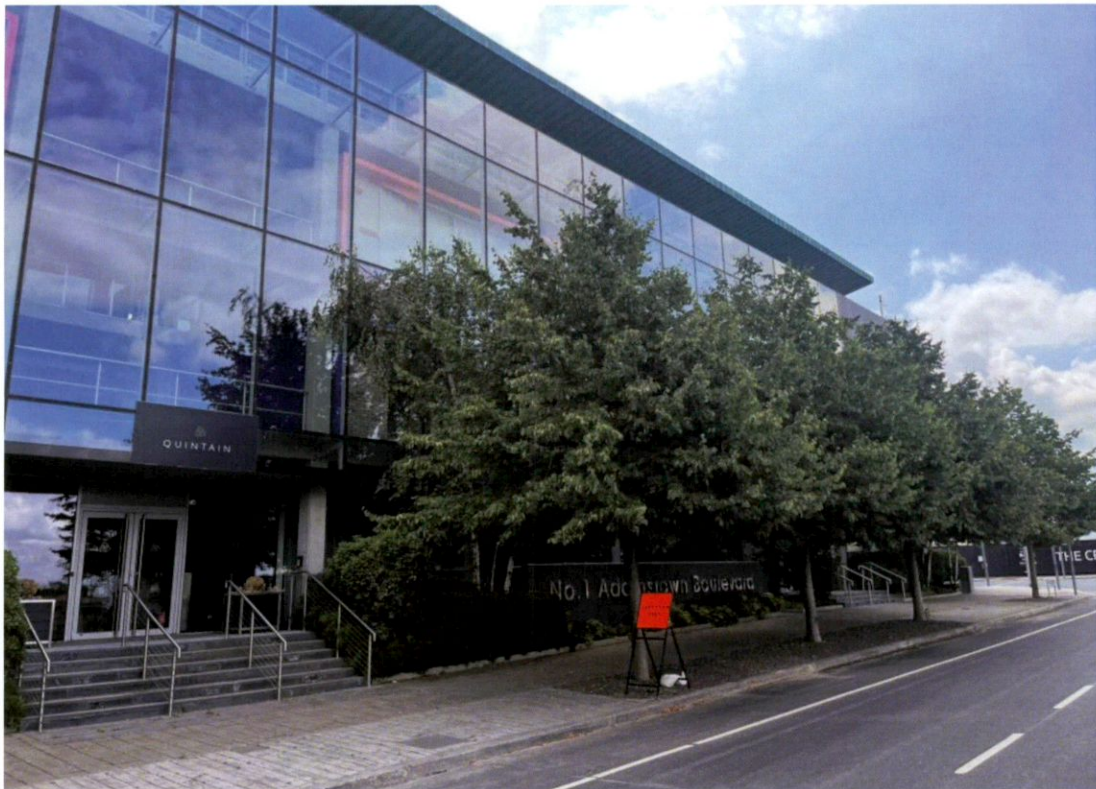
**Photo 1:** View of the semi-mature lime trees T553 to T556 located adjacent to No. 1 Adamstown Boulevard.

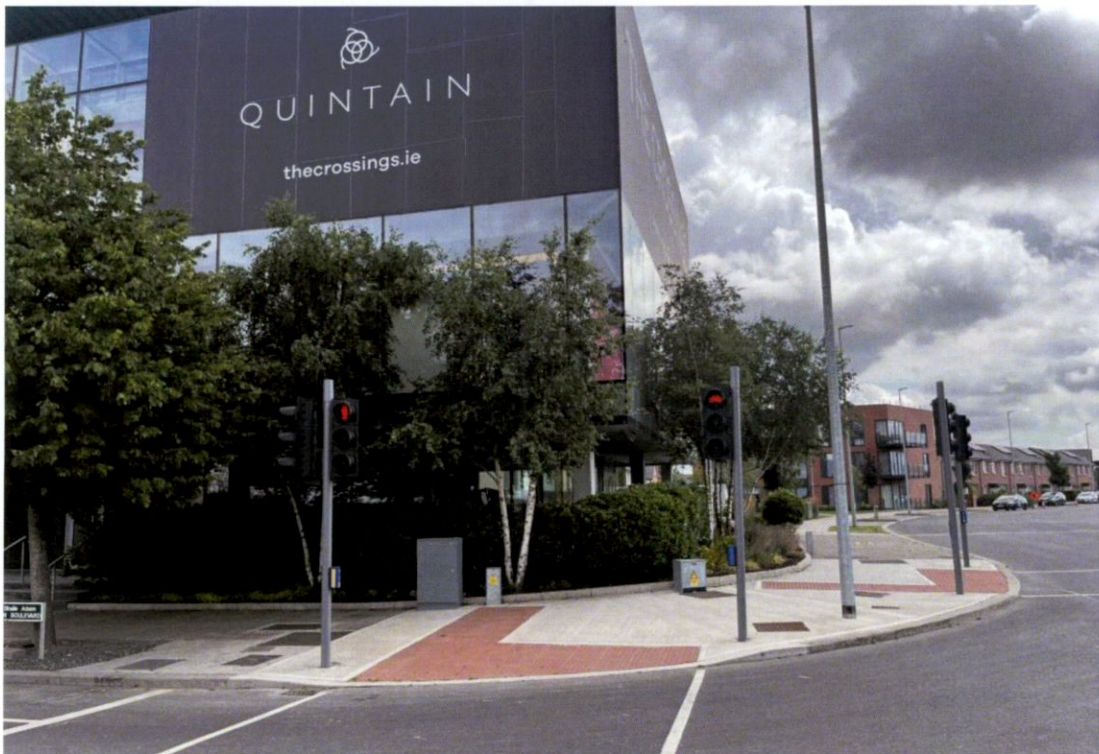
**Photo 2:** View of the multi-stemmed silver birch trees (T557 to T560) located around the perimeter of the building adjacent to the corner of Adamstown Boulevard and Adamstown Avenue.

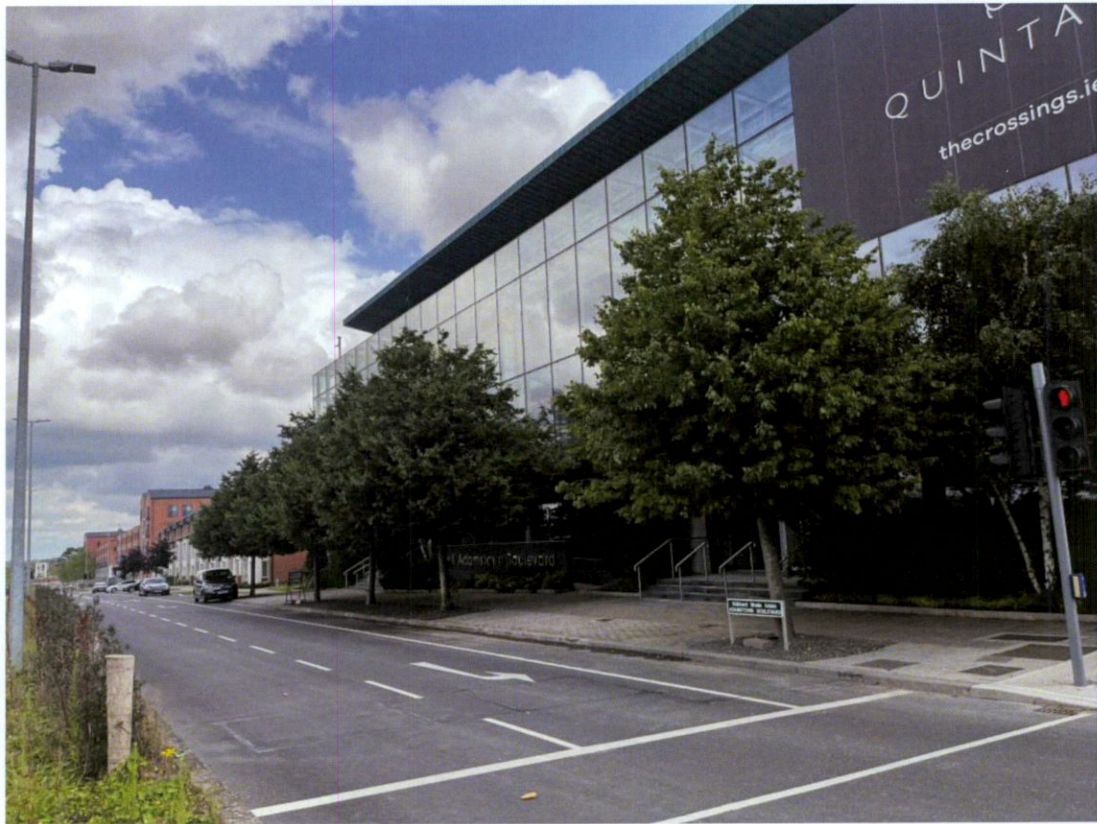
**Photo 3:** Second view of the semi-mature lime trees T552 to T556 looking down Adamstown Boulevard.

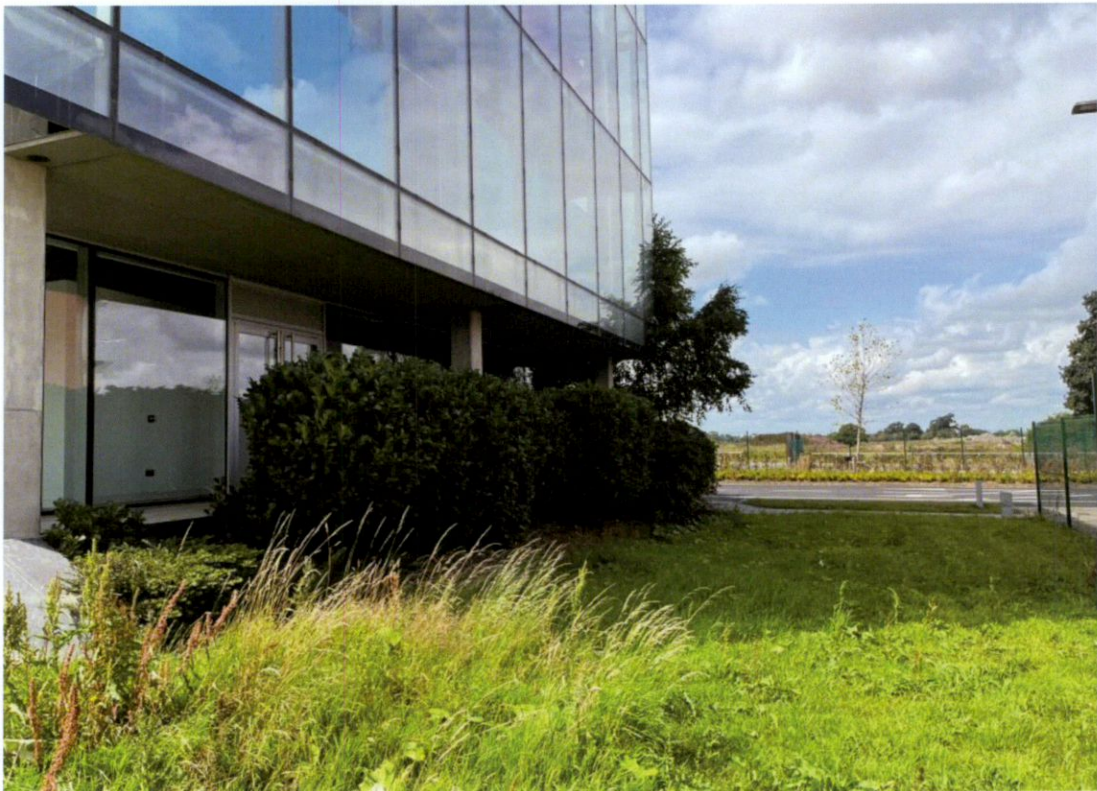
**Photo 4:** View of the shrubs (S566) located along the northern side of the building.
