## Arboricultural Impact Assessment & Tree Protection Plan

Arboricultural Impact Assessment & Tree Protection Plan to accompany planning application by Pavement Homes Ltd. for the construction of 6 three-bedroom dwelling houses and all ancillary site works at St. Finian's Way, Main Street, Newcastle, Co. Dublin.

Planning Ref: SD22A/0045

August 2022

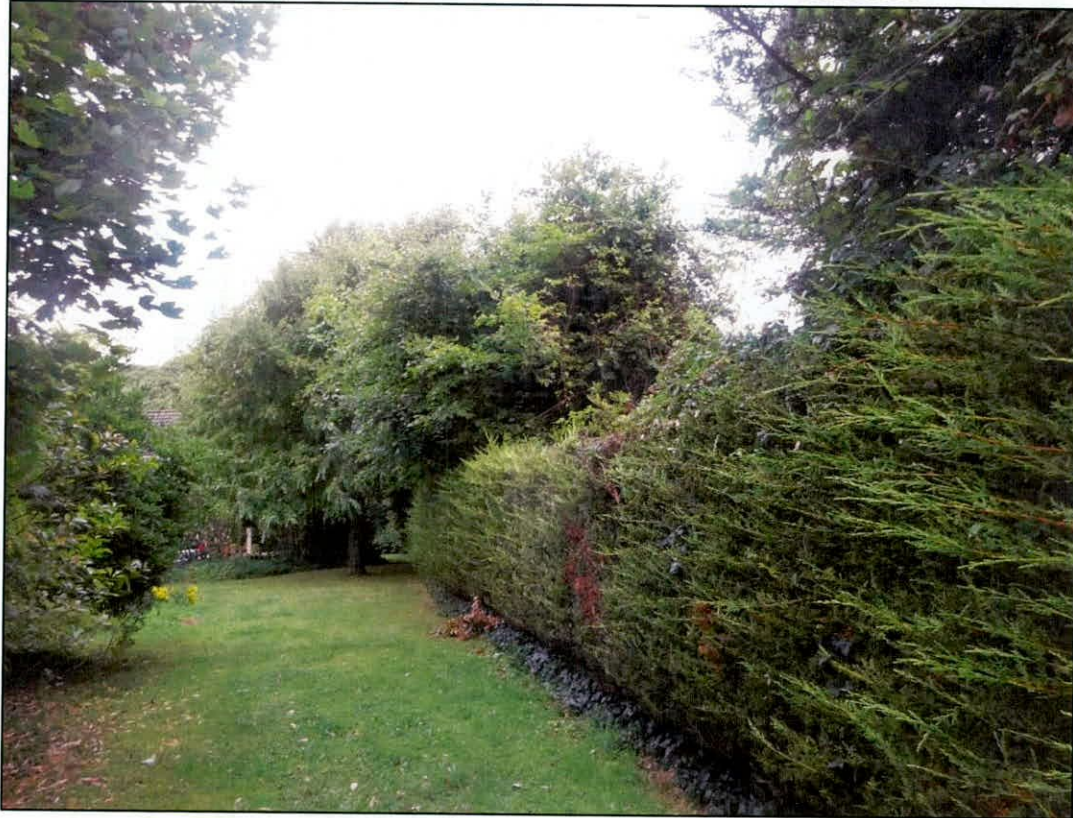
**Photograph 5.1: Leylandii hedge and semi-mature Beech trees**

This grouping of trees forms the boundary between the site and the existing development of St Finian's Way. It is largely composed of a Leylandii hedge (Castlewellan Gold variety) with some semi-mature Beech trees contained within it towards the northern end and a clump of semi-mature Sycamore trees towards the southern end. On the southern edge of this group on the inside of the

boundary there is a coppiced Copper Beech tree which has been pruned and maintained as a shrub tree. The Copper Beech is approximately 2.5 m height. The average height of the Leylandii hedge is 2m and the average height of the semi-mature Beech trees along this boundary is 4m. Photograph 5.1 below shows the maintained portion of the Leylandii hedge and the semi-mature Beech trees on the northern end of the grouping.

The remaining trees in this group are to be retained and protected with a suitable fence during the construction process. The category of the trees to be protected is similar to that outlined in Table 5.1 above with nothing assessed above a C2 category.

The semi-mature Sycamore trees, Leylandii hedge and the Copper Beech shrub will have to be removed to facilitate development (Figure 4.4). The trees to be removed are assessed as trees of low to medium quality as summarized in Table 5.1 below.

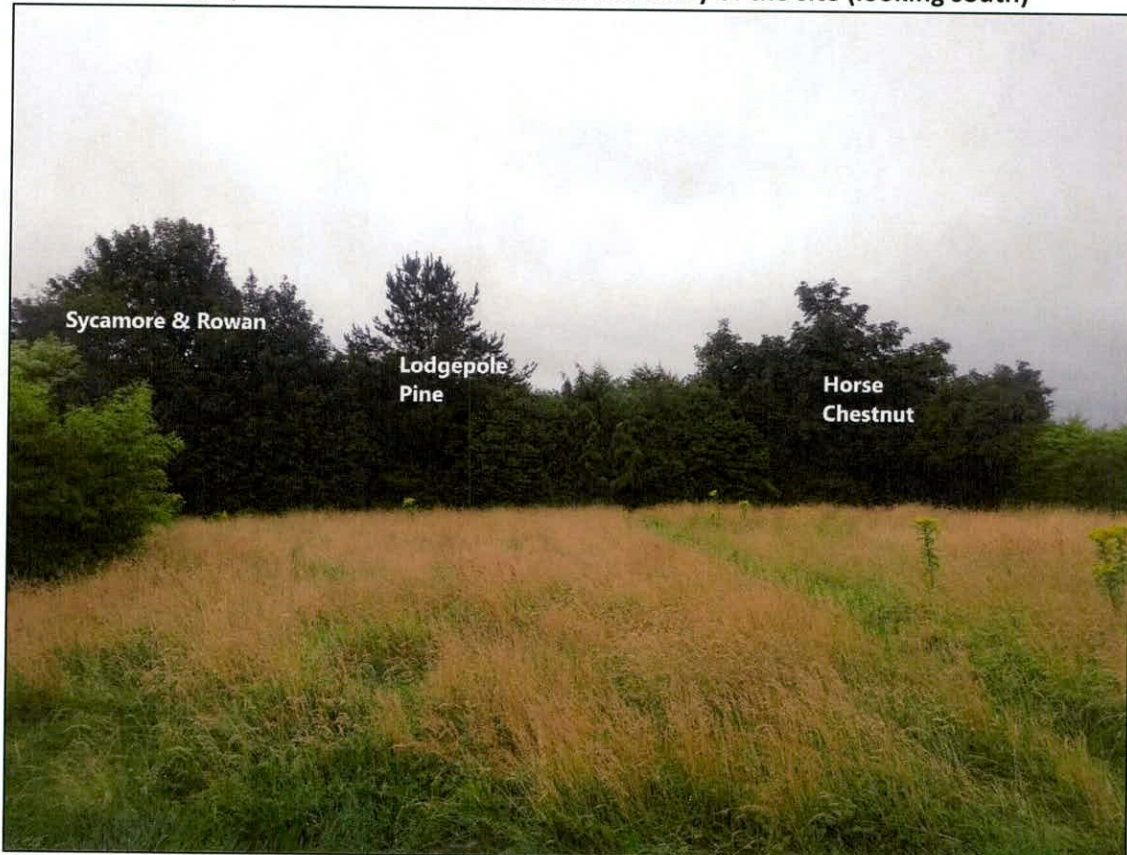
**Photograph 5.2: Trees on the southern boundary of the site (looking south)**

Photograph 5.2 gives an overview of this grouping of trees with a Horse Chestnut tree on the far right, Lodgepole Pine tree in the centre and Sycamore trees on the far left. The Leylandii Hedge is approximately 2.5-3 m in height and the other trees range in height from 6-8m.

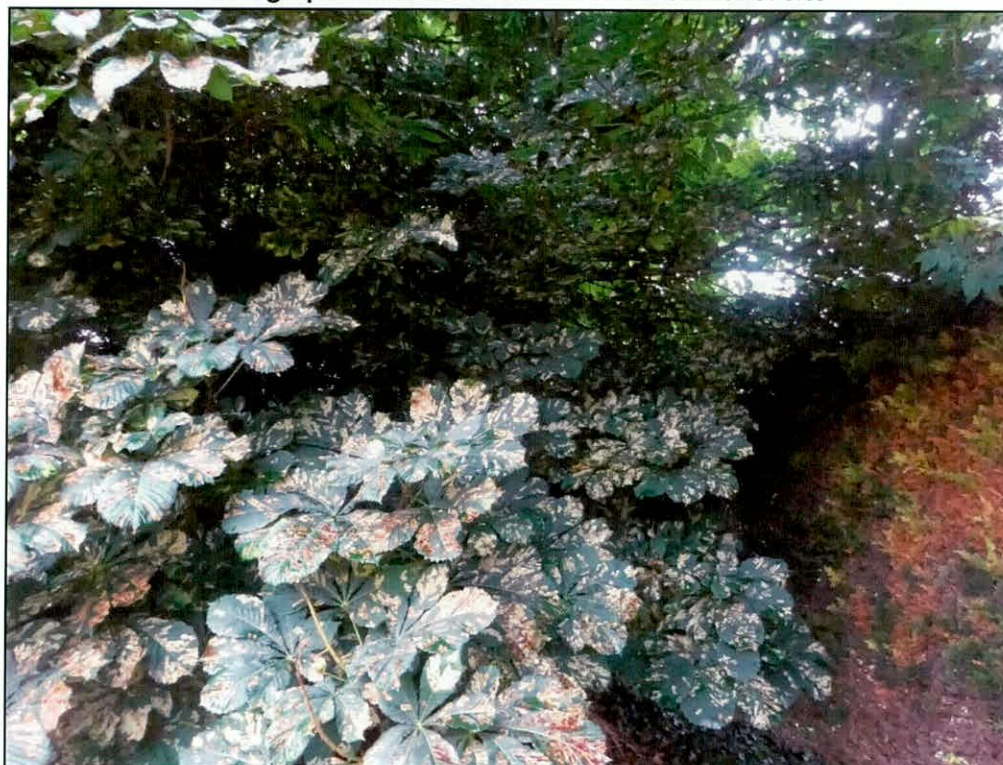
**Photograph 5.3: Horse Chestnut in SW corner of site**

Starting at the western end of the group there is a semi-mature Horse Chestnut which has significant crown spread of over 5m in most directions. It appears structurally sound but the foliage is in poor condition. This is likely to be due to a fungal infection and worthy of further investigation if the tree was due to be retained. Photograph 5.3 below show the fungal infection present in the leaves of this tree.

Of this grouping the Horse Chestnut tree, some of the Portuguese Laurel and the Leyland Cypress tree will require removal to facilitate development of the proposed turning bay in the development (Figure 4.4). The Cypress tree is slightly outside the footprint of the turning bay, but the removal of a significant amount of its root plate will make this tree unviable so should be removed before construction begins. The Portuguese Laurel is a common hedging plant and will be able to recover from severe pruning and partial removal without causing lasting damage. The Horse Chestnut tree to be removed is showing signs of a severe fungal infection and may not be suitable for retention in the short to medium term regardless of development plans. The trees to be removed are assessed as trees of low to medium quality as summarized in Table 5.2 below.

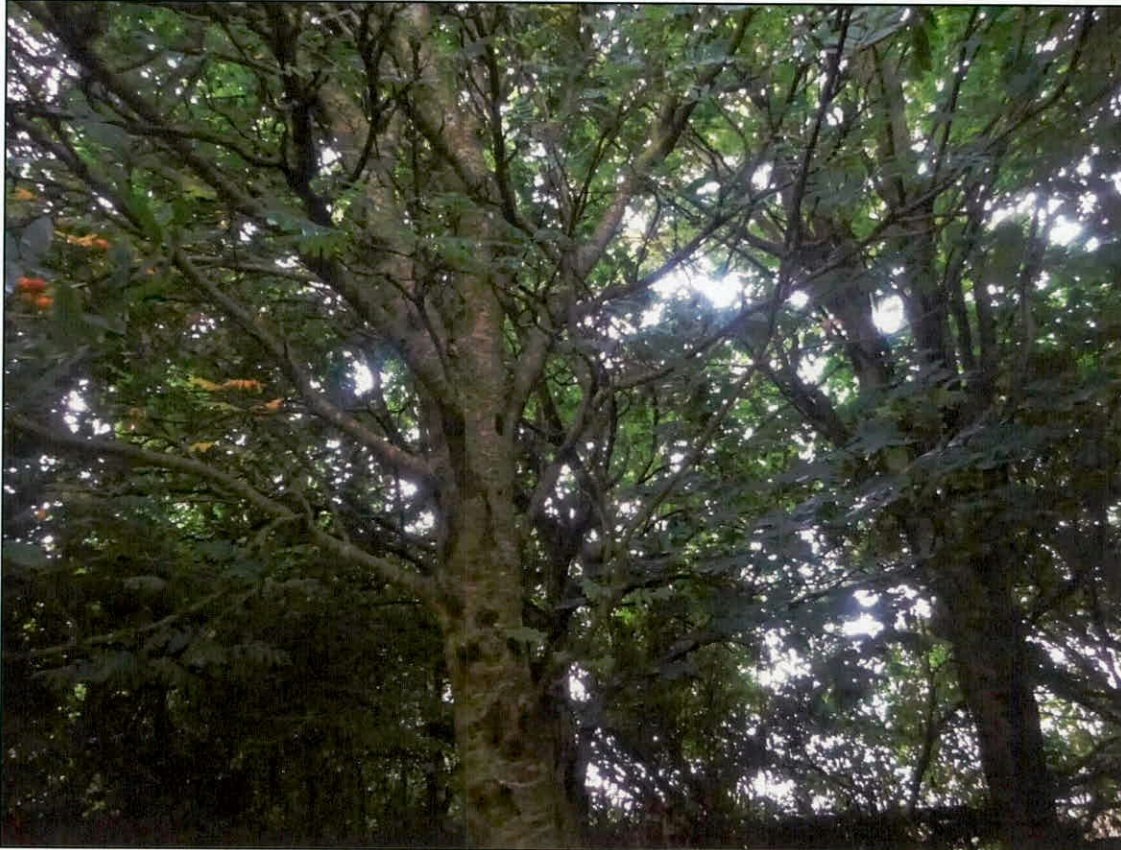
**Photograph 5.4: Sycamore and Rowan trees for retention in south-east corner of site.**

The remaining trees in this group are to be retained and protected with a suitable fence during the construction process. The category of the trees to be protected is assessed as B2. These trees are to form part of the green space proposed in the development. Photograph 5.4 below shows the Sycamore and Rowan tree that are schedule to remain and be protected during construction.

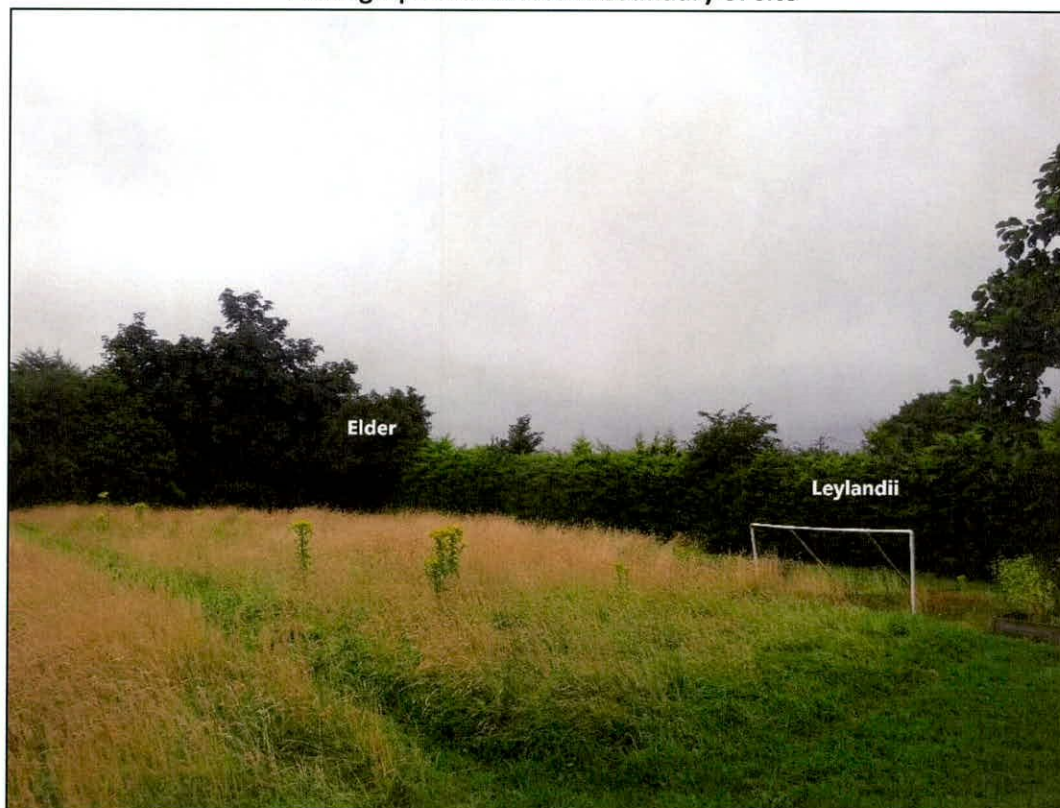
**Photograph 5.5: Western boundary of site**

This grouping of trees forms the western boundary between the site and the neighbouring property to the west. It is mainly a Leylandii hedge (Castlewellan Gold Variety) with a semi-mature Elder tree at the southern end. The hedge is maintained at approximately 2-2.5m height. The Elder tree is approximately 3m in height. Photograph 5.5 show this western boundary of the site.

All trees are to be retained in this group and the category of the trees is assessed as C2.

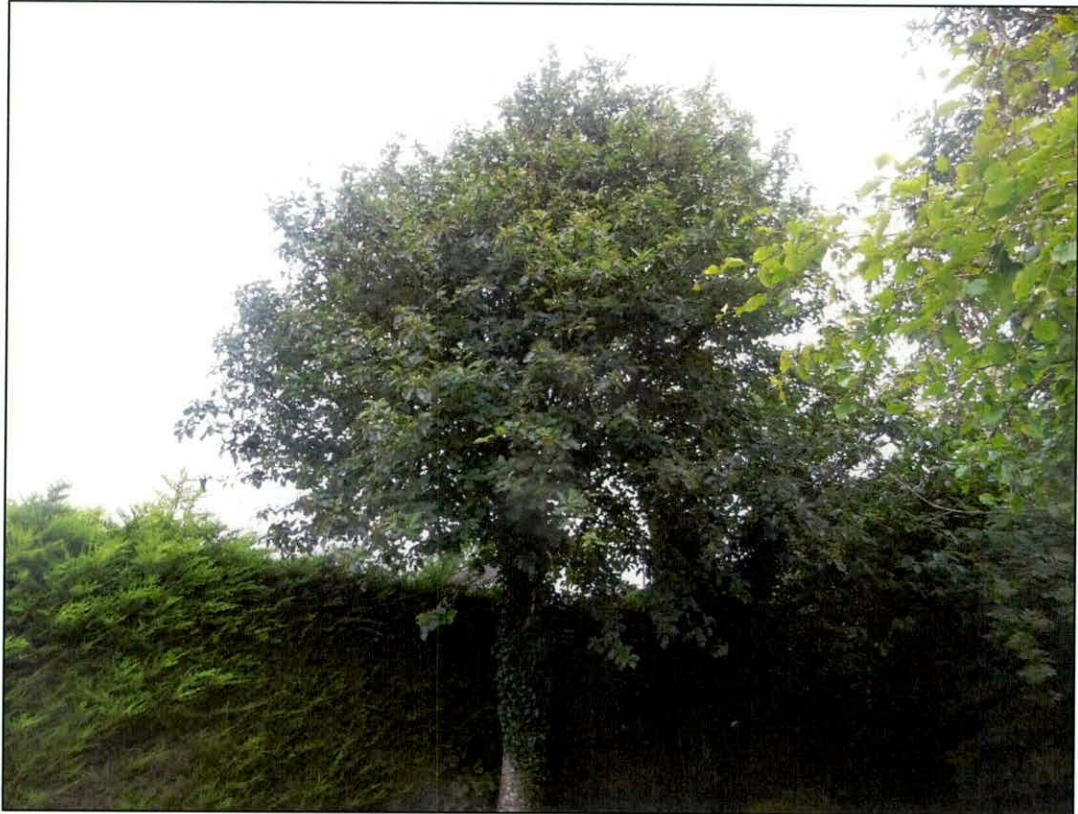
**Photograph 5.6: Oak tree in north-west corner of site**

Starting at the north-west corner there is a semi-mature Oak tree in good condition with some smaller Elder bushes growing underneath. The Oak is categorized as B2. Next to the Elder there is a clump of trees including a semi-mature Alder tree and several young stems of Ash & Beech. The Alder tree is assessed as category C2. The Ash is showing signs of Ash die-back disease. In the north-east corner of this group there is a semi-mature Sweet Chestnut tree in good condition. This tree is assessed as category B2. The semi-mature trees range in height from 6-8m and the young trees range in height from 2-5m.

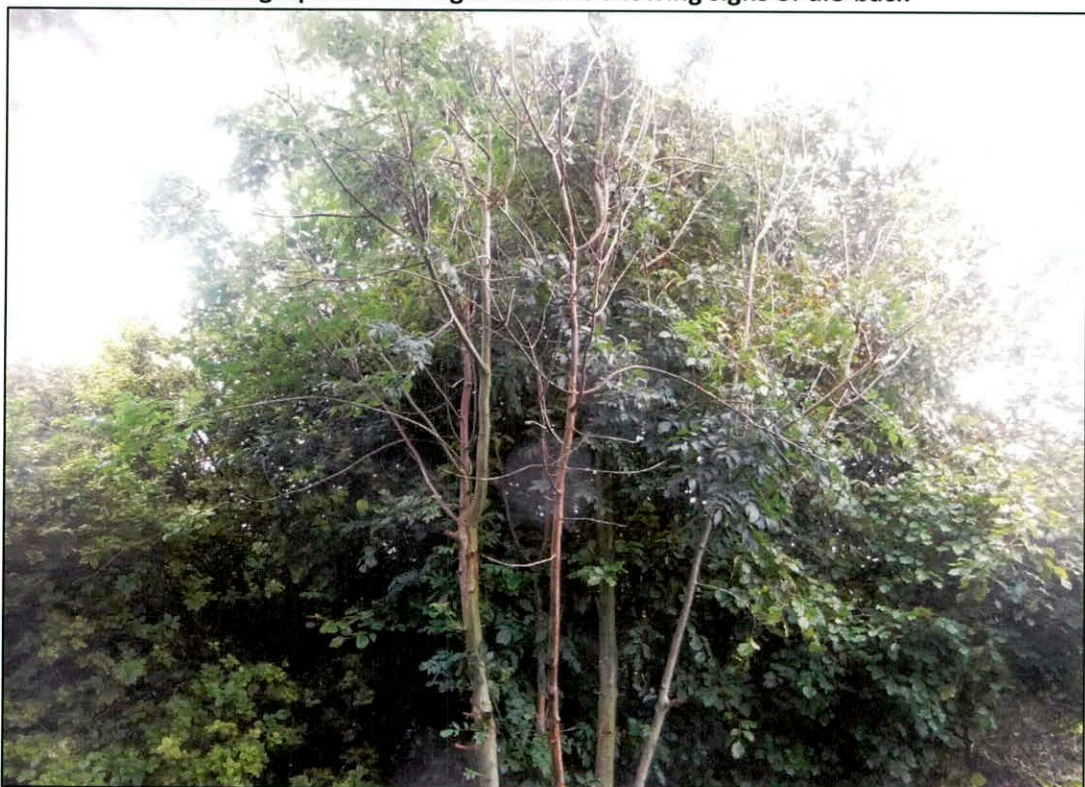
**Photograph 5.7: Young Ash stems showing signs of die-back**

Photograph 5.6 below shows the Oak tree in the north-west corner of the site. Photograph 5.7 below shows the young Ash stems showing signs of Ash die-back disease. Photograph 5.8 shows the semi-mature Sweet Chestnut tree in the north-east corner of the site.

There are no trees required to be removed from this group to facilitate development. However, it would be prudent to remove the young Ash stems as they will not recover from Ash die-back disease.

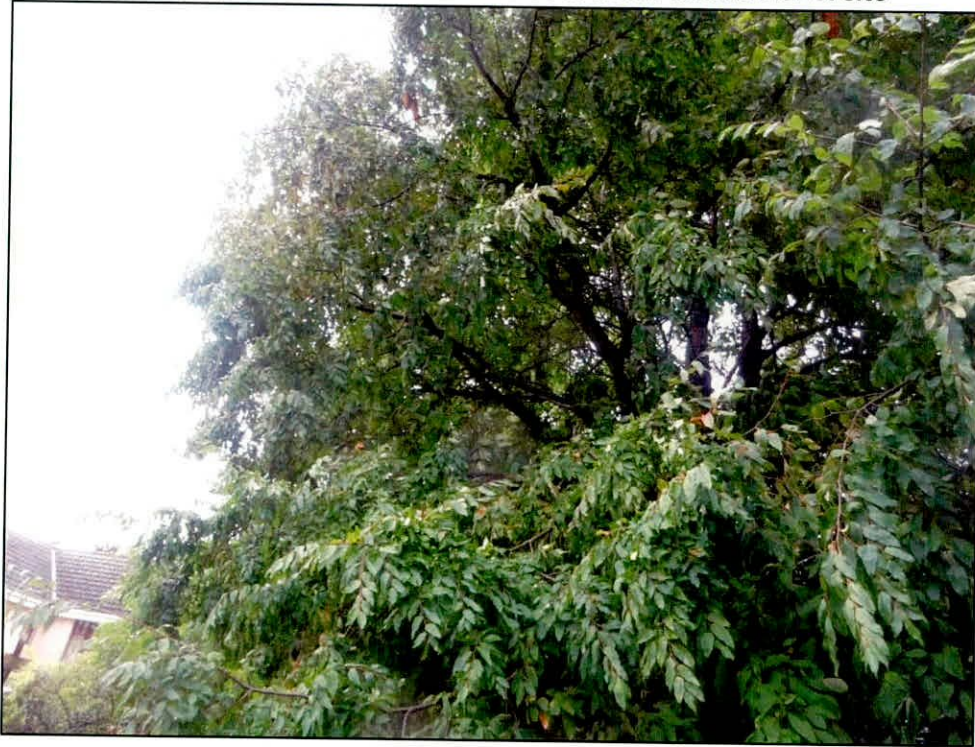
**Photograph 5.8: Sweet Chestnut tree in north-east corner of site**

The remaining trees in this group are to be retained and protected with a suitable fence during the construction process. The category of the trees to be protected is assessed as B2 for the Oak and Sweet Chestnut and C2 for the Alder and young Beech.

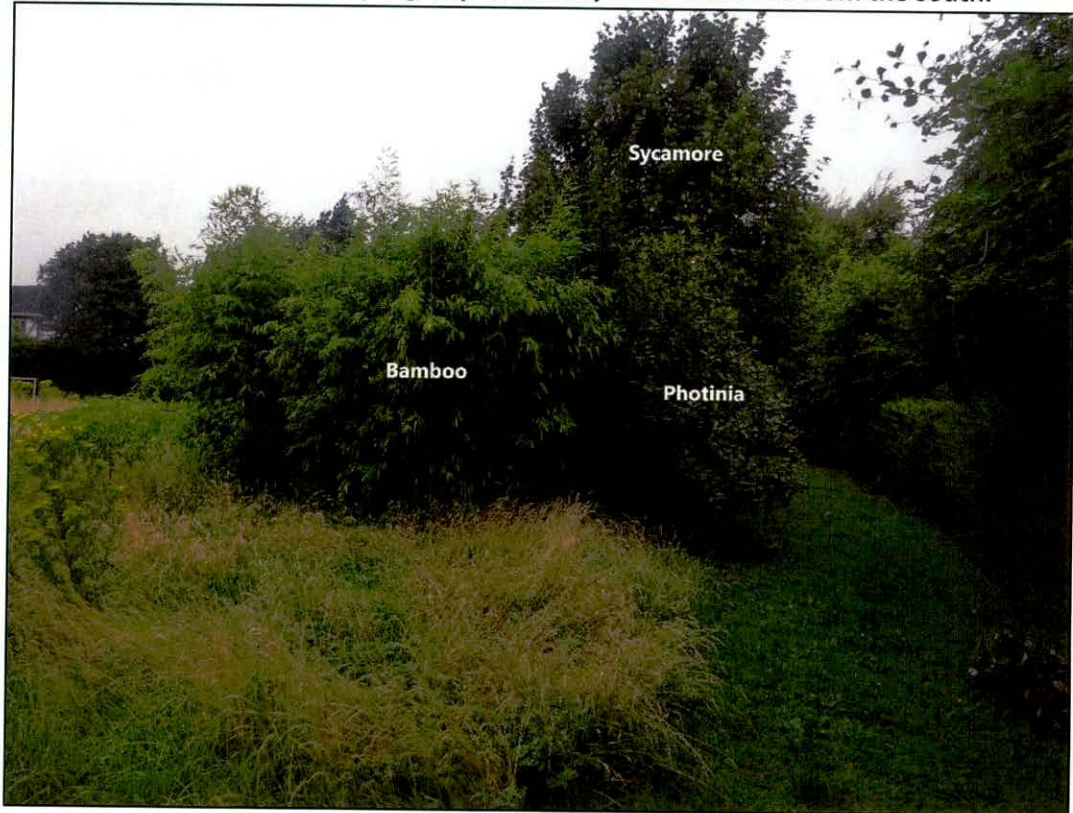
**Photograph 5.9: Group 5 group of shrubs/trees as viewed from the south.**

This grouping of trees/shrubs is located in the central eastern part of the site. It appears to have been a former shrub bed that has no longer been maintained. It contains various shrub species including, Bamboo, Spirea, Variegated Laurel, and Photinia along with some young Sycamore trees. The shrub height averages 2-3m and the Sycamore is approximately 6m height. The condition of the shrubs and Sycamore is good. Photograph 5.9 below shows the group of shrubs/trees as viewed from the south.

All the trees/shrubs in this group will be required to be removed to facilitate development
