Stormwater Soakaway Report

1 Sundale Green Tallaght Dublin 24

29/09/2022

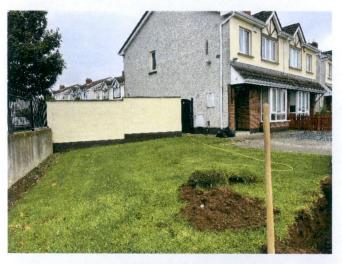
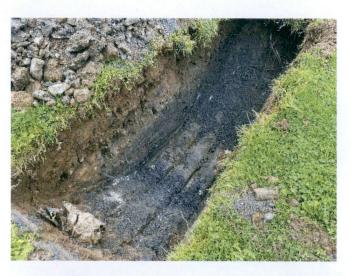
Site Views House, Test location & test pit

A test pit was excavated on the site measuring 0.8m wide X 1.5m long X 1.8m deep which revealed a top layer of filled ground consisting of partially gravelly stiff clays and silts with mixed in rubbles to a depth of 0.9m which in turn overlies a layer of hardcore / 804 fill to a depth of 1.1m which in turn overlies a soil stratum of very firm massive / compact stiff CLAY (no cobbles, sand or gravel within this soil layer) to the base of the pit at 1.8m.

The water level dropped to 1.3m (100mm) in a 58 minutes before becoming static with no notable drop over the following period which reflects the soil description as a stiff (putty like) CLAY.

The soil stratum from 1.2-1.8m below ground are considered to have very low permeable characteristics and due to the limited available space on the existing site the site is considered unsuitable for a storm water soak-a-way system.

The storm water generated from the proposed extension will need to discharge into the main system along with the existing house.

Permeable paving and drive way is recommended to reduce the hard surface area on the site.
