# Independent Tree Surveys Ltd

## Tree Survey & Planning Report 1A The Crescent Lucan Co. Dublin

July 2022

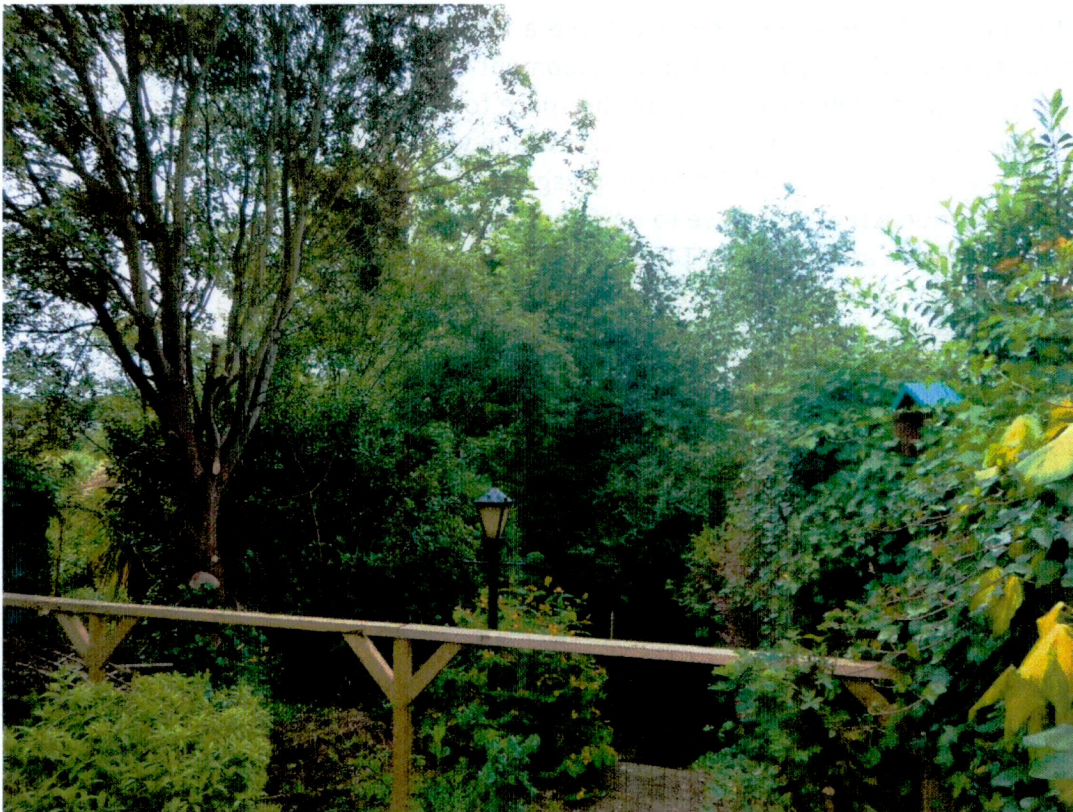
The tree cover of the site is all relatively young and of comparatively low arboricultural value. The Holm Oak tree T452 is in good physiological condition but is arguably an inappropriate species choice for such a narrow garden. It will require regular pruning or pollarding if its height and spread is to be kept under control.

Photo 1 View looking south from just outside the site boundary, with Holm Oak T452 to the left

The trees highlighted on the drawing will be felled and the resulting arisings removed to a licenced green waste facility or recycled as mulch on the site. The trees inside the site being felled are the seven tagged T452-T458, with the trees tagged T459, T463, T465 and T466 in the neighbouring garden also being removed as part of the development planned for the adjoining lands.

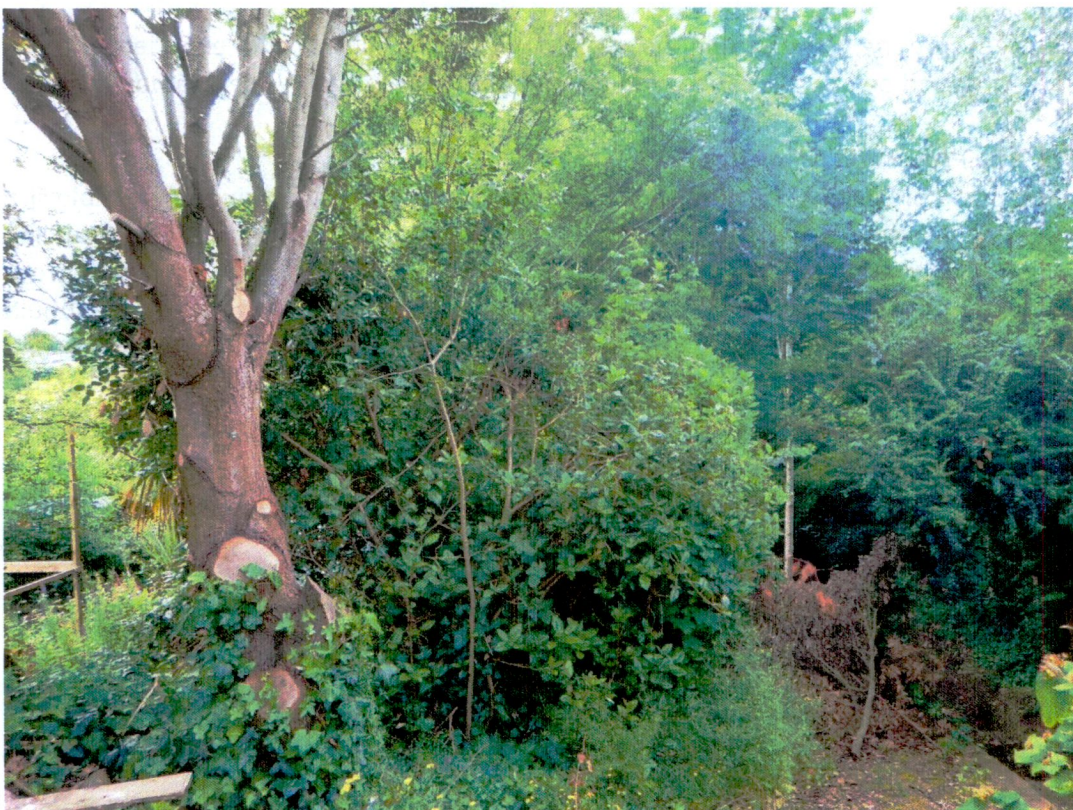
The site is compact and roughly rectangular (approx. 6.5mx23m) and occupies the southern end of the sloping rear garden of the house. The area seems to have been actively managed in the past, but, apart from some recent branch pruning to the Holm Oak T452, has evidently been left mostly unmanaged for some period.

Photo 2 Recently pruned Holm Oak T452 to left, dense shrubs behind and slender young Birch beside steps and path
