Arboricultural Report

Tree Survey &
Arboricultural Impact Assessment

Lands at Kingswood Truck Wash

220728-PD-11

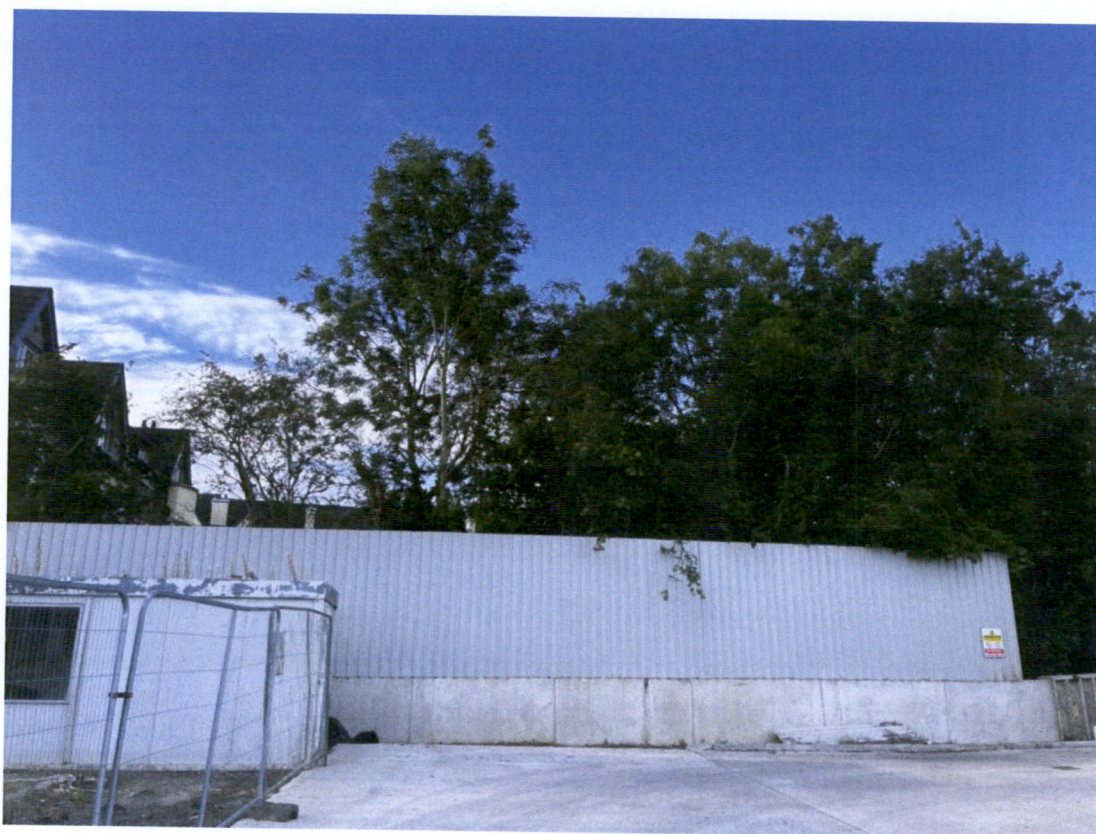
Photo 1: View of the existing hawthorn and elder hedgerow (G6) and early-mature ash (T2, T4, T5) located adjacent to the southern boundary.

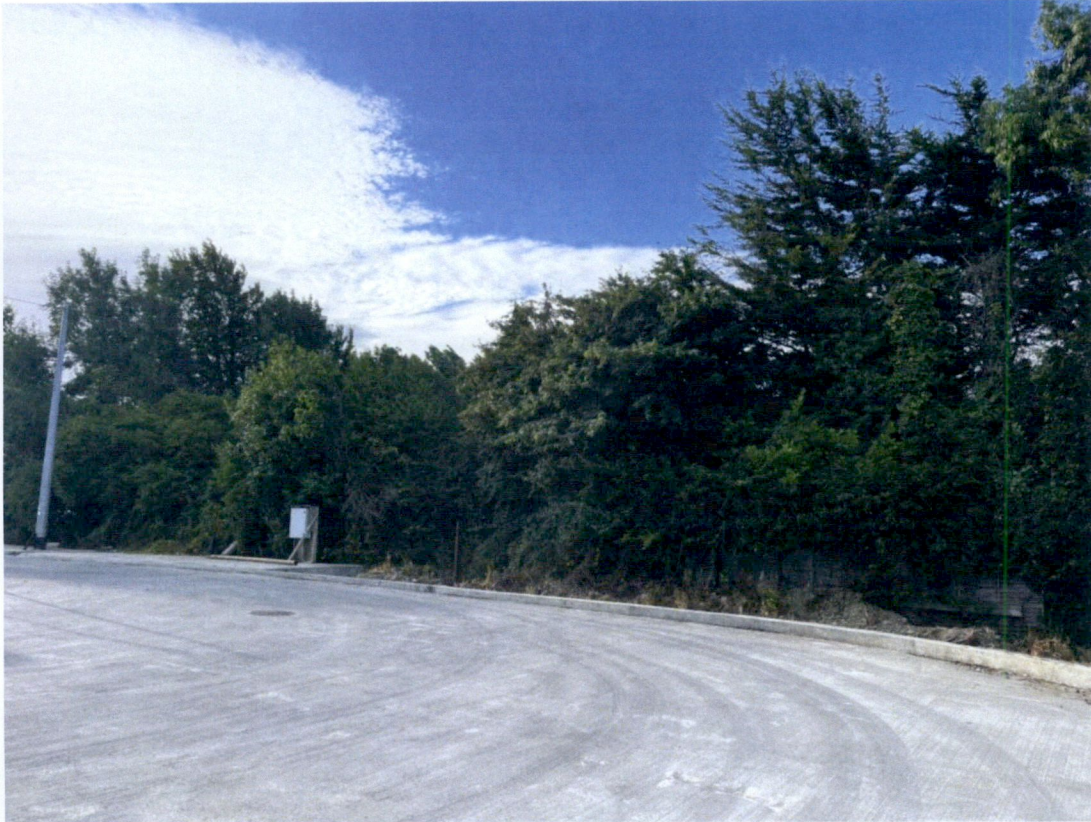
Photo 2: View of the mixed tree and shrub group (G1) located adjacent to the southern boundary and to the west of the hawthorn and elder hedgerow.

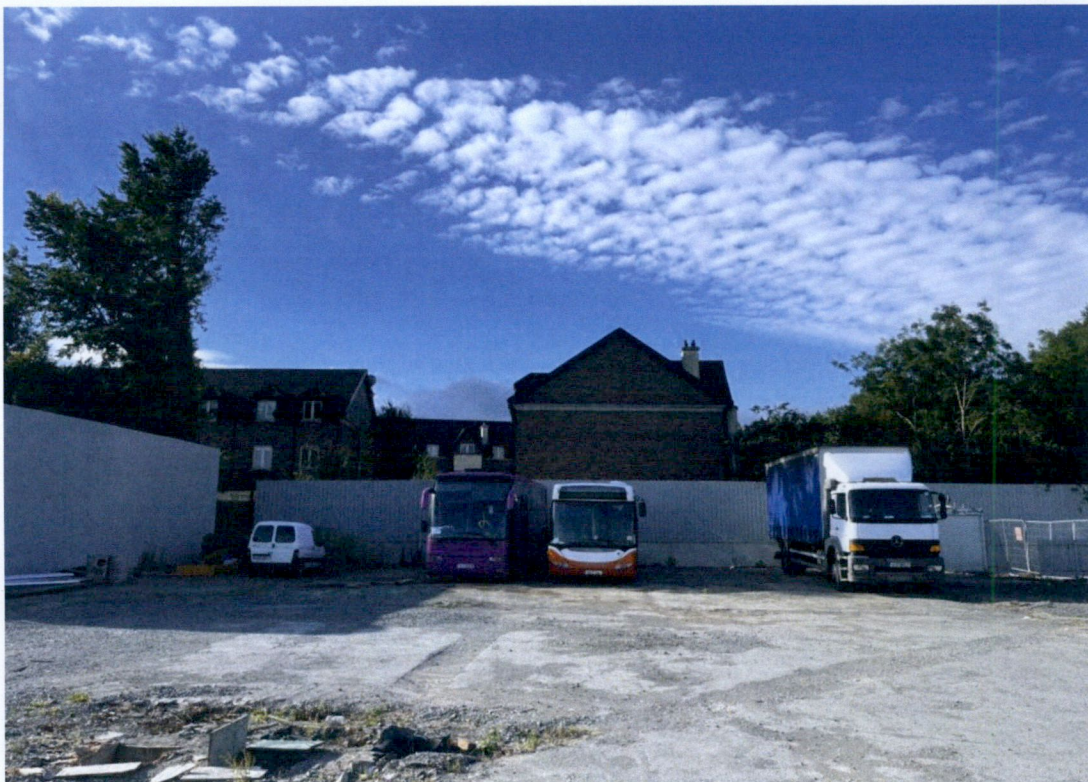
Photo 3: View of the existing gap where trees and hedging have been removed. This is located along the southern boundary between the hedgerow (G6) and two poor quality trees (T7 & T8).

- 2.10 The extent of trees and the section of hedgerow that was removed between G6 and T7 was approximately 25 linear metres in length. The exact number of trees removed could not be determined during the site visit as no stumps were remaining.
- 2.11 Based on old google images, the trees and hedgerows removed appear to have been similar to what is currently present along the existing boundary. It would appear that several early-mature overstorey elm and ash trees were removed and a section of understorey hawthorn and elder.
- 2.12 The elm and ash trees would most likely have been assessed as being of low or poor quality, considering they have a limited life expectancy due to the risks posed by their associated fungal pathogens, Dutch elm disease and ash dieback. The hawthorn hedgerow would have been of a low or moderate quality depending on its condition.

- 3.1 **Loss of trees** – Approximately 25 linear metres of the trees and hedgerow cover along the southern boundary has been removed. The trees removed appear to have been elm and ash. These would likely have been graded as being of low (C Category) or poor (U Category) quality only, due to the risk posed by the fungal pathogens Dutch elm diseases and ash dieback. Both of which reduce the life expectancy of a tree. The understorey native hawthorn hedgerow would likely have been graded as being of low quality (C Category) or moderate quality (B Category).

- 3.2 The removals were carried out along the side of the neighbouring residential property, 24 Brownsbarn Wood. Even though the overstorey elm and ash trees may have been of low quality, their loss has had a visual impact on the adjacent neighbouring dwellings, as they now overlook the Application Site.

- 3.3 **Arboricultural mitigation** – To mitigate the loss of trees, a detailed landscape proposal, that includes new high quality trees, hedgerows, and woodland planting, has been prepared by Jane McCorkell Landscape Architects.

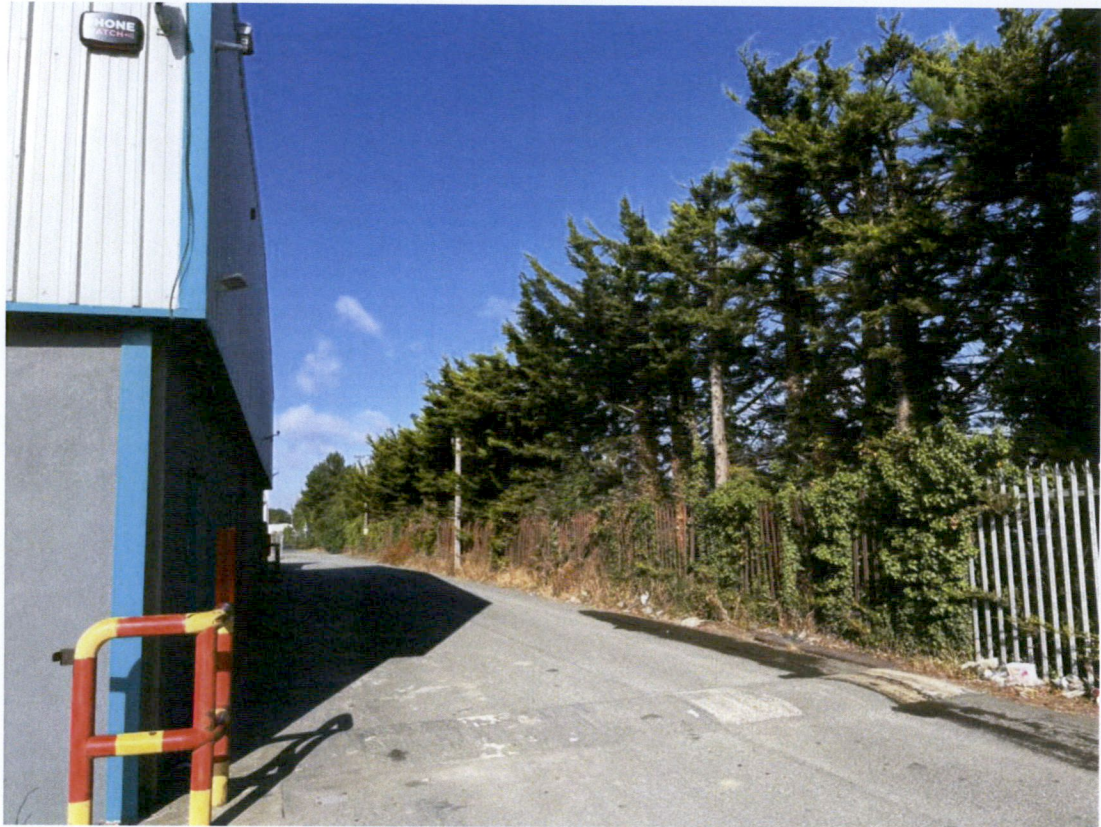
Photo 4: View looking west at the neighbouring tree and shrub groups (G13 & G14) located adjacent to the northern boundary of the site and main entrance road.

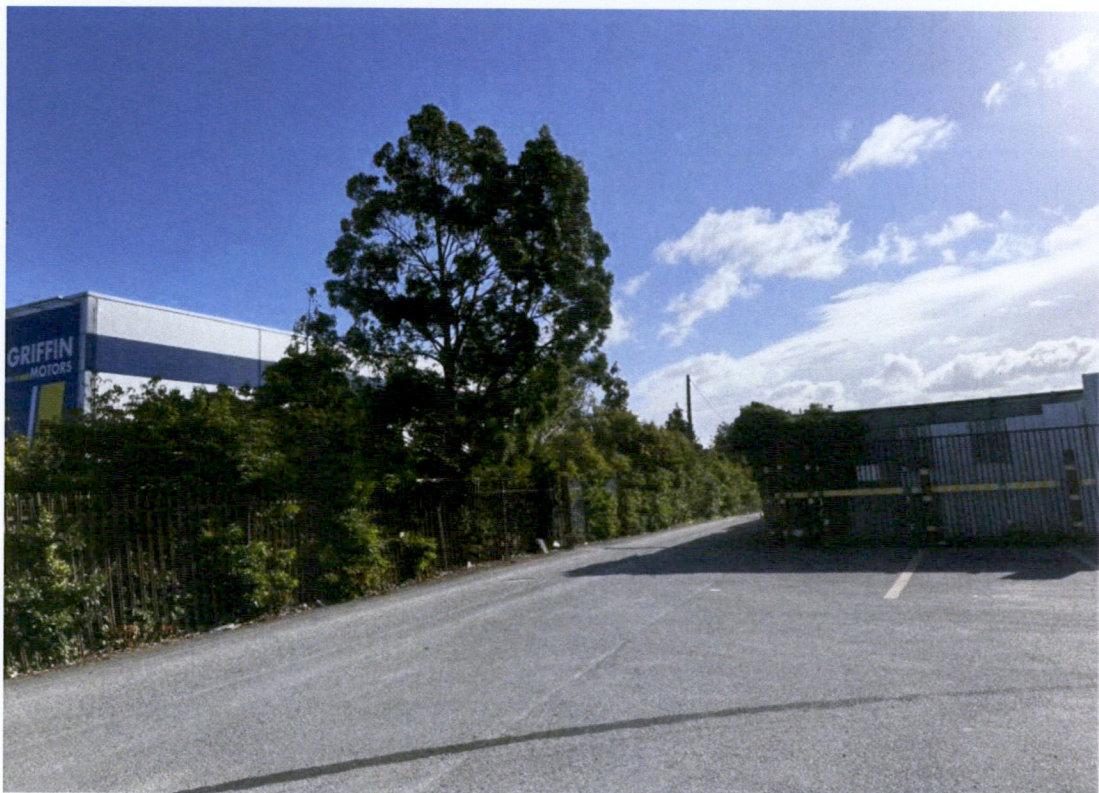
Photo 5: View looking east at the neighbouring tree and shrub groups (T15 to G17) located adjacent to the northern boundary of the site and main entrance road.

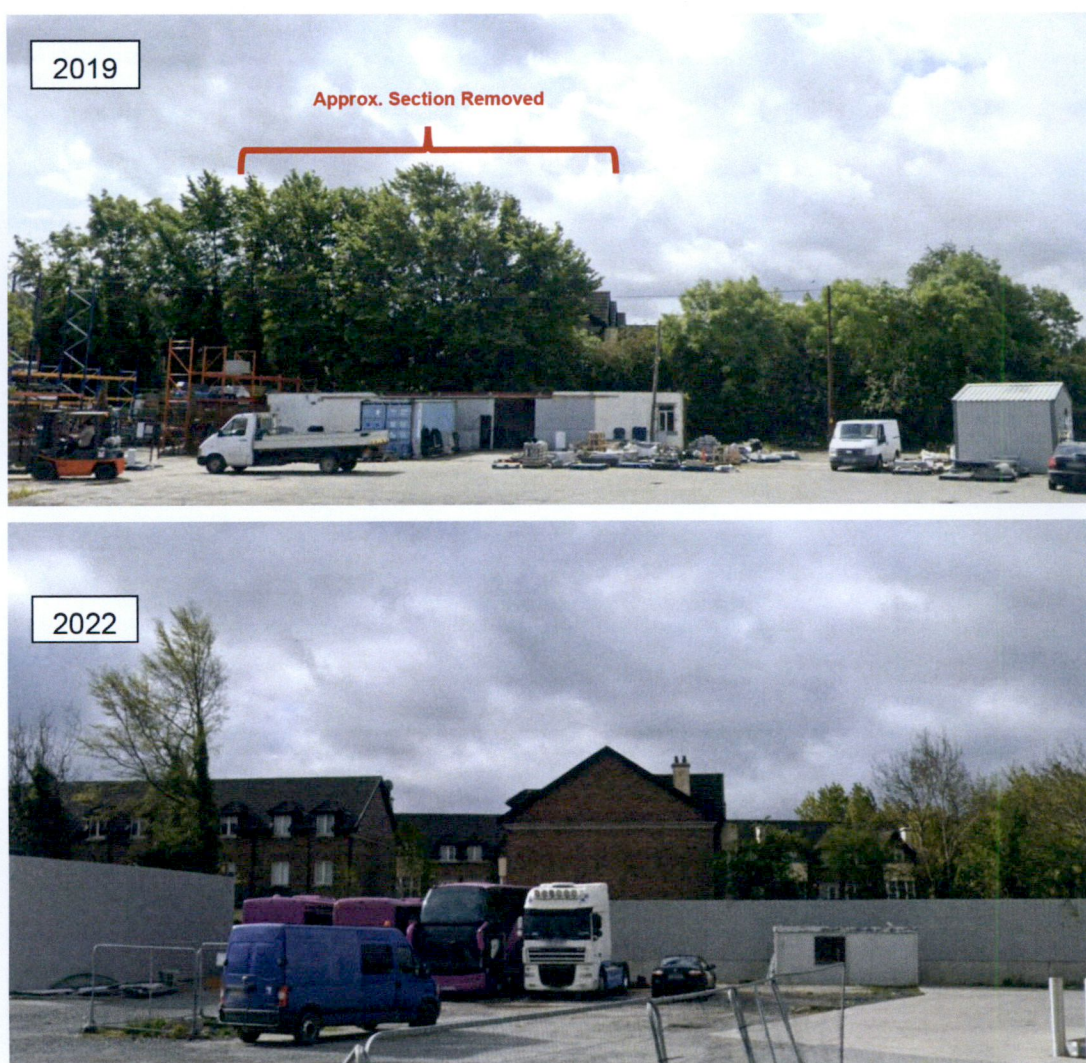
Photos 6 & 7: Comparison of Google images from 2019 and 2022 showing the extent of trees and the section of hedgerow that has been removed.

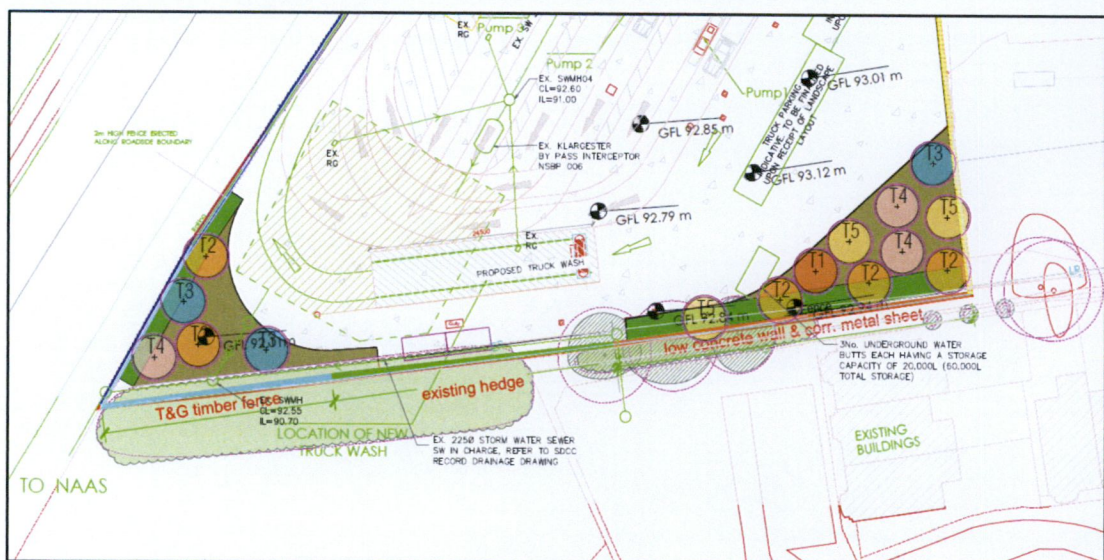
Image 1: Extract from the landscape architect's plan showing the two new planting areas.

- 3.4 To allow for new planting, two large areas of concrete are required to be removed to a depth of 1m and new soil and drainage installed to provide a good growing medium for plant establishment.

- 3.6 The new planting includes 70 linear metres of mixed native hedging, 310m² of native woodland planting, and 15 semi-mature trees. The extent of the new planting proposed is greater than what has been removed from the site. In the medium to long term, this will have a positive impact on local canopy cover as well as replacing the trees and section of hedgerow that have been removed.
- 3.7 ***Tree protection measures*** – All neighbouring trees can be successfully retained and protected during the proposed development works. The location and specification of tree protection measures are highlighted in the Tree Protection Plan at Appendix B.
