Independent Tree Surveys Ltd

Tree Survey & Planning Report
Aderrig Phase 3
Residential Development
Adamstown SDZ
Dublin

October 2022

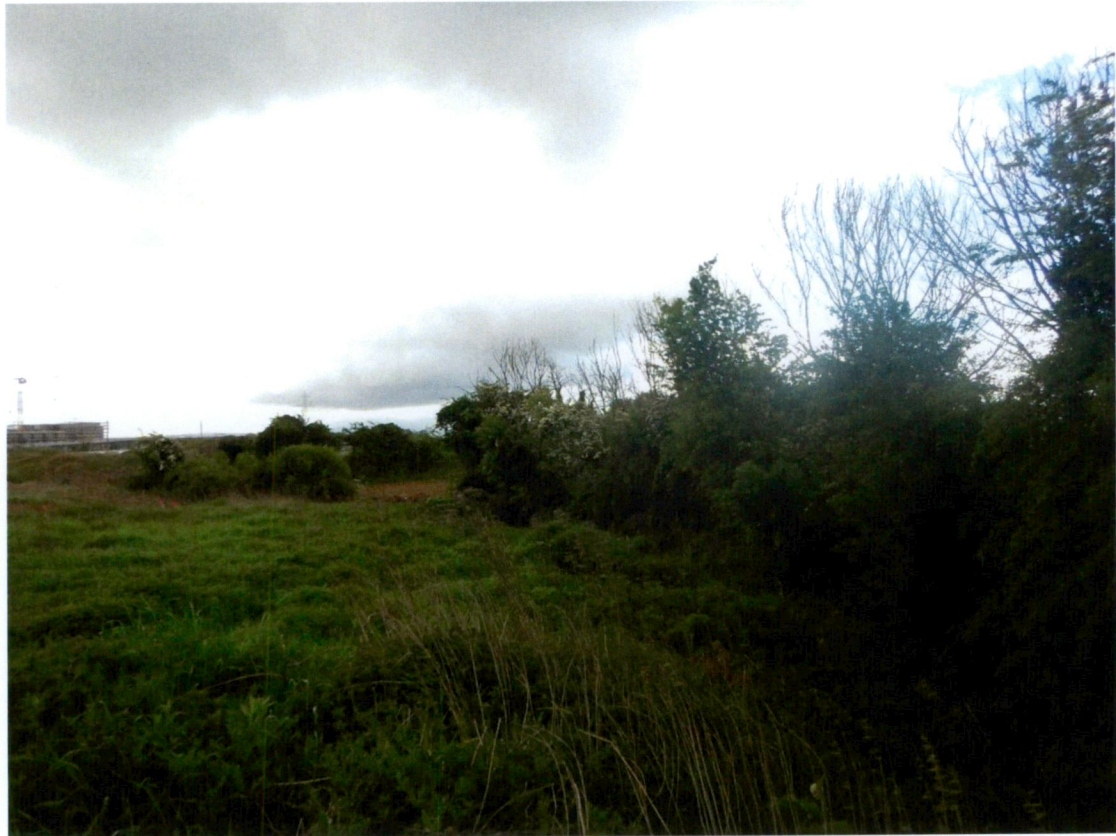
1. Southern end of Hedge H1 viewed from the north

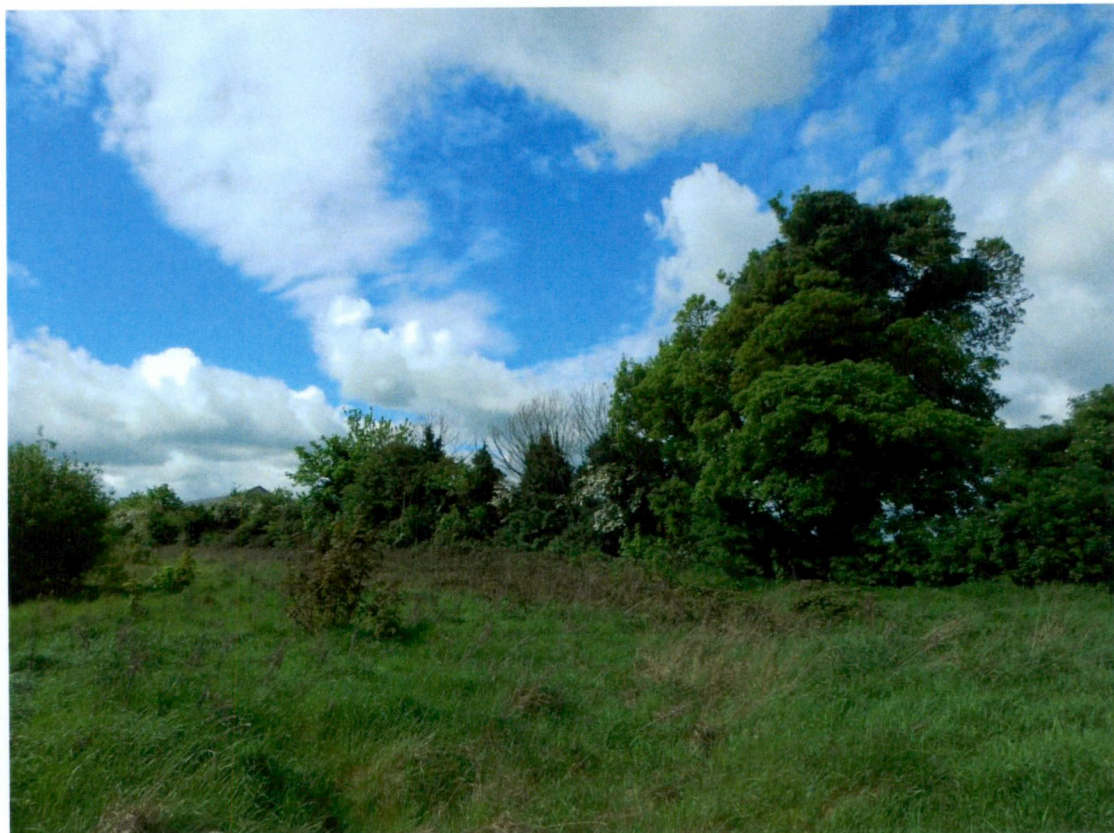
2. Mature Sycamore tree T2 in Hedge H2

T 2	Acer pseudoplatanus (Sycamore)	M	16	950	1	0.5	6.5	7	7	8	10+	Fair	Fair/Poor. Larger hedgerow tree covered by thick Ivy growth which restricts the view of the main stem and branch unions. Wood decay established in extensive old bark wounding to lower stem and stem base; the actual extent of basal decay unclear due to thick Ivy/undergrowth. Excessive Ivy growth in crown.	Cut Ivy around stem base. Review extent of stem decay and crown reduce tree accordingly.	11.4	C2
T 3	Fraxinus excelsior (Ash)	EM	11.5	350	1	0.5	5	5	4	4	10+	Fair	Fair. Growing in hedgerow. Medium sized tree. Thick Ivy growth on tree stem. Ivy restricts view of main branch unions. Epicormic shoots on branching throughout crown.	Monitor tree condition.	4.2	C2
T 4	Ulmus glabra (Wych Elm)	EM	9	400	1						<10	Dead	Bad. Tree standing dead in hedge.	Fell tree.	4.8	U
T 5	Fraxinus excelsior (Ash)	EM	10	566	2	0	5	5	5	5	10	Fair/Poor	Fair. Medium sized tree at end of hedge. Thick Ivy growth restricts view of main branch unions. Unable to inspect stem due to undergrowth. Epicormic shoots consistent with Ash dieback disease (ADB) on branching throughout crown.	Monitor tree condition. Cut Ivy around stem base. Clear undergrowth to allow proper view of tree base.	6.79	C2

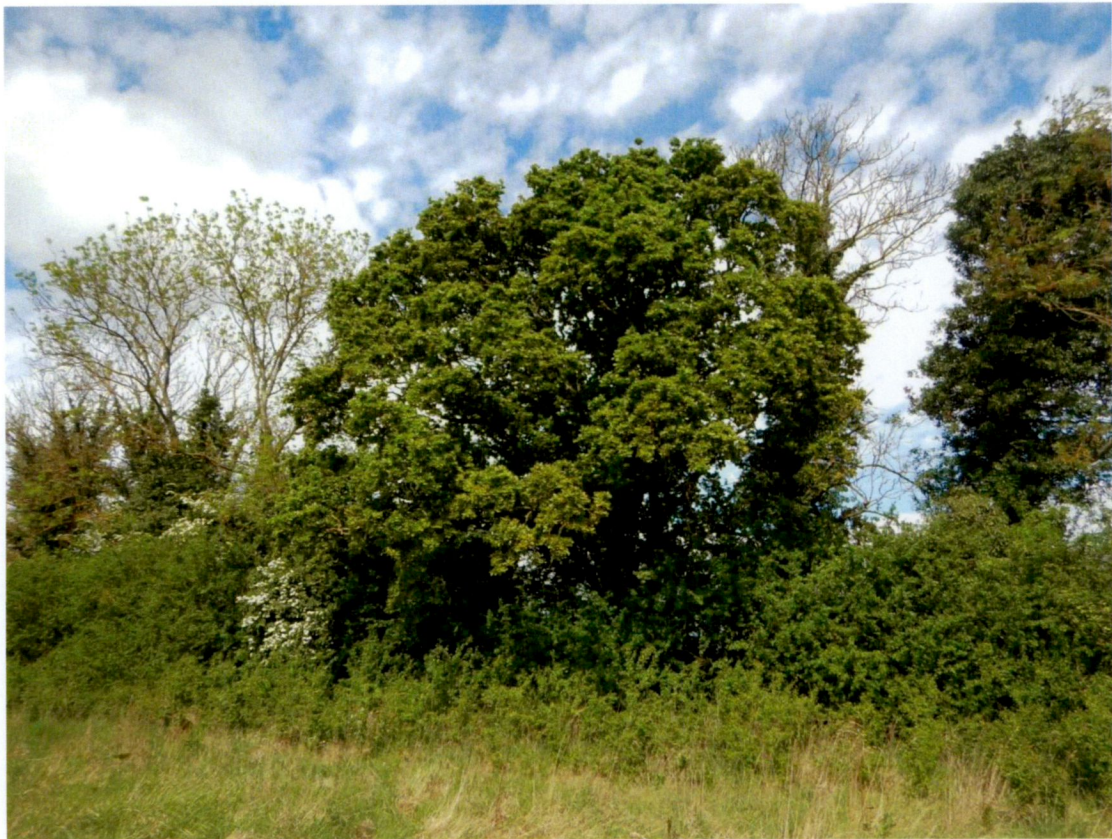
3. High value mature Oak tree (T16) in Hedge H2 – note poor quality Ash trees on either side
