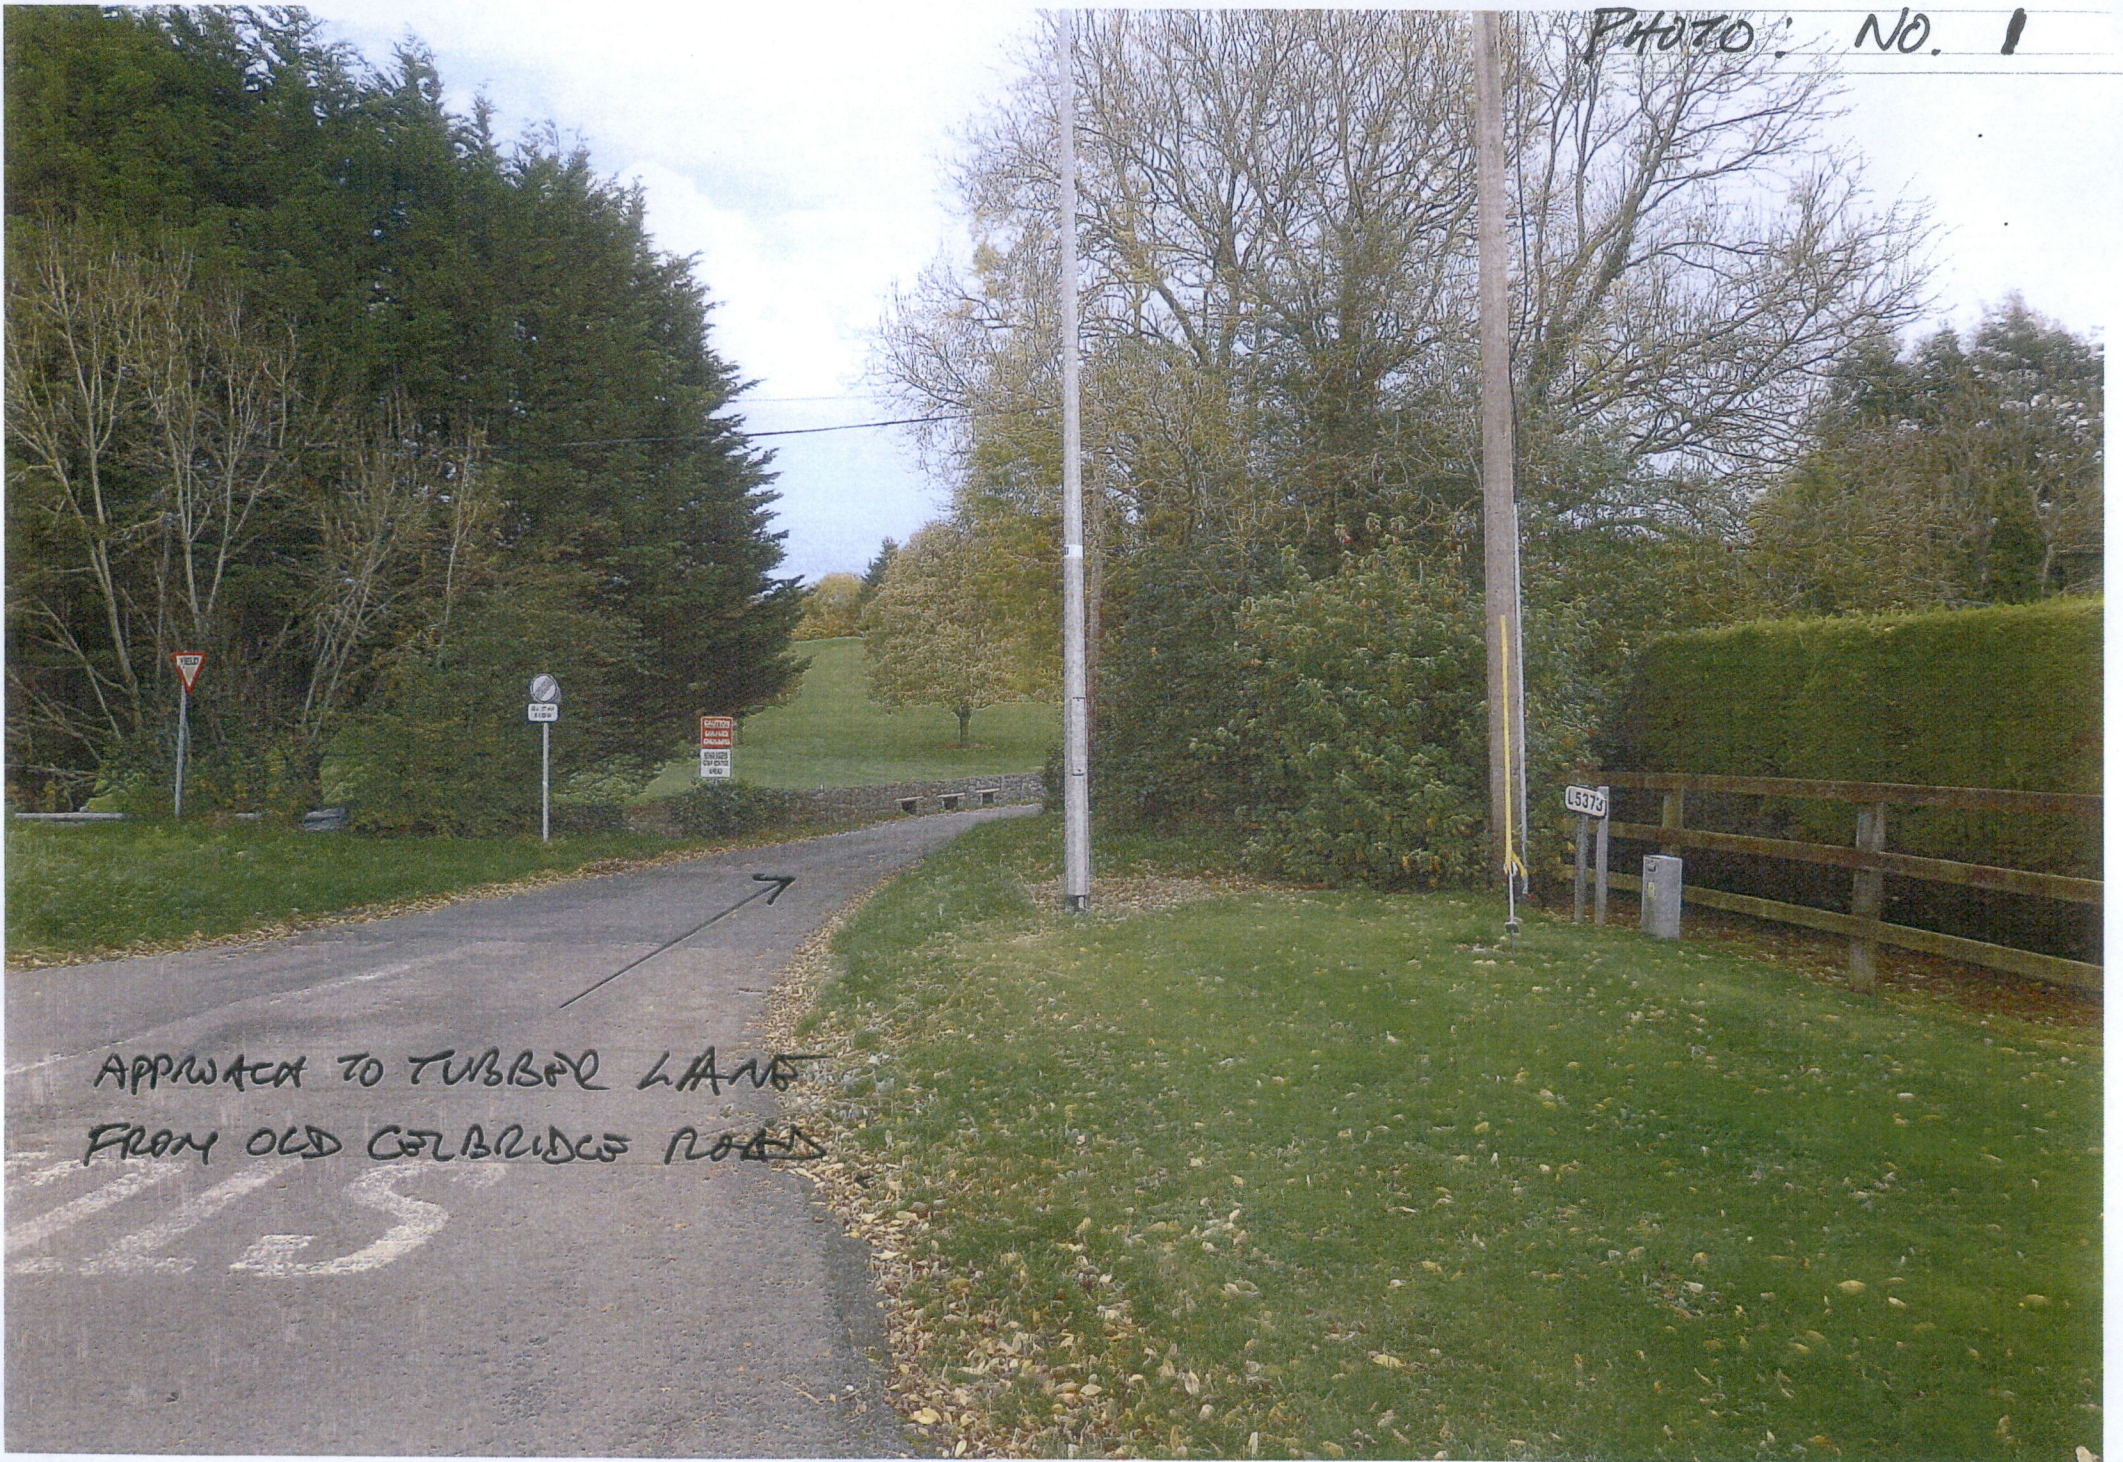
PHOTO: NO. 1

APPROACH TO TUBBER LANE
FROM OLD COLBRIDGE ROAD

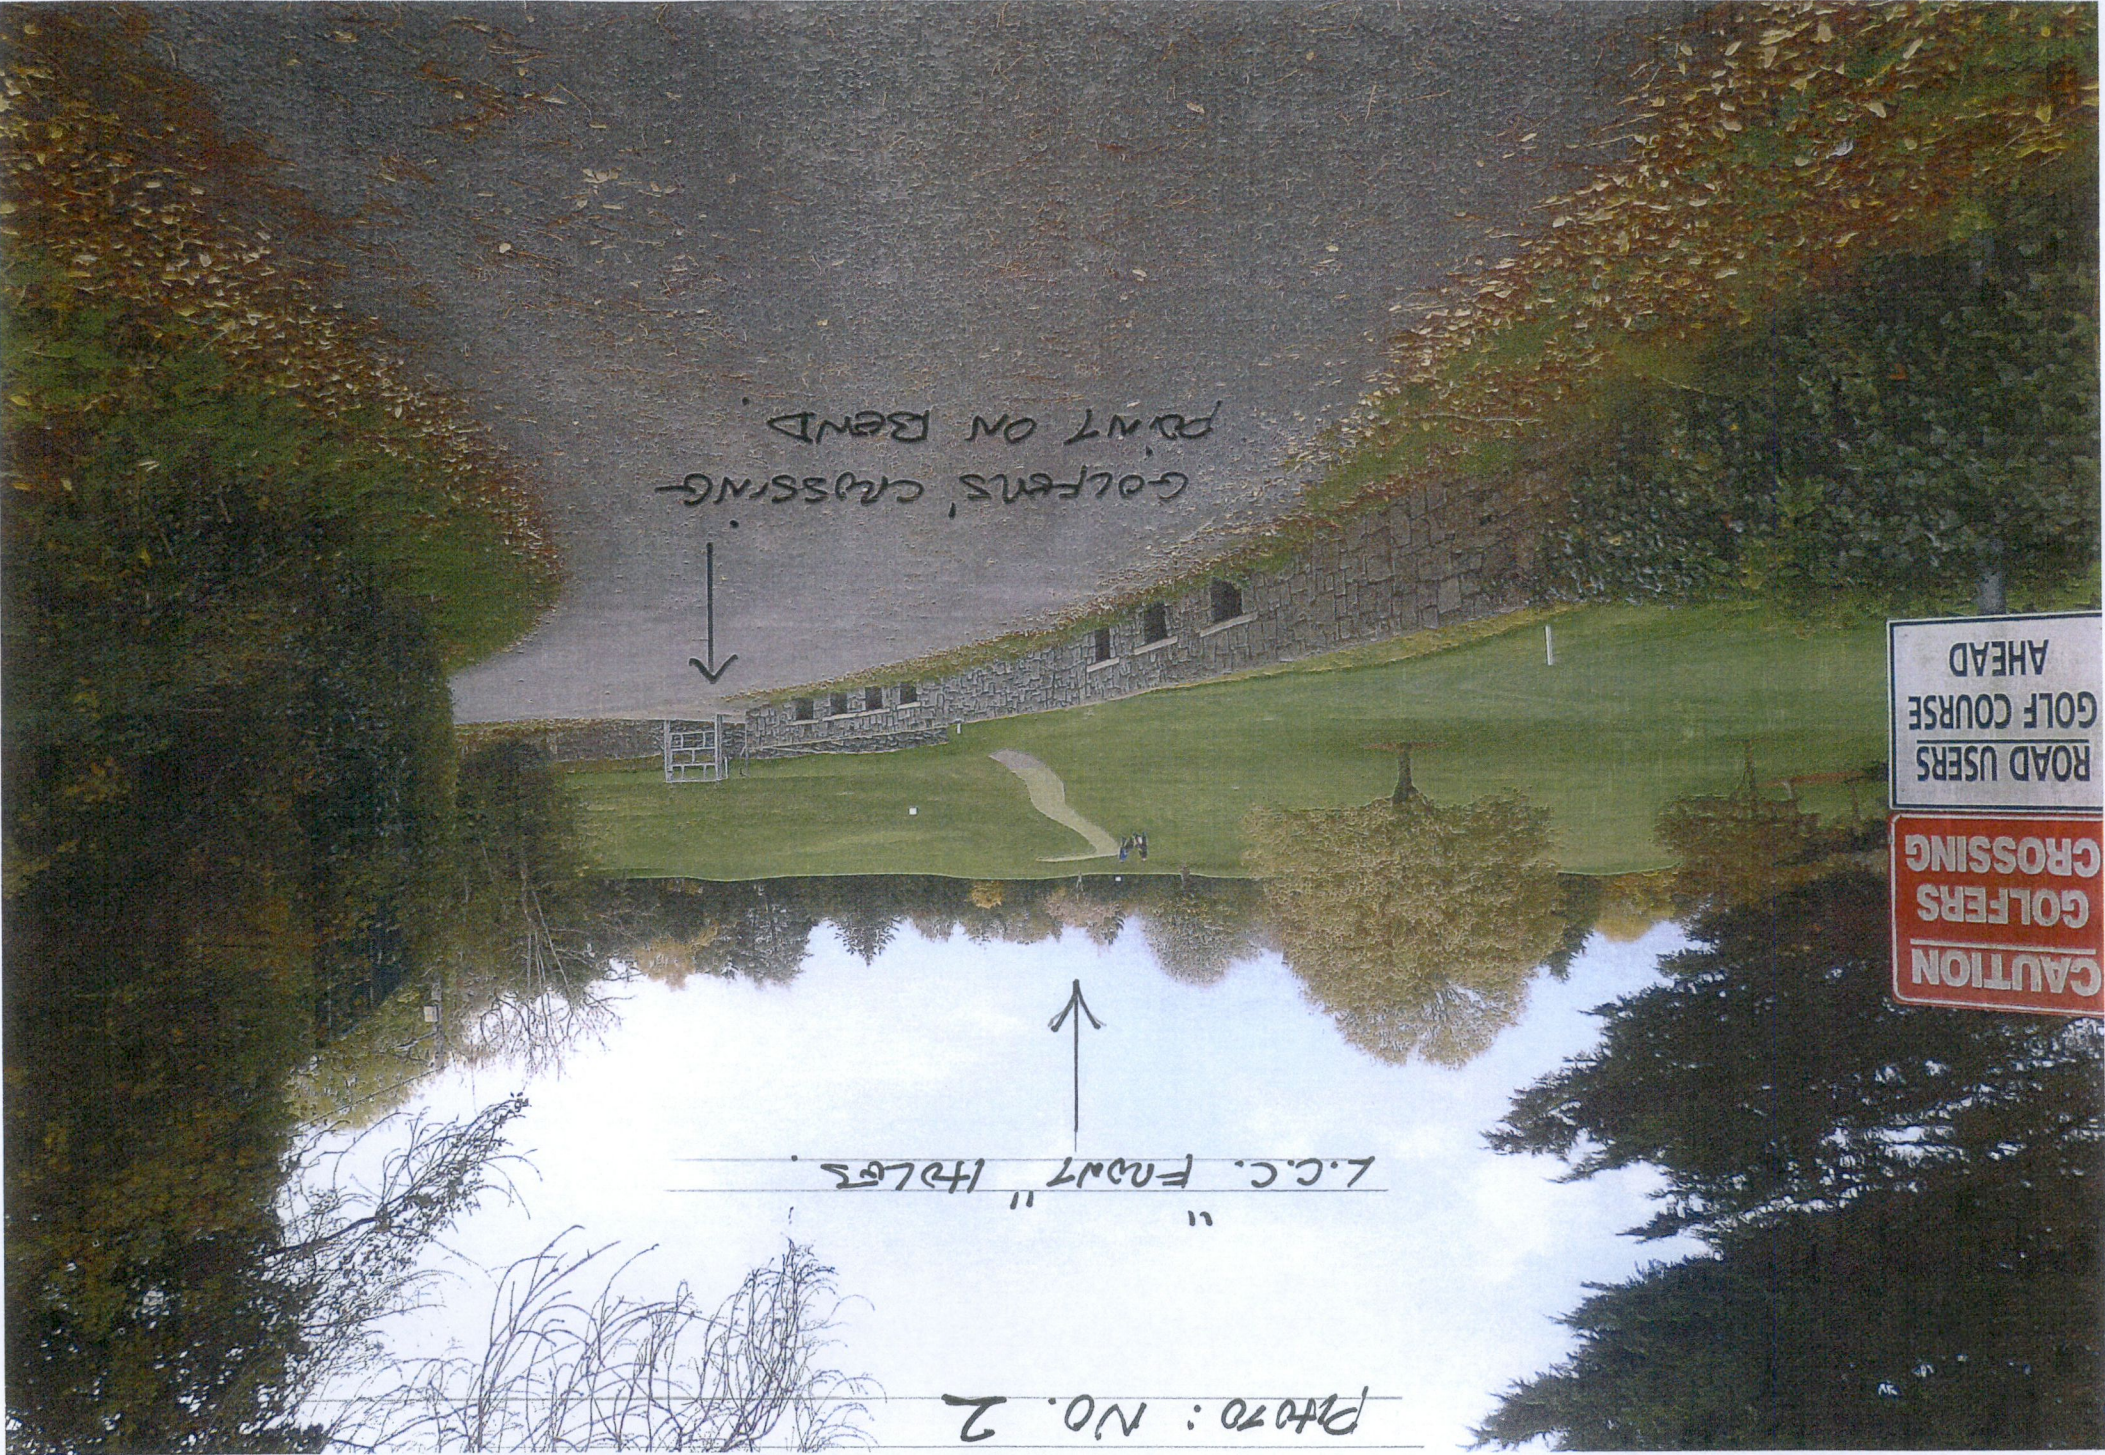
PHOTO: NO. 2

GOLFERS CROSSING
POINT ON BEND

ROAD USERS
GOLF COURSE
AHEAD

CAUTION
GOLFERS
CROSSING

L.C.C. FRONT HOLE

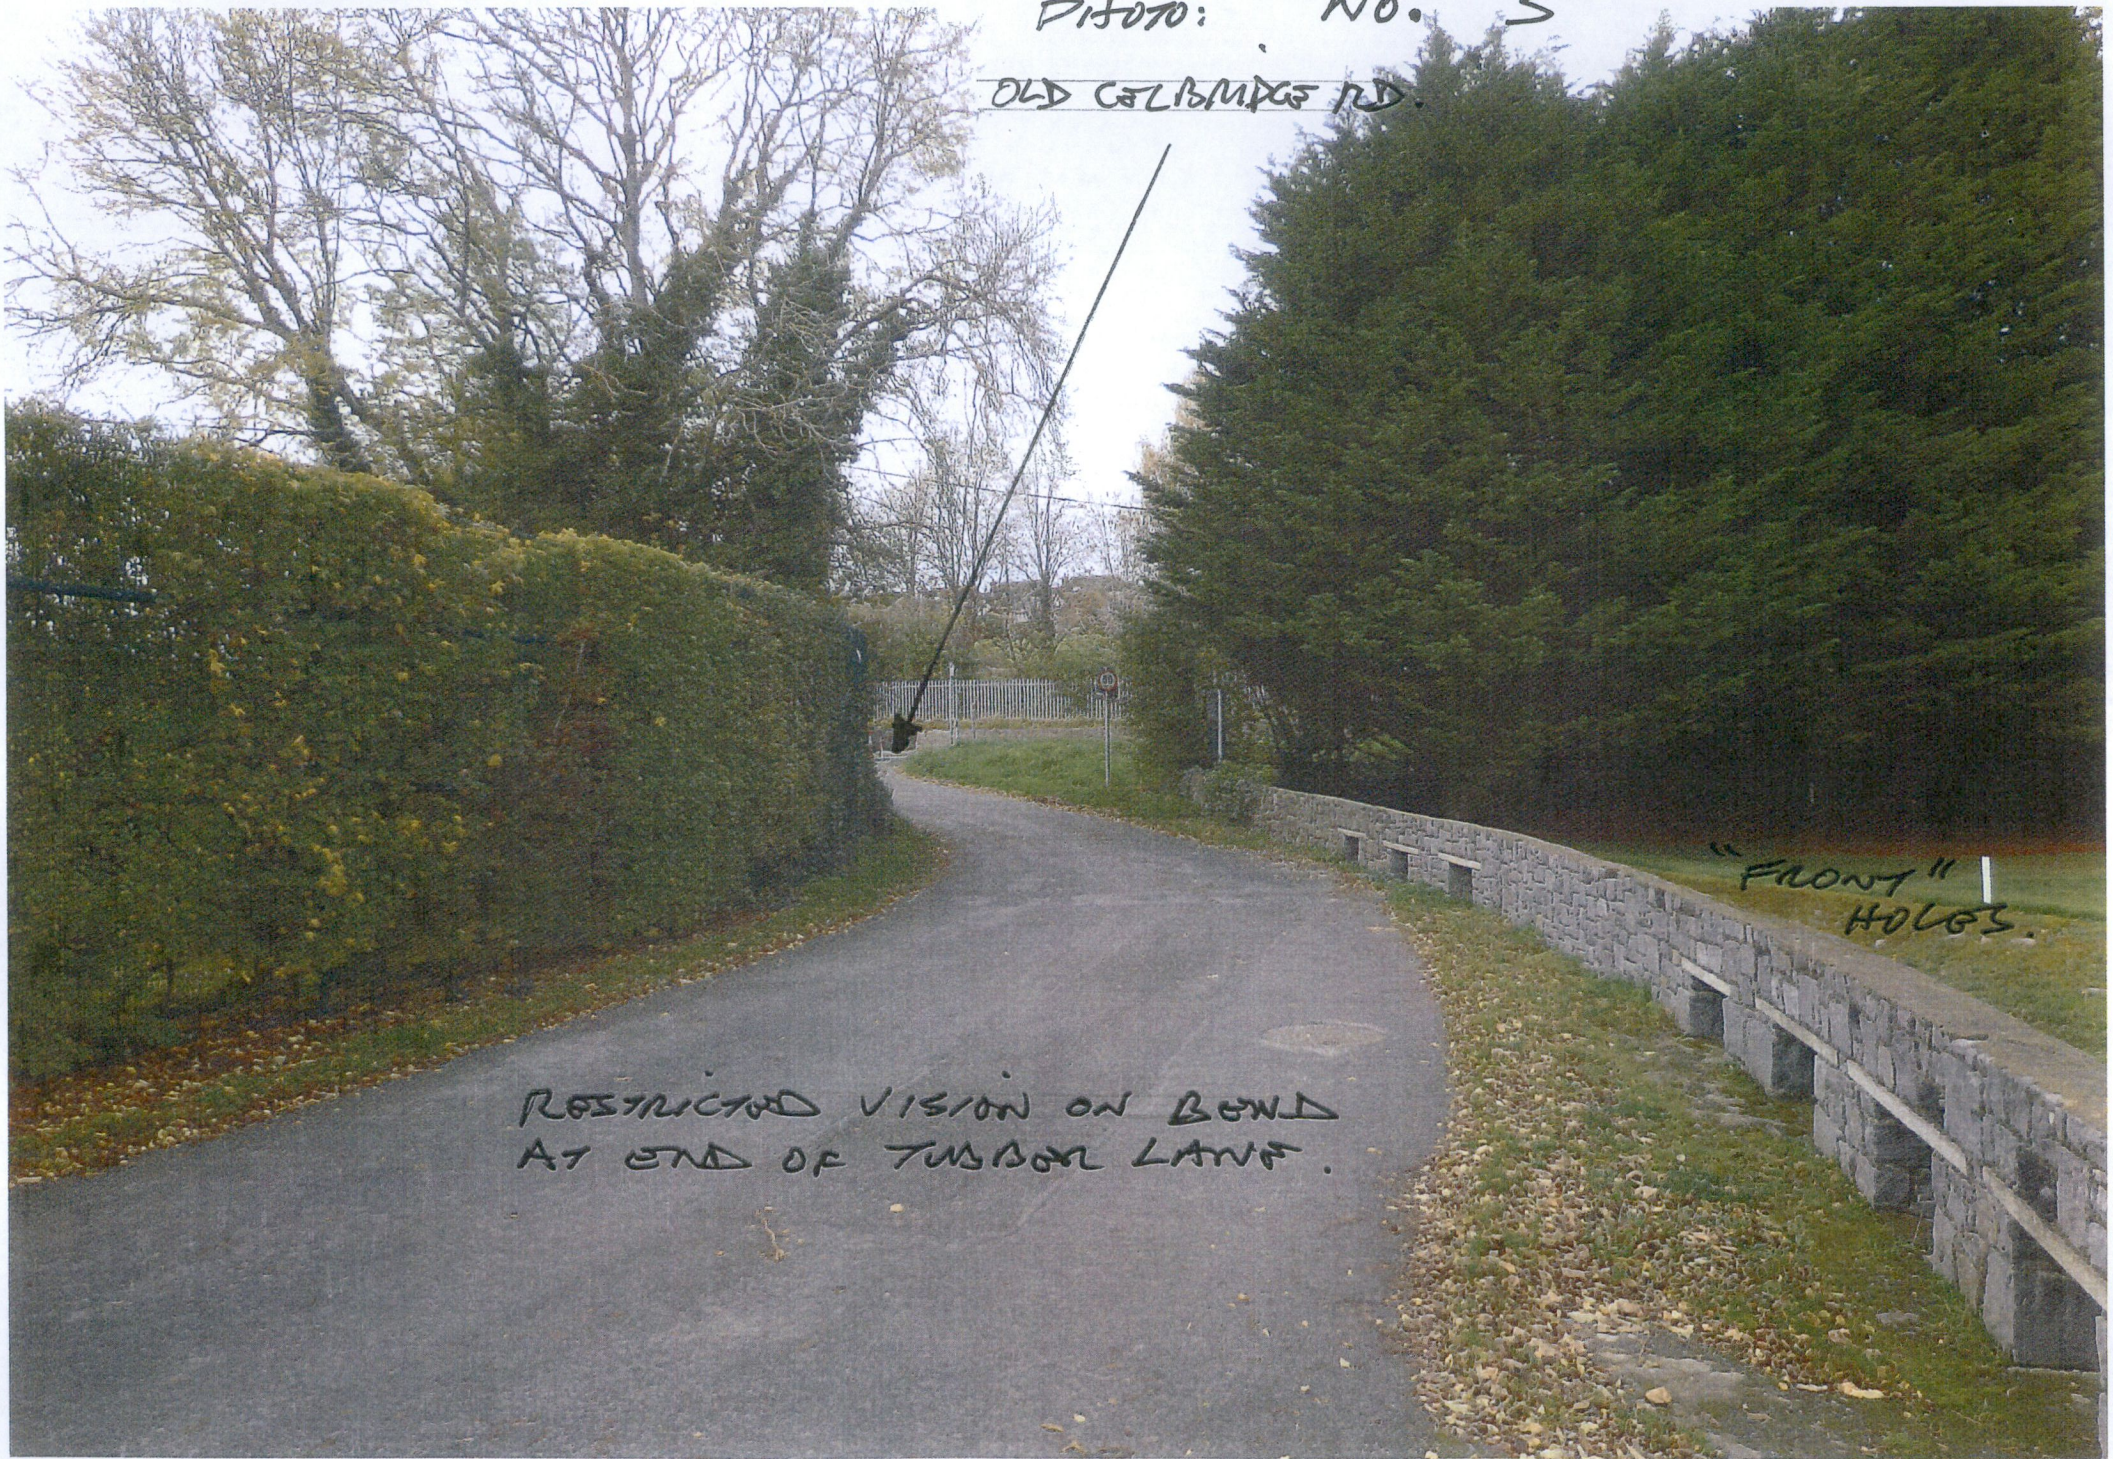
PHOTO: NO. 3

OLD CALBRIDGE RD.

RESTRICTED VISION ON BEND
AT END OF TUSKILL LANE.

"FRONT"
HOLDS.

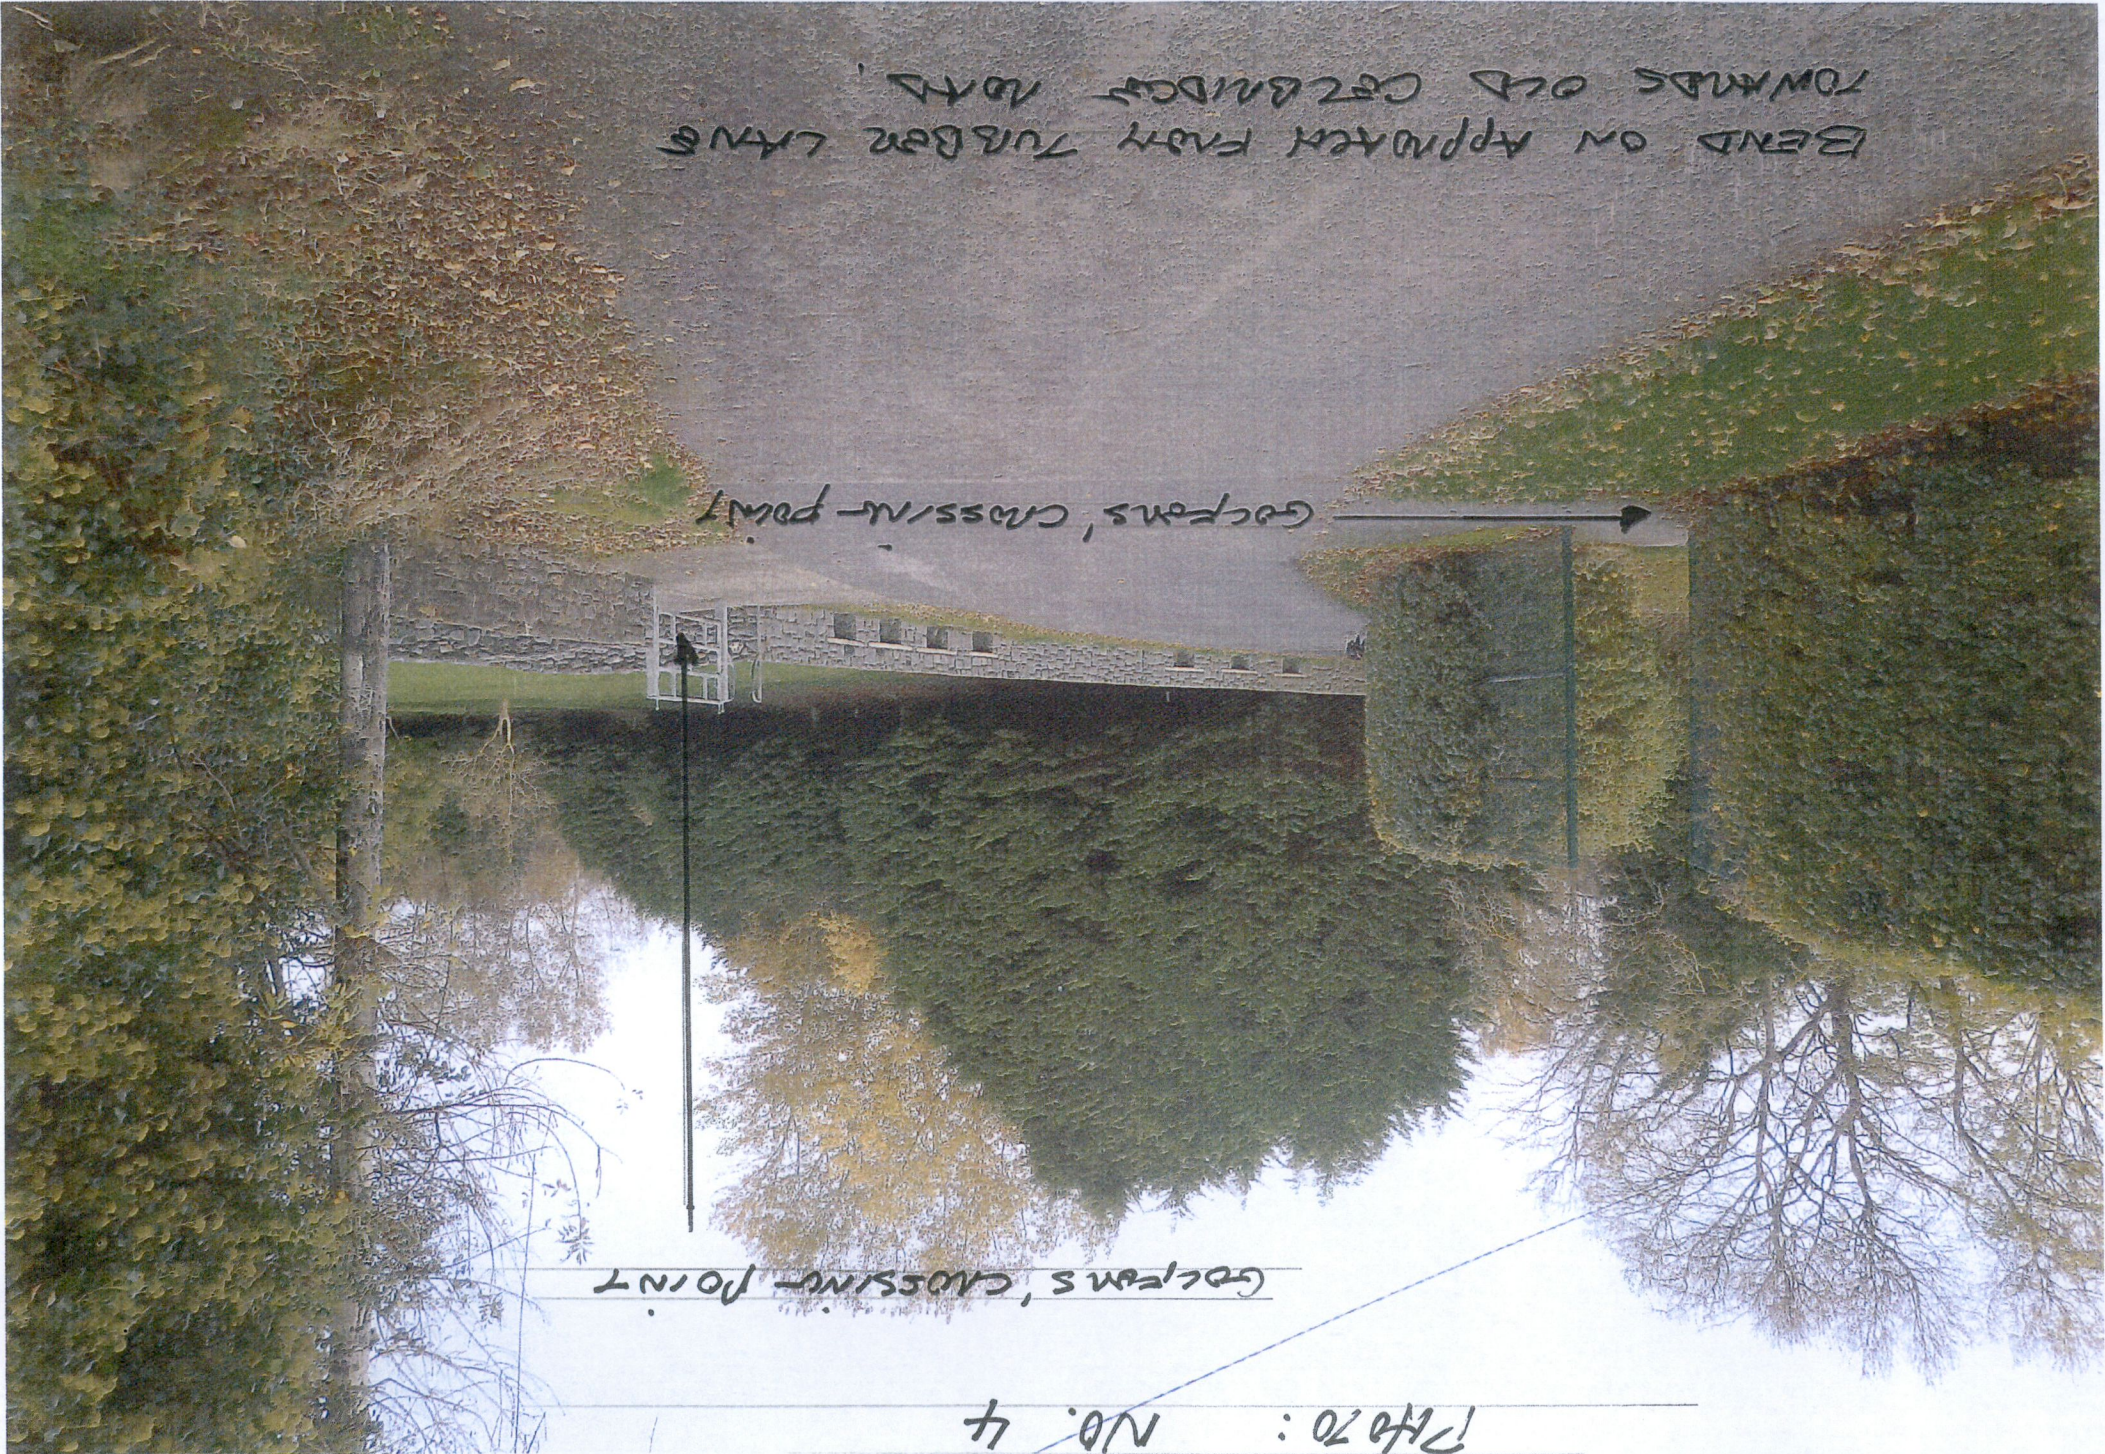
PHOTO: NO. 4

BEND ON APPROXIMATELY NORTH TURNER LANE
TOWARDS OLD GET BRIDGE ROAD

GOLEMAN'S CROSSING-POINT

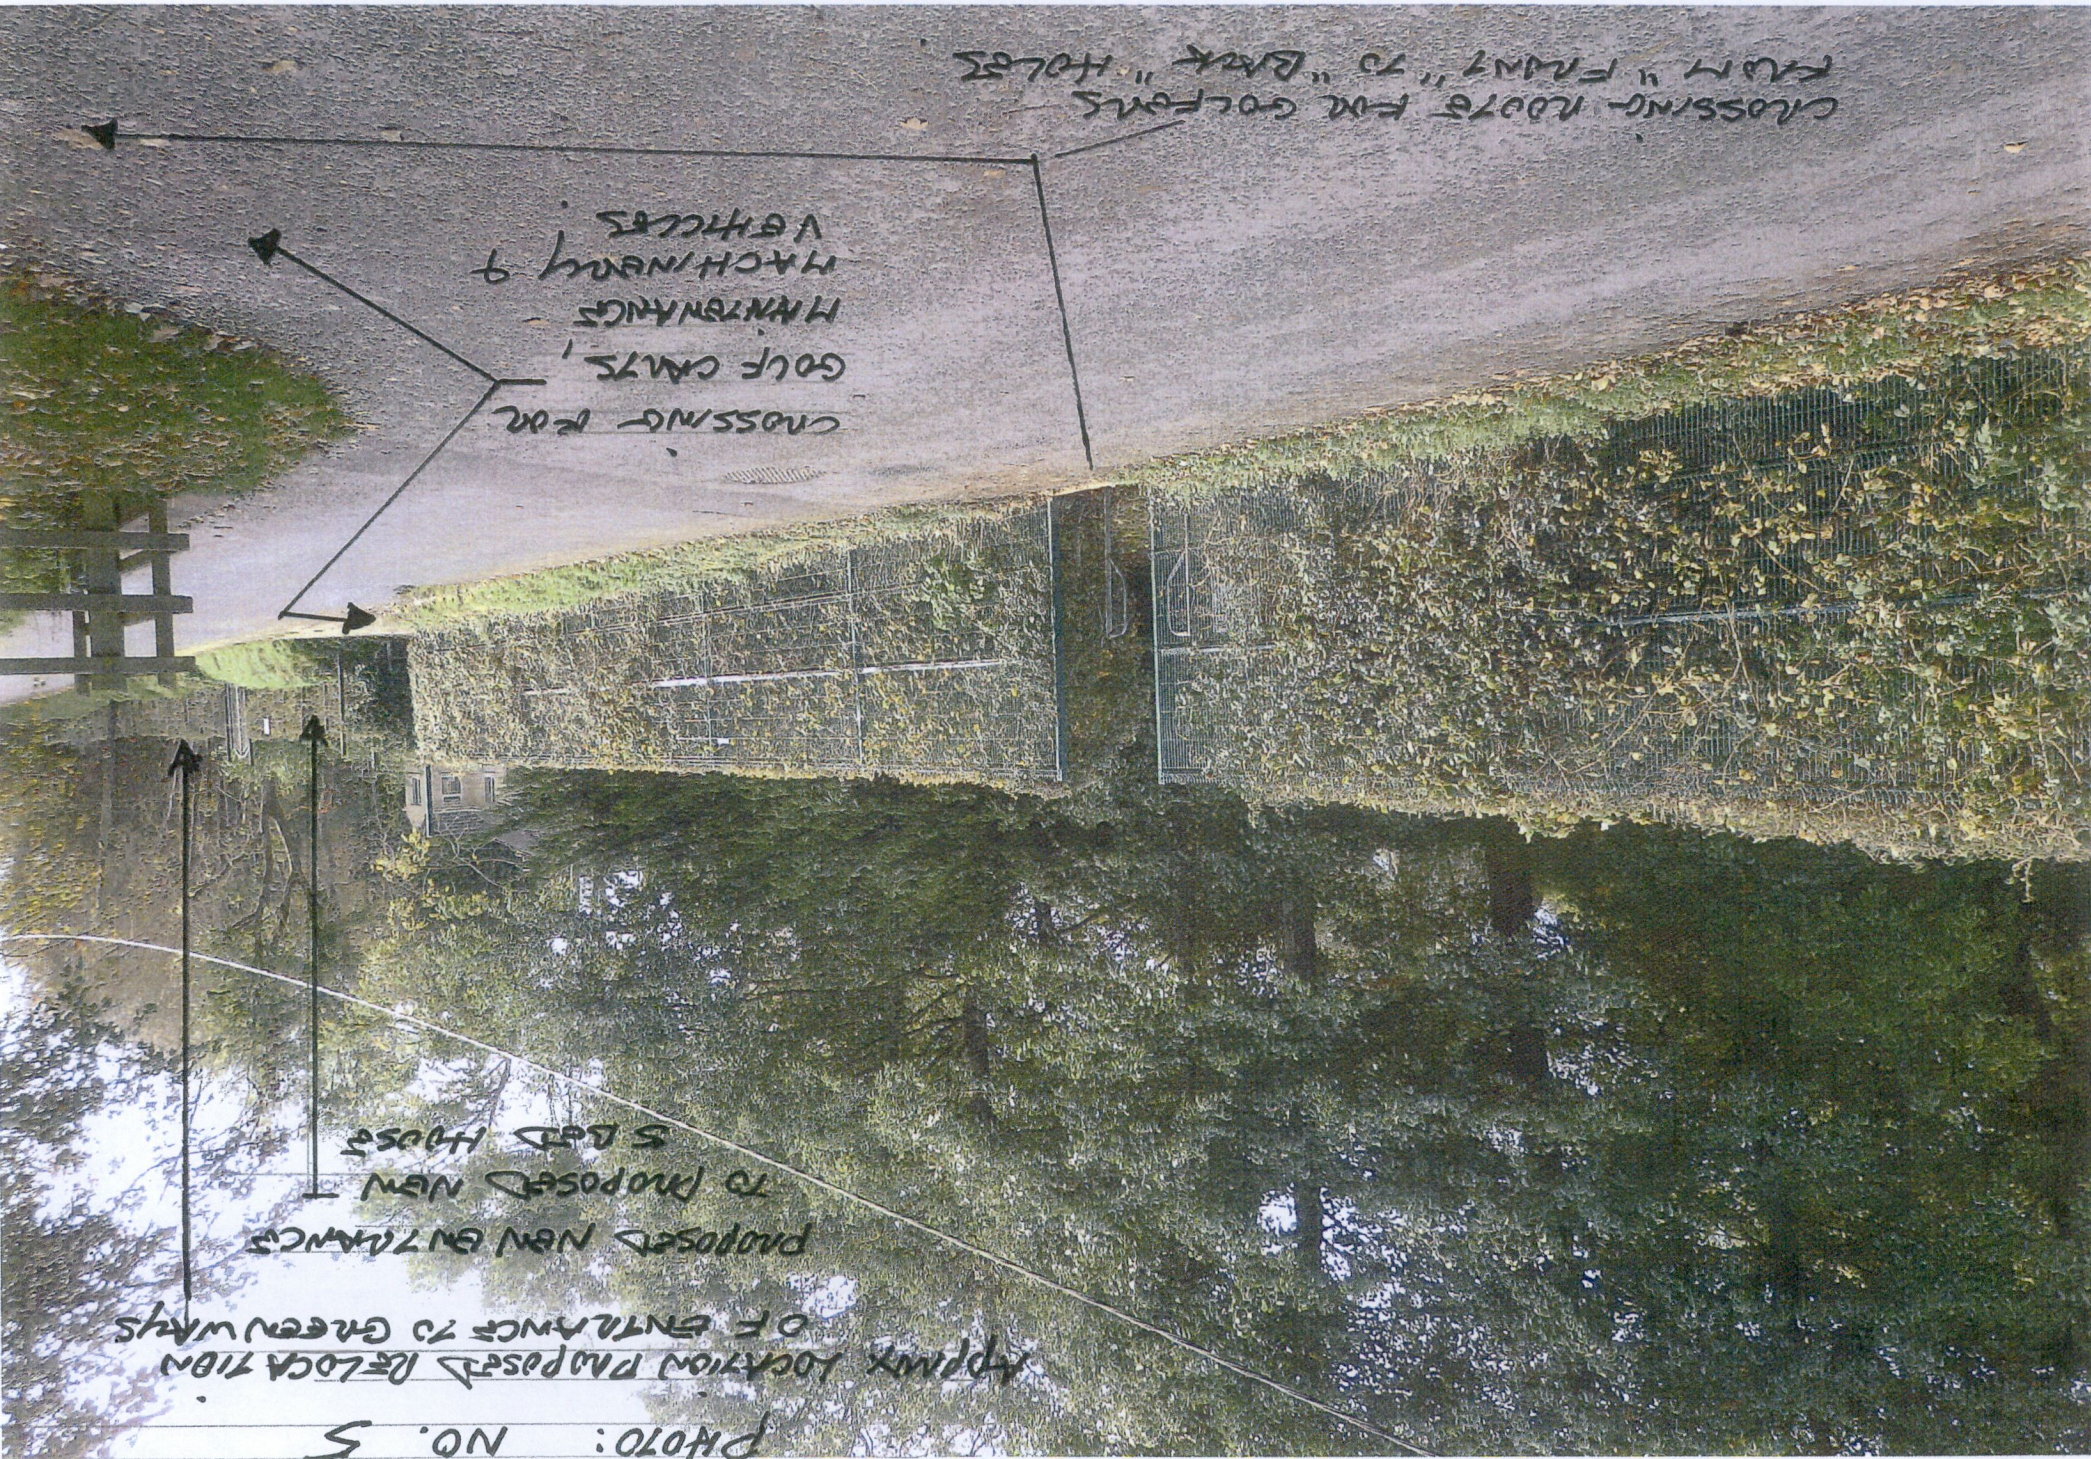
PHOTO: NO. 5

APPROX LOCATION PROPOSED RELOCATION
OF ENTRANCE TO GREENWAYS

PROPOSED NEW ENTRANCE

CROSSING FOR
GOLF CARTS,
MAINTENANCE
VEHICLES

CROSSING ROUTE FOR GOLFERS
FROM "FRONT" TO "BACK" HOUSE

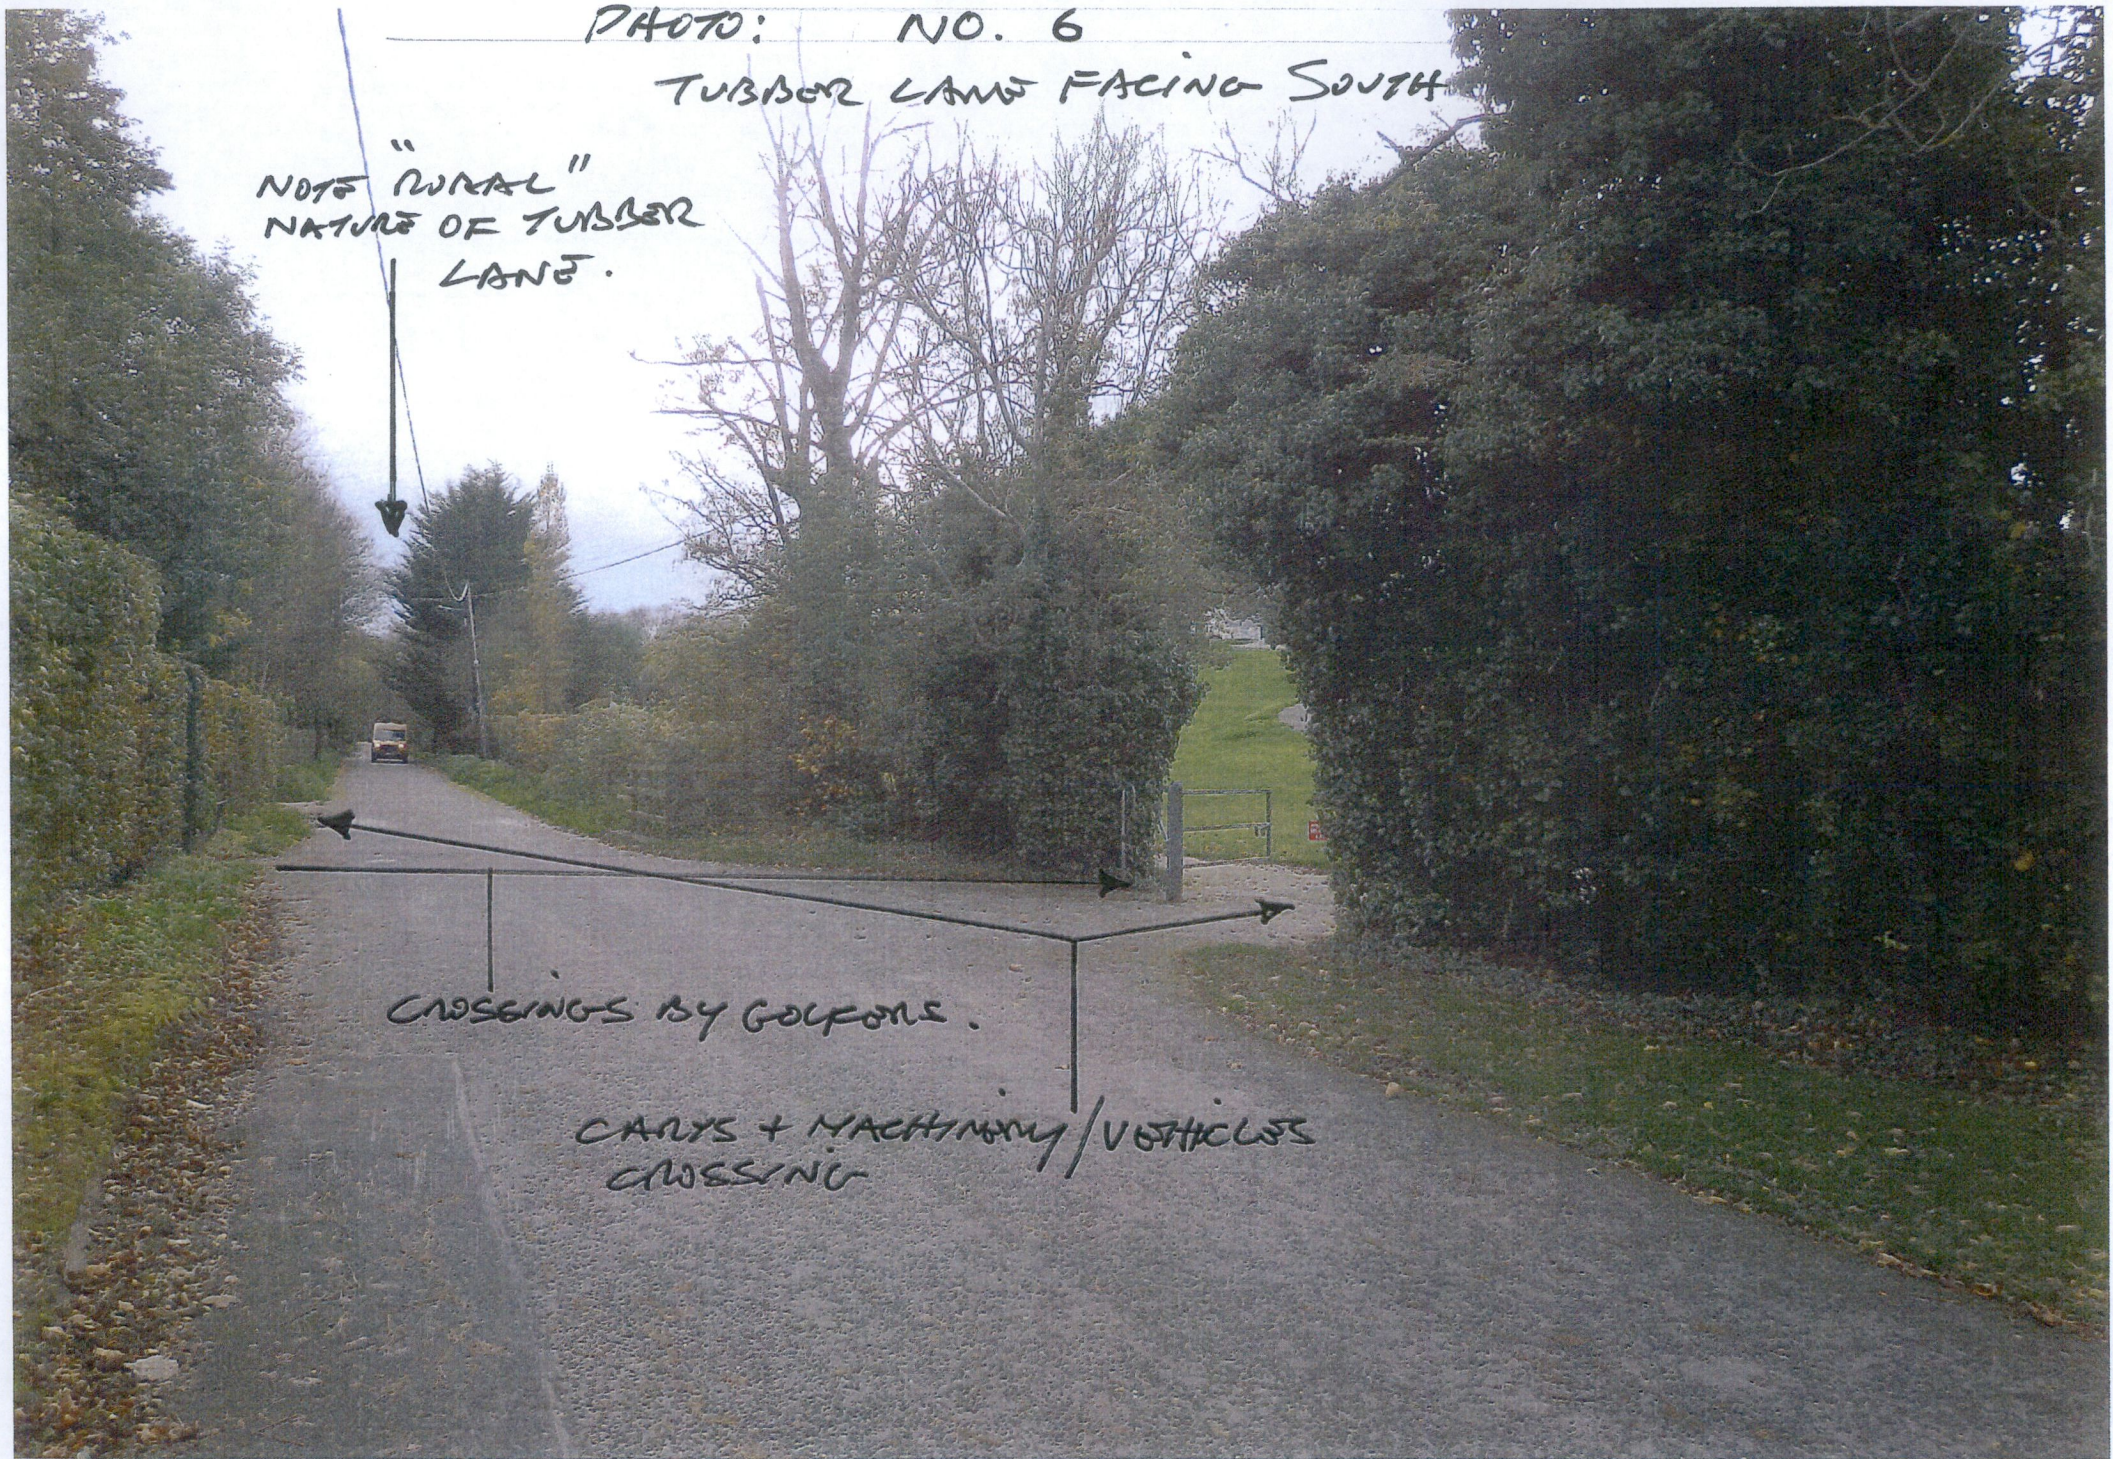
PHOTO: NO. 6

TUBBER LANE FACING SOUTH

NOTE "RURAL"
NATURE OF TUBBER
LANE.

CROSSINGS BY GOLFERS.

CARS + MACHINERY / VEHICLES
CROSSING

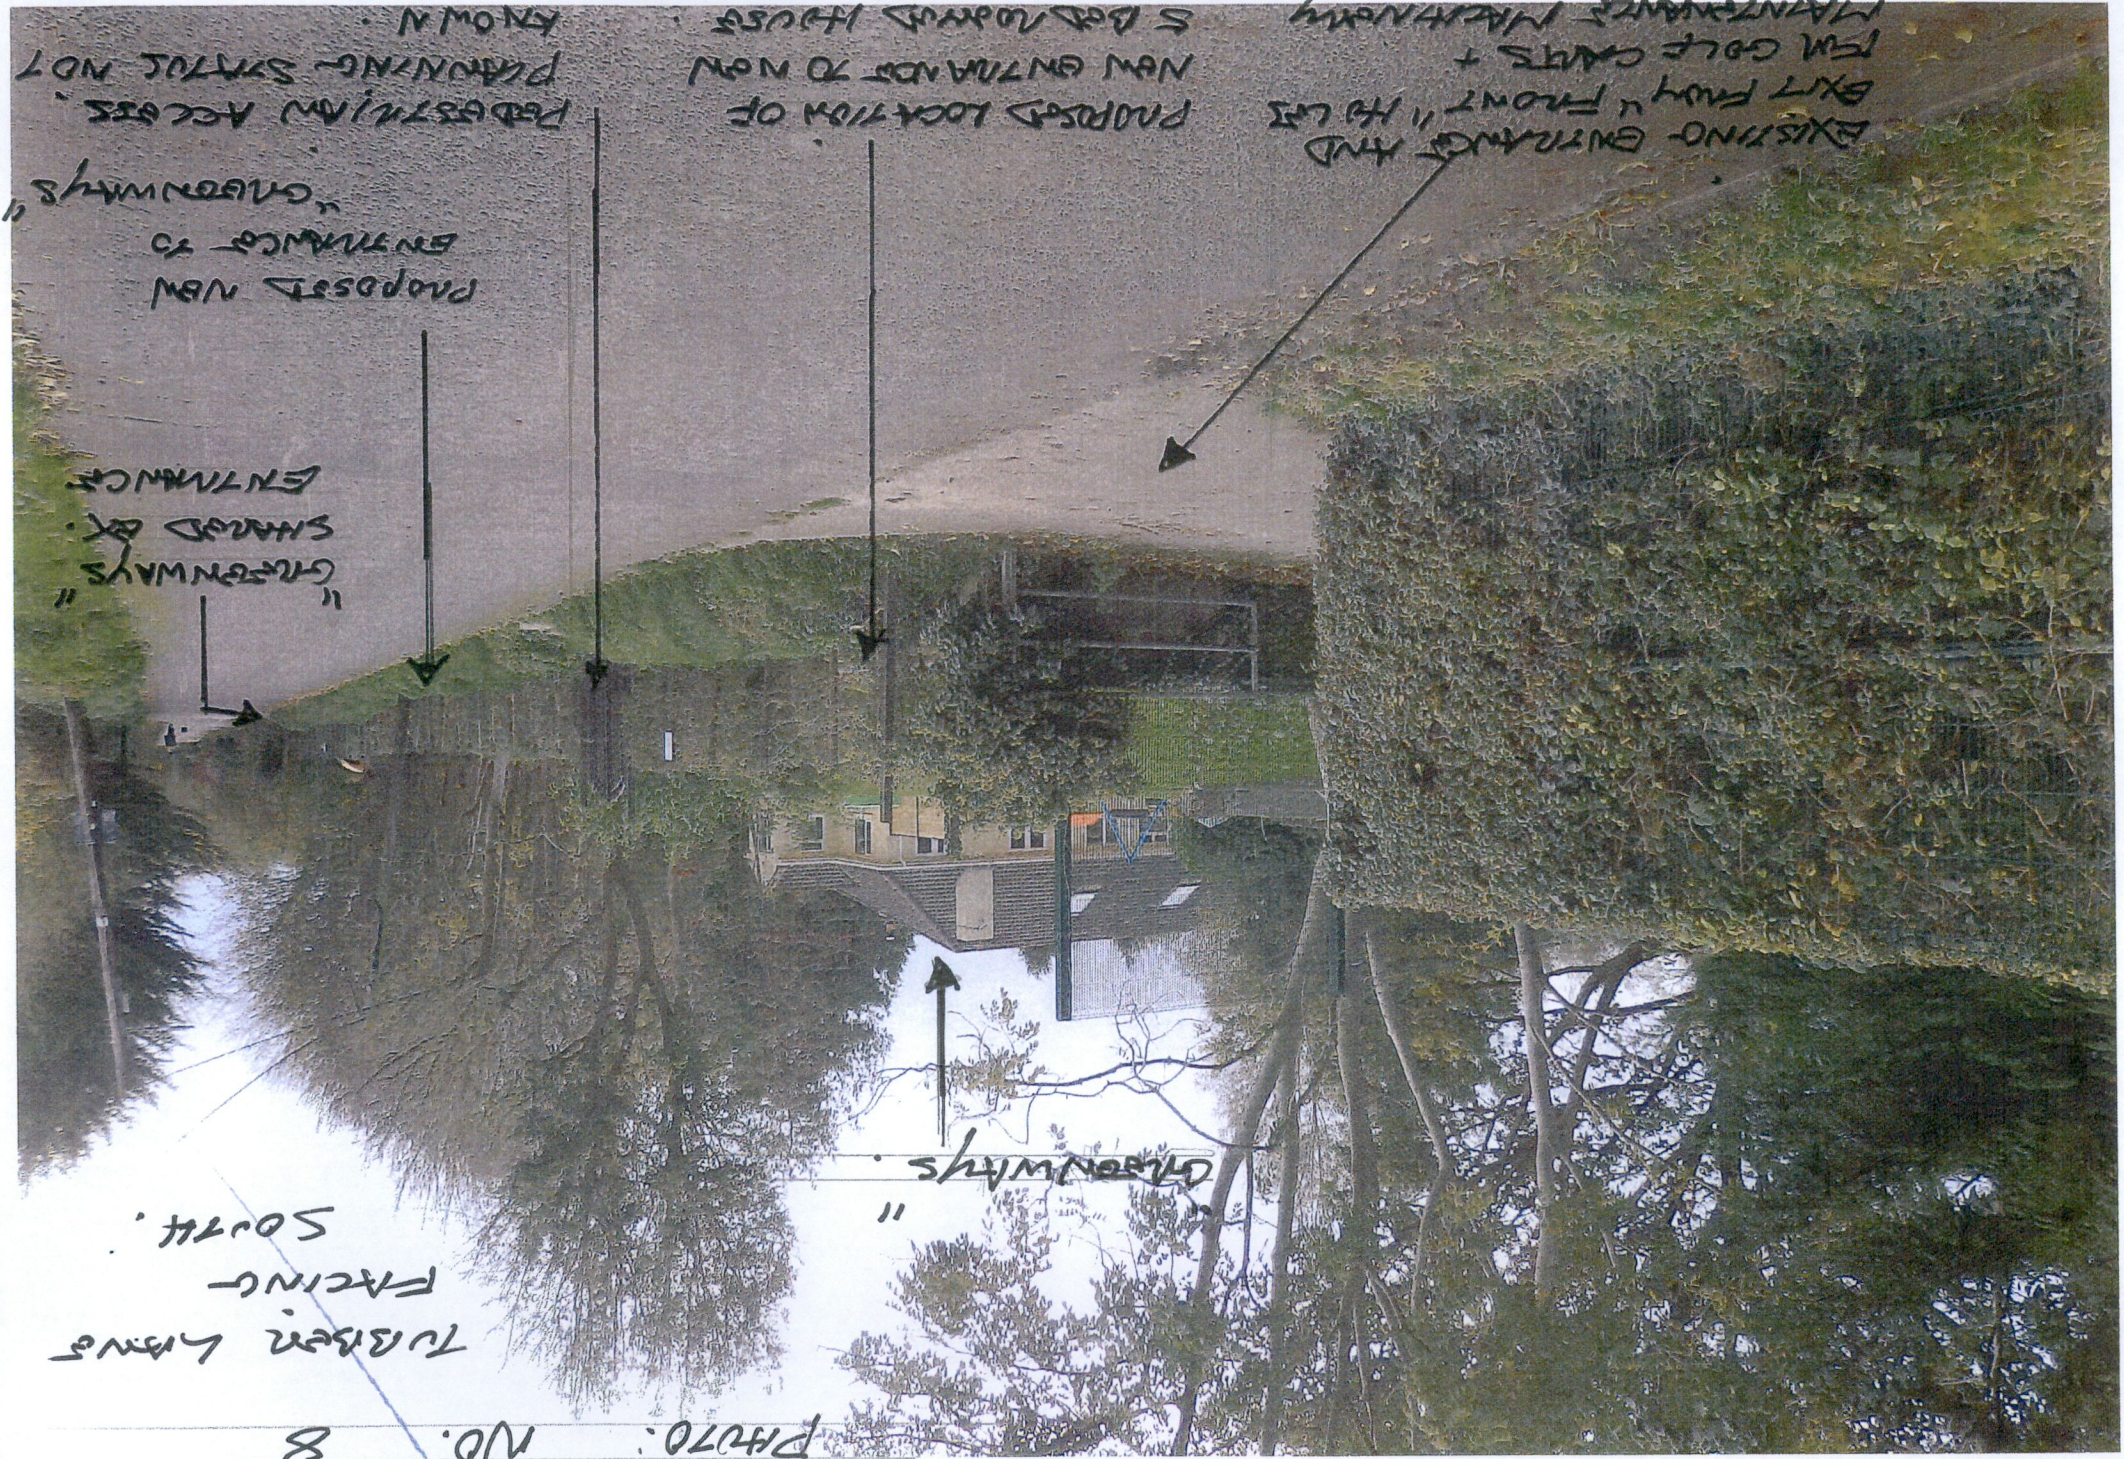
PHOTO: NO. 7

TURBID LAND FACING
SOUTH.

PROPOSED NEW ENTRANCE
TO NEW 5 BED. HOUSE

CROSSING ROUTE FOR GOLF CARTS
AND MAINTENANCE VEHICLES/MACHINERY

CROSSING POINT FOR GOLFERS FROM "FRONT"
TO "BACK HOLES"
