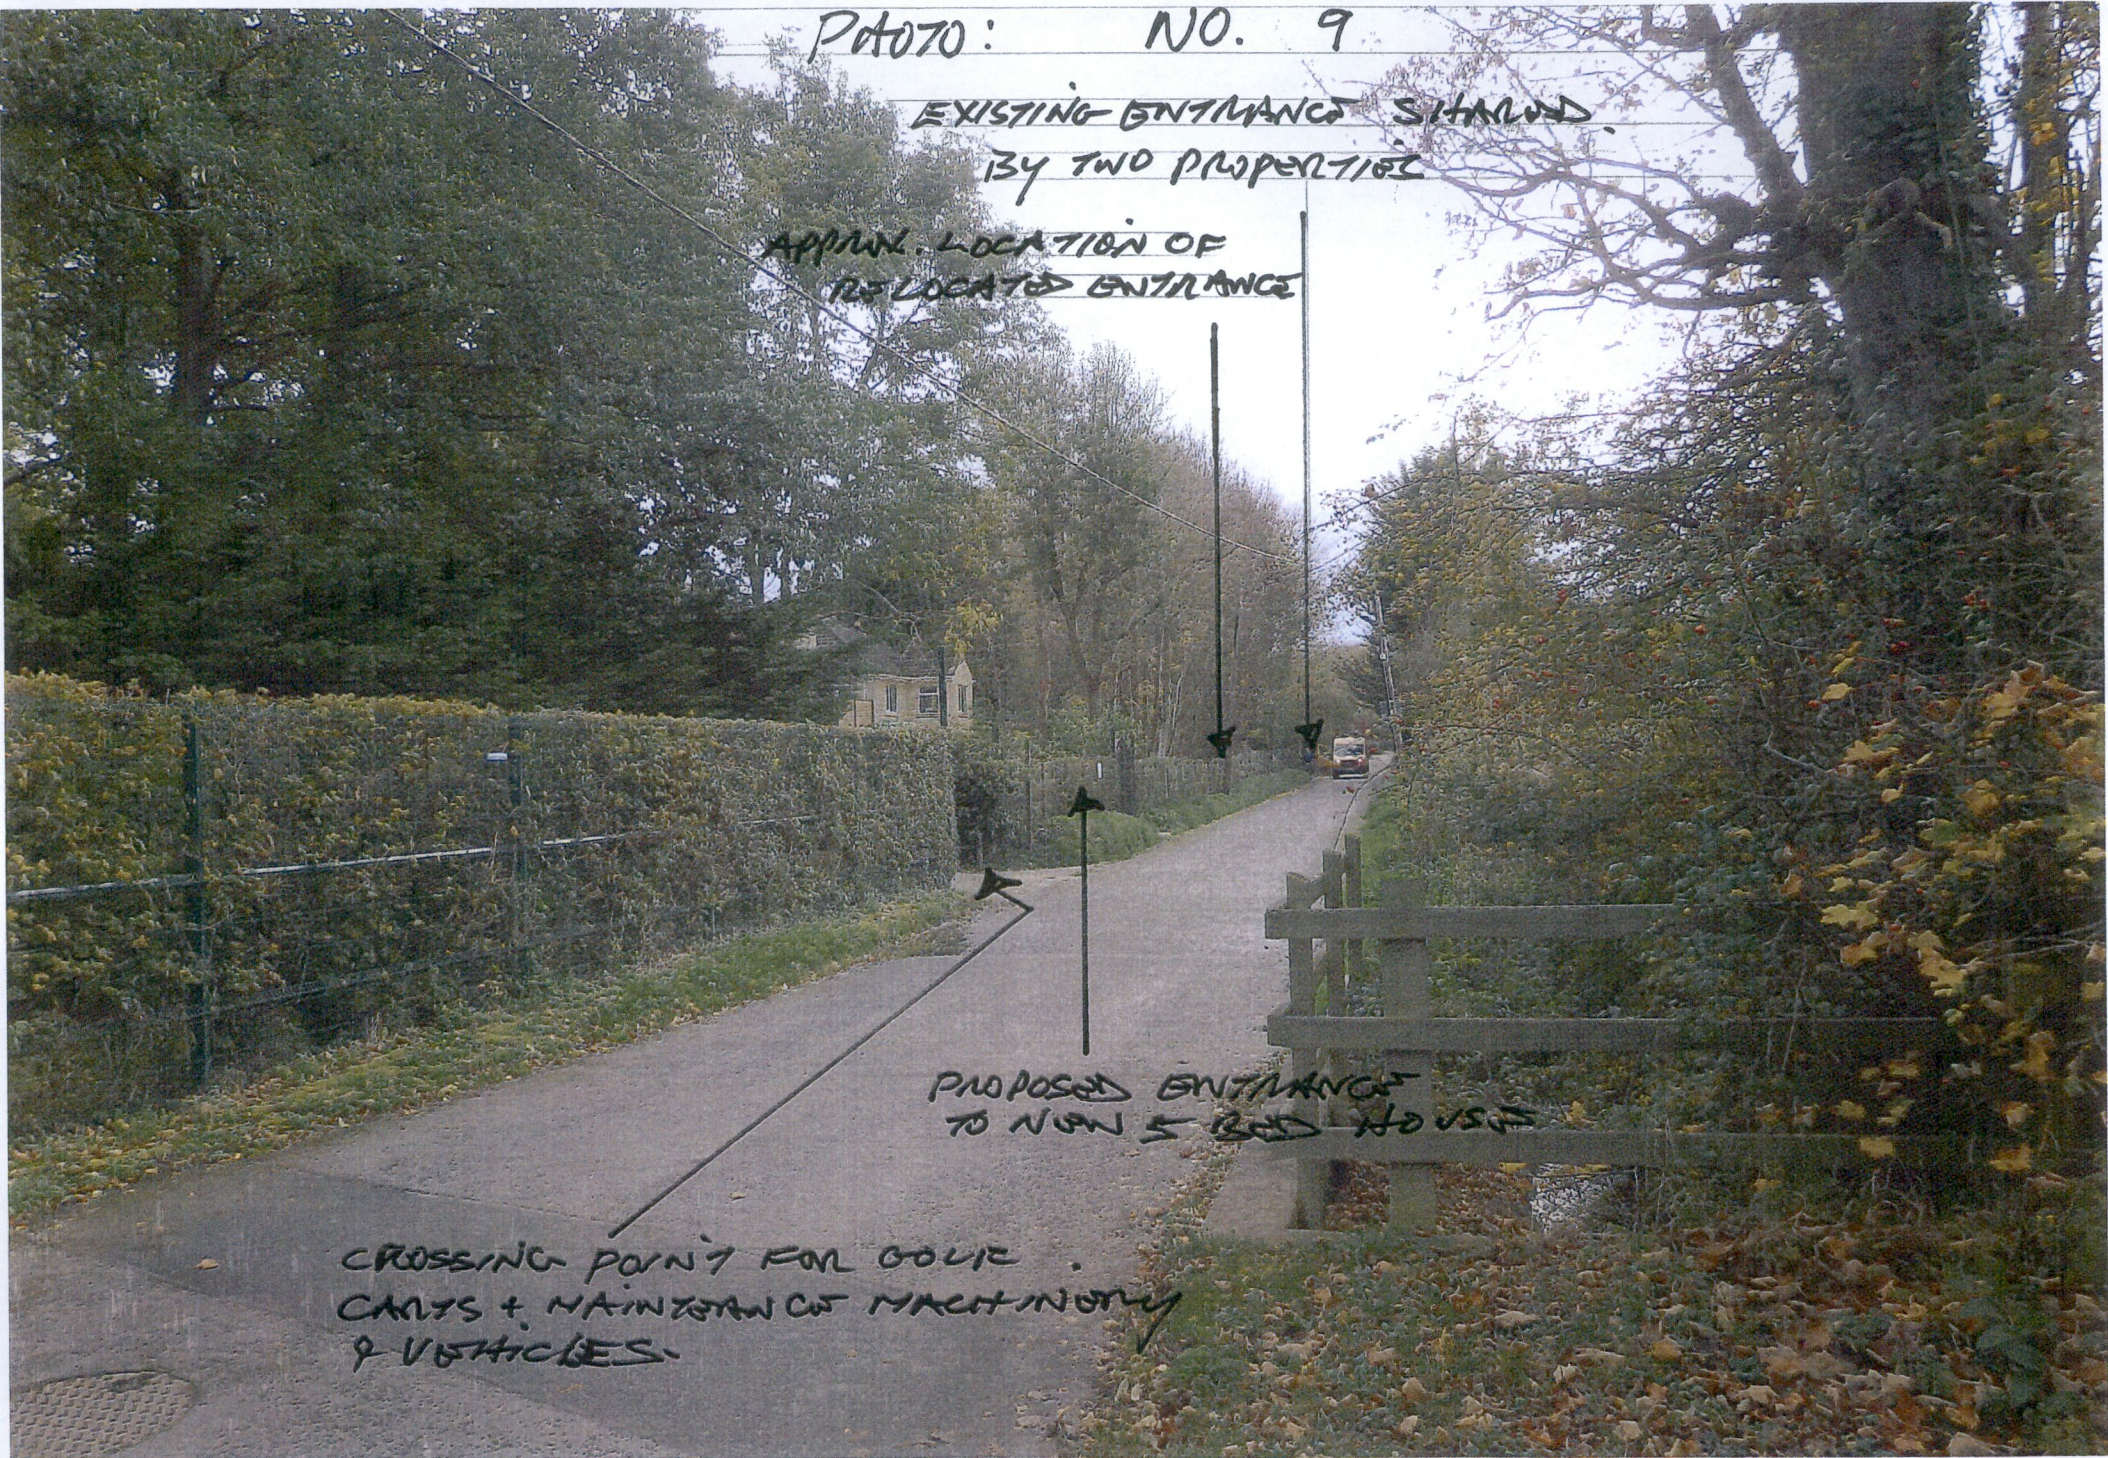
PHOTO: NO. 8

TUBER LANS
FACING
SOUTH.

PROPOSED NEW
ENTRANCE TO
"GREENWAYS"
PEDESTRIAN ACCESS.
PLANNING START NOT
KNOWN.

"
GREENWAYS"
SHAD EX.
ENTRANCE

PROPOSED LOCATION OF
NEW ENTRANCE TO NEW
S BOYHOOD HOUSE

EXISTING ENTRANCE AND
EXIT FROM "FRONT" TO LEFT
FROM GOLF CARTS +
MAINTENANCE BUILDING

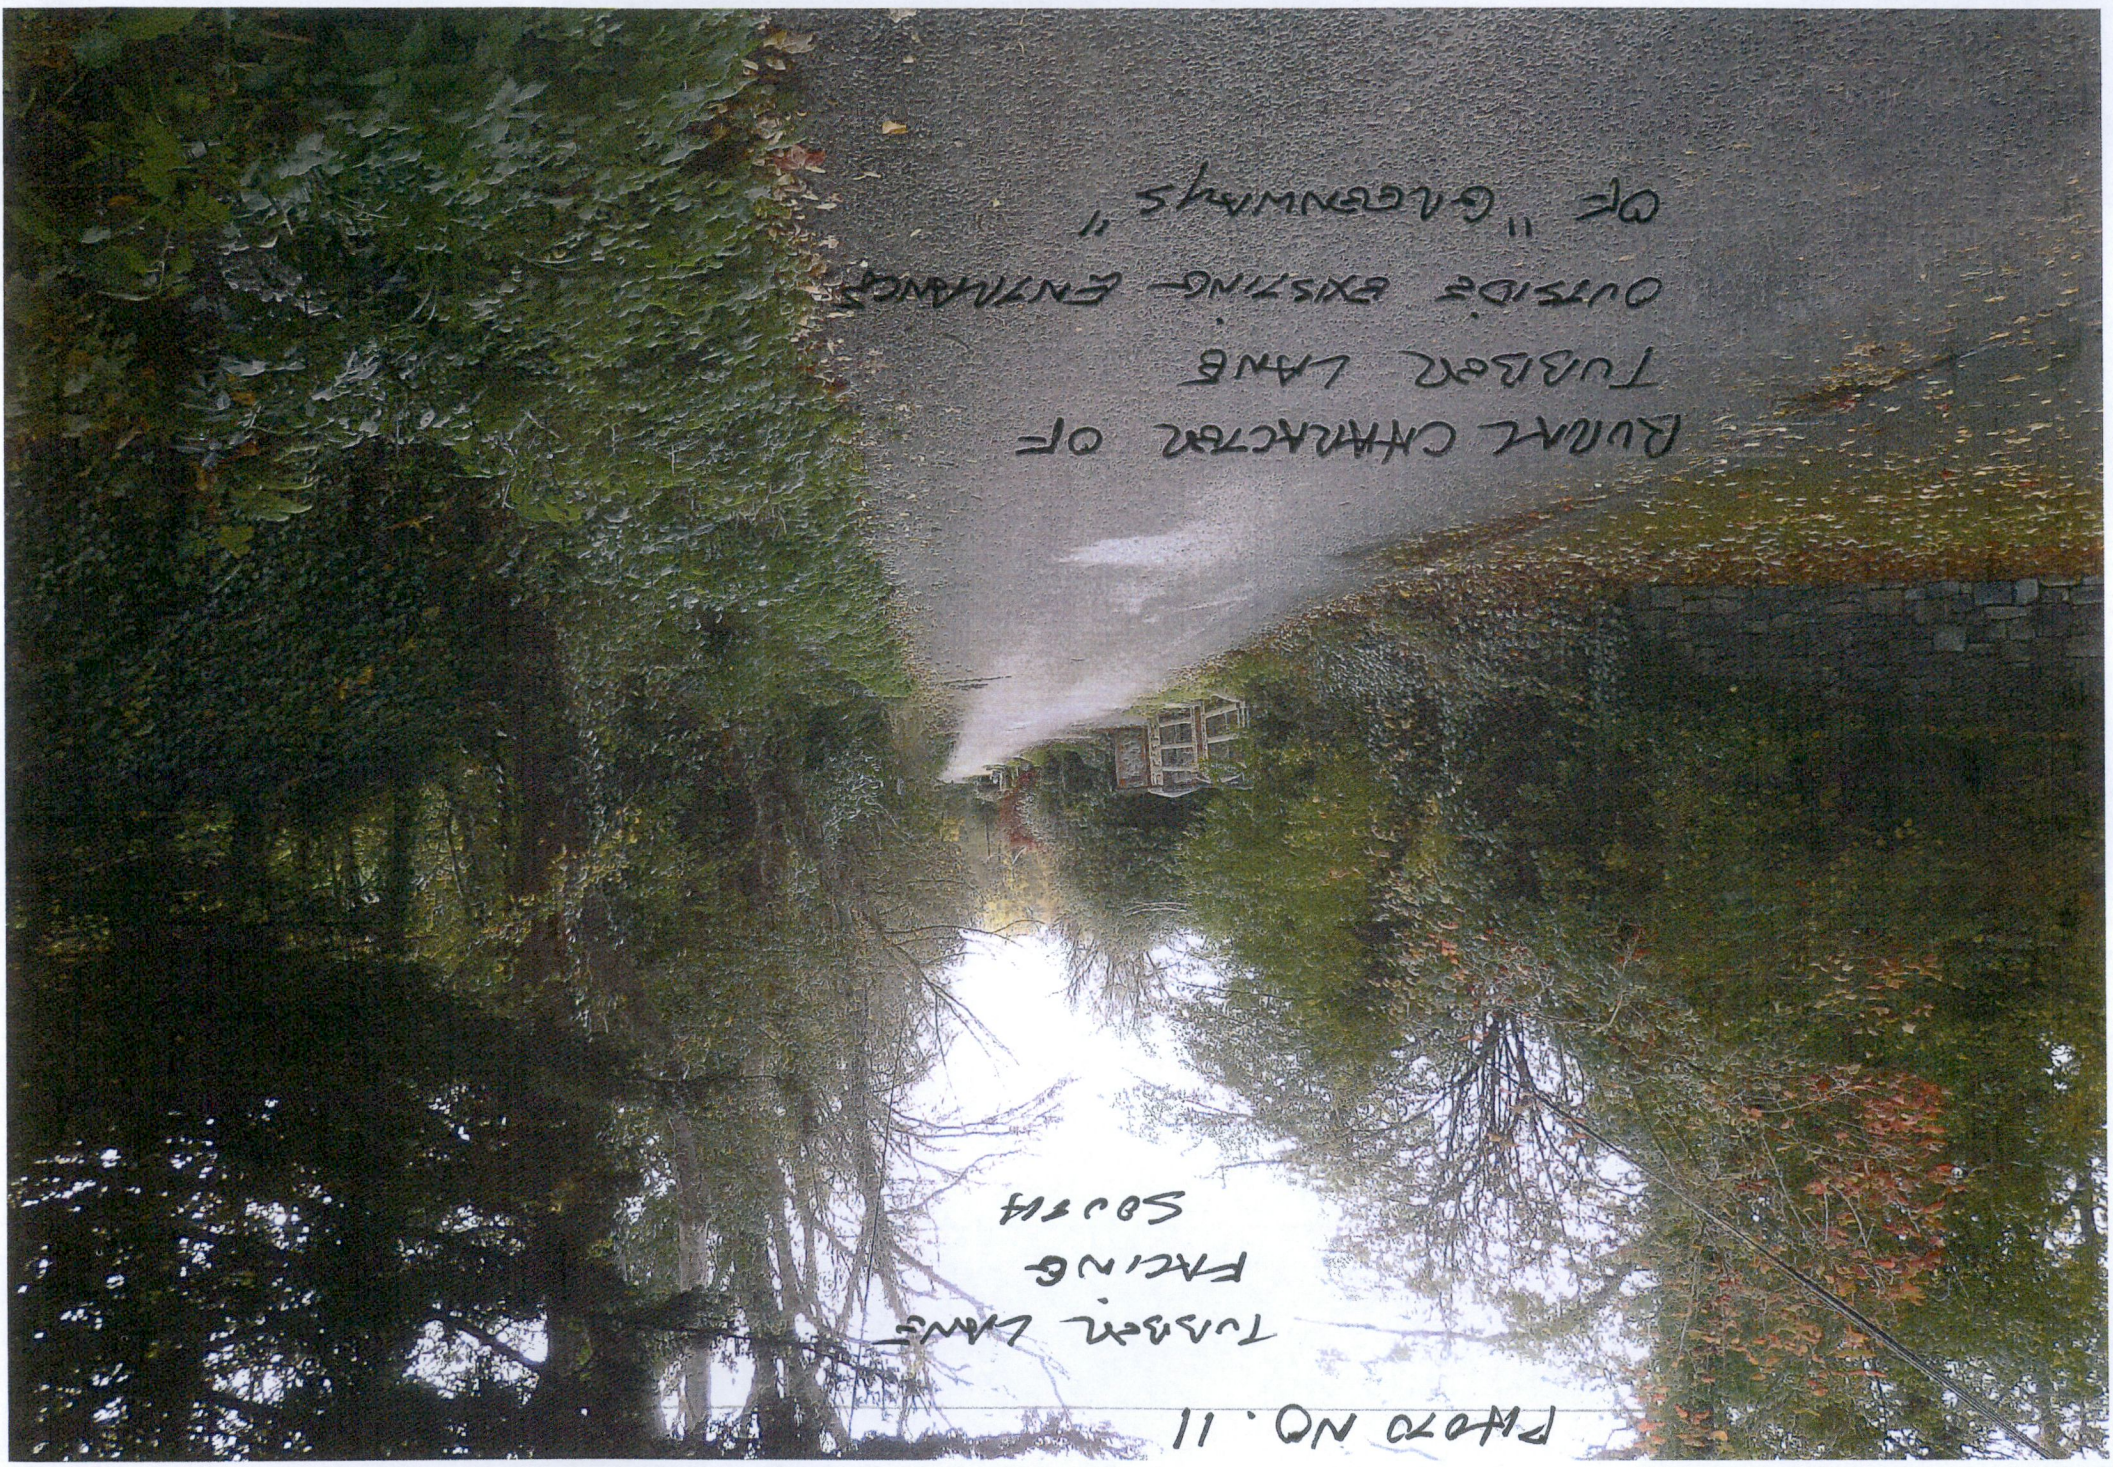
PHOTO: NO. 9

EXISTING ENTRANCE SHOWN
BY TWO PROPERTIES

APPRX. LOCATION OF
RELOCATED ENTRANCE

PROPOSED ENTRANCE
TO NEW 5 BED HOUSE

CROSSING POINT FOR GOLF
CARTS + MAINTENANCE MACHINERY
& VEHICLES.

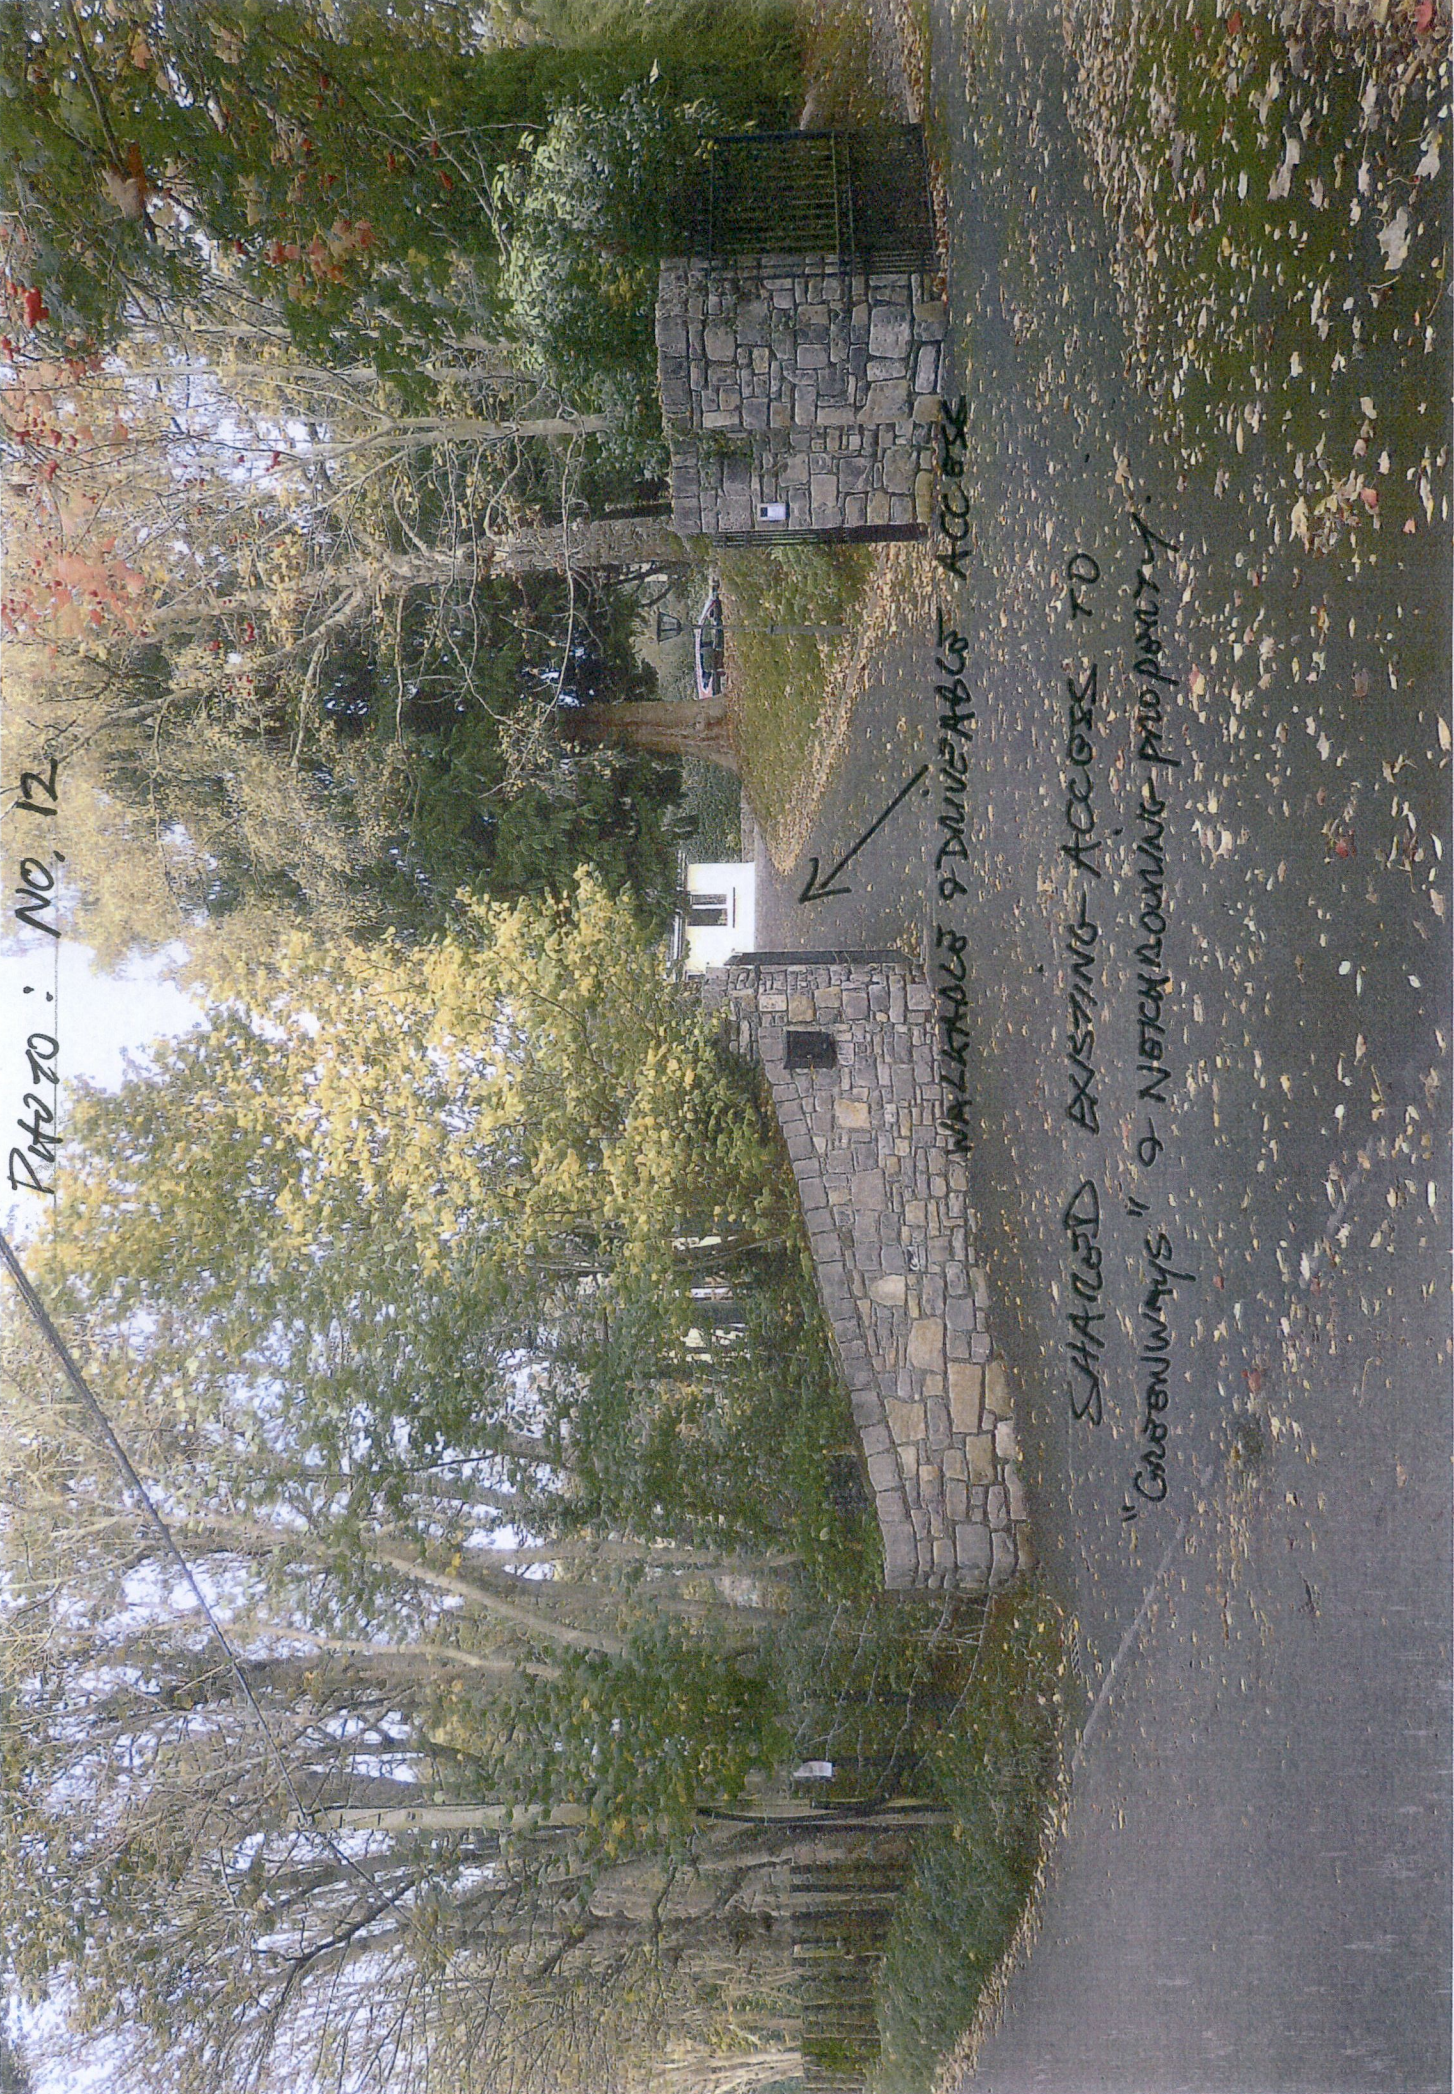
PHOTO: NO. 10

↑
CROSSING CARTS
EXITING "FRONT" HOLES
OF L.G.C.

↑
PROPOSED NEW ENTRANCE TO PROPOSED
5 BEDROOM NEW HOUSE

PLANNING STATUS OF PROPOSED ENTRANCES NOT COMPLETED

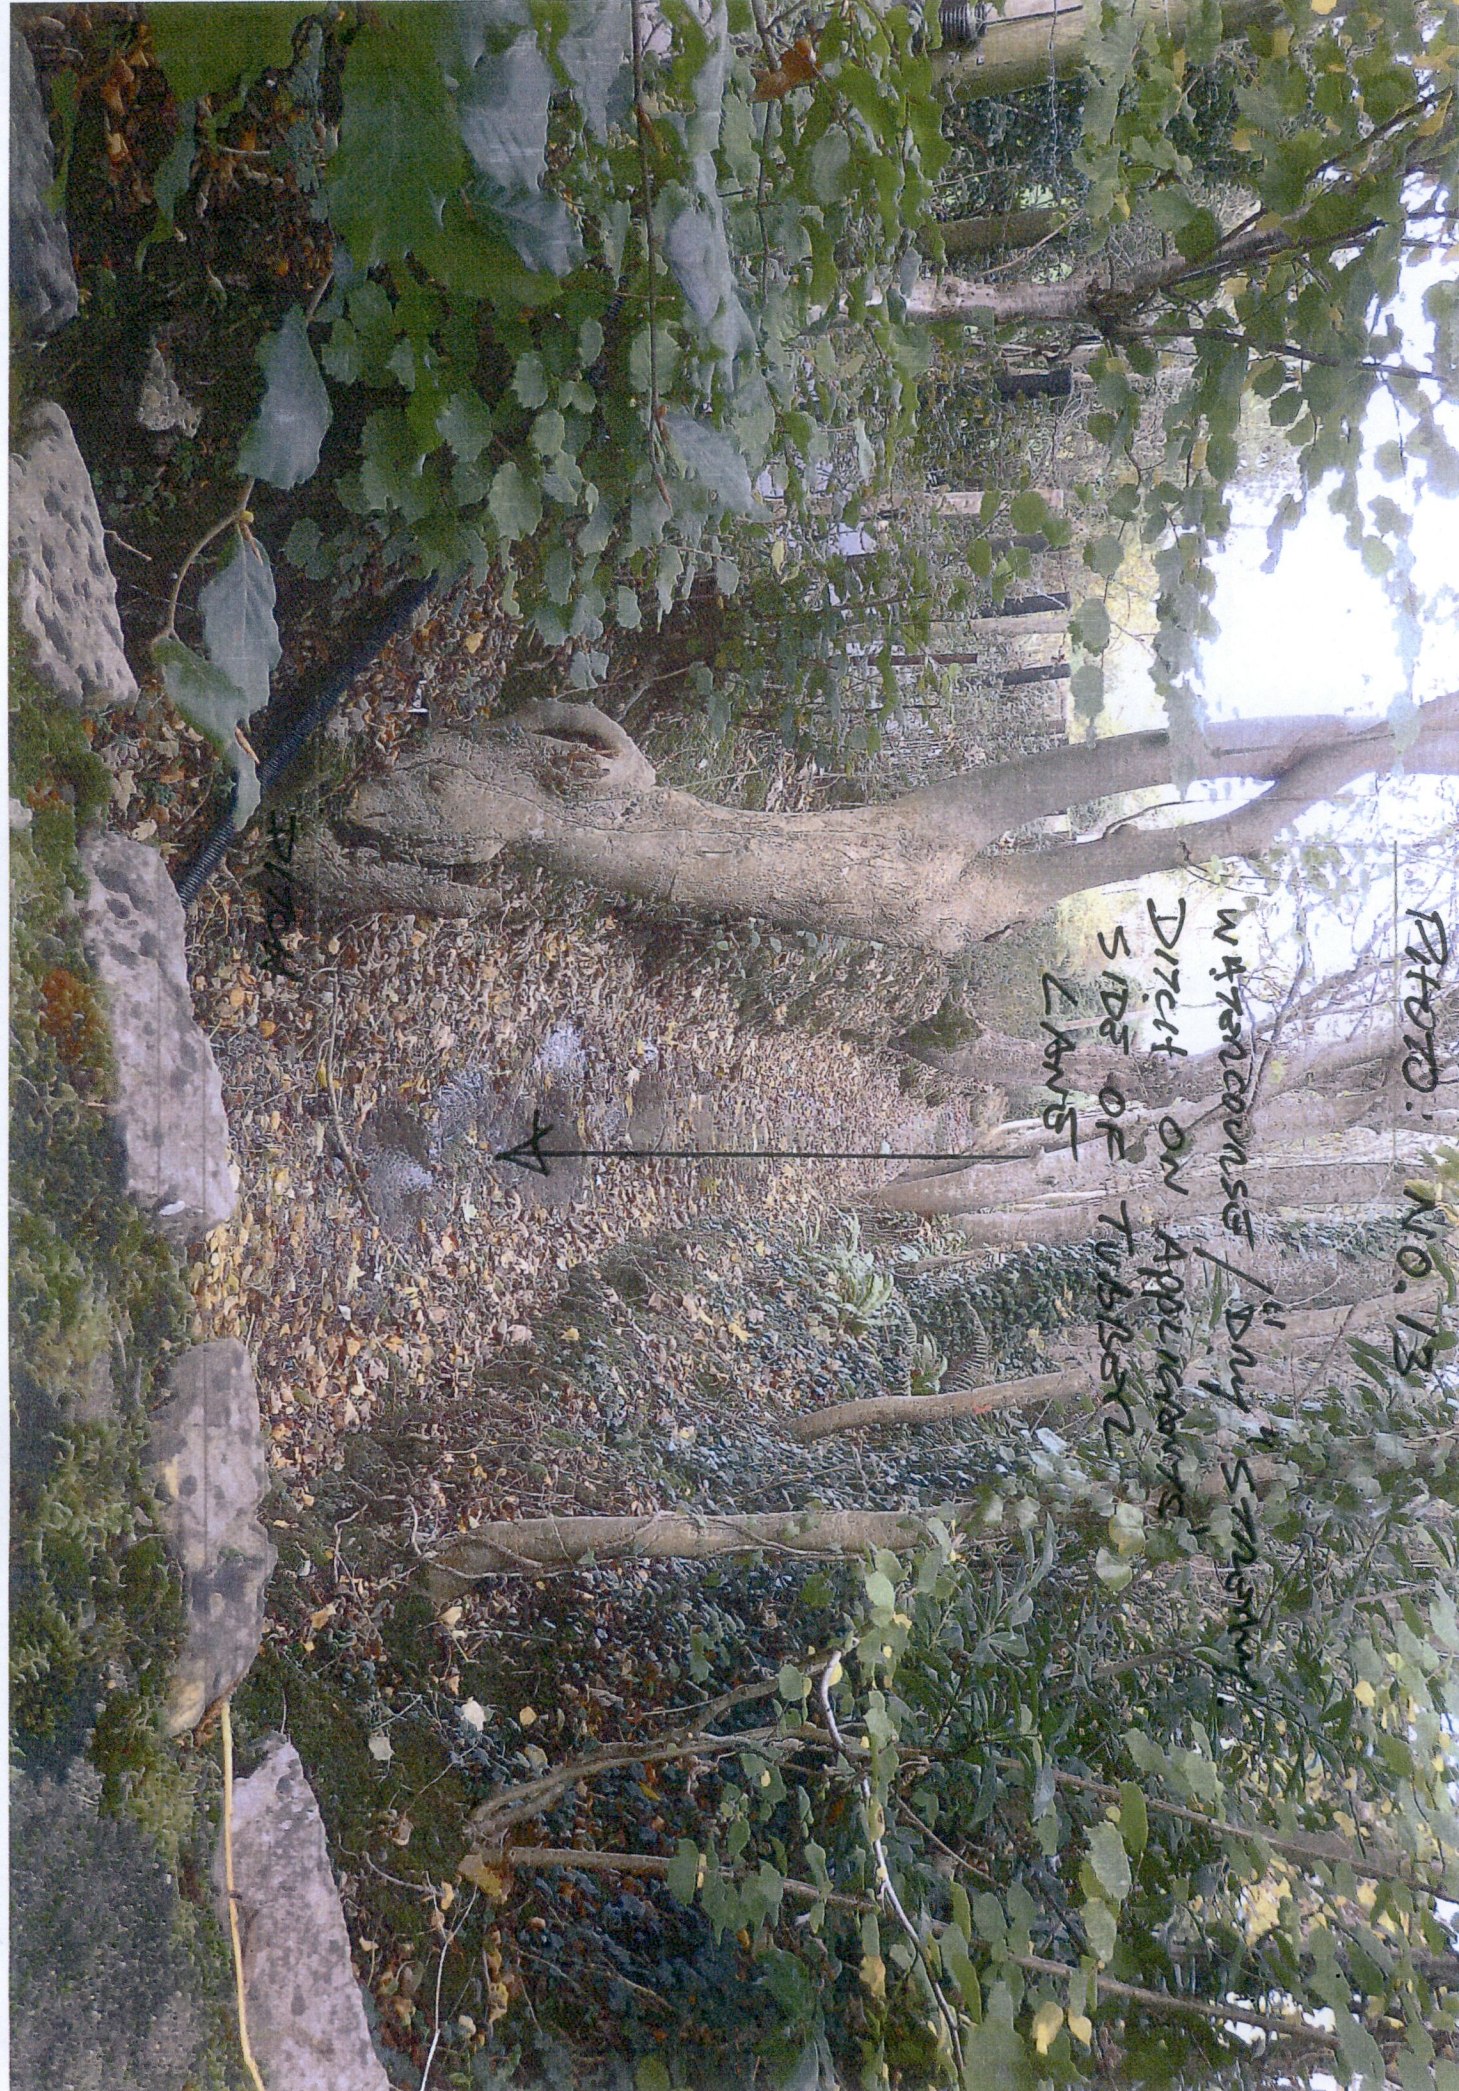
PHOTO NO. 11
TUBBER LANE
FACING
SOUTH

RURAL CHARACTER OF
TUBBER LANE

OUTSIDE EXISTING ENTRANCE

OF "GARDENWAYS"

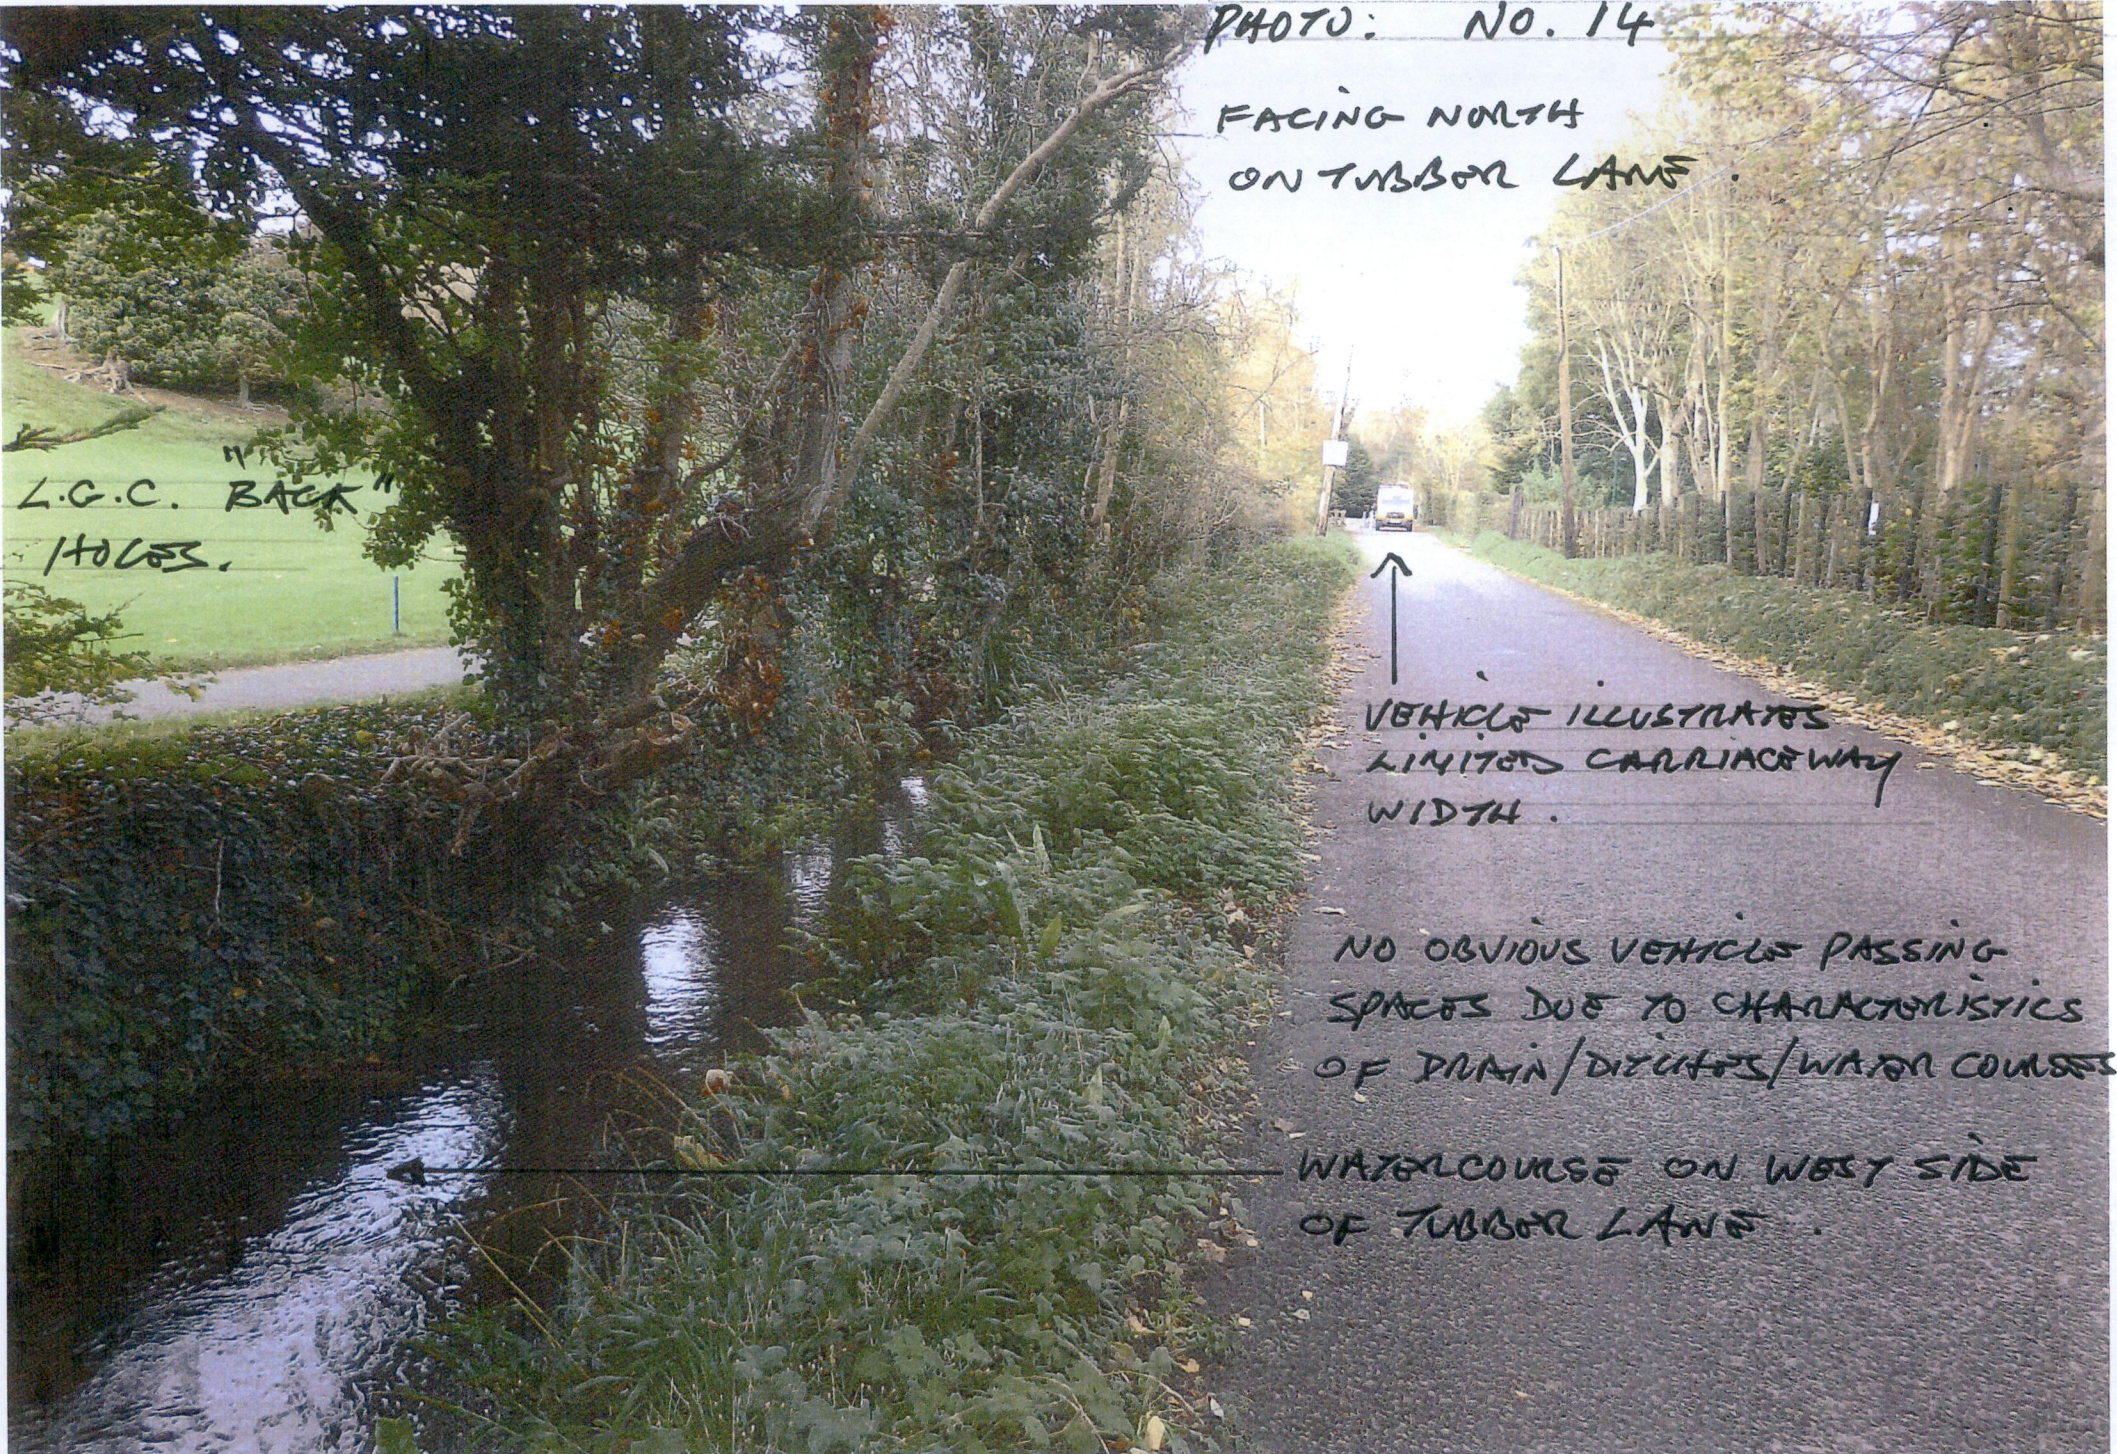
PHOTO: NO. 13

MAINTENANCE & DRIVEWAY ACCESS

SHARED EXISTING ACCESS TO
"GREENWAYS" & NEIGHBORING PROPERTY

WATERCOURSE / DITCH
DIRT ON APPLICANTS
SIDE OF TUBES
LAWNS

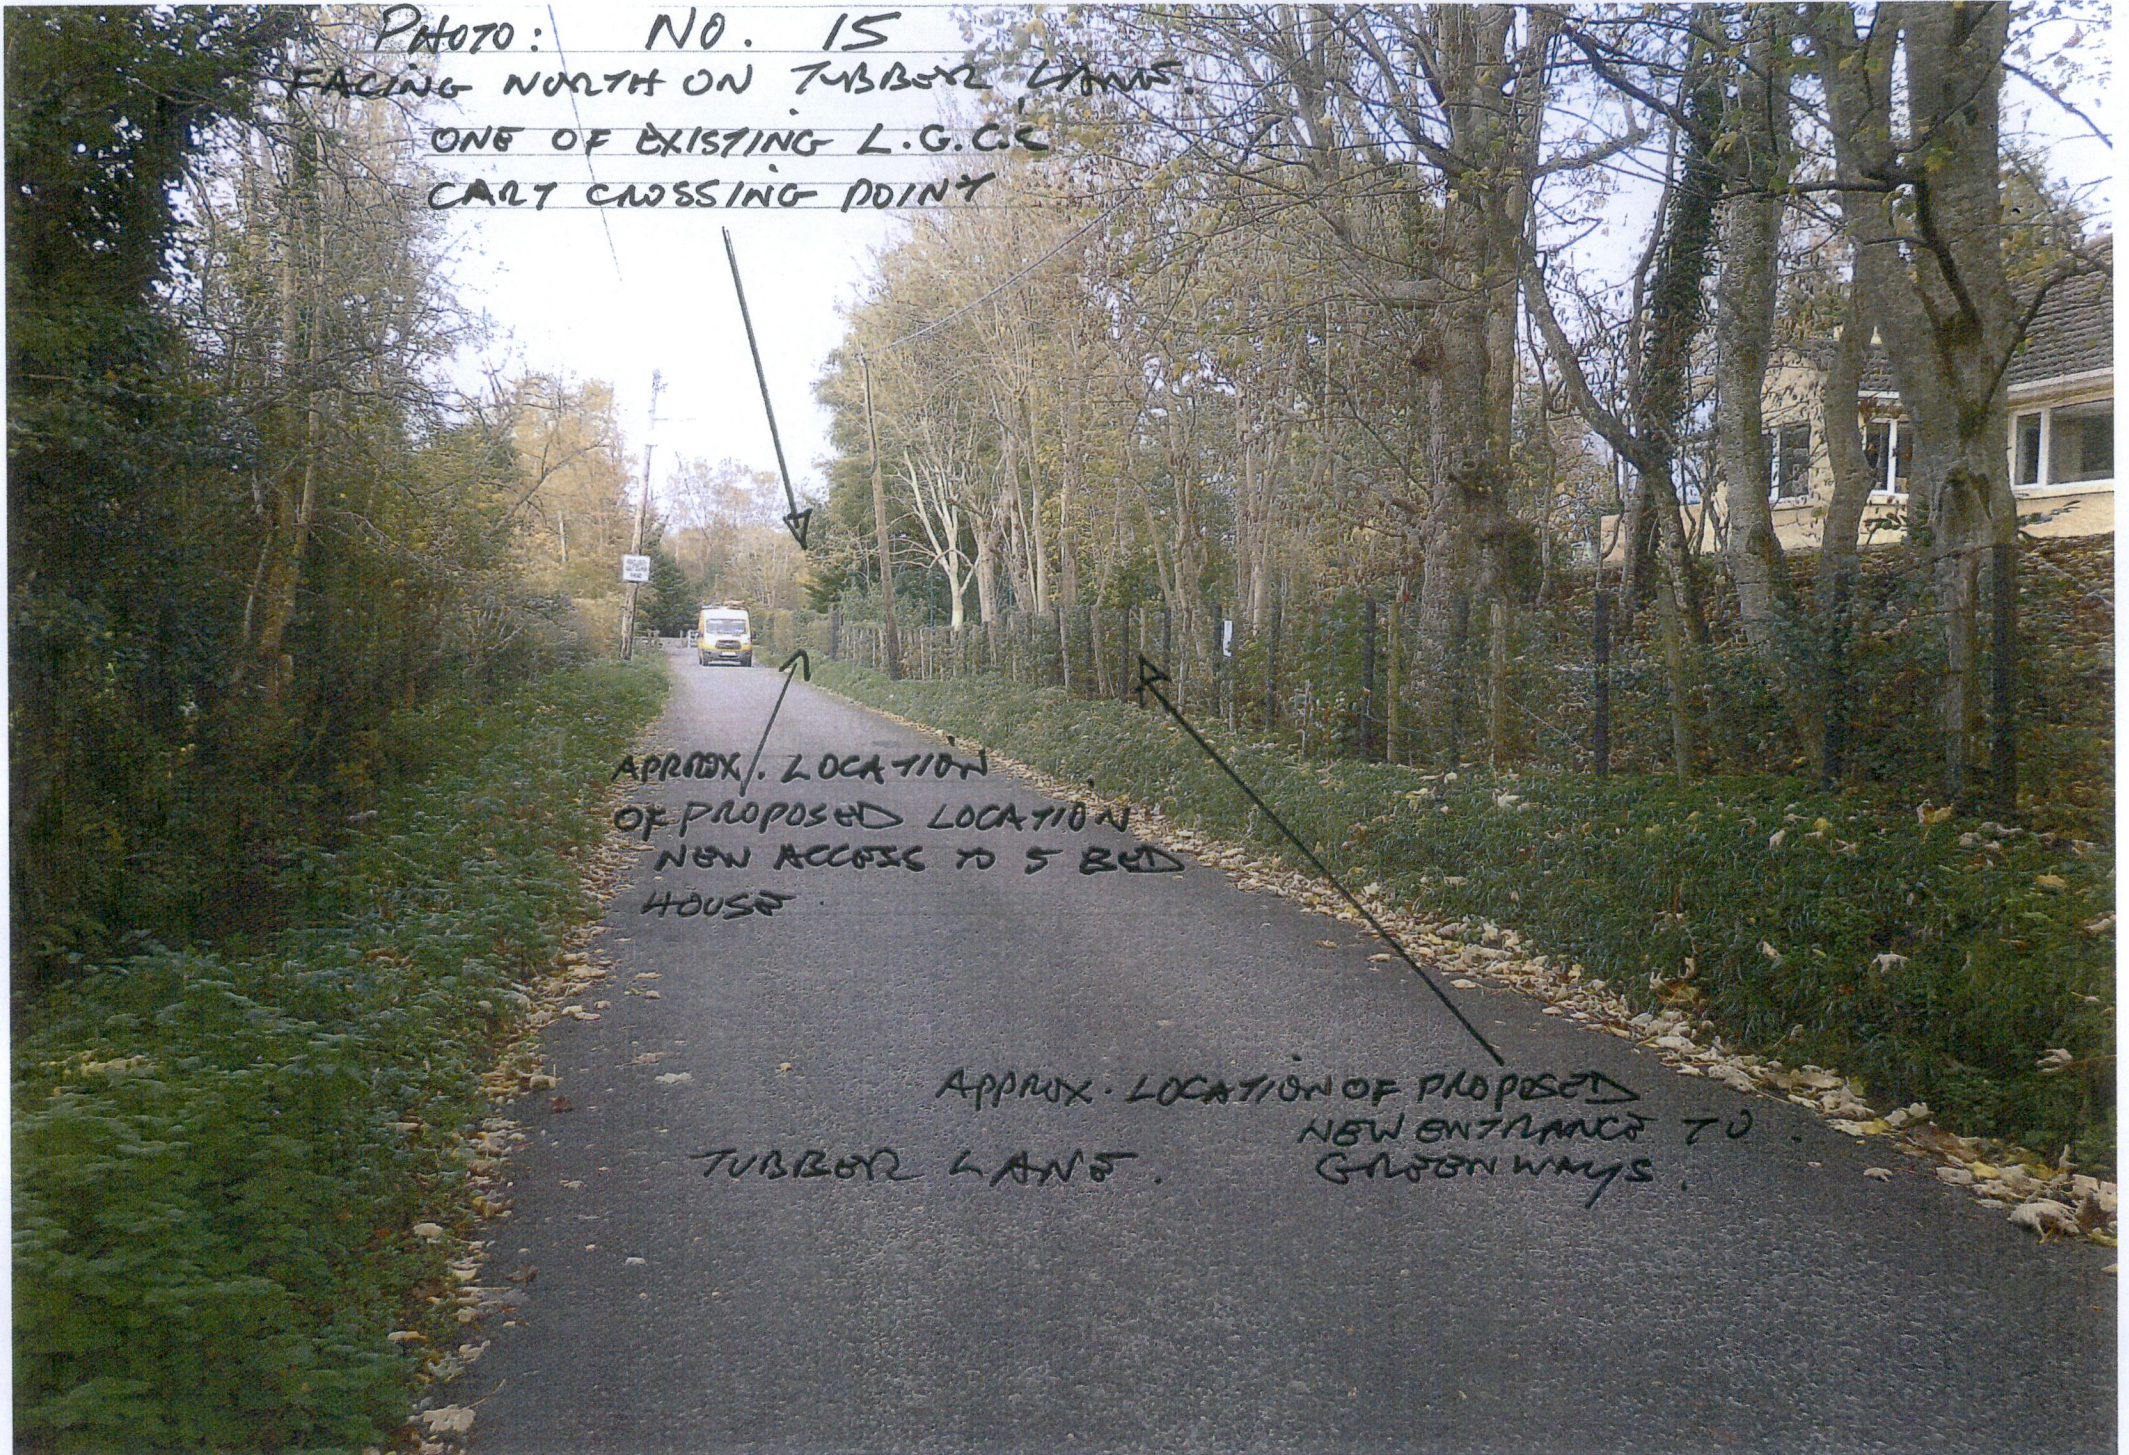
PHOTO: NO. 14

FACING NORTH
ON TUBBON LANE.

L.G.C. BACK
HOLES.

VEHICLE ILLUSTRATES
LIMITED CARRIAGEWAY
WIDTH.

NO OBVIOUS VEHICLES PASSING
SPACES DUE TO CHARACTERISTICS
OF DRAIN/DITCHES/WATER COURSES

← WATERCOURSE ON WEST SIDE
OF TUBBON LANE.
