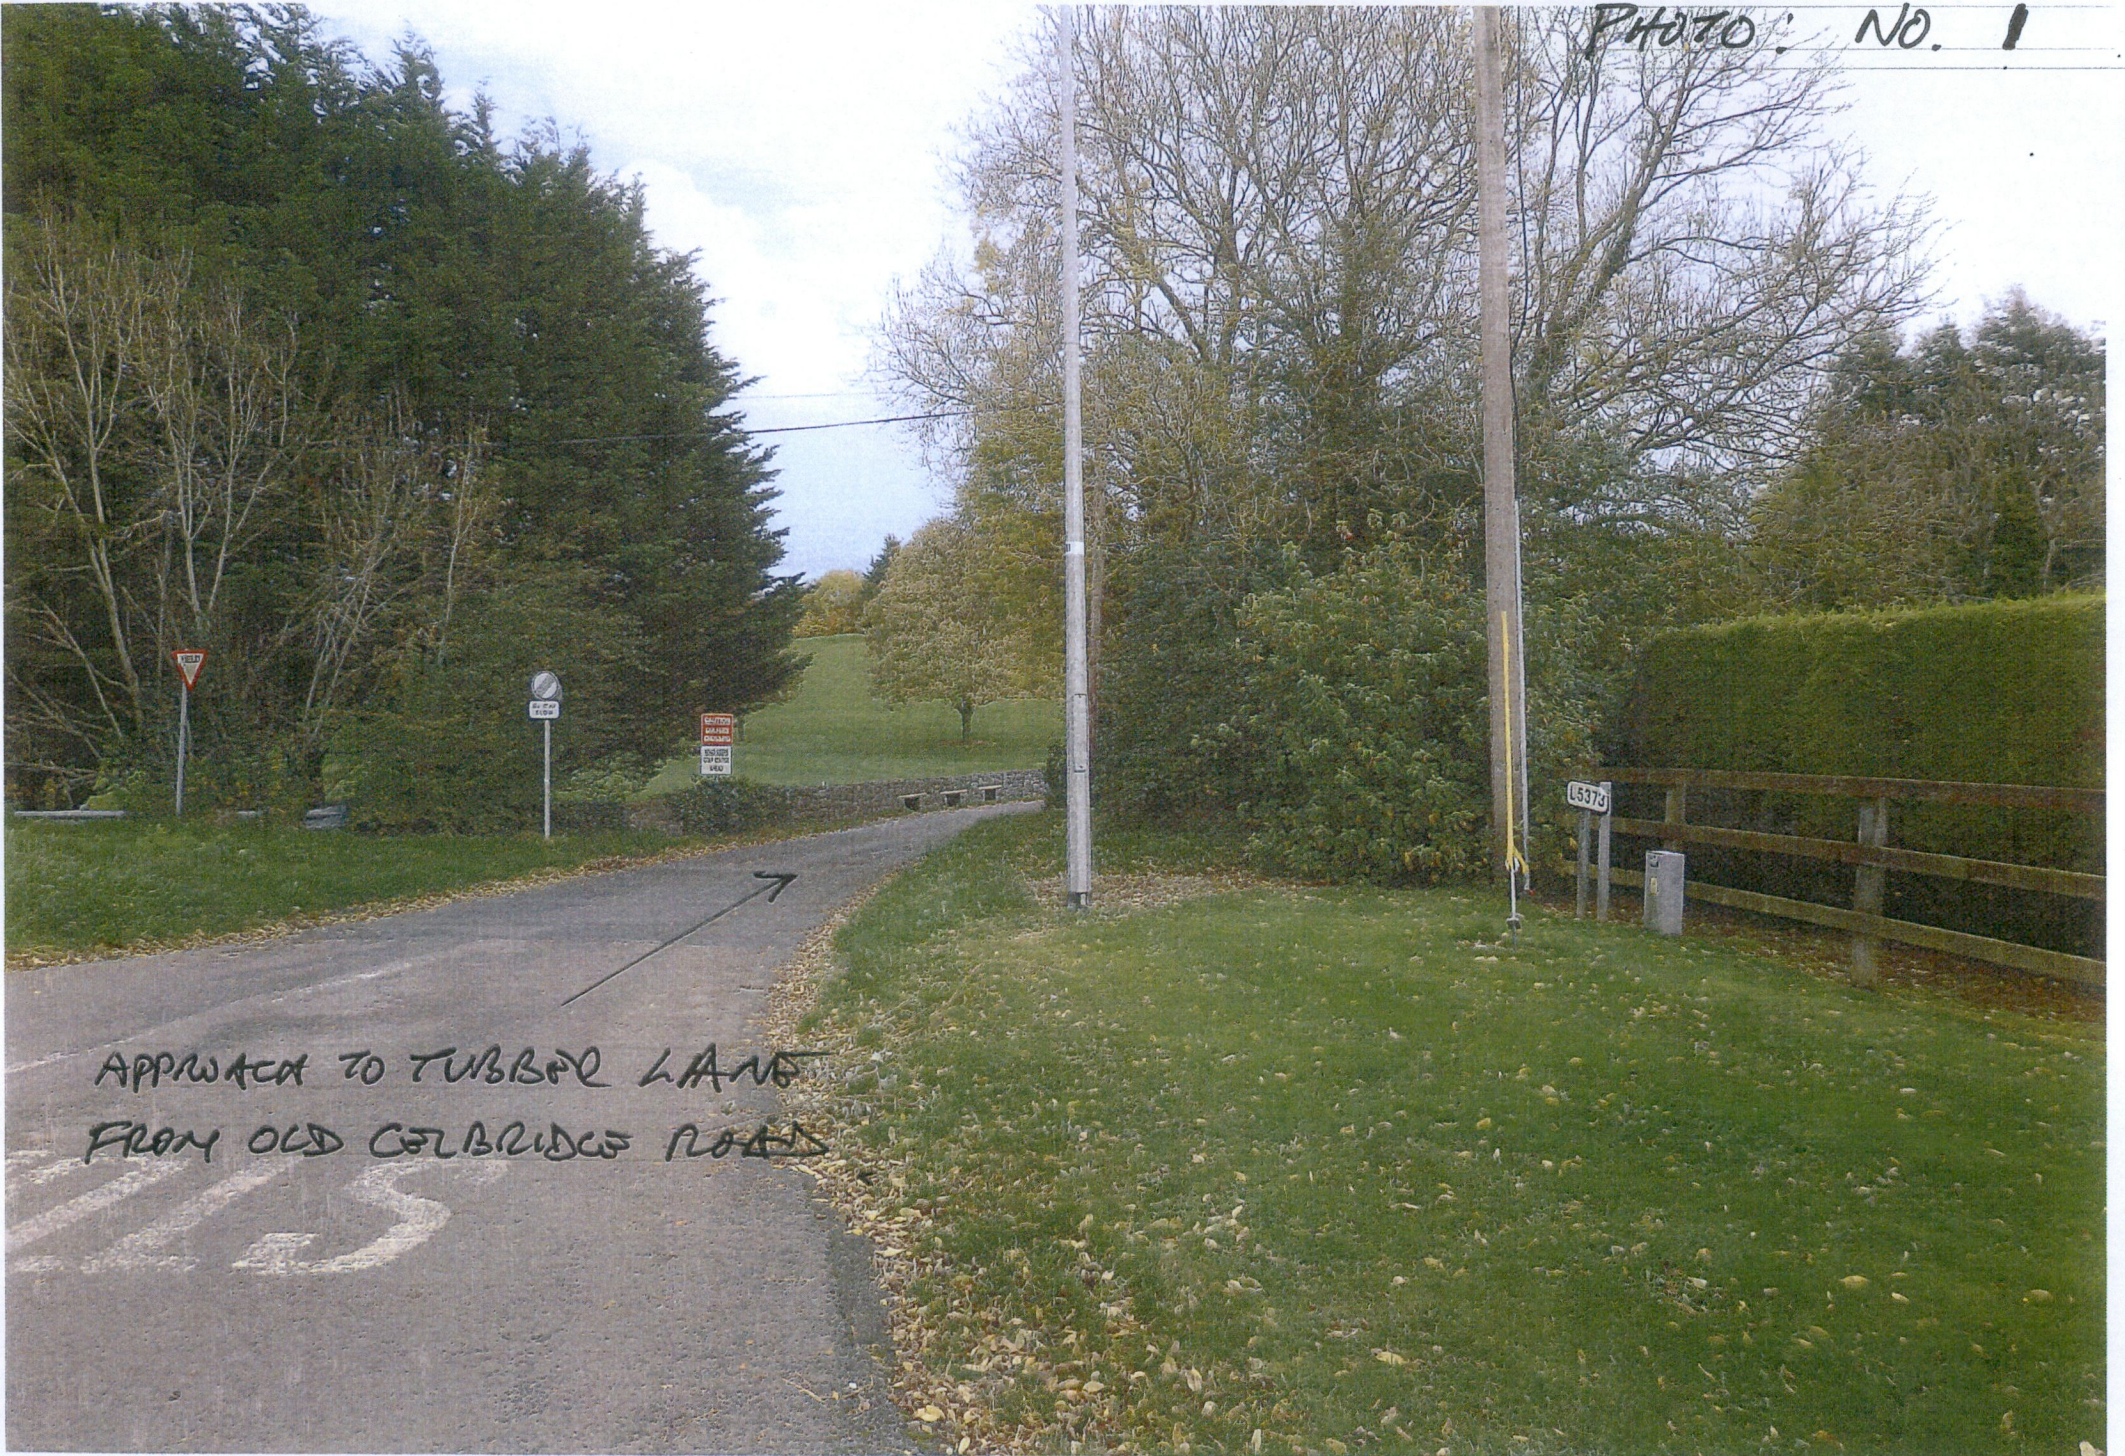
PHOTO: NO. 1

APPROACH TO TUBBER LANE
FROM OLD COLBRIDGE ROAD

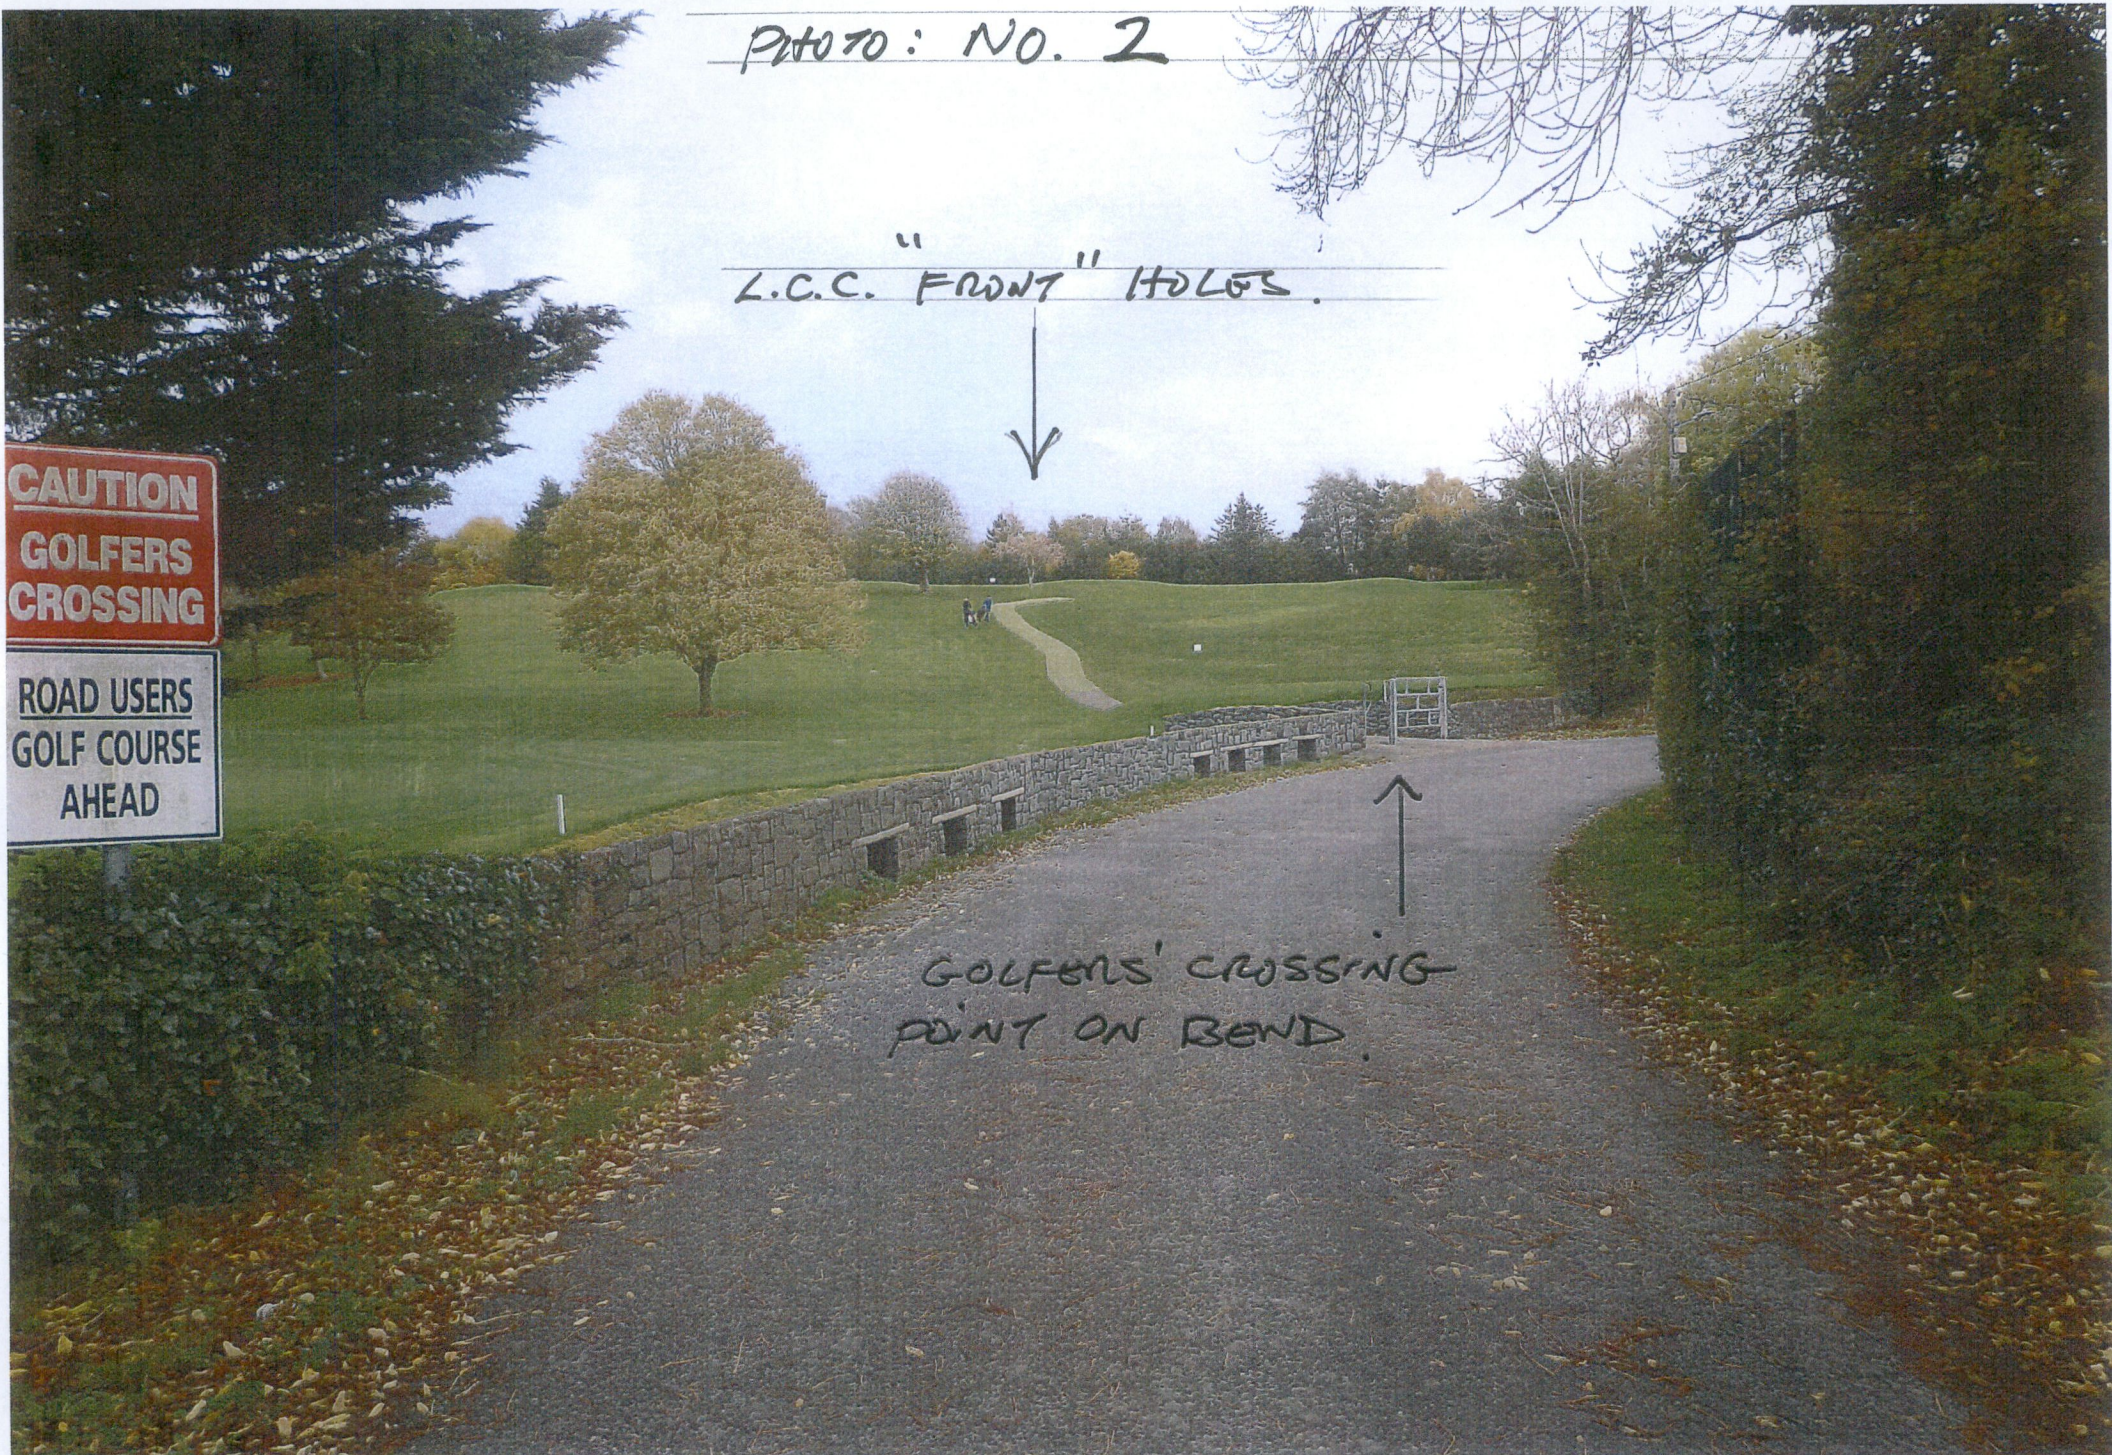
PHOTO: NO. 2

"L.C.C. FRONT" HOLES

GOLFERS' CROSSING
POINT ON BEND

RESTRICTED VISION ON BOUND
AT END OF TUSsock LAWS.

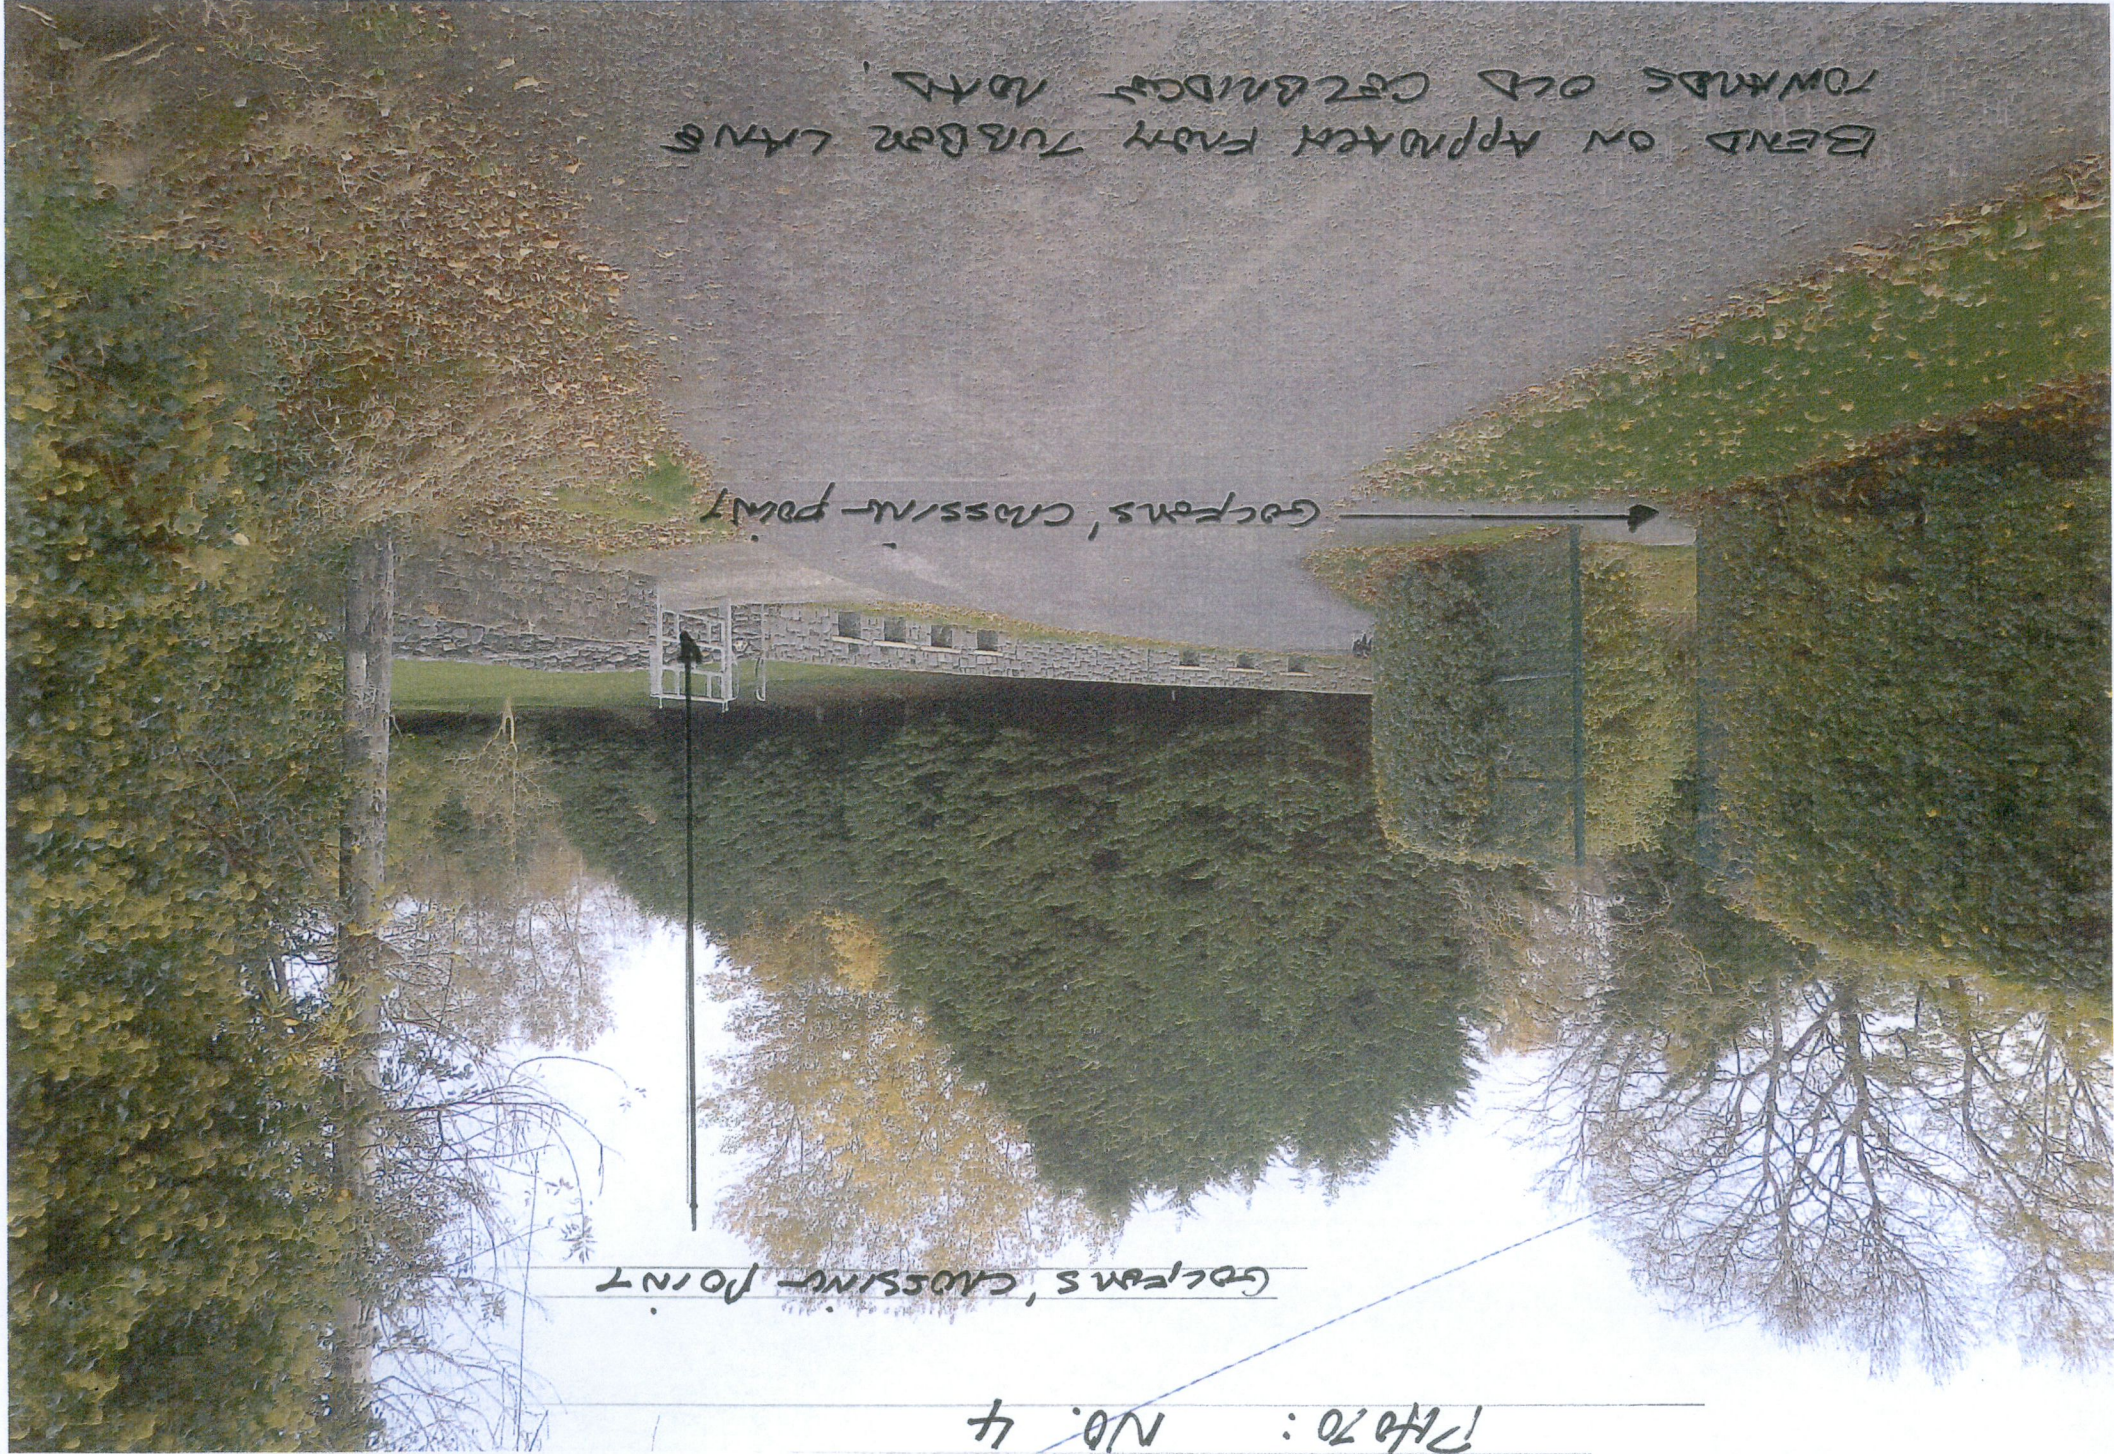
PHOTO: NO. 4

GOLFERS' CROSSING-POINT

BEND ON APPROACH FROM TURBON LAKE
TOWARDS OLD GOLF BRIDGE ROAD

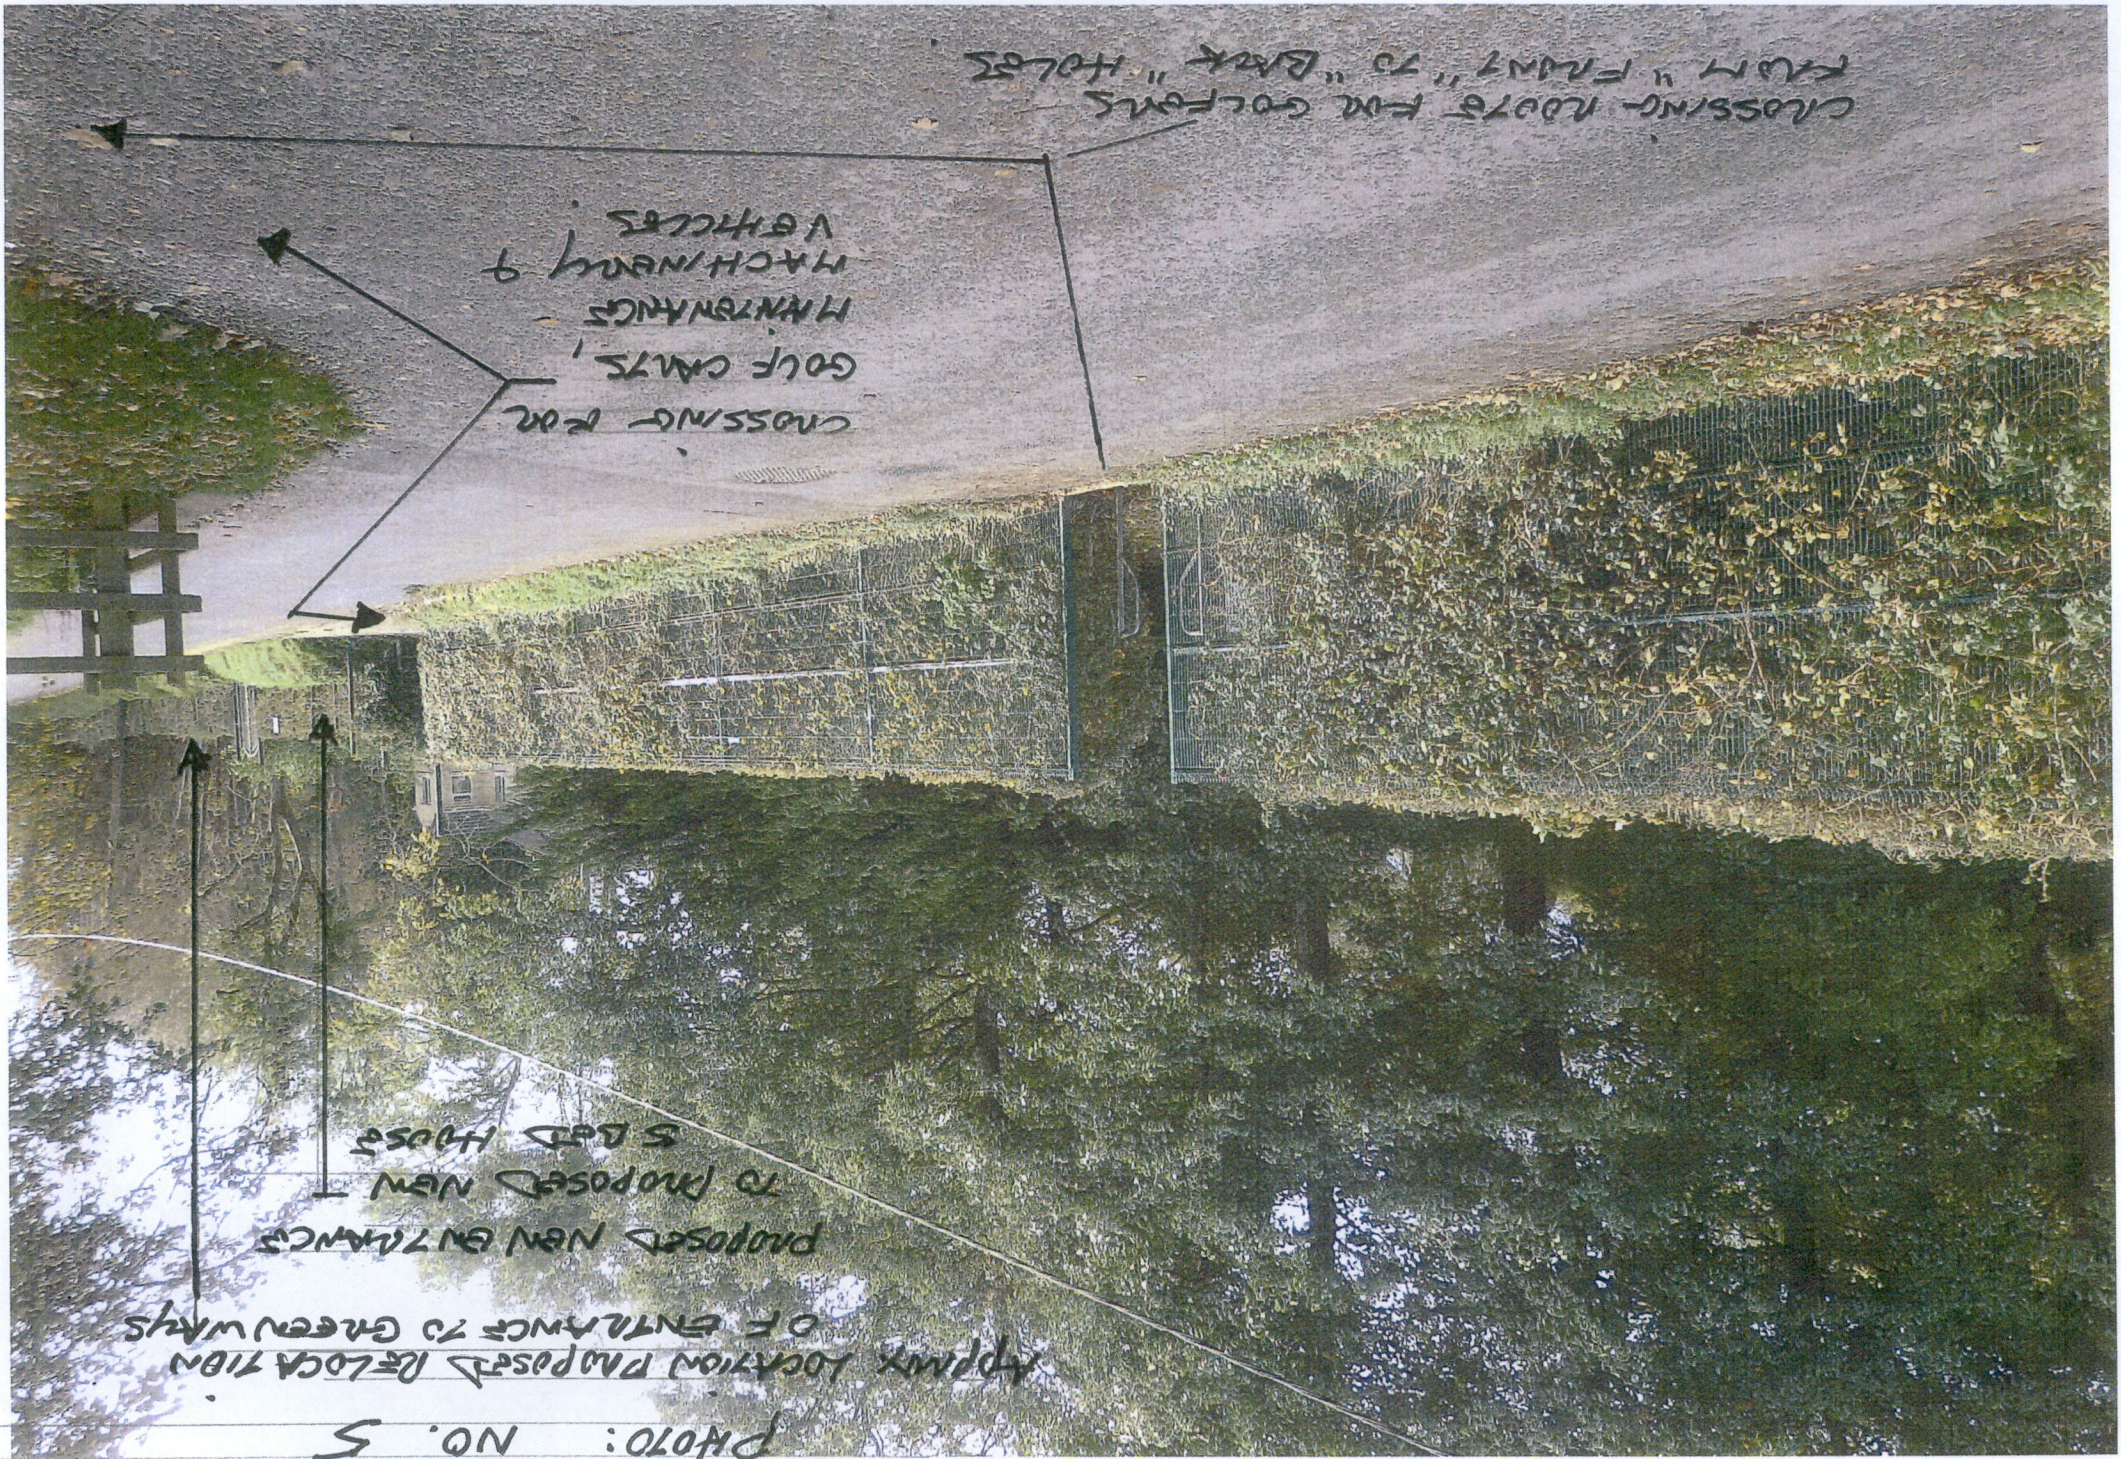
PHOTO: NO. 5

APPROX LOCATION PROPOSED RELOCATION
OF ENTRANCE TO GREENWAYS

CROSSING FOR
GOLF CARTS,
MAINTENANCE
MACHINERY &
VEHICLES

CROSSING ROOTS FOR GOLFERS
FROM "FRONT" TO "BACK" HOLES

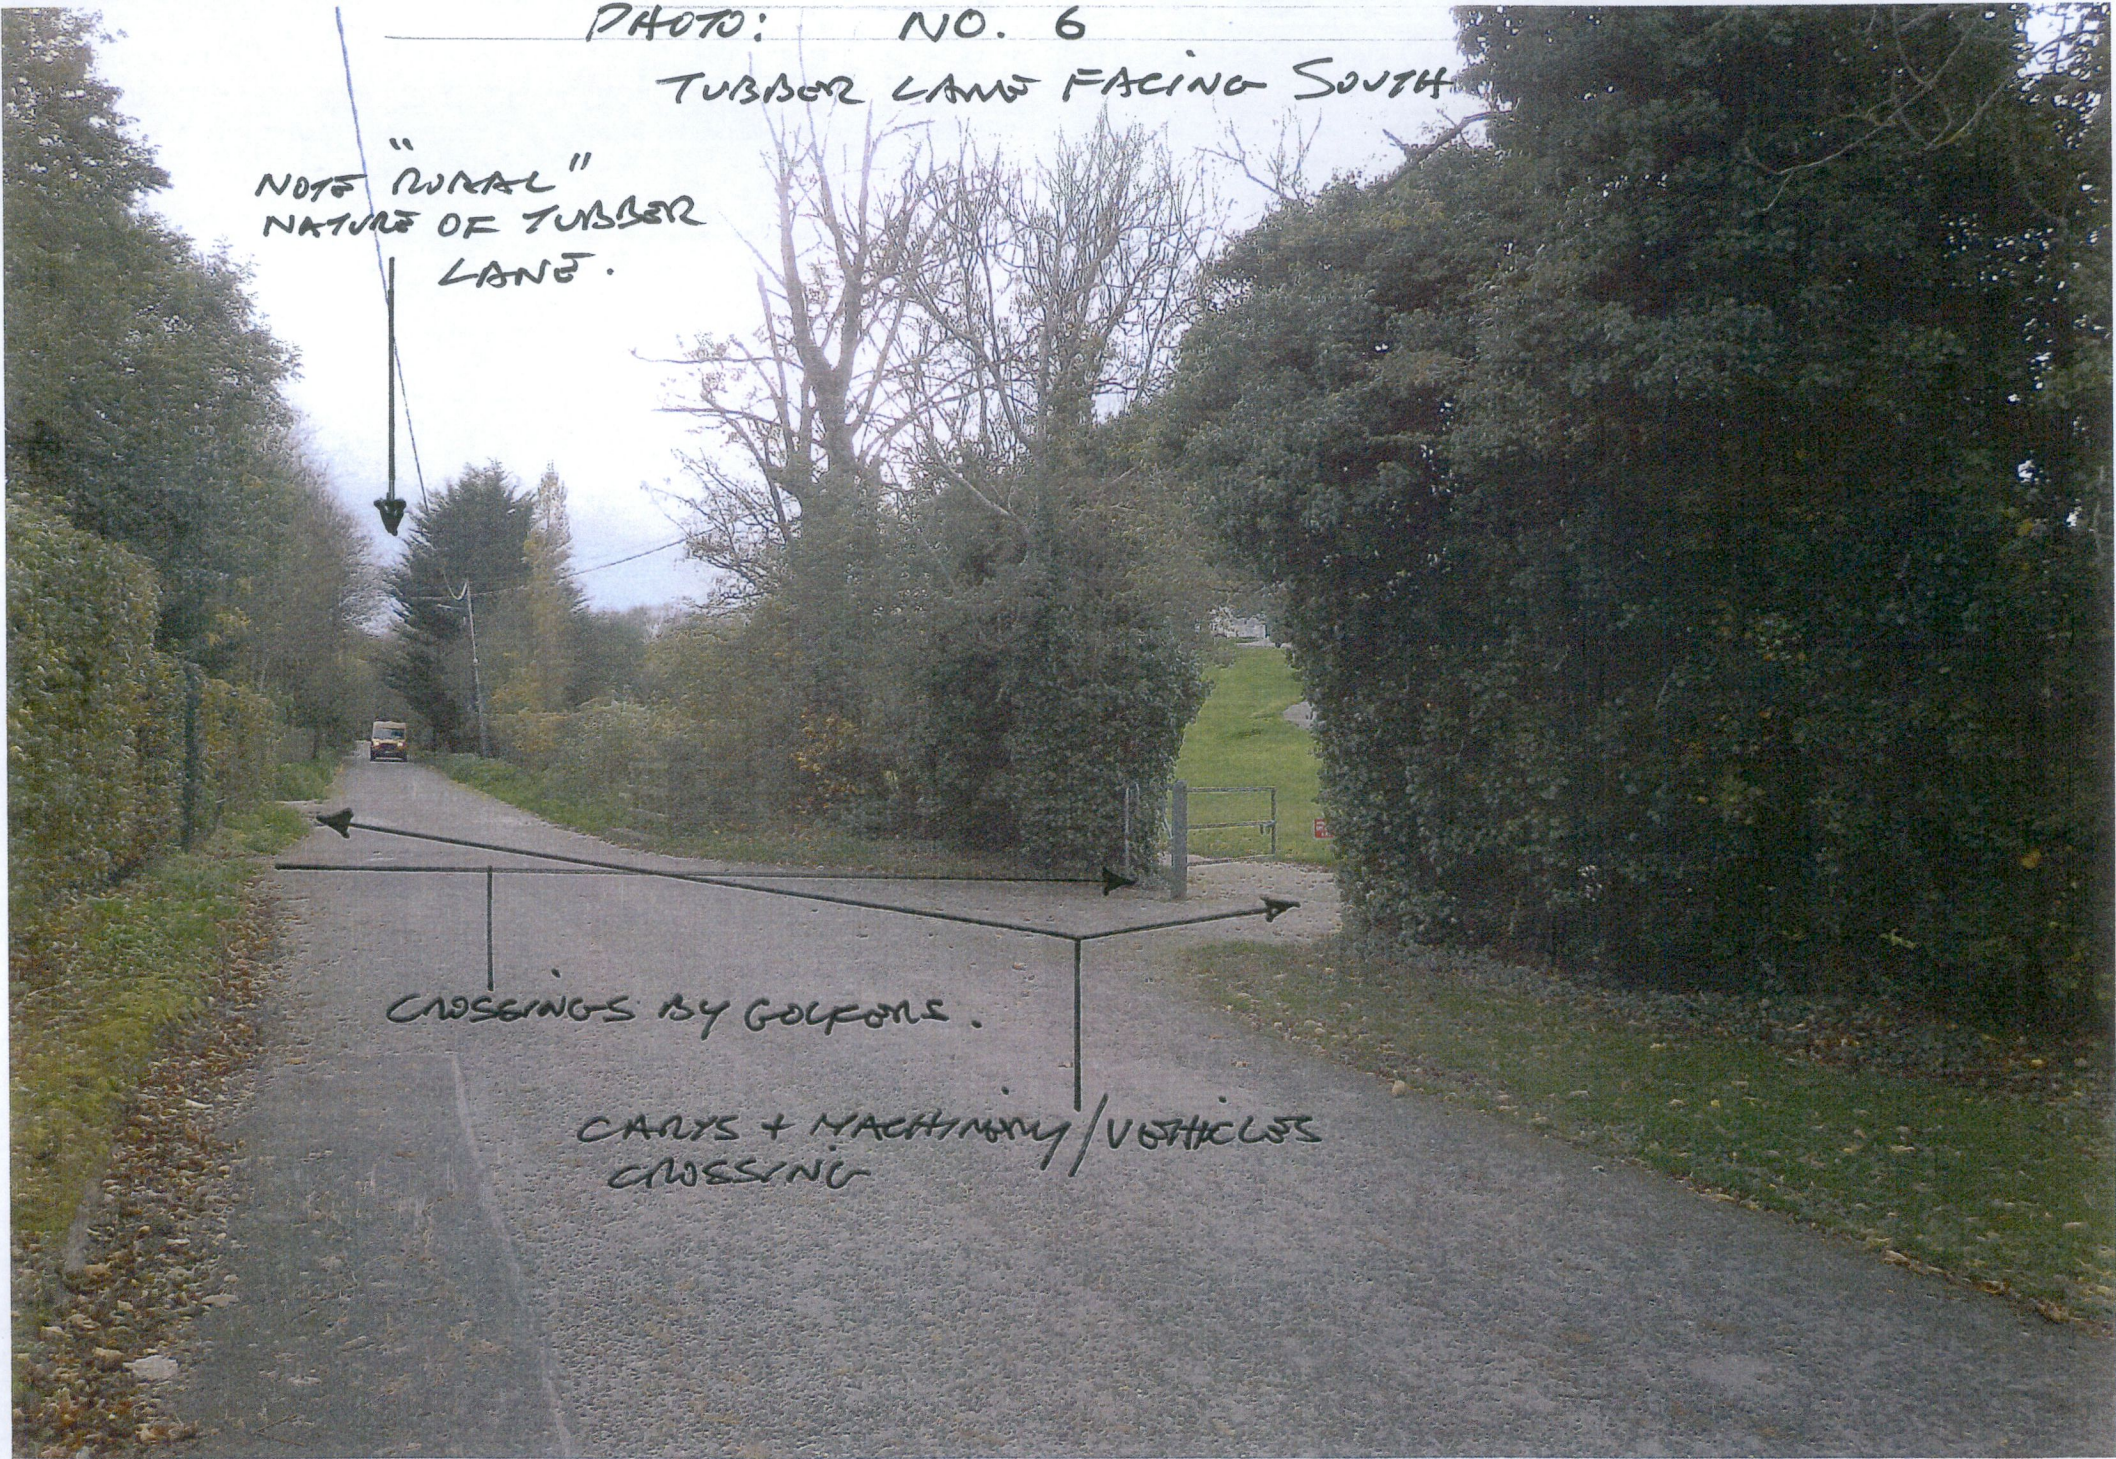
PHOTO: NO. 6

TUBBER LANE FACING SOUTH

NOTE "UNUSUAL"
NATURE OF TUBBER
LANE.

CROSSINGS BY GOLFERS.

CARS + MACHINERY / VEHICLES
CROSSING

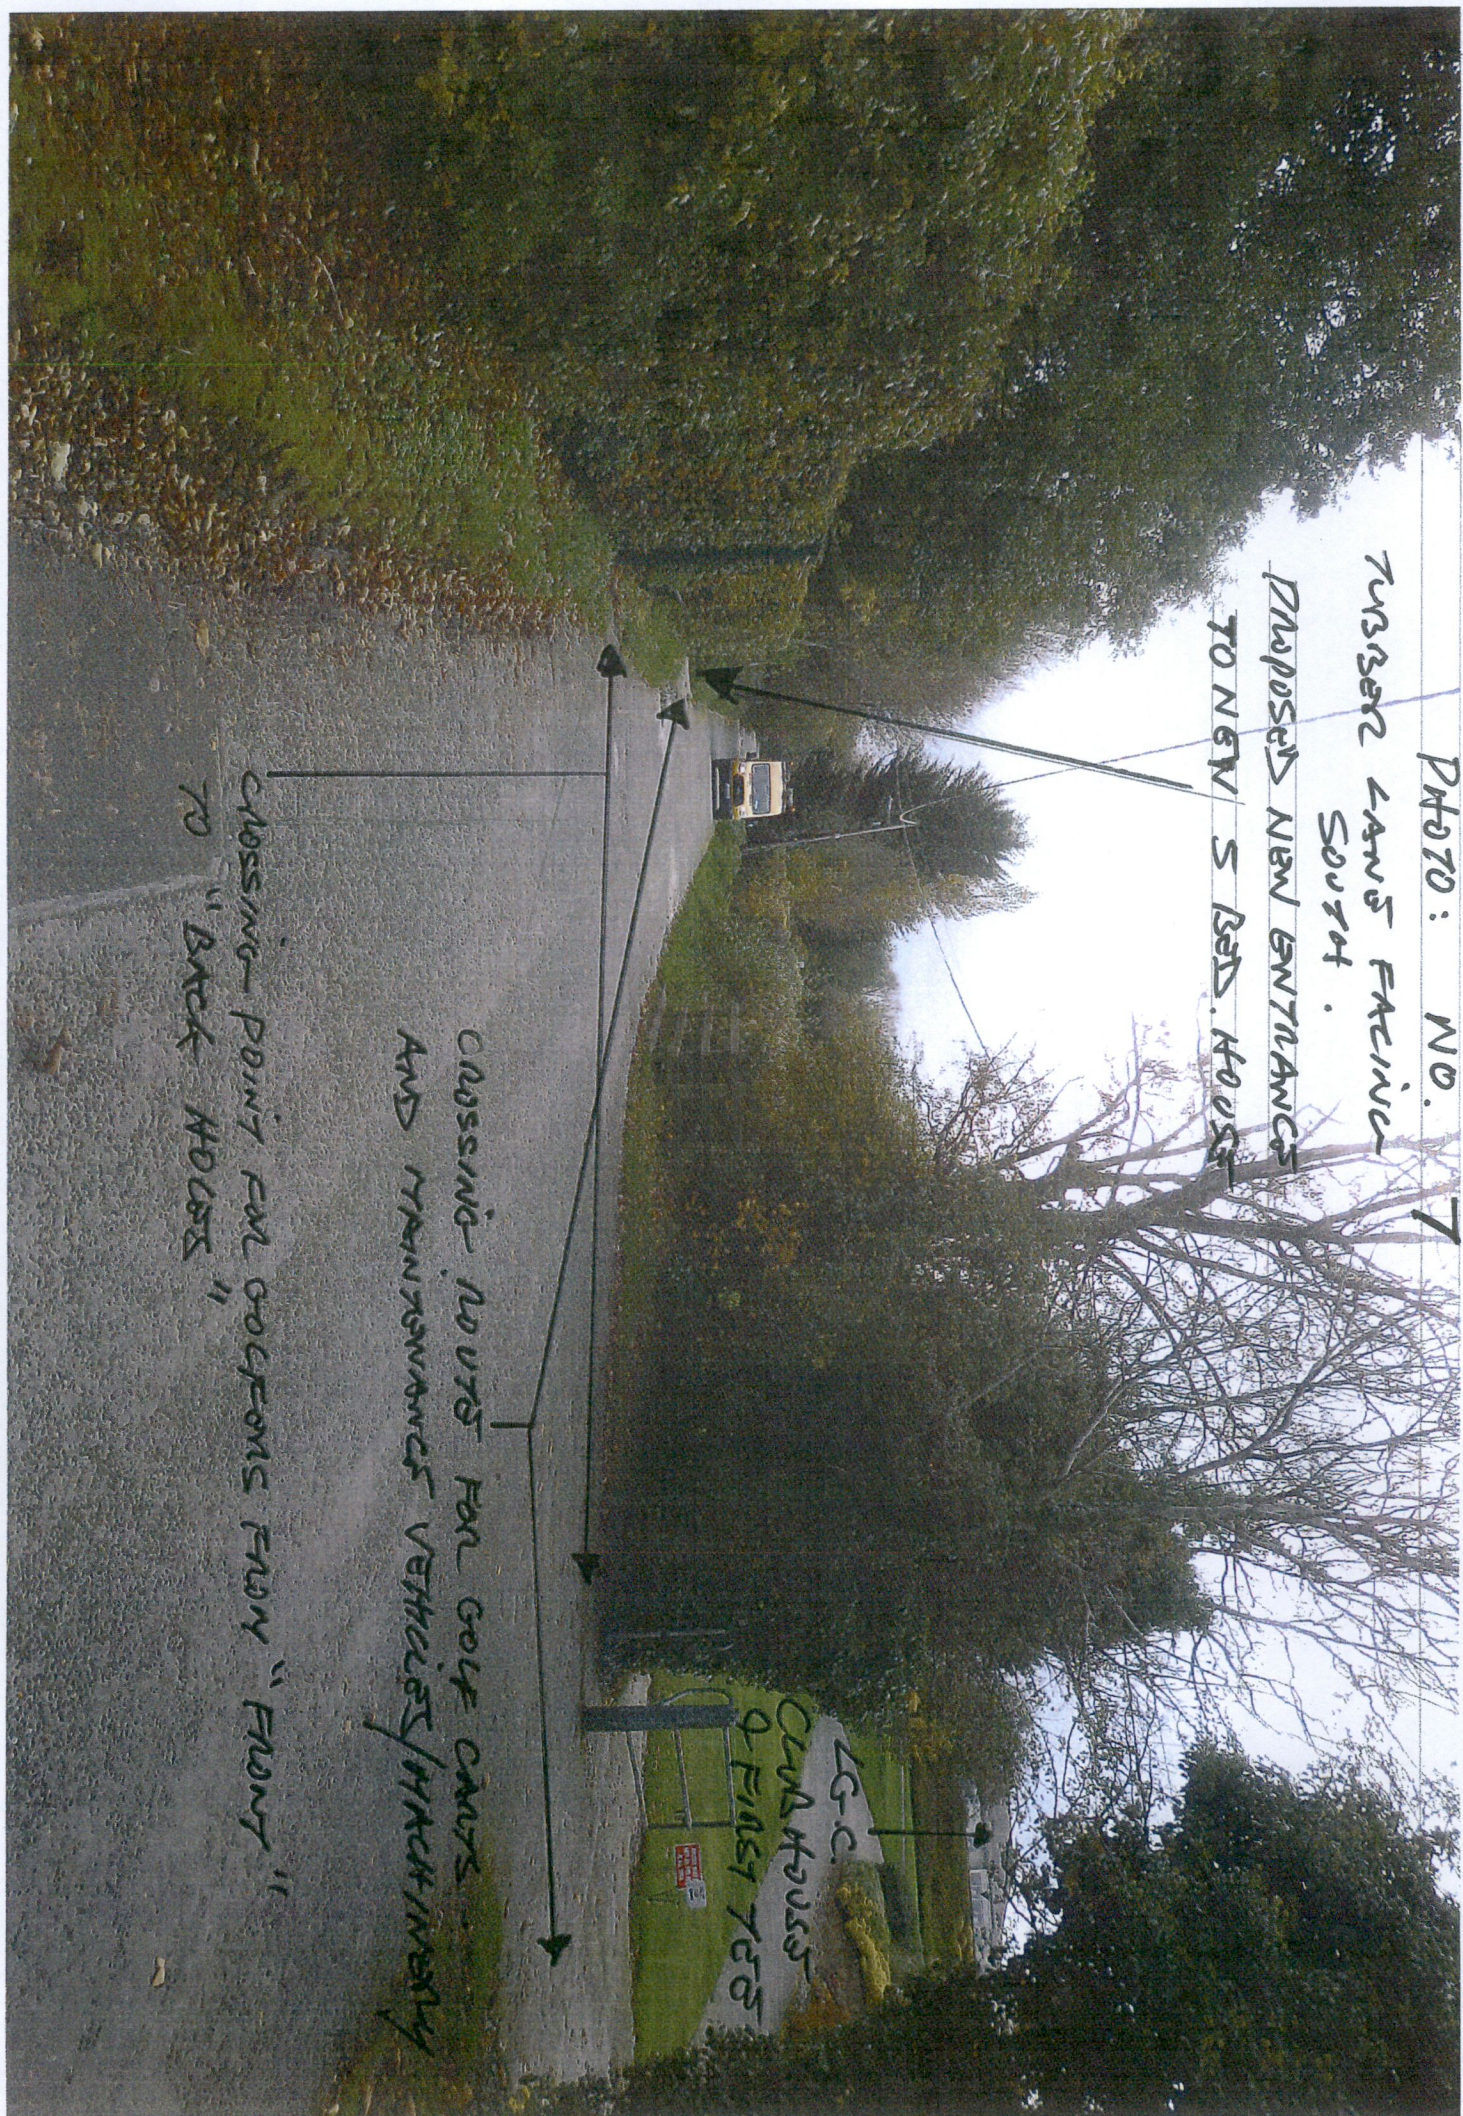
PHOTO: NO. 7

TURBER LAWS FACILITY
SOUTH.

PROPOSED NEW ENTRANCES
TO NEW S BLD. HOUSE

CROSSING POINTS FOR GOLF CARTS
AND MAINTENANCE VEHICLES/TRACTORS

CROSSING POINT FOR GOLFERS FROM "FRONT"
TO "BACK HOUSES"

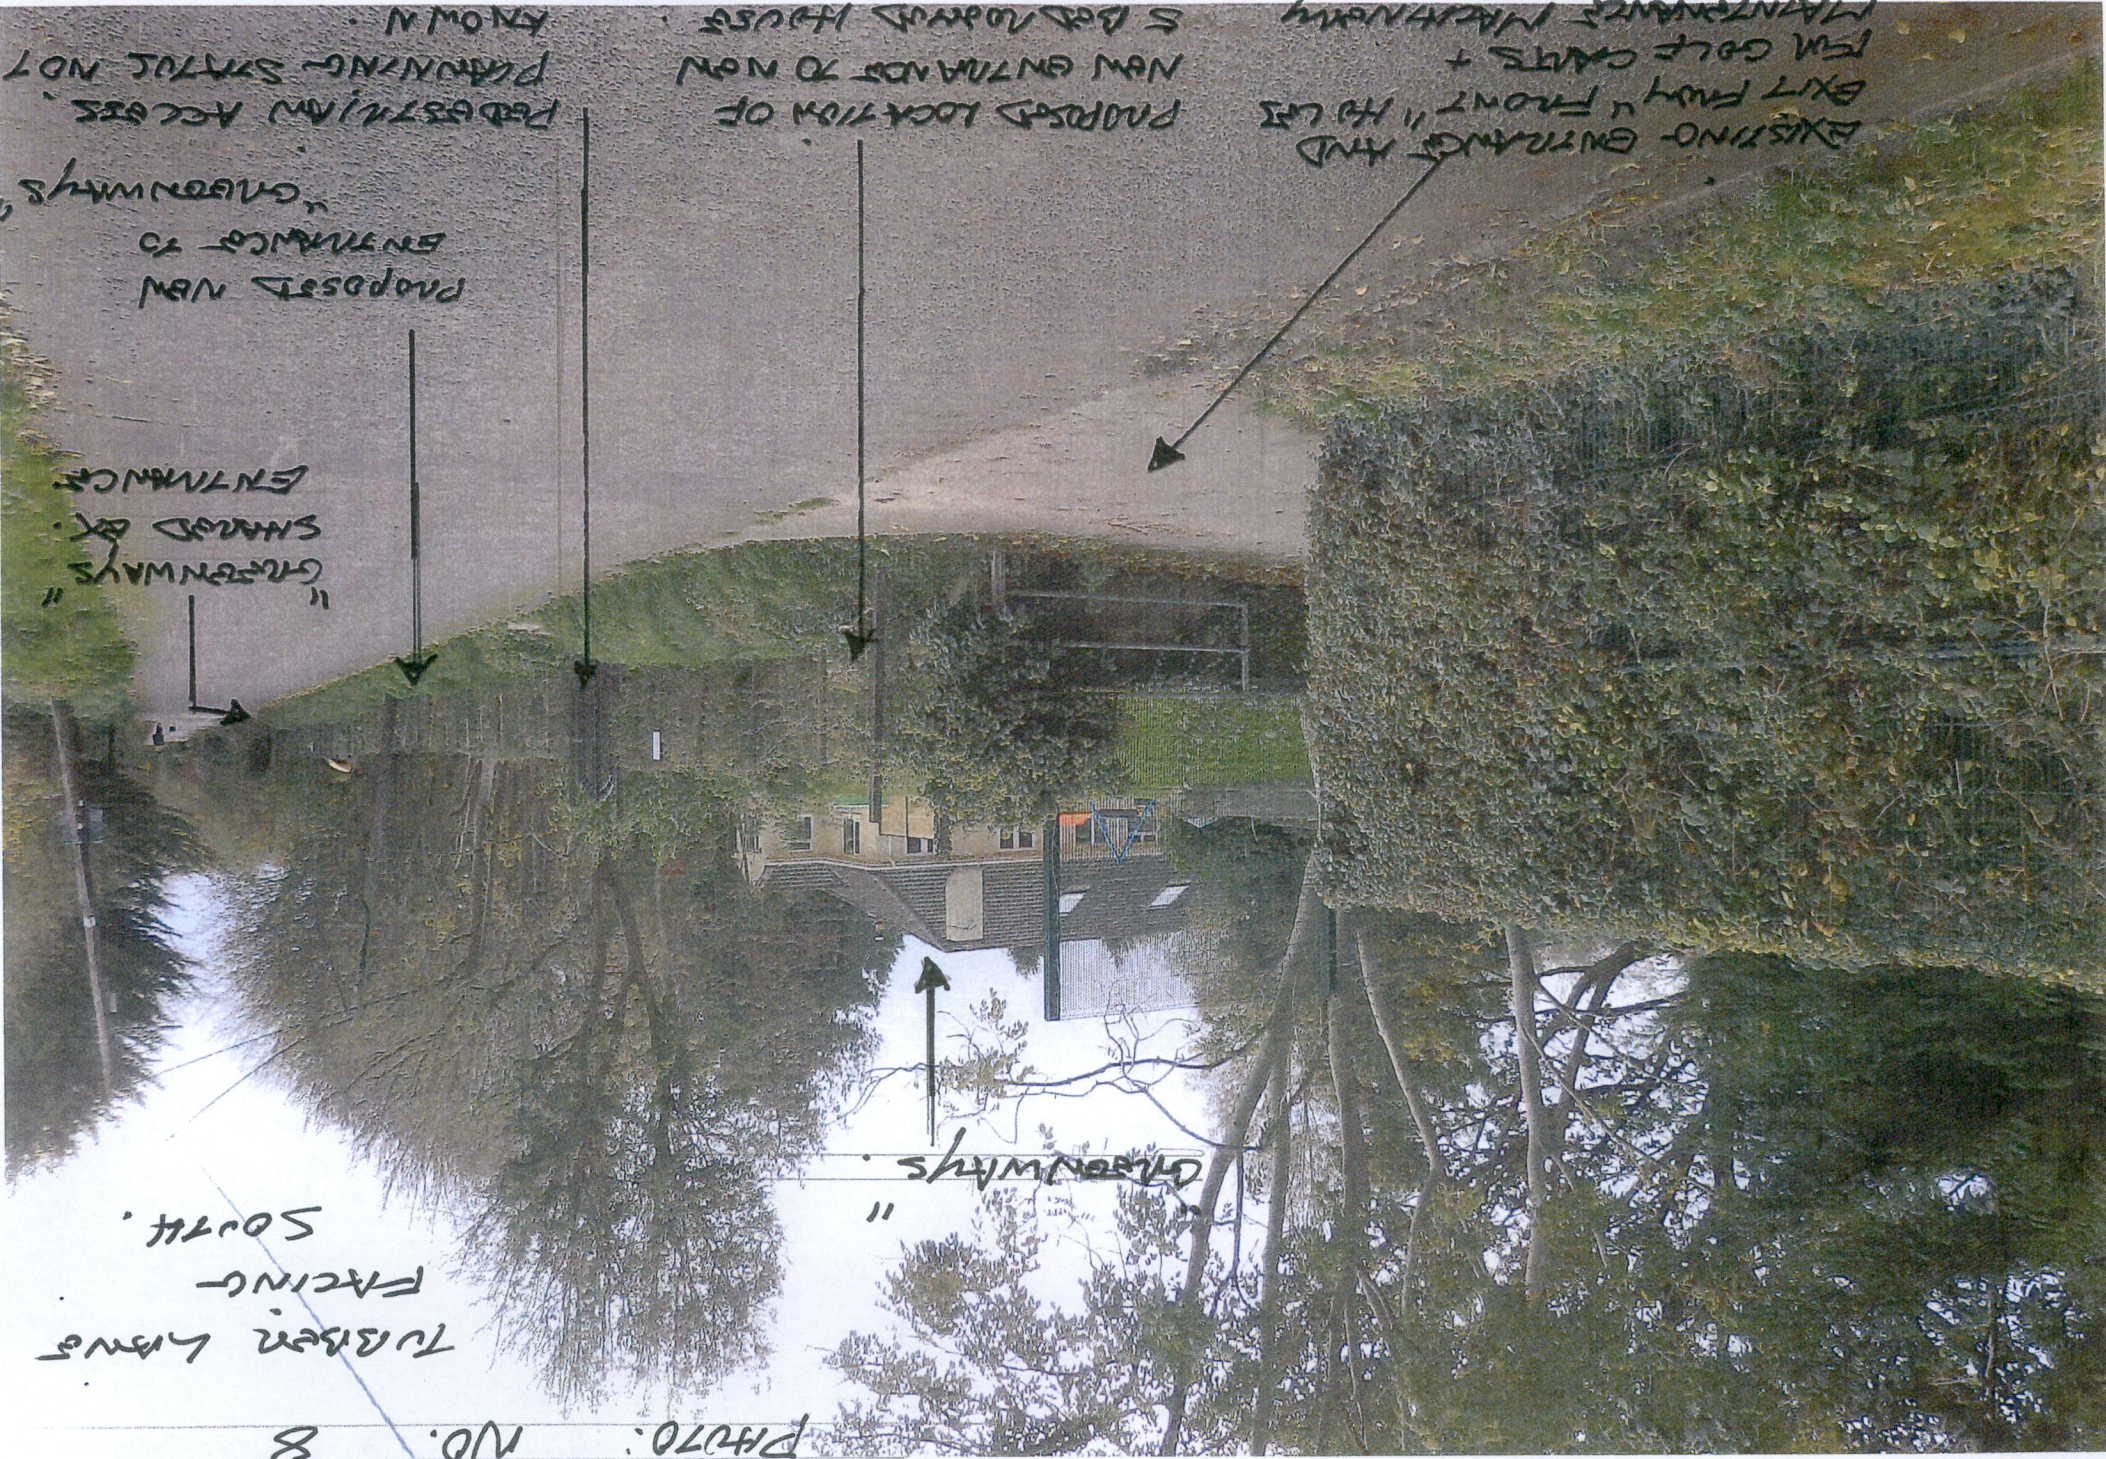
PHOTO: NO. 8

TUBSEN LANE
FACING
SOUTH.

PROPOSED NEW
ENTRANCE TO
"GREENWAYS"

RESTRICTION ACCESS.
PLANNING START NO. 7
KNOWN.
