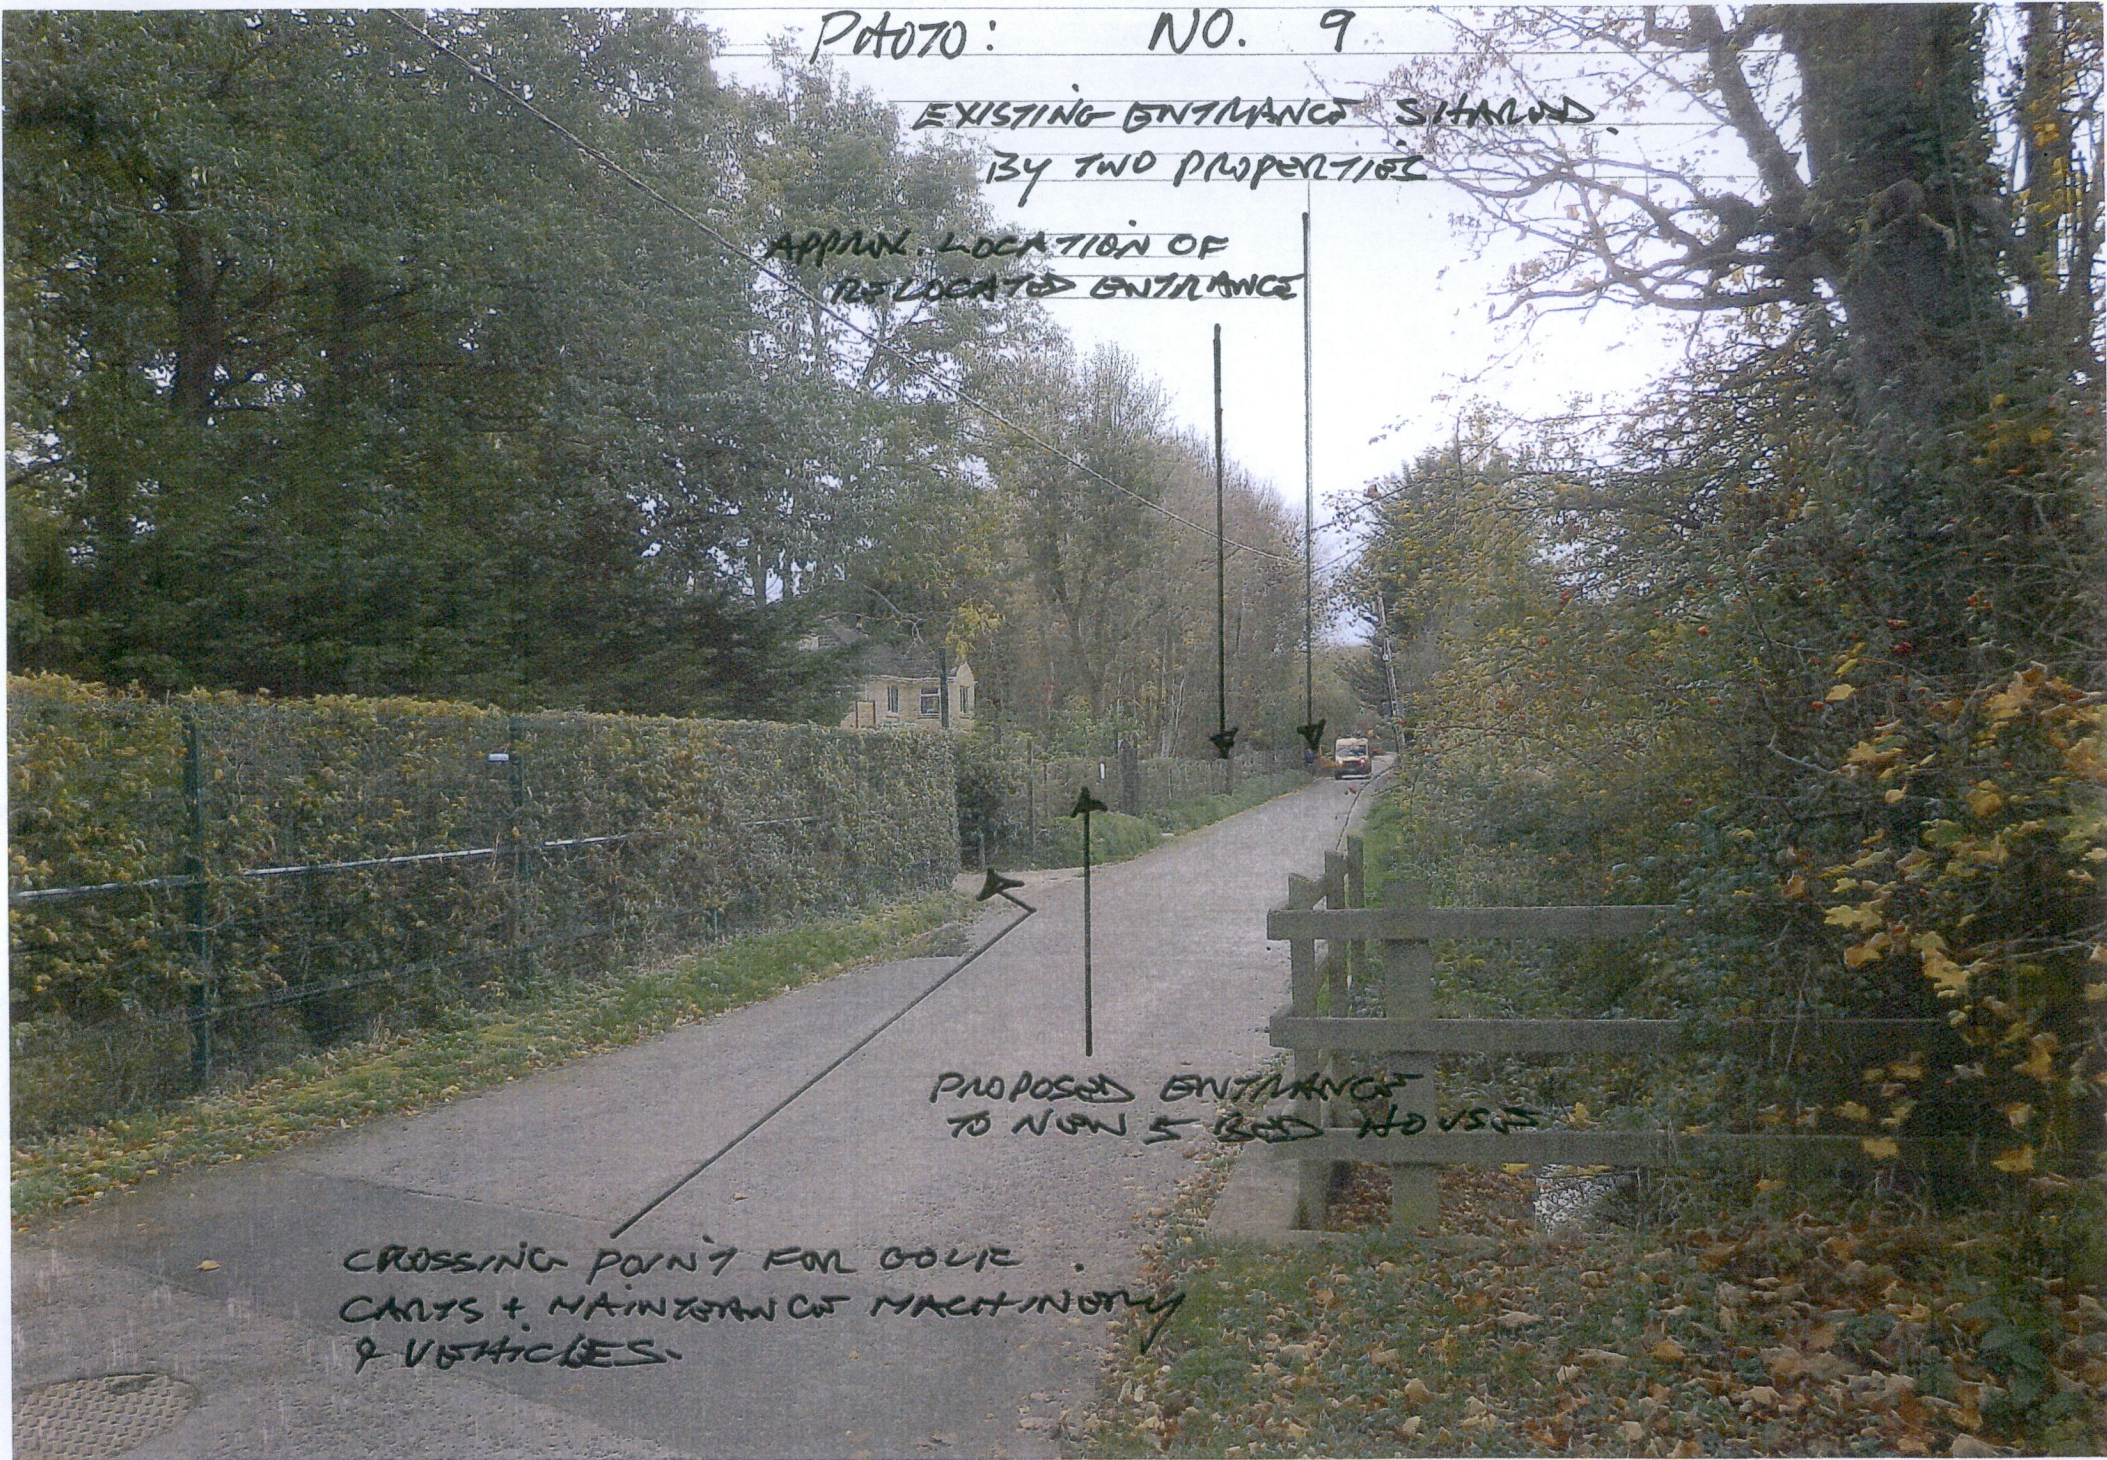
PHOTO: NO. 9

EXISTING ENTRANCE SHOWN
BY TWO PROPERTIES

APPROX. LOCATION OF
RELOCATED ENTRANCE

PROPOSED ENTRANCE
TO NEW 5 BED HOUSE

CROSSING POINT FOR GOLF
CARTS + MAINTENANCE MACHINERY
& VEHICLES.

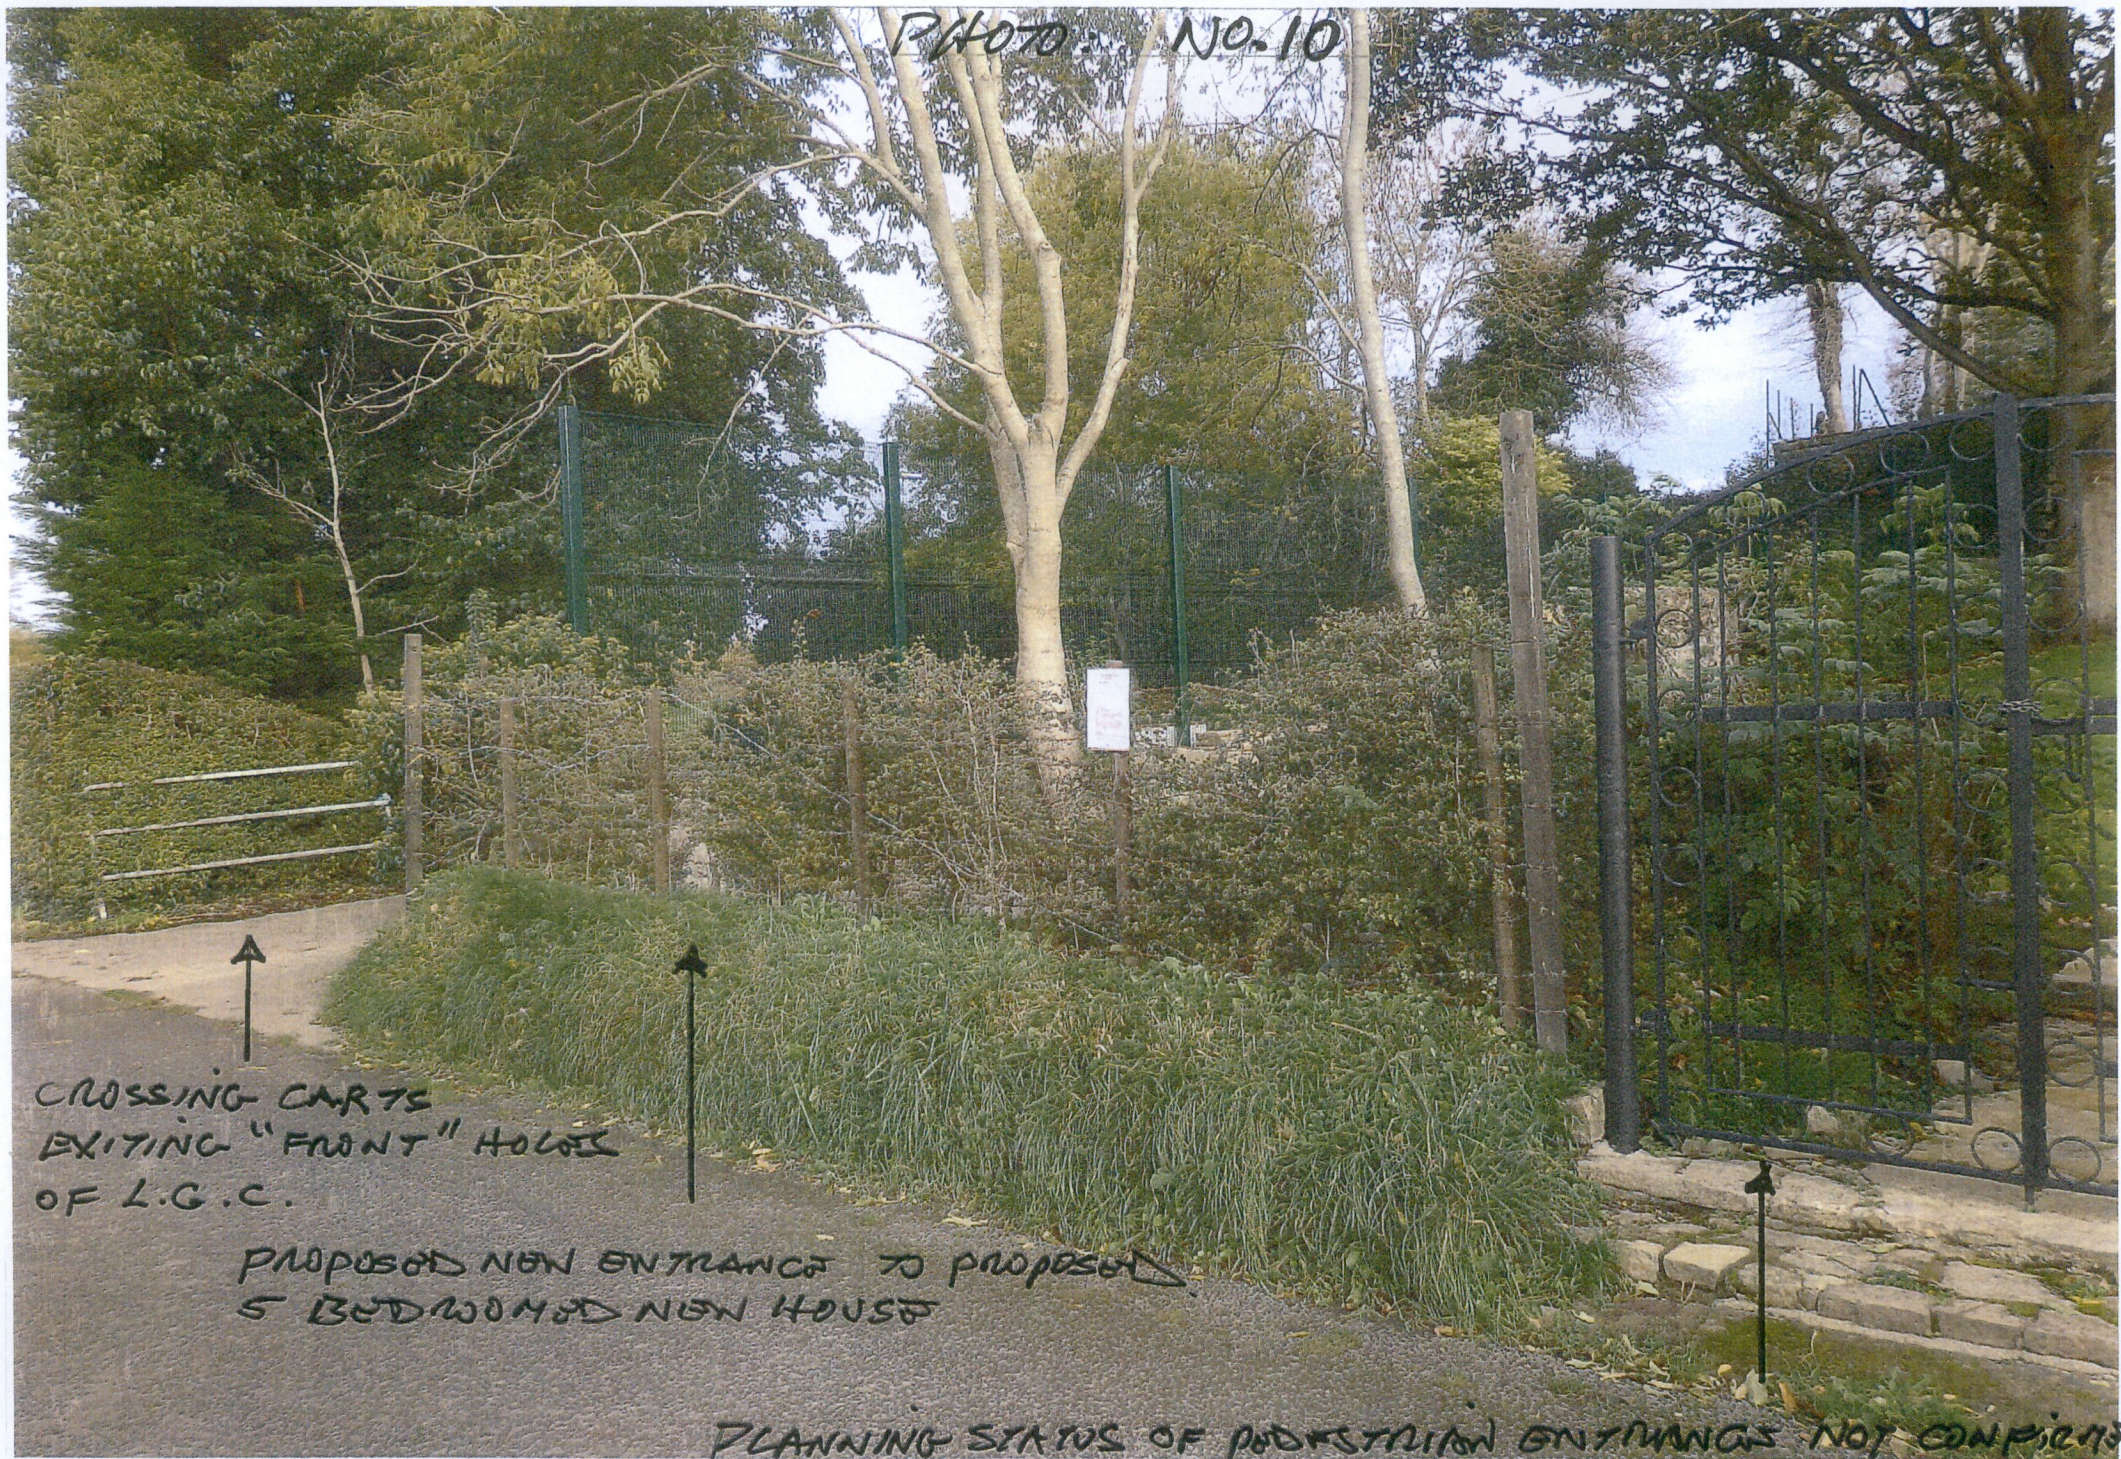
PHOTO NO. 10

CROSSING CARTS
EXITING "FRONT" HOLES
OF L.G.C.

PROPOSED NEW ENTRANCE TO PROPOSED
5 BEDROOM NEW HOUSE

PLANNING STATUS OF PROPOSED ENTRANCES NOT COMPLETED

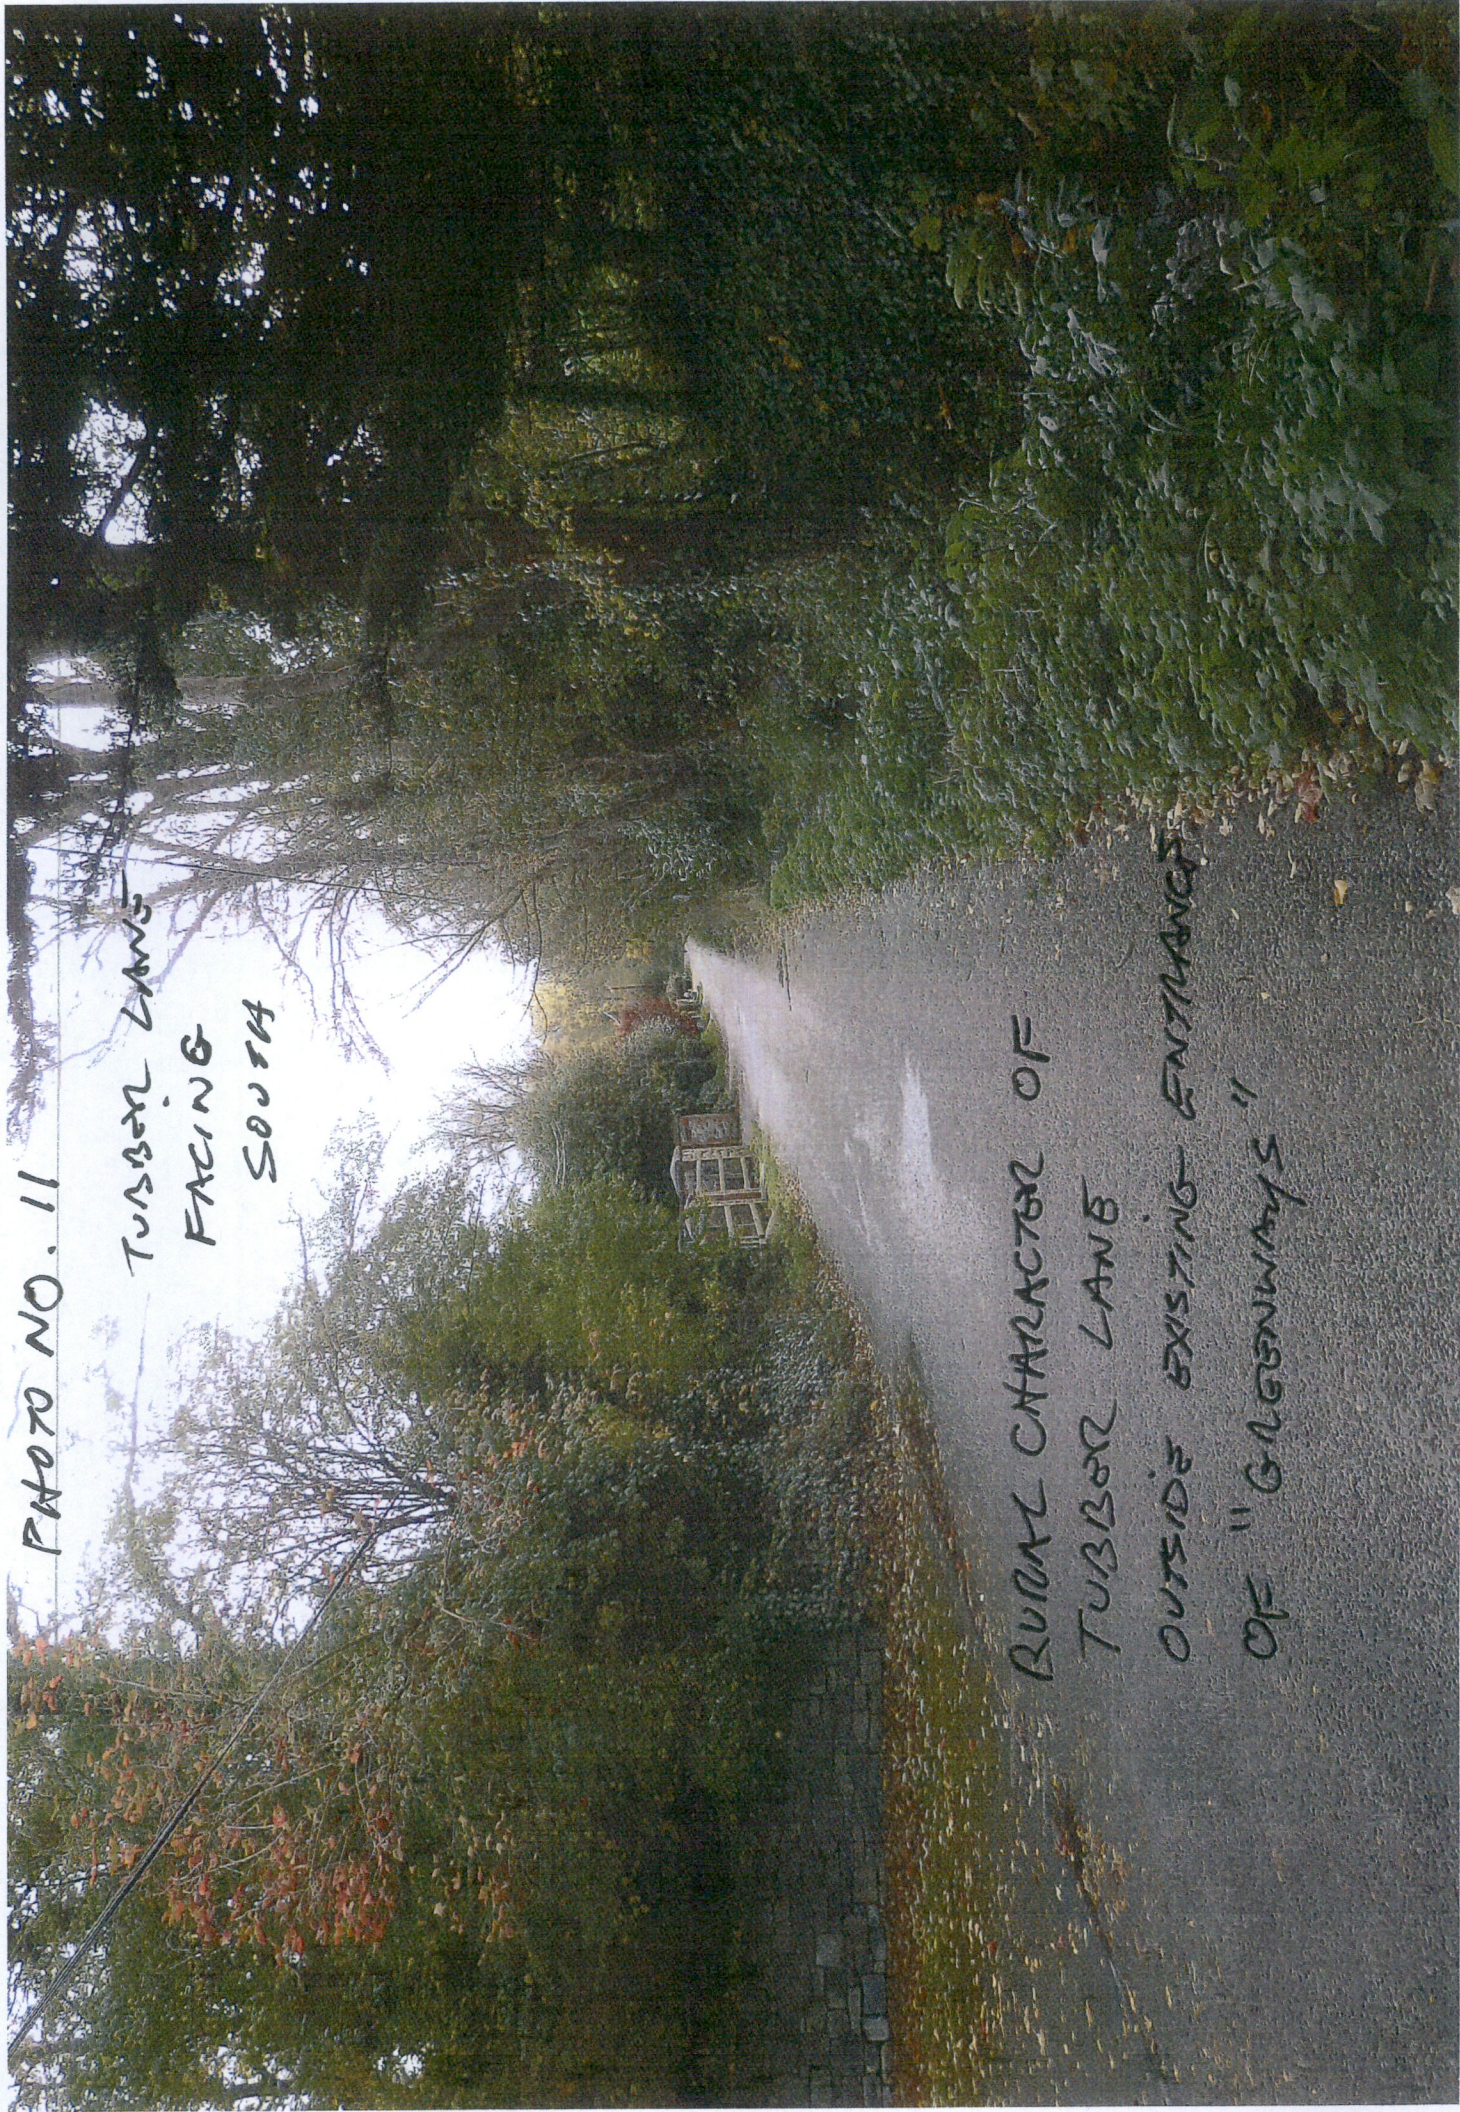
PHOTO NO. 11

TUBBON LANE
FACING
SOUTH

RURAL CHARACTER OF
TUBBON LANE
OUTSIDE EXISTING ENTRANCE
OF "GARDENWAYS"

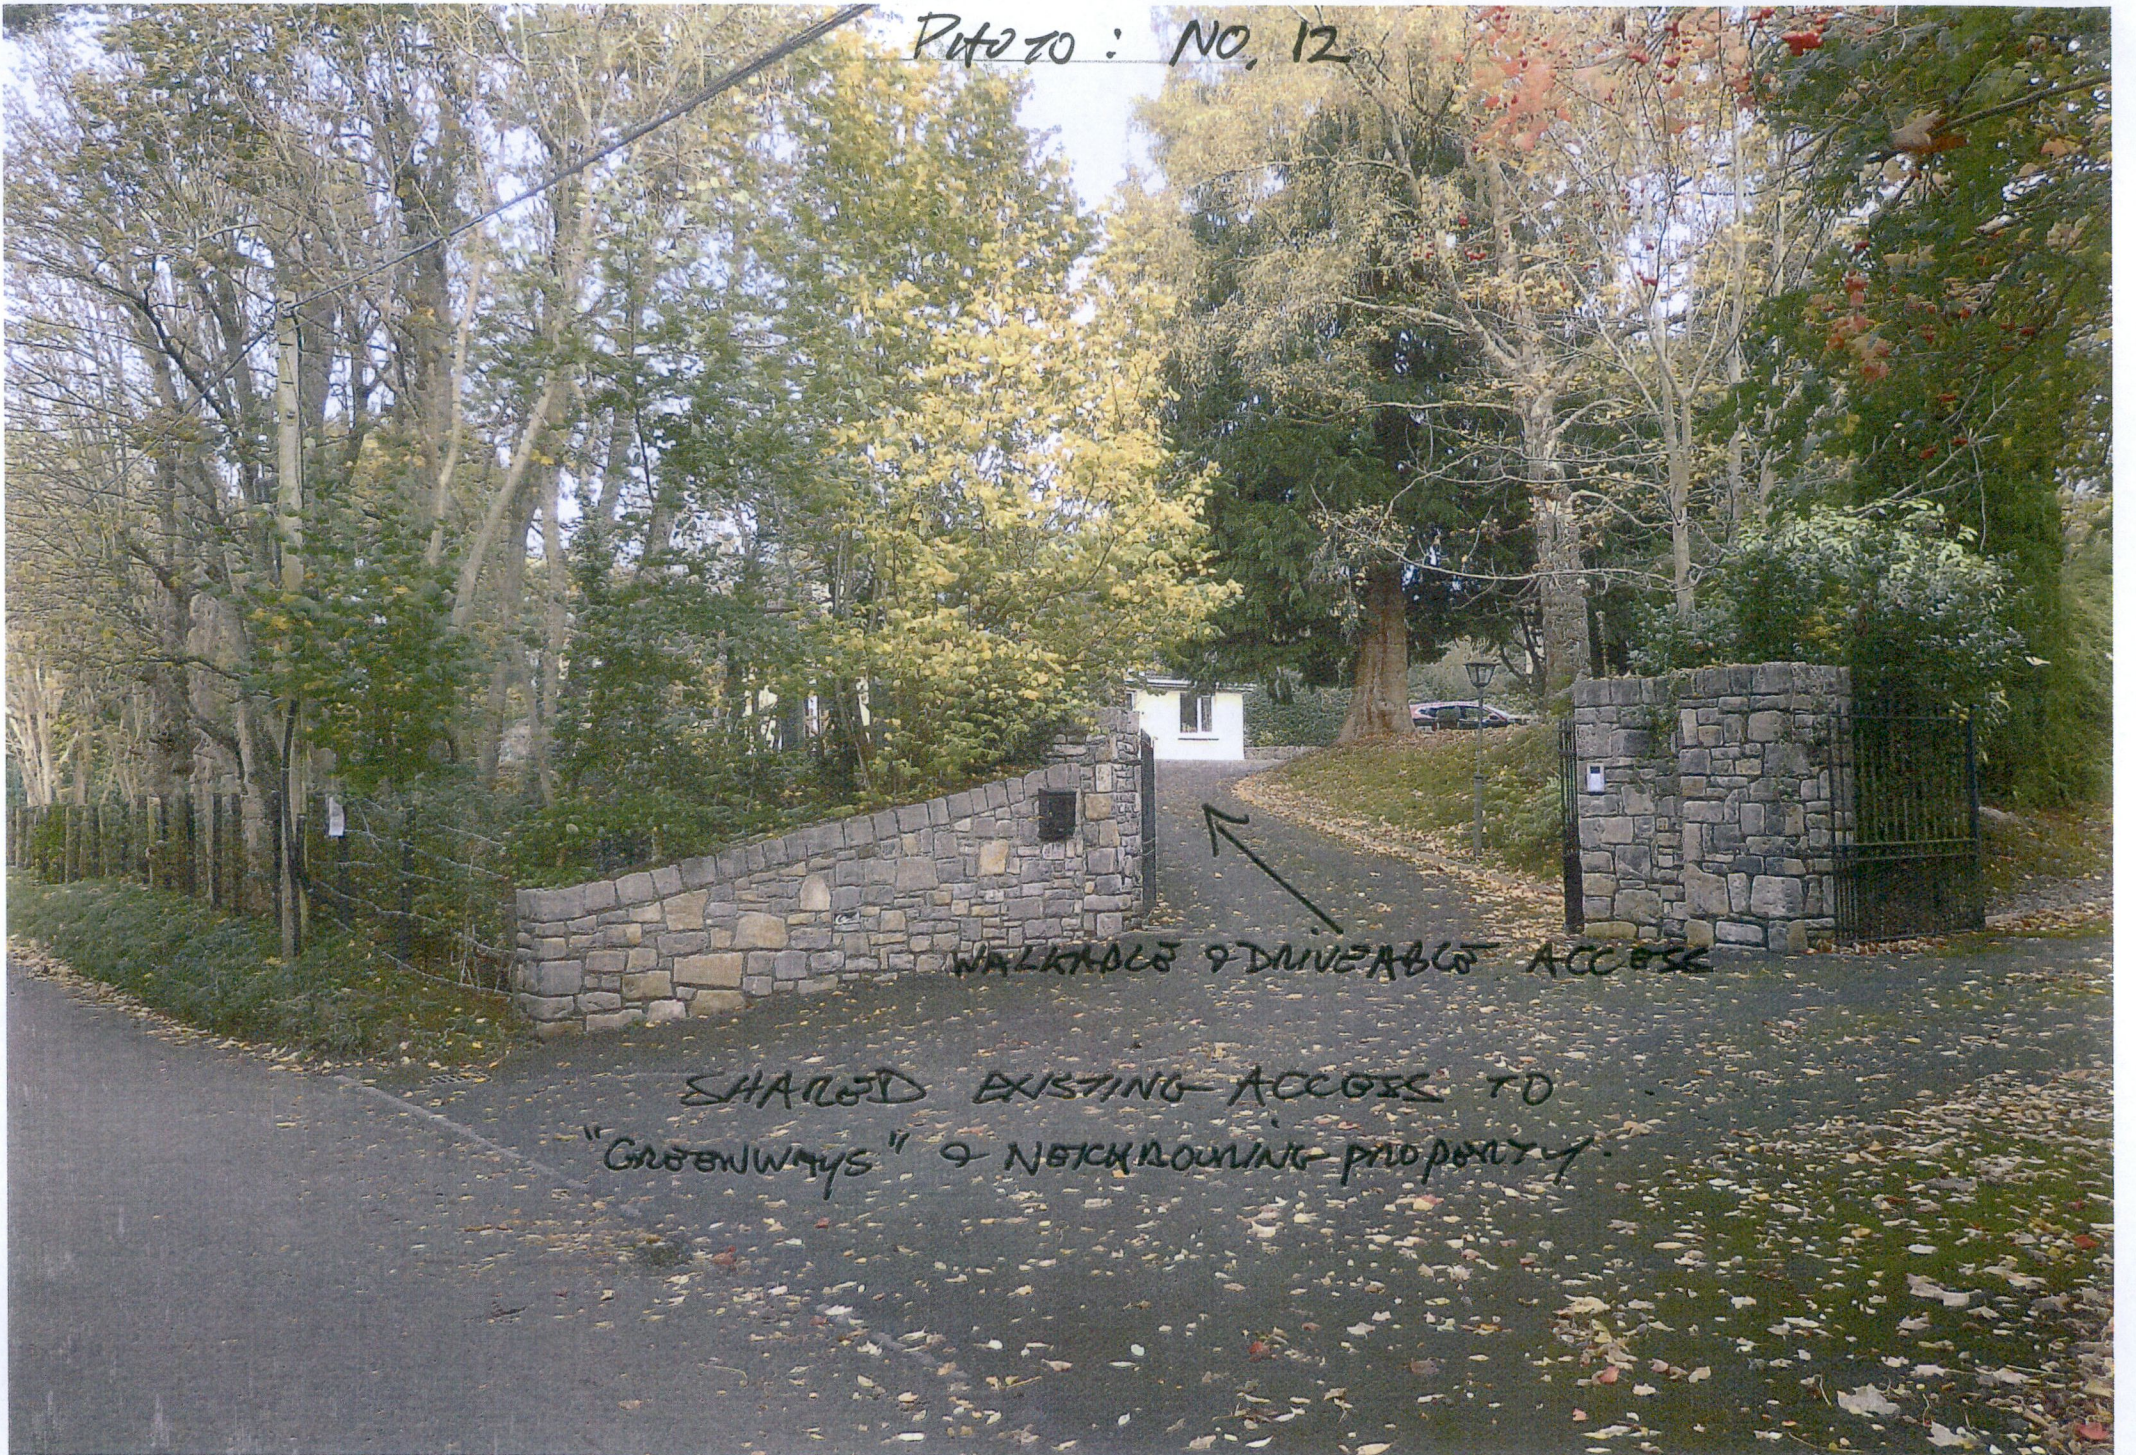
Photo : NO, 12

WALKABLE & DRIVEABLE ACCESS

SHARED EXISTING ACCESS TO
"GREENWAYS" & NEIGHBORING PROPERTY.

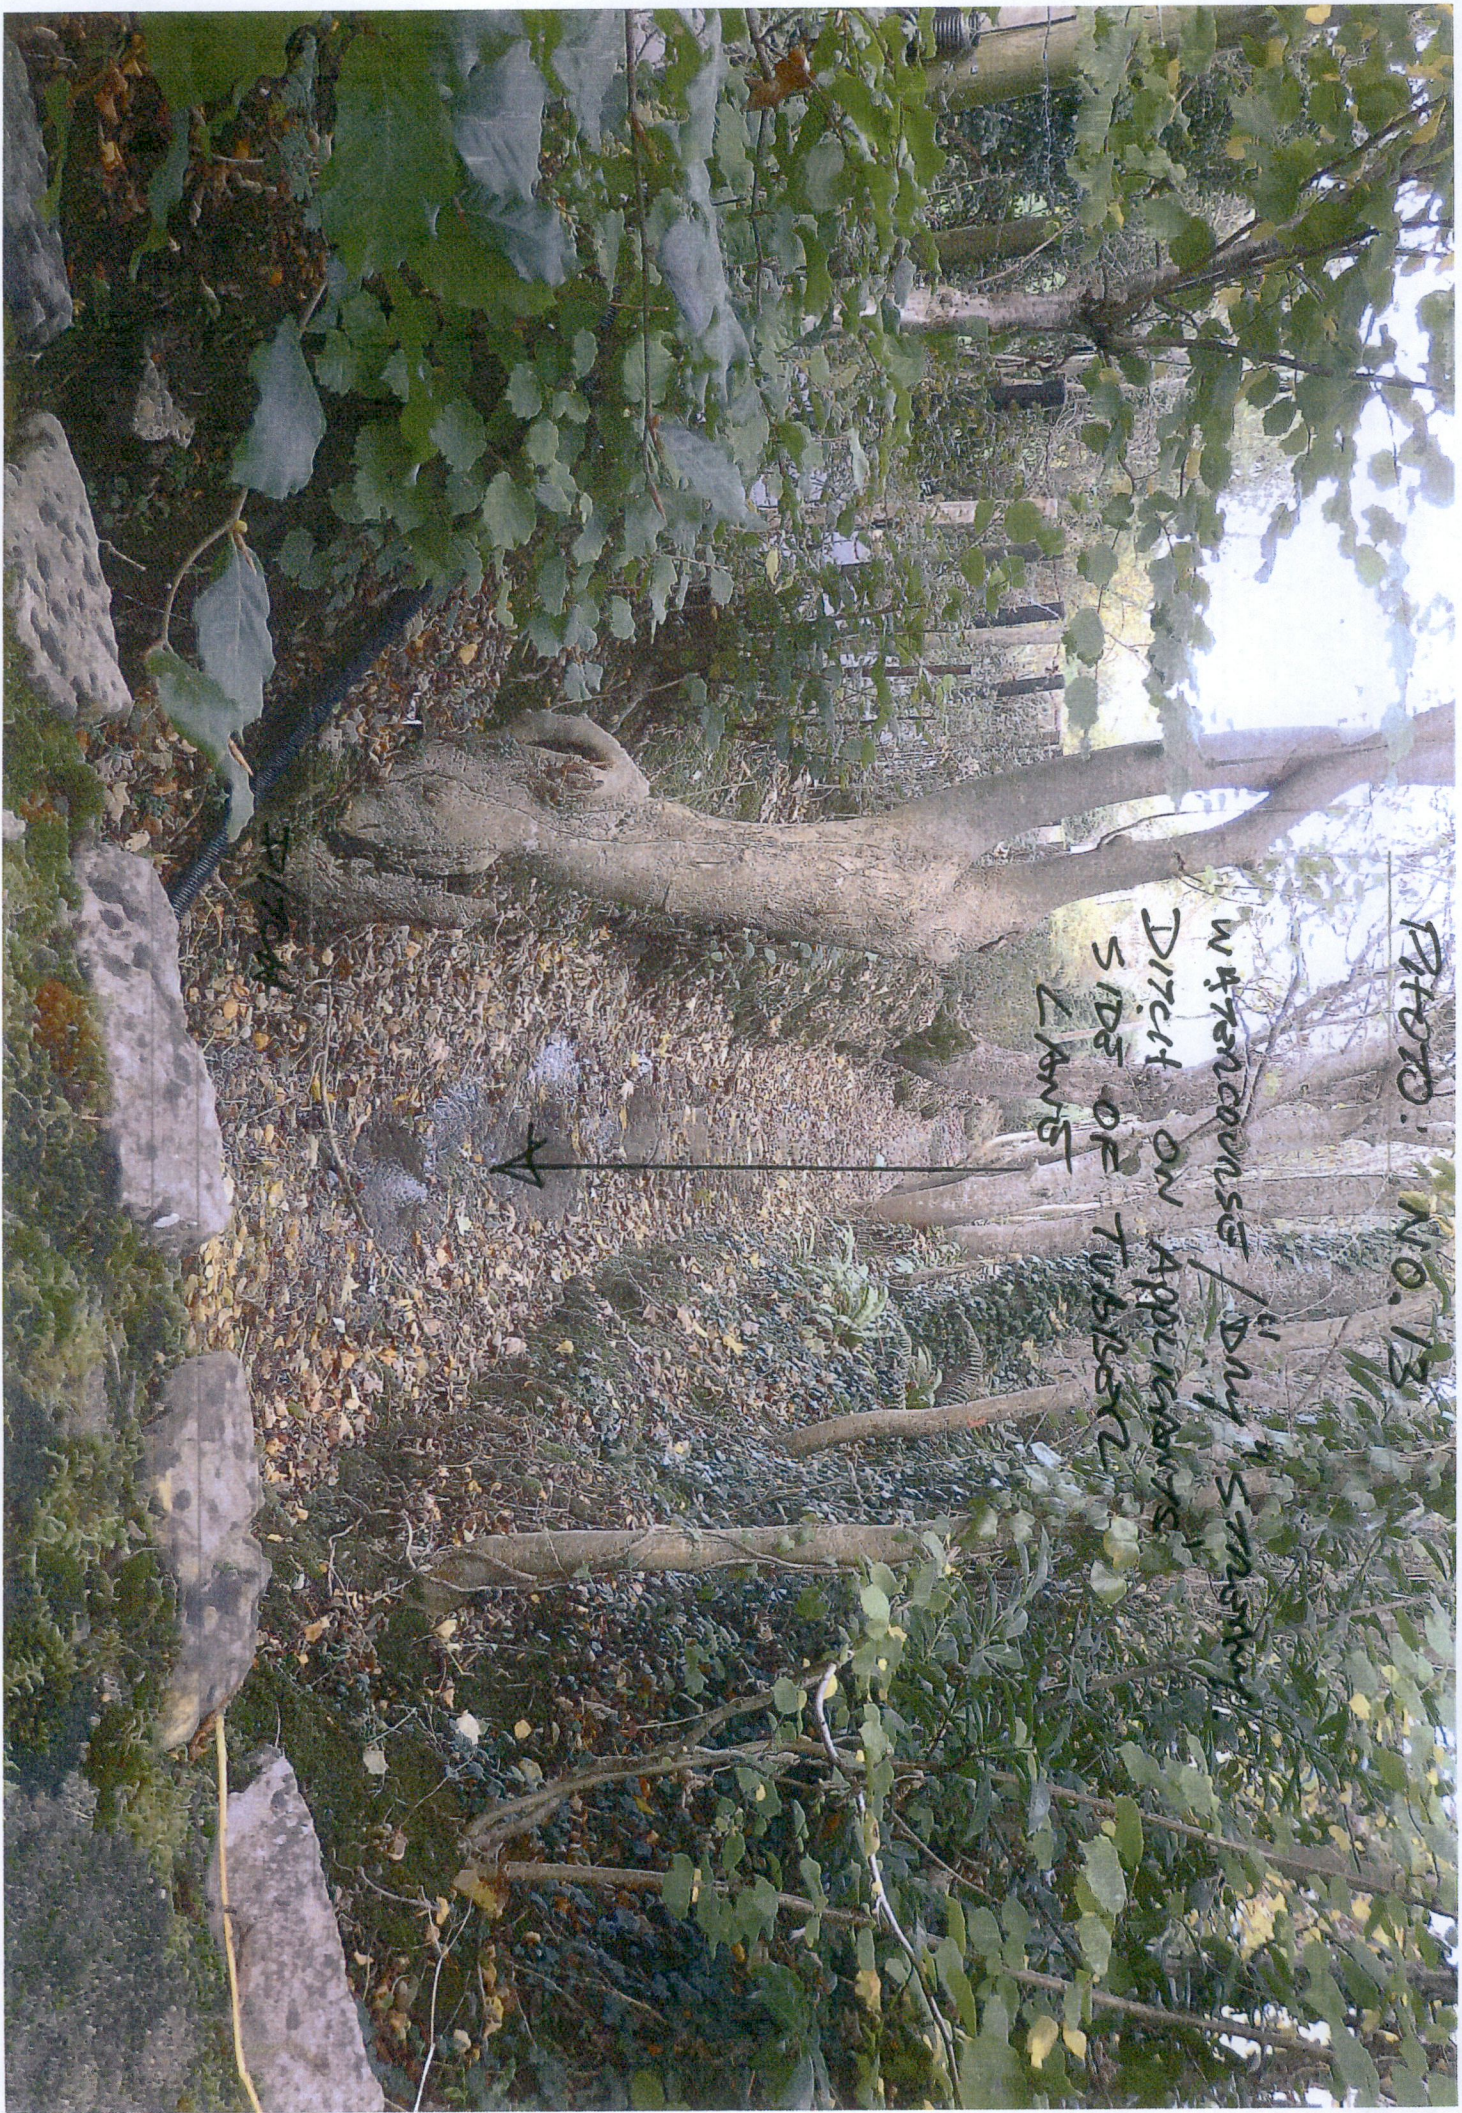
PHOTO: NO. 13

WATERCOURSE / "DIP" SINKING
DIRT ON APPLICANTS
SIDE OF TUBER
LAWNS

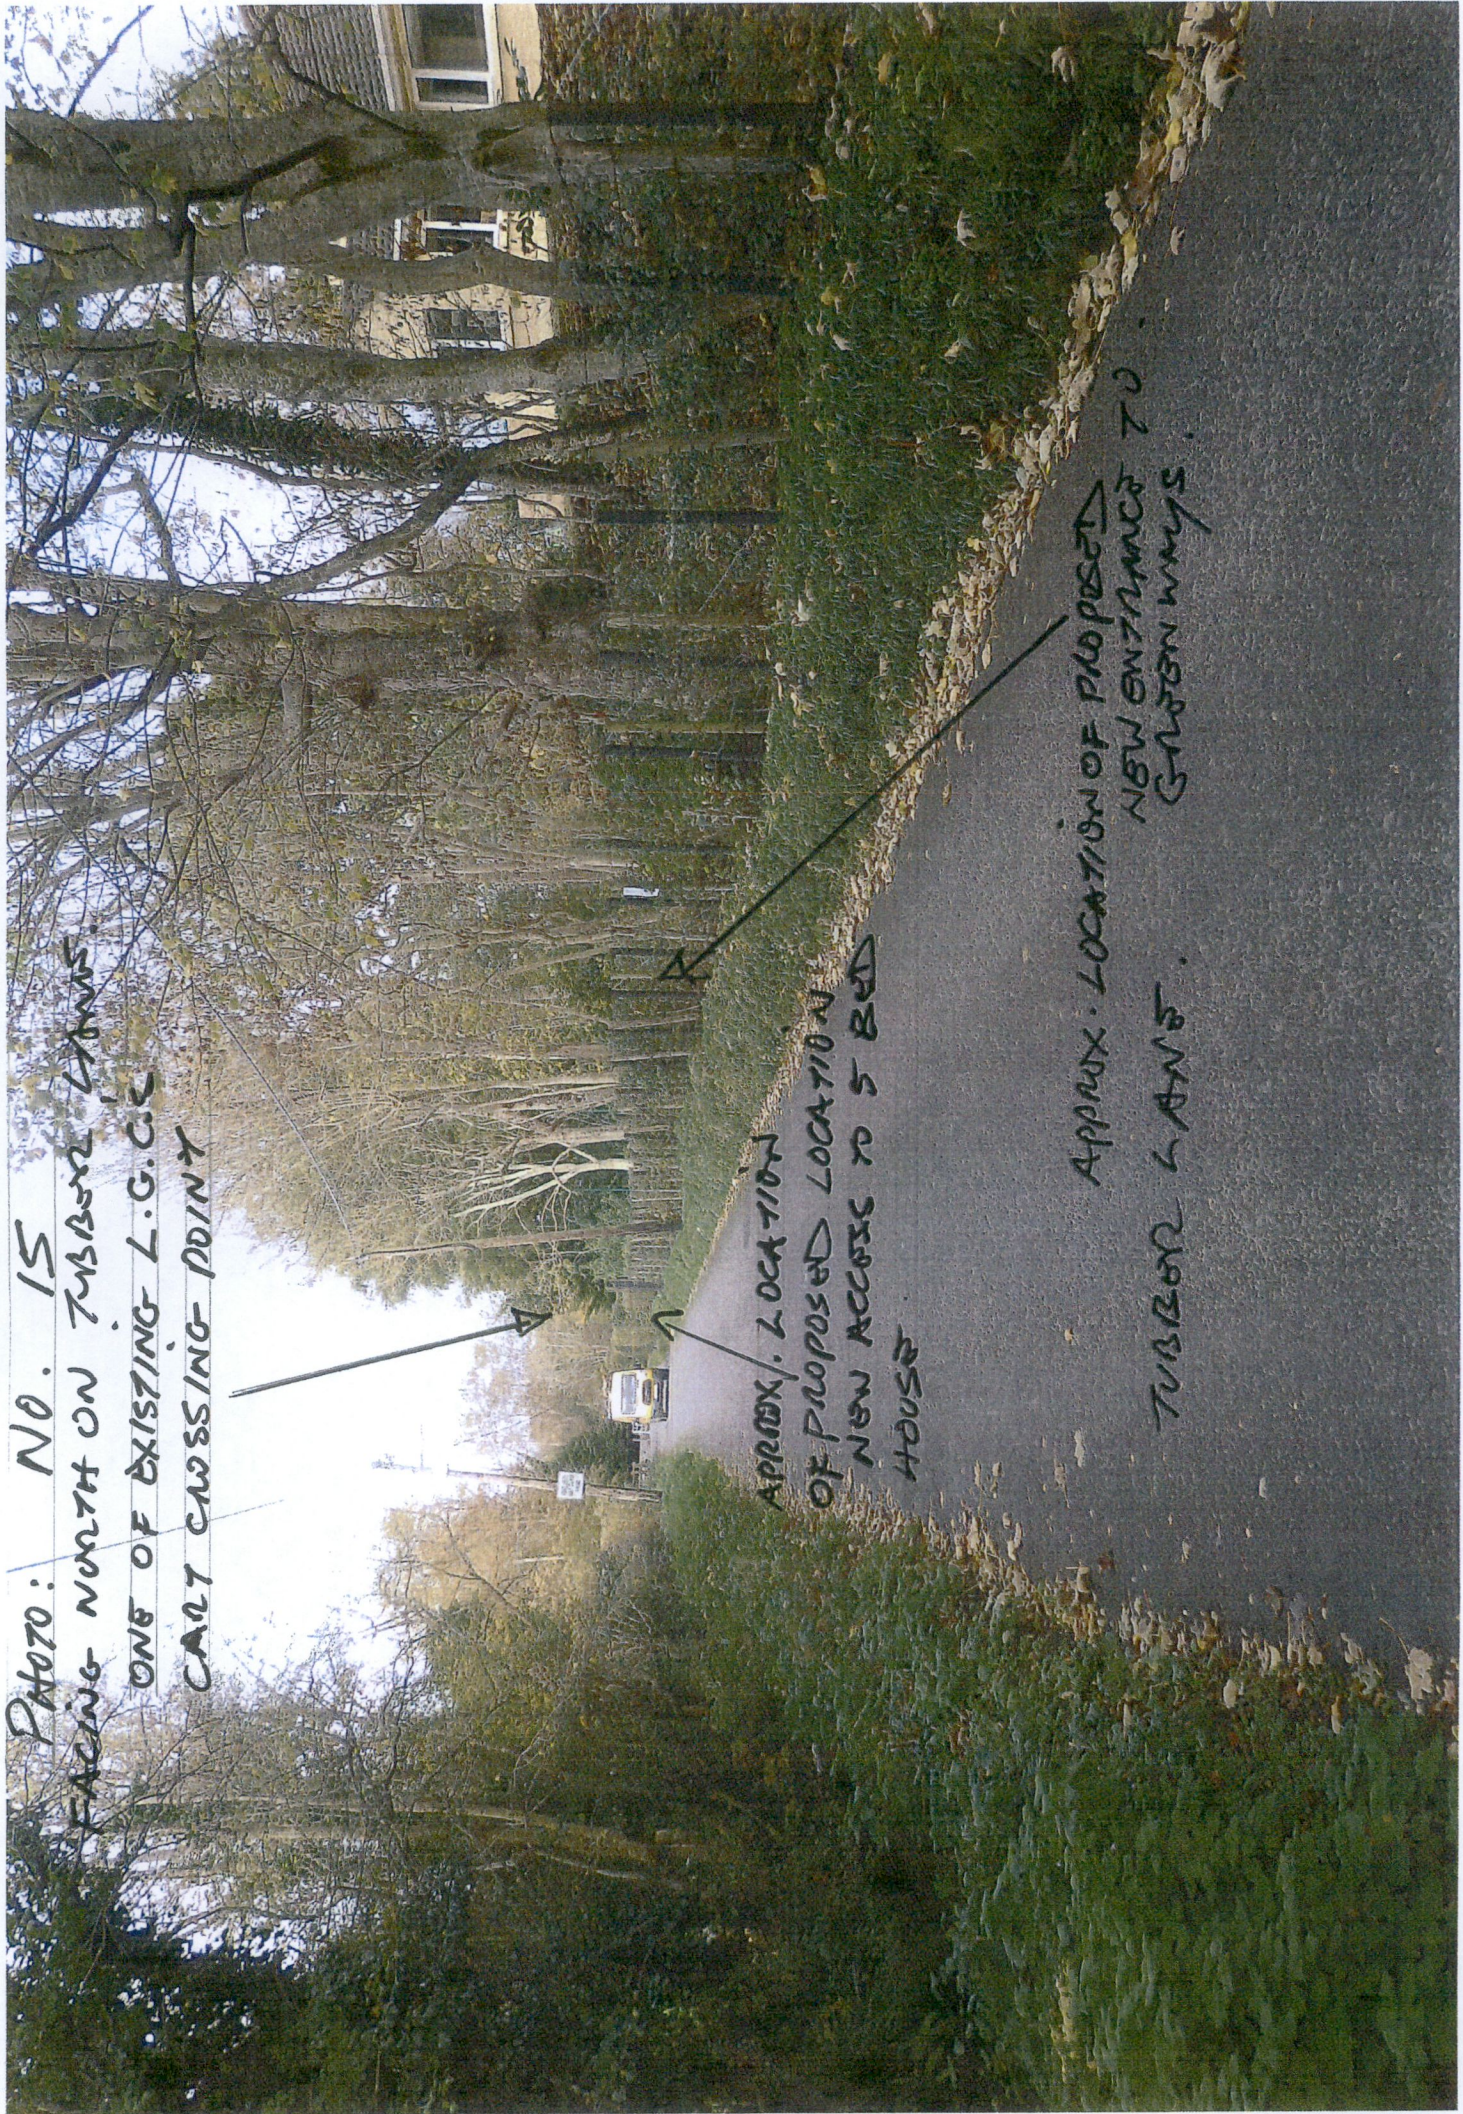
PHOTO: NO. 15
FACING NORTH ON TUBBON LANE
ONE OF EXISTING L.G.C.C.
CART CROSSING POINT

APPROX. LOCATION
OF PROPOSED LOCATION
NEW ACCESS TO 5 BED
HOUSE

APPROX. LOCATION OF PROPOSED
NEW ENTRANCE TO
GARDEN WAYS.
TUBBON LANE
