Arboricultural Report

Tree Survey,
Arboricultural Impact Assessment &
Arboricultural Method Statement

Scholarstown House
Scholarstown Road
Dublin 16

October 2022

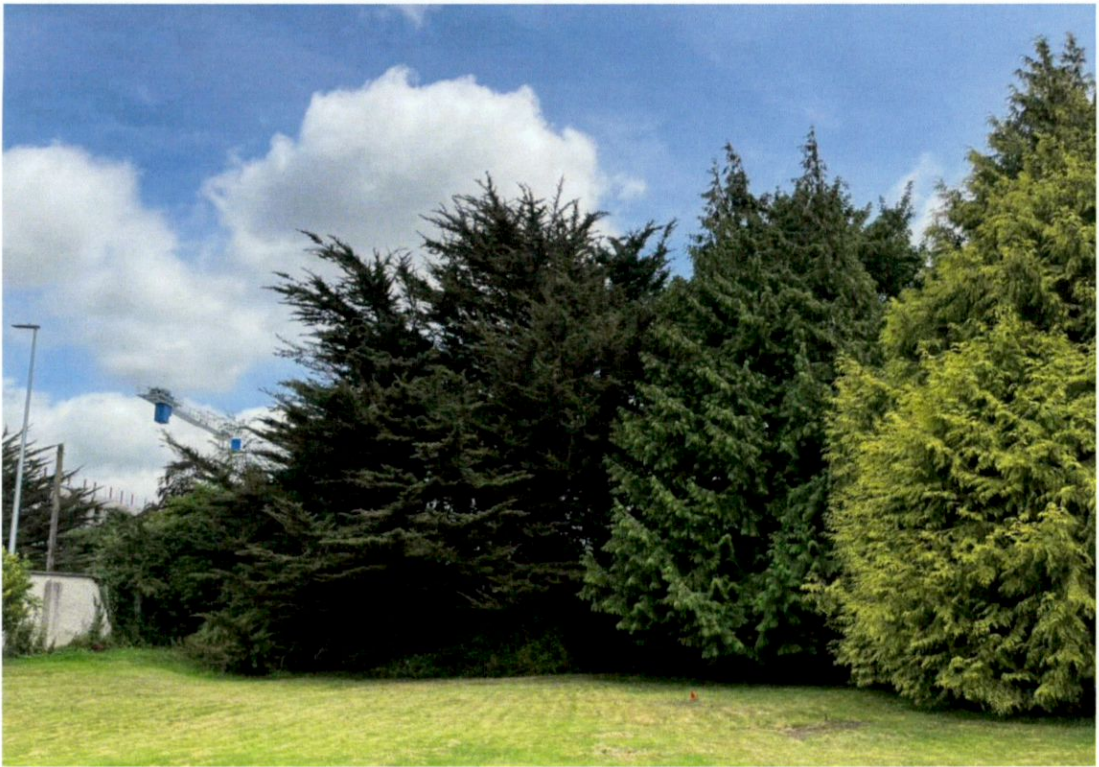
Photo 1: View of the Monterey cypress trees T11 to T14 and western red cedar trees T7 to T9 located on the eastern side of the site.

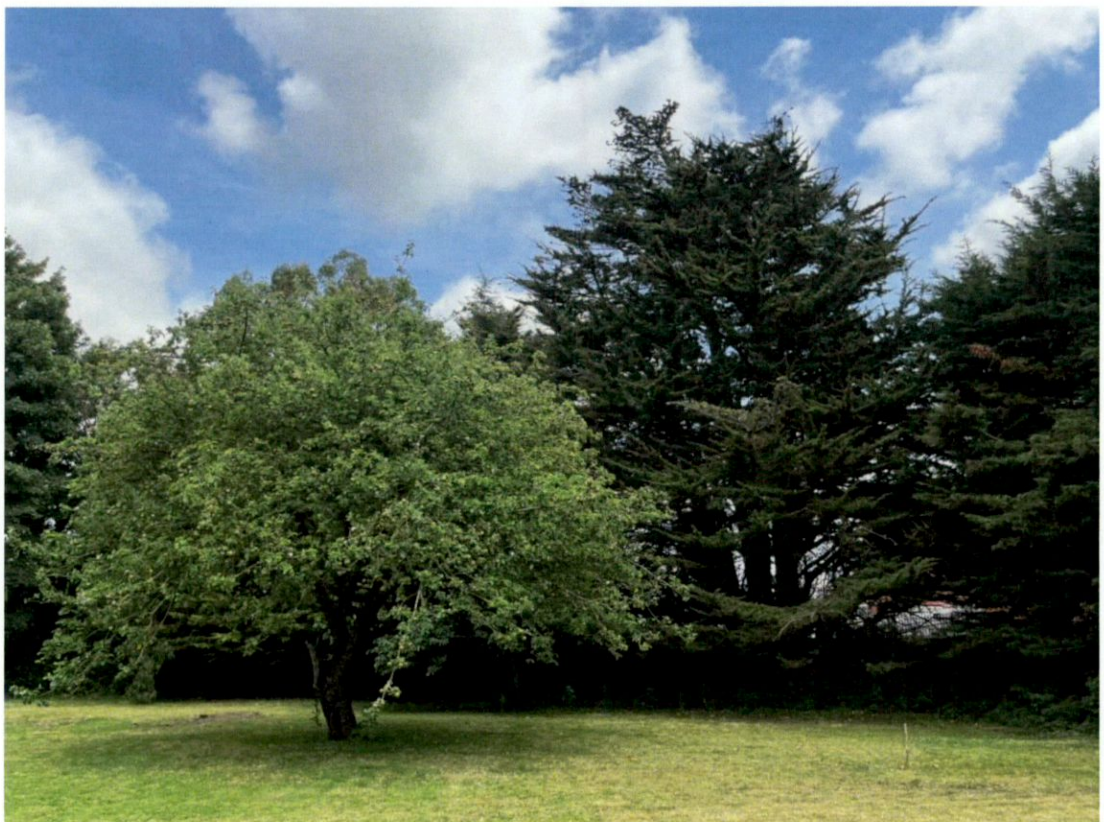
Photo 2: View of the mature apple tree T27 and Monterey cypress T25 located in the south-eastern corner of the site.

- 6.15 A new boundary wall is proposed to be constructed within the RPA of tree T25. Conventional strip foundations in this instance would have a negative impact on the rooting structure of the tree and therefore, special engineered foundations, such as helical piles and an above-ground beam will be required. The use of helical piles will ensure that excavation works will be localised to small holes only while the above-ground beam will bridge over the main rooting area of the tree. Each pile location will require preliminary excavation holes to undercover areas where significant tree roots are not present and will not be affected.

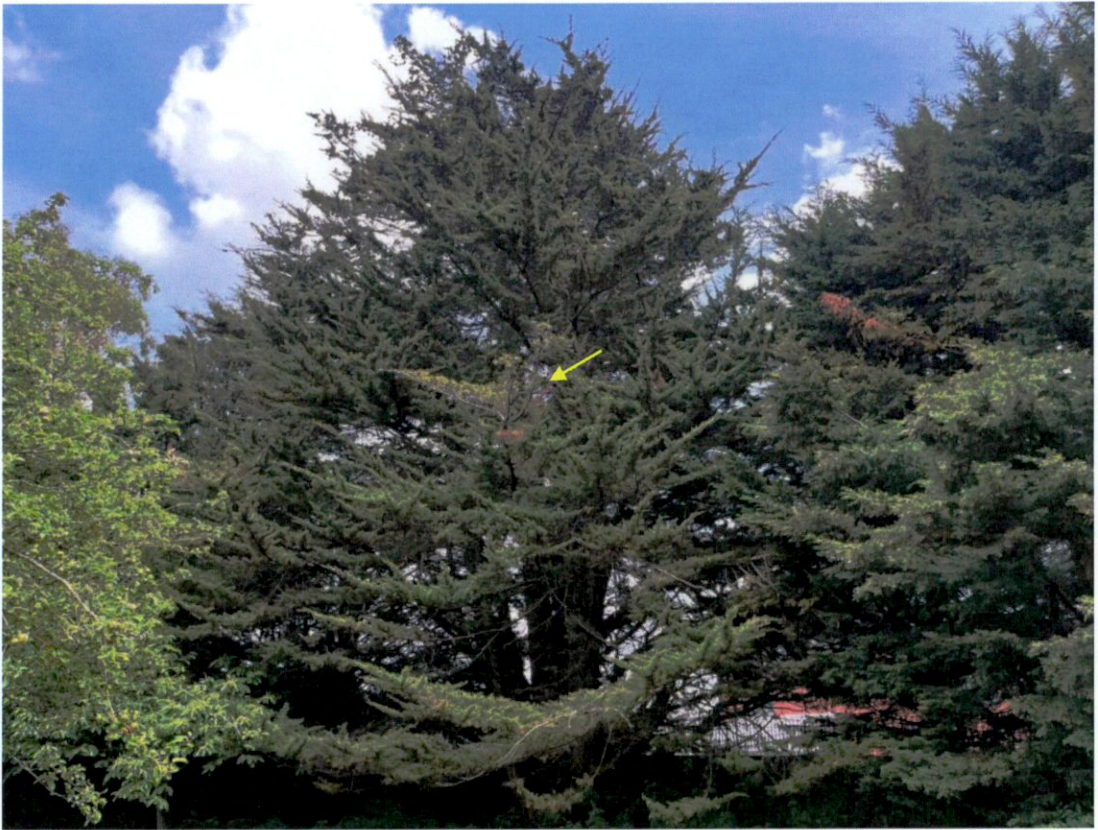
Photo 3: View of the branch dieback and browning of foliage observed in the canopy of the Monterey cypress tree T25. This is caused by the fungal pathogen Seiridium canker.

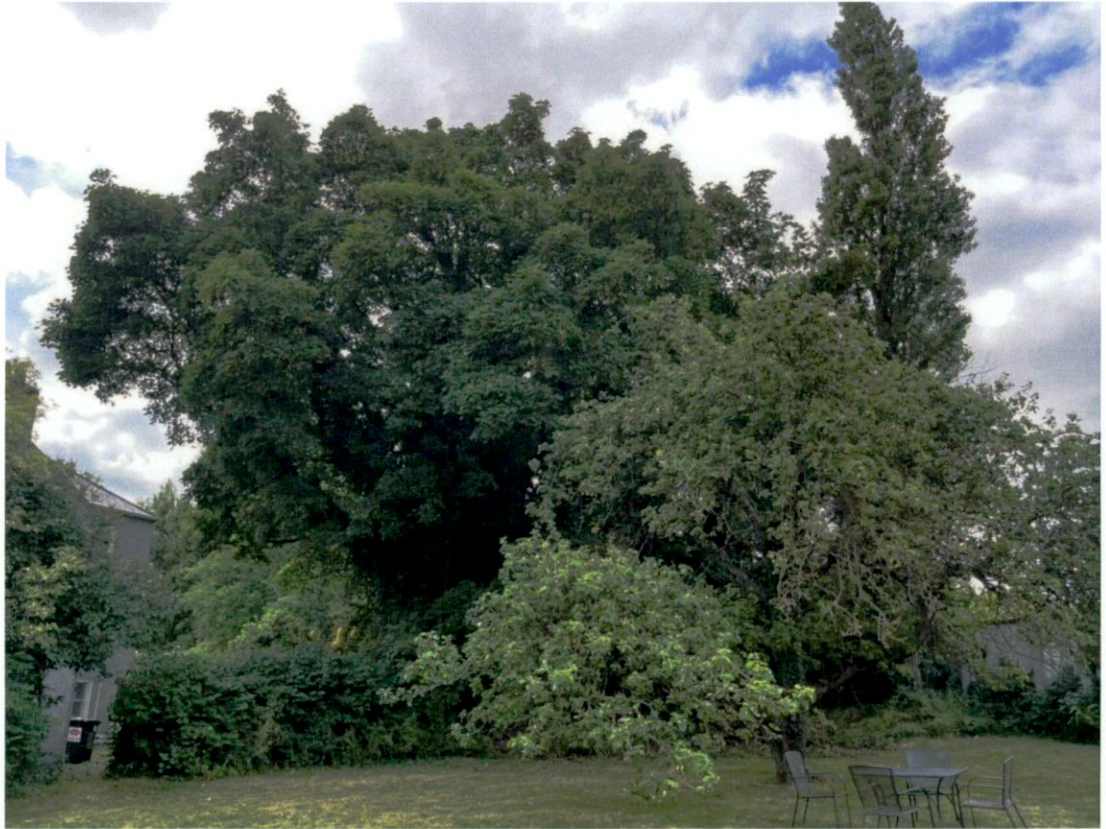
Photo 5: View of the apple tree T41, sycamore T42, and Lombardy poplar T43, located adjacent to the roundabout at Scholarstown Road.
