# **Arborist Associates Ltd.**

## **An Arboricultural Assessment of the Hedgerow Vegetation within the Site Area at 'Redgap', Rathcoole, Co. Dublin.**

**Prepared for: Mr. Pearse McKiernan (Planning Applicant)**

**Date: 1<sup>st</sup> September 2022**

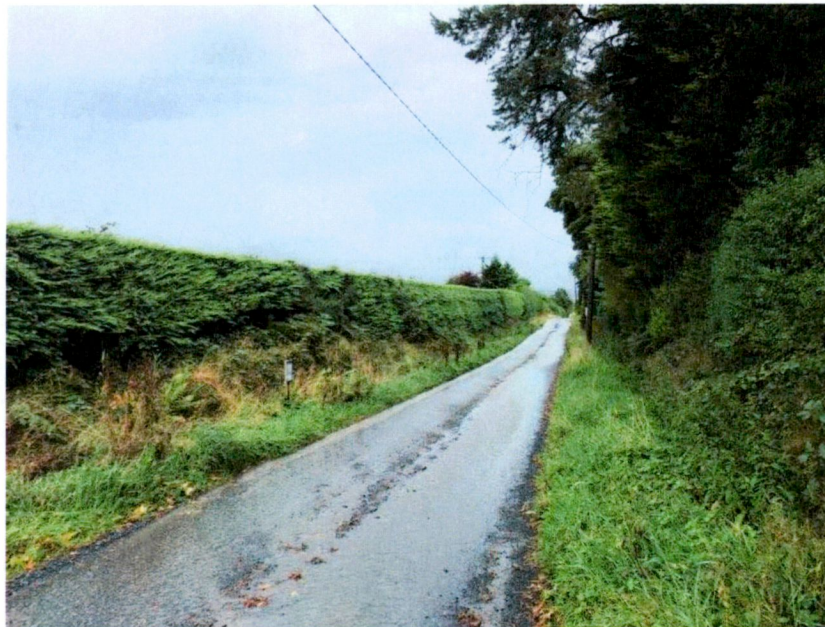
- 3.3 **Hedge No.1** is located on the site side of the original boundary hedge along the southern boundary with the public road. The bulk of the original hedgerow has been removed/lost over the years to leave one clump of Hawthorn at the western end with some pockets of Bramble and Gorse.

Planted on the inside of the original hedgerow soil bank is a line of Leyland Cypress (*Cupressocyparis leylandii*) trees of an early-mature age class in fair condition both physiologically and structurally. This has been regularly trimmed to maintain as a formal hedge with a height on average of 3 meters (m) and a crown spread of 4m. It forms a good screen barrier along this road and has been given a category grade scoring of 'C2' as per the cascade chart in BS5837 2012.

**Photograph No: 1:** Shows Hedge No.1 looking eastwards along the boundary with the public road.

- 4.3 This existing tree and hedge vegetation will require ongoing maintenance to maintain within this area, and in particular Hedge No.1 will require regular trimming to maintain its formal hedge structure.

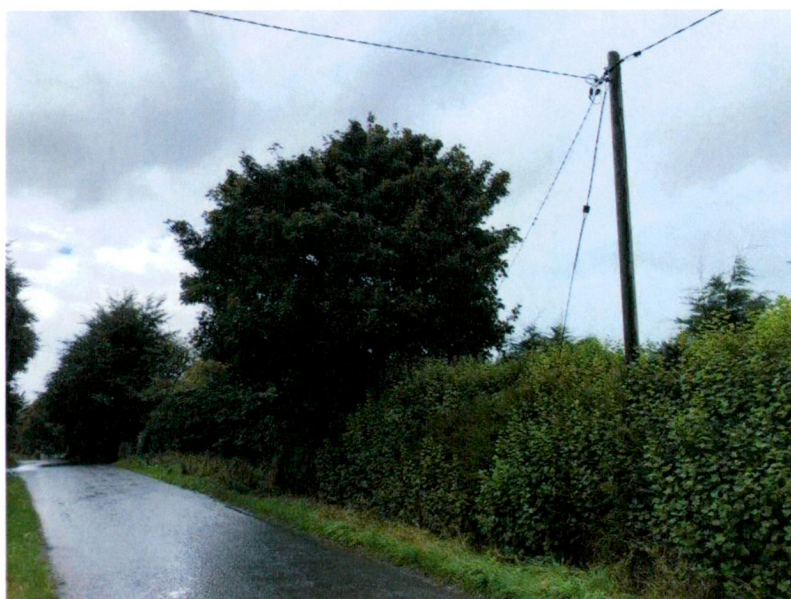
- 3.4 **Tree No.1** is located at the western end of Hedge No.1 to the right of an existing field entrance. This is a Sycamore (*Acer pseudoplatanus*) of an early-mature age class in fair/good condition both physiologically and structurally. It most likely established itself here from seed and was allowed to grow up into a tree. It subdivides into two stems at a height of c.1.7m with a slightly acute union formation between stems and the lower branches have been removed previously in order to raise up its crown over Hedge No.1 and the surrounding surfaces. This tree is of good quality with the potential to provide medium to long-term tree cover and as a result, it has been given a category grade scoring of 'B1' as per the cascade chart of BS5837 2012. It has a trunk diameter of 520mm, a crown spread on average of 8m diameter, a total tree height of 11m and crown clearance over the surrounding surfaces of 3.5m.

**Photograph No. 2:** Shows Tree No.1 at the western end of Hedge No.1.

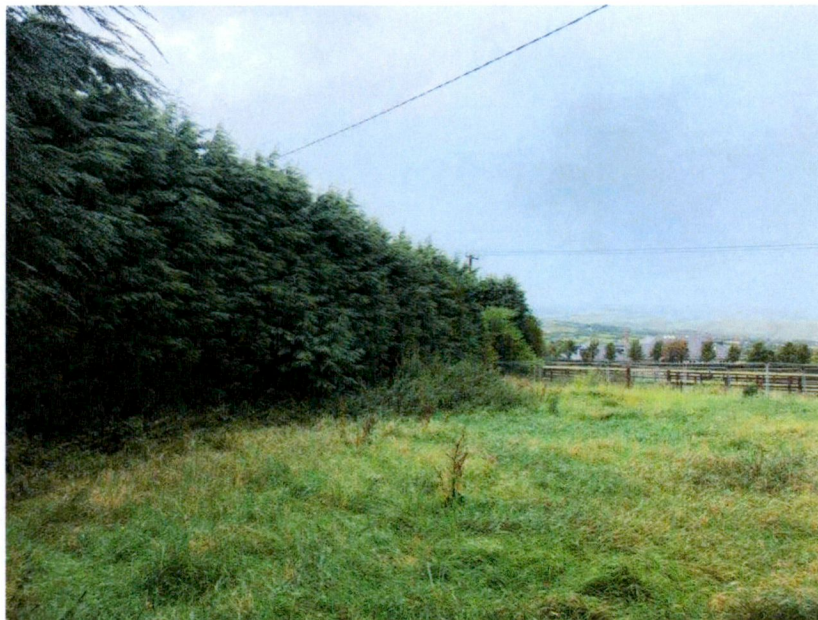
- 3.5 **Tree Line No.1** runs at ninety degrees to Hedge No.1 and extends down along the western boundary. It is located on the adjoining property side of the stud rail fence and may be located on the adjoining property side of the boundary. It consists of a double line of Leyland Cypress of an early-mature age class in fair/good condition physiologically and in fair condition structurally. They have grown up together to form part of the one group canopy formation and provide support/shelter to one another. They have a total tree height of c.12m with a trunk diameter on average of 200mm and a crown spread of 6m diameter. They have received cutting in the past of their lower branches on the site side to a height of c.5m and this has helped to maintain their lower foliage to ground level and to form a good dense screen barrier. This tree line has been given a category grade scoring of 'C2' as per the cascade chart in BS5837 2012.

Photograph No.3: Shows Tree Line No.1 along the western boundary.
