SOIL CHARACTERISATION AND
SITE SUITABILITY ASSESSMENT REPORT
TE REF: 21/712A TE

BRIAN DUNNE
LYNBROOK
WHITECHURCH RD
RATHFARNHAM
DUBLIN 16
SITE A

IN ACCORDANCE WITH
EPA CODE OF PRACTICE
WASTEWATER TREATMENT AND DISPOSAL
SYSTEMS SERVING SINGLE HOUSES 2021

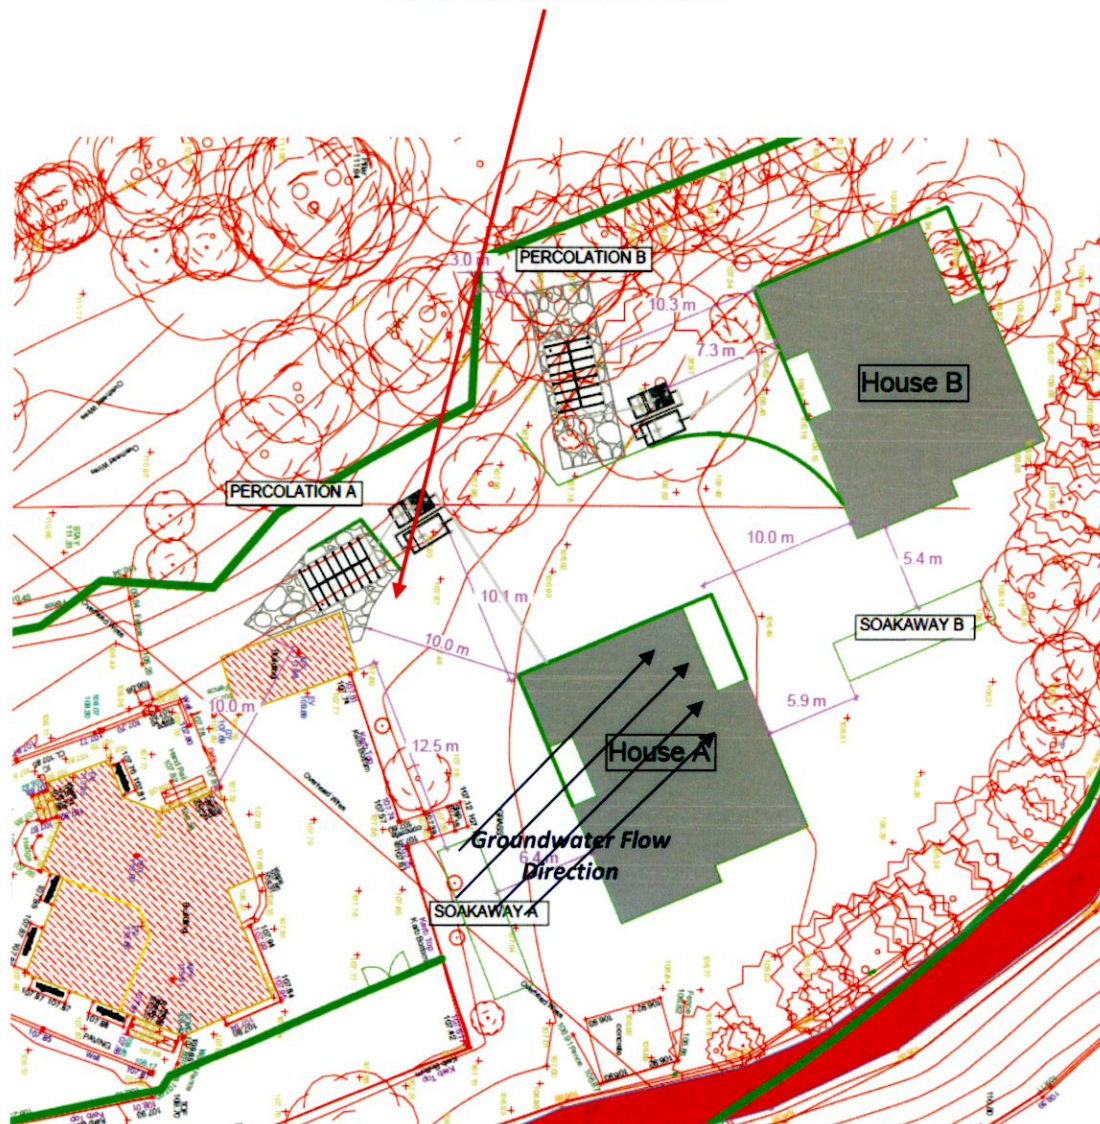
SITE LAYOUT DRAWING SHOWING TEST HOLE LOCATIONS

*Approximate Location of Trial Hole & Percolation
Test Holes Examined on 24.09.21*

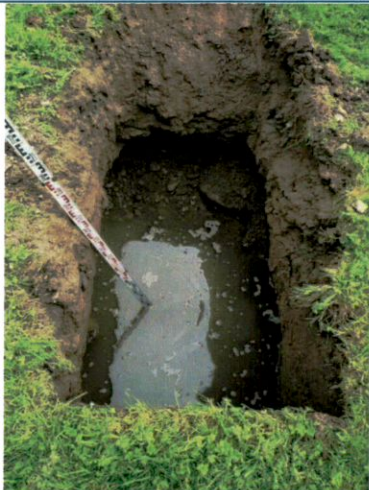
Trial Hole – Front View

According To The Flowchart For Describing Subsoil's based on BS5930:1999, the subsoil is best described as Clay intermixed with stone & Gravel

Groundwater was encountered in the trial hole at a depth of 1.40m BGL. Winter Groundwater was encountered in the trial hole at a depth of 1.10m BGL. Bedrock was not encountered in the trial hole.

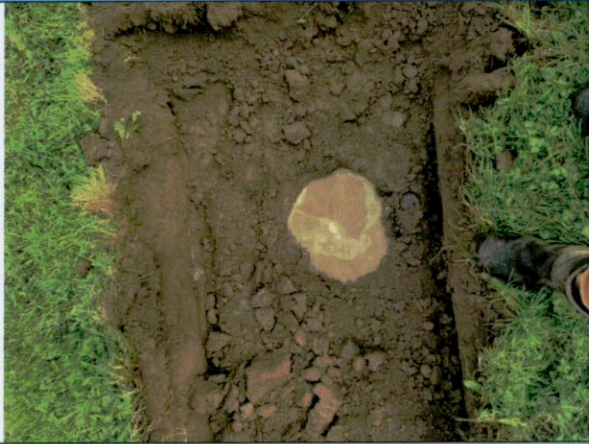
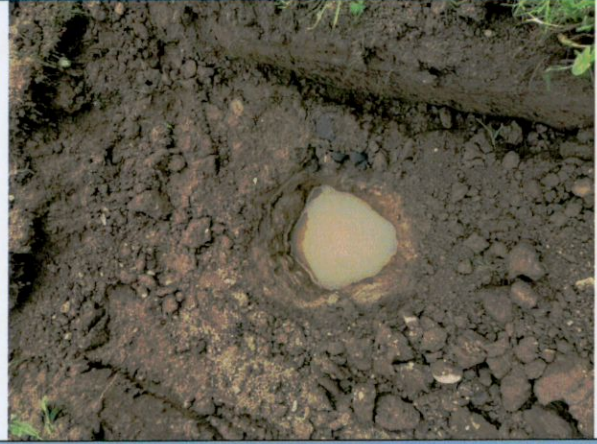
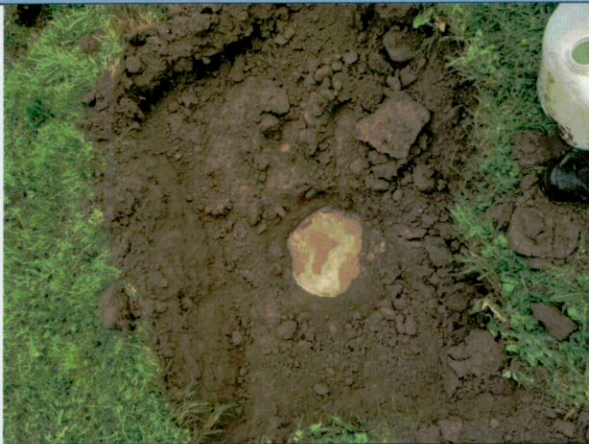
Result of Test: Subsurface
Percolation Value: 28.57 min/25mm

**Result of Subsurface Percolation: 28.57min/25mm.
Good Percolation Characteristics of the Surface Material.**

Percolation ("Sub-surface") Test 1

Percolation ("Sub-surface") Test 2

Percolation ("Sub-surface") Test 3

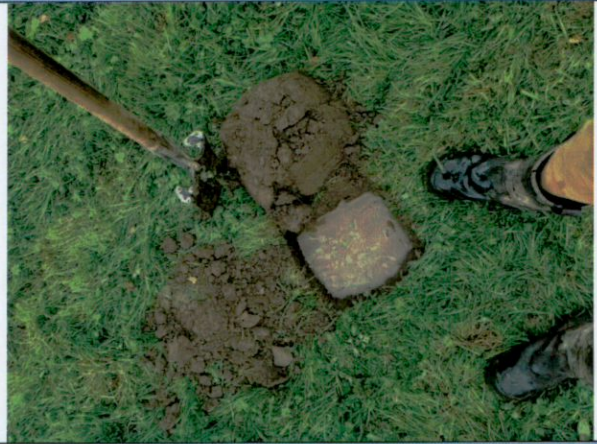
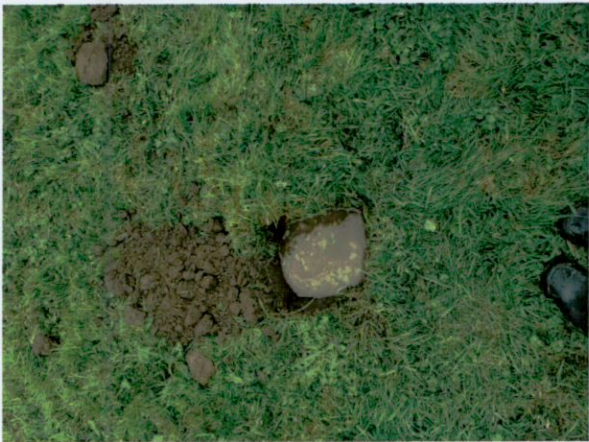
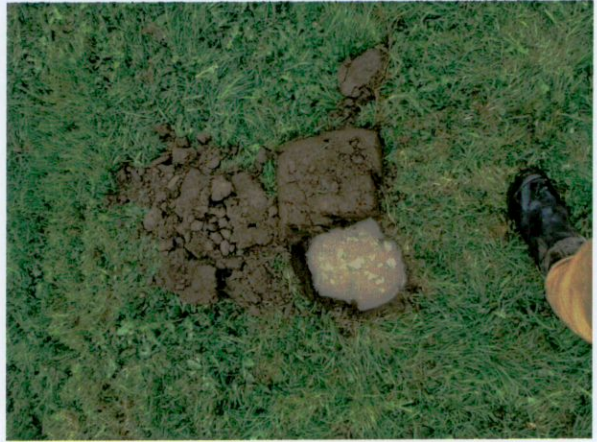
Percolation ("surface") Test 1

Percolation ("surface") Test 2

Percolation ("surface") Test 3

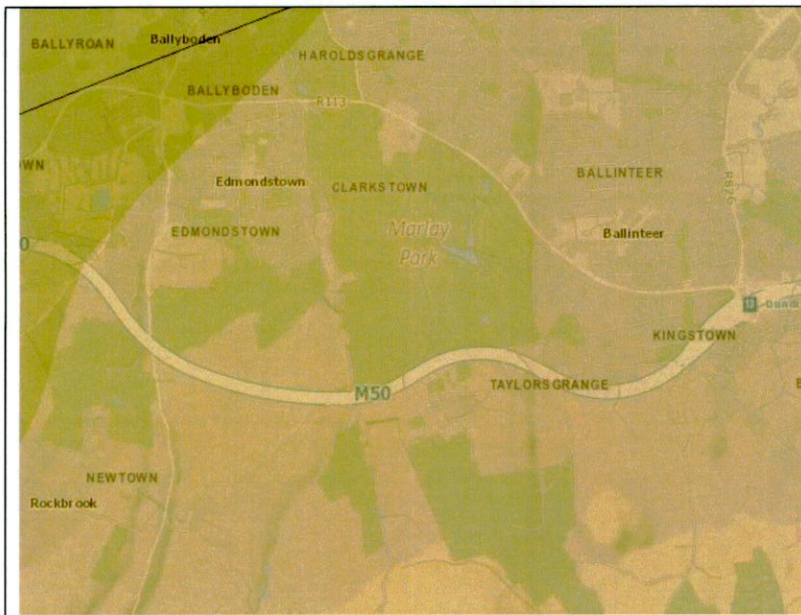
Groundwater/Aquifer Map

From the GSI Groundwater Aquifer Map Site is classified as P1- Poor Aquifer - Bedrock which is Generally Unproductive except for Local Zones

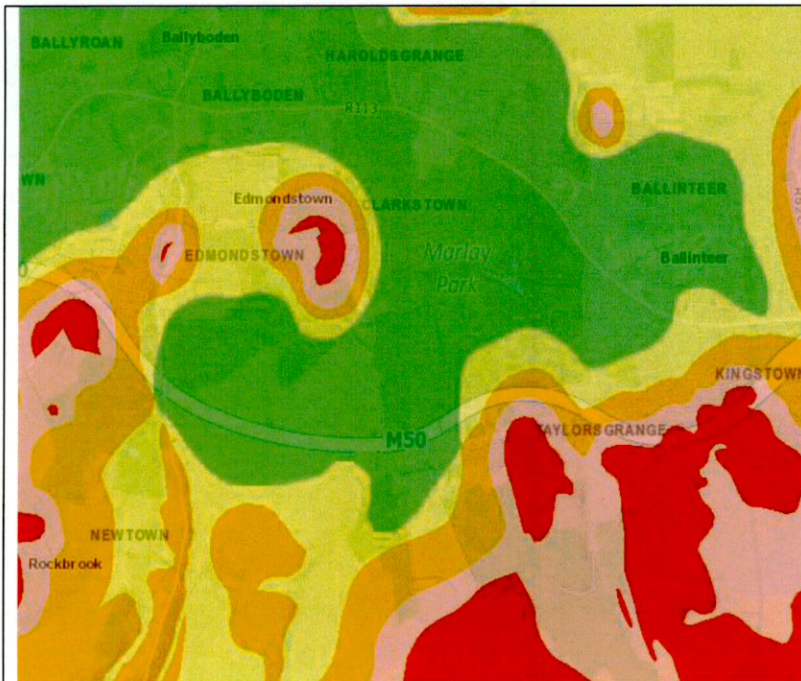
From the GSI Vulnerability Map Site is classified as Low
