Arboricultural Survey & Report

Client: Richie O'Farrell

Site: Lynnbrook, Whitechurch Rd, Rathfarnham, Dublin 16

Gary Doherty, Dermot Casey Tree Care Ltd.

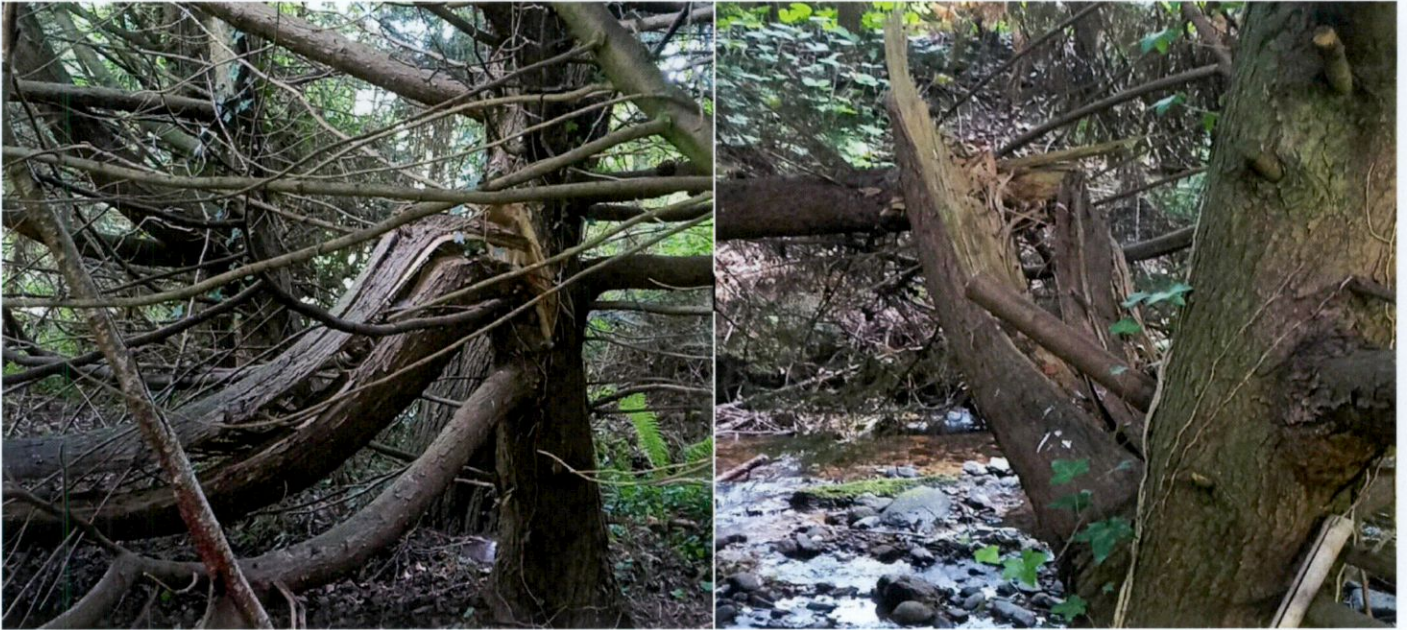
FIG 3 – Large branch fractures

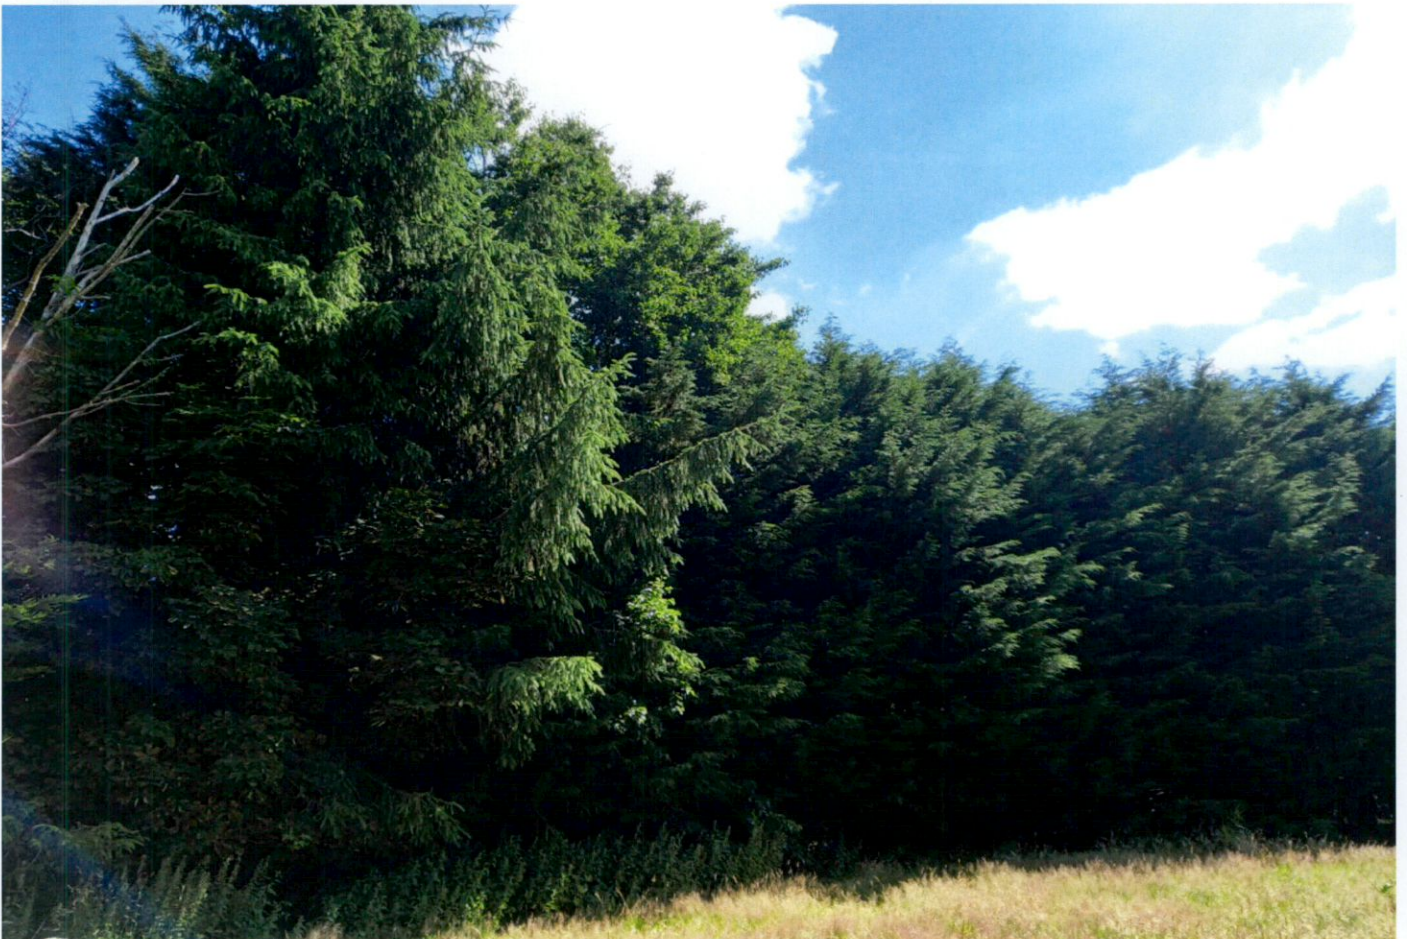
The trees along the eastern boundary with the stream include a group of 19 large canopy mature Lawson Cypress, T030, 3 mature Italian Alder, T031, T032 and T035, a large mature Spruce, T033, a group of small canopy Horse Chestnut trees, T034 and a small canopy Holly, T036.

The group of Lawson Cypress trees create a dense shelter belt along the stream and serves the purpose of screening the site from the road. The recommendations within the tree data propose that if the trees are to be retained, they should be maintained at their current height and the extended branches to the west to be pruned to create a more compact hedge-like structure. There is evidence that the trees have had a crown reduction in the past and allowing them to continue to grow can increase the potential for wind induced damage. There are also large branch fractures within the canopy of the trees, Fig 3, especially to the west where the branches are heavily weighted. Removal of the fractured branches will create gaps within the canopy, it is therefore recommended to prune these branches as much as possible and create the dense hedge-like structure

FIG 4 – Trees along eastern boundary

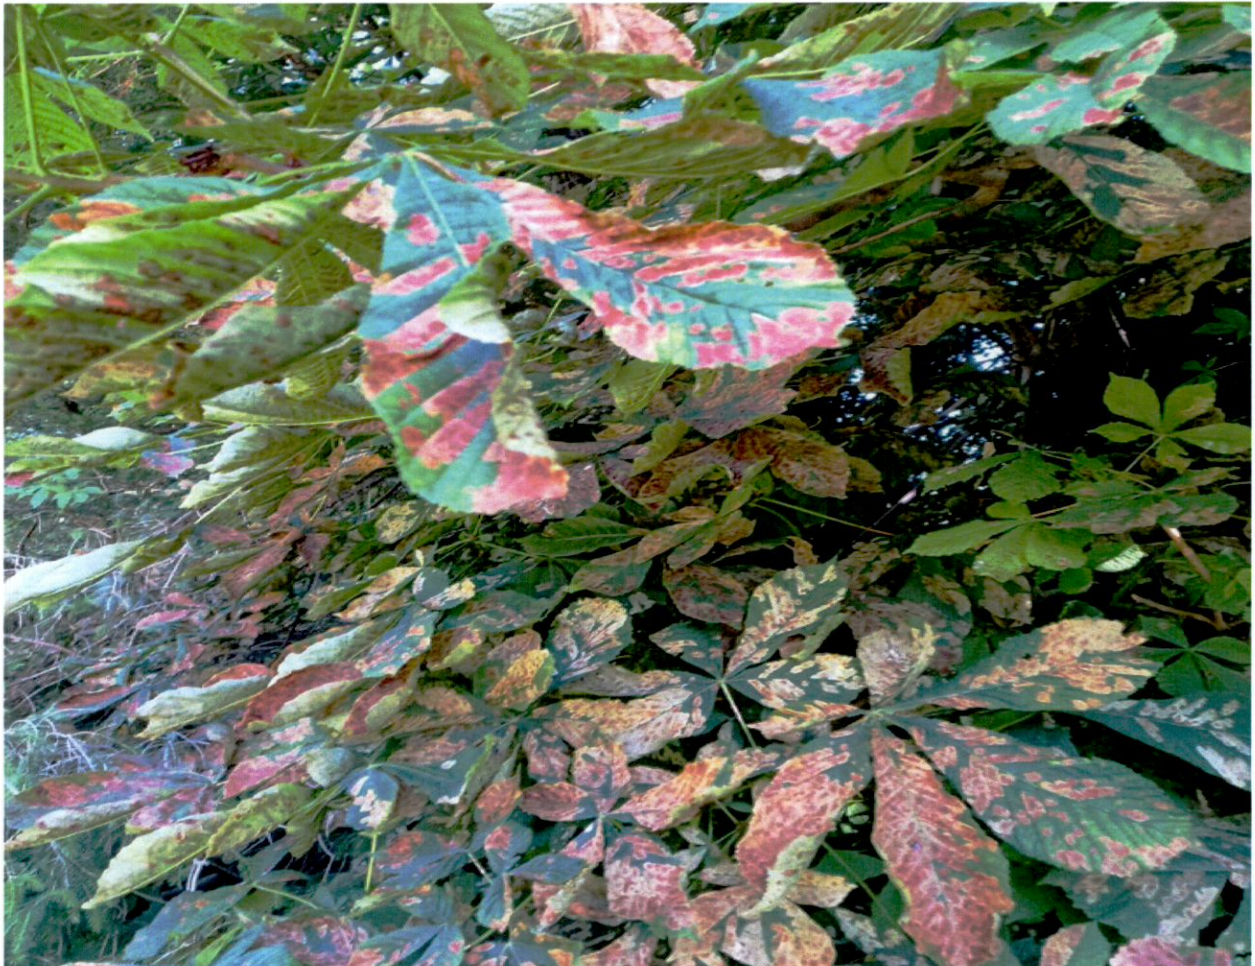
The group of Horse Chestnut trees, T034, are all small canopy trees, having been overgrown and suppressed by the large canopies of the Spruce and L. Cypress. There is extensive leaf damage within the canopies of the 3 living trees as shown in Fig 5. The cause of the damage is the Horse Chestnut Leaf Miner and when infestations build up, all of the leaves of the infected tree can become brown and shrivelled as the larvae eat all of the inner leaf material. Over years of sustained infestation, the tree can become weakened and susceptible to secondary infection from a different bacteria and fungi. It is recommended to remove the small canopy trees and replant with species more suited to the site where the space allows.

FIG 5 – Leaf damage from Horse Chestnut Leaf Miner

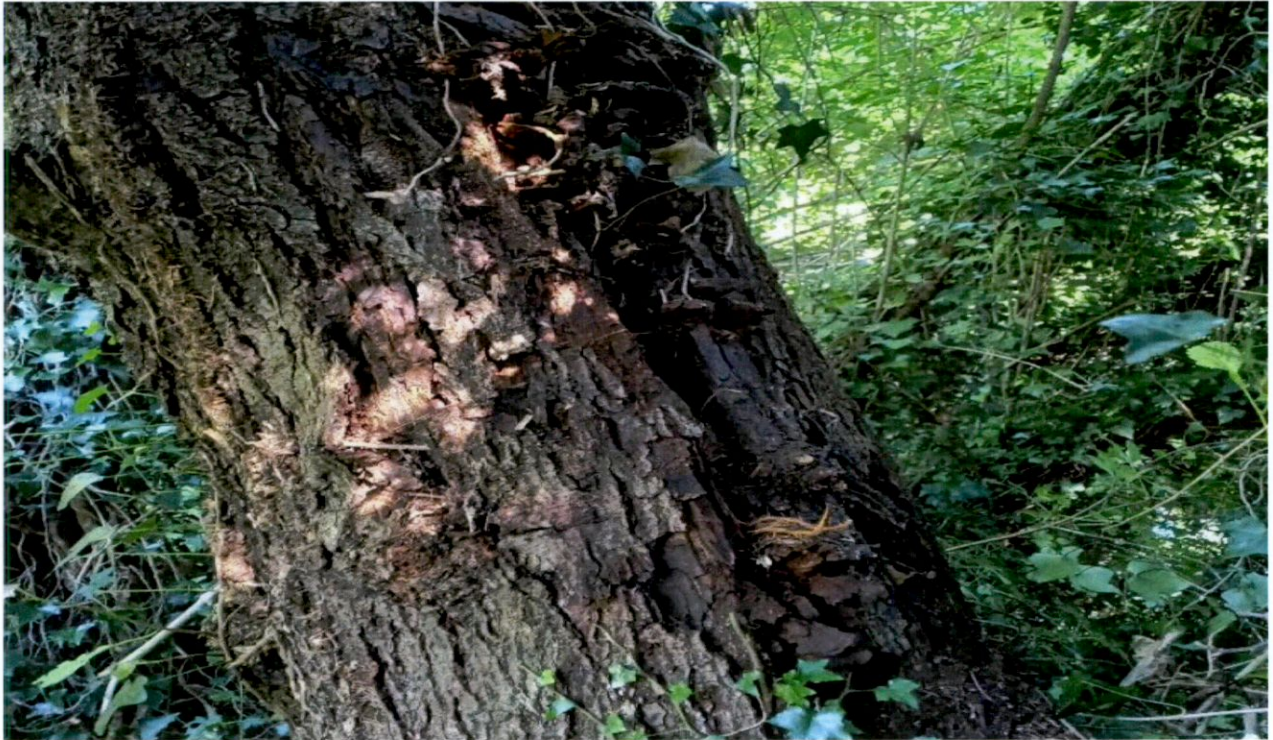
The Italian Alder tree, T035, has four distinct stems growing from a large bowl. There is extensive decay throughout the base of three of the stems, the stem to the south is already dead and the central stem and stem to the north are showing signs of dysfunction. There is a large decay column, Fig 6, along both these stems and there is evidence of the perinial brackets of the wood decay fungi *Inonotus radiatus* colonizing the cavity. The stem to the east over the stream has a healthy canopy and there is

FIG 6 – Large decay column colonized by *Inonotus radiatus*

no evidence of decay along the main stem. it is recommended to remove the three dysfunctional stems and retain and reassess the stem to the east.

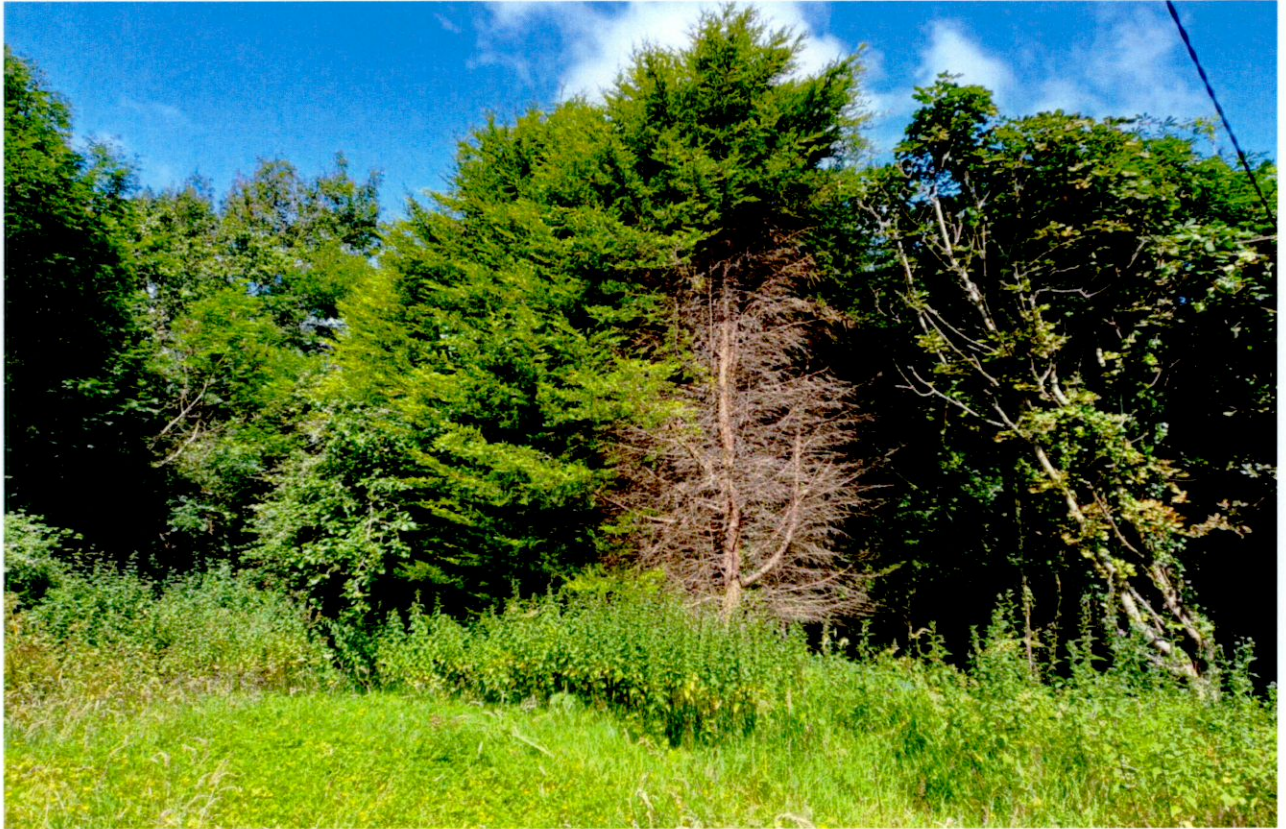
Trees T039 are a group of 9 Leylandii ‘Castlewellan Gold’. The group of trees have formed a very dense canopy along the northern boundary of the site. There have been a number of trees to the east of T039 removed in the past and this has left the remaining trees with little canopy cover as shown in Fig 7. Leylandii trees do not have the capacity to re-shoot or create epicormic growth when their canopies have been removed.

FIG 7 – Leylandii with bare canopy – H.Chestnut to right under ESB lines

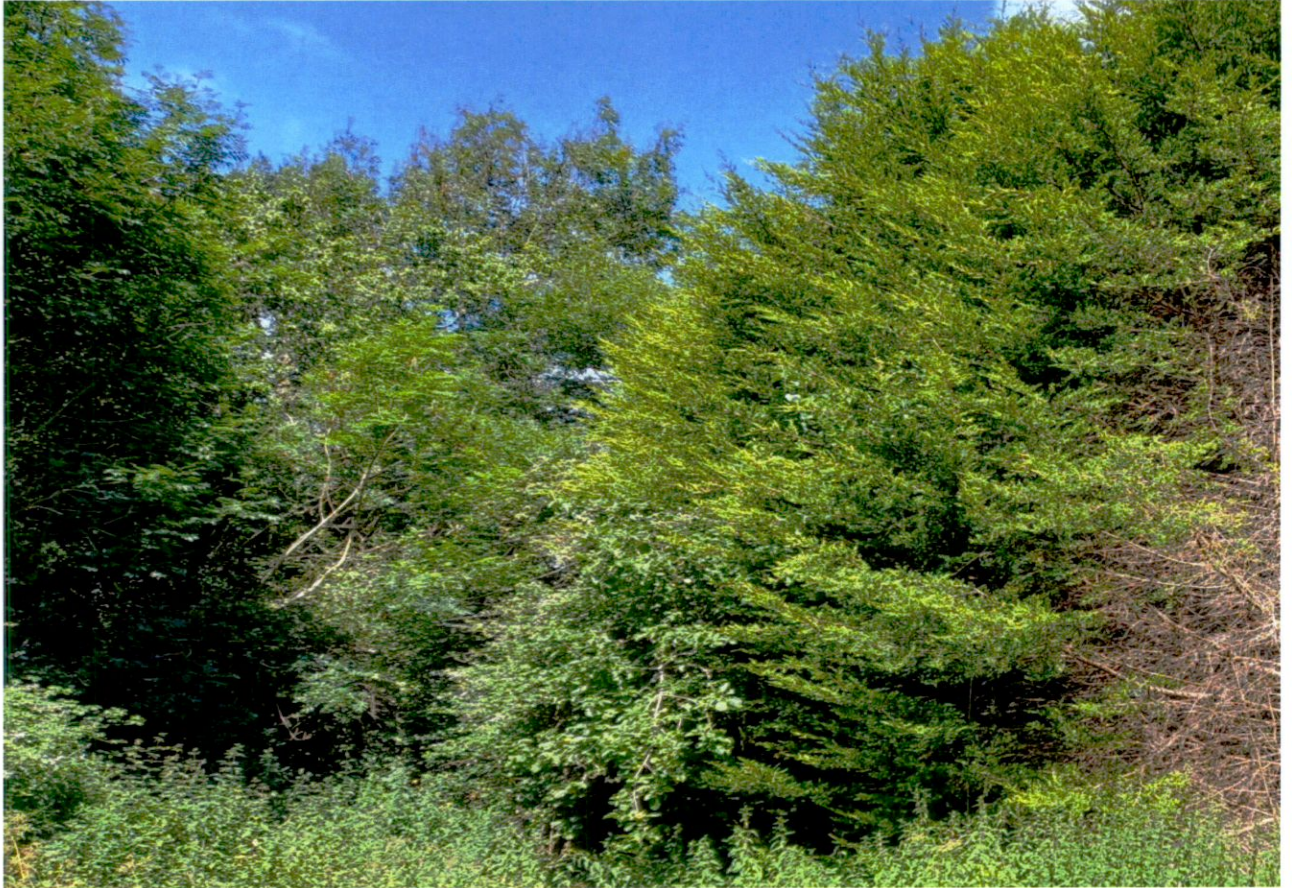
FIG 8 – T040 – T042

The image in Fig 8 shows trees T041 and T042 in the background and the dense area of Ash, Blackthorn and Apple, T040, in the foreground. The two Ash trees have evidence of dieback within their canopies. T040 is a large area of self-seeded trees, dominated by young Ash.

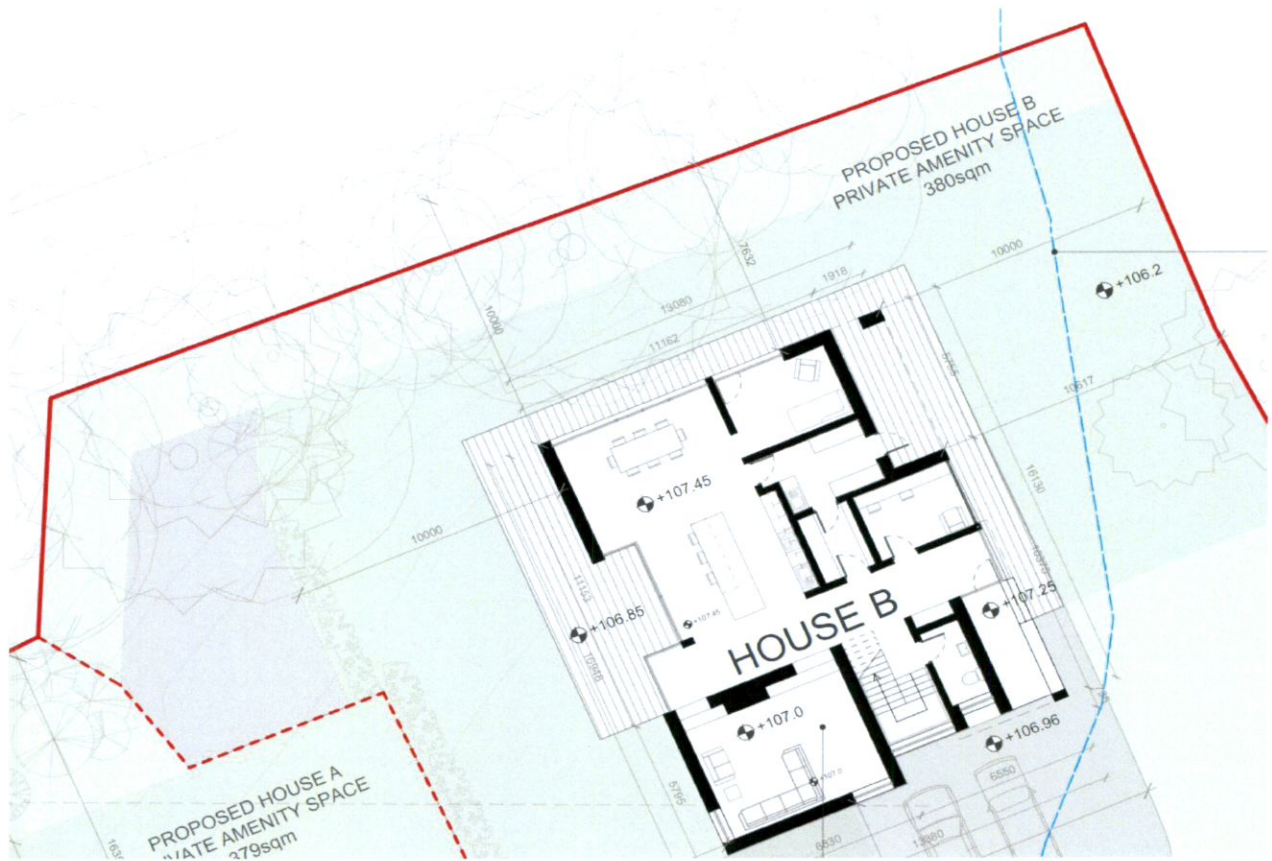
The extended, heavily weighted, lateral branches of Monterey Cypress trees have the potential to fracture under strong wind conditions. The risk of wind induced branch failure to the proposed development formed the recommendations to prune all extended branches by approx. 30%. As these trees have the capacity to respond well to pruning, it will not have any long-term negative effects on the tree. However, the trees would have to be maintained on an on-going basis after initial pruning. All the trees have been heavily pruned in the past to the west due to the presence of ESB wires.

FIG 9 – Proximity of proposed House B to trees along the western boundary

It is also recommended to crown thin these trees, as the present dense branching structure does not allow the wind to pass freely through the canopy. The crown thinning should only involve the removal of all small diameter branches from the main stem and large branches. The crown thinning should not leave any remaining large branches heavily weighted or create a 'lion-tailing' effect. Pruning cuts to thin the crown of a large tree typically range in size from **one to four inches** in diameter. For purposes of reducing damage from wind, cuts smaller than about one inch in diameter appears to be less effective.

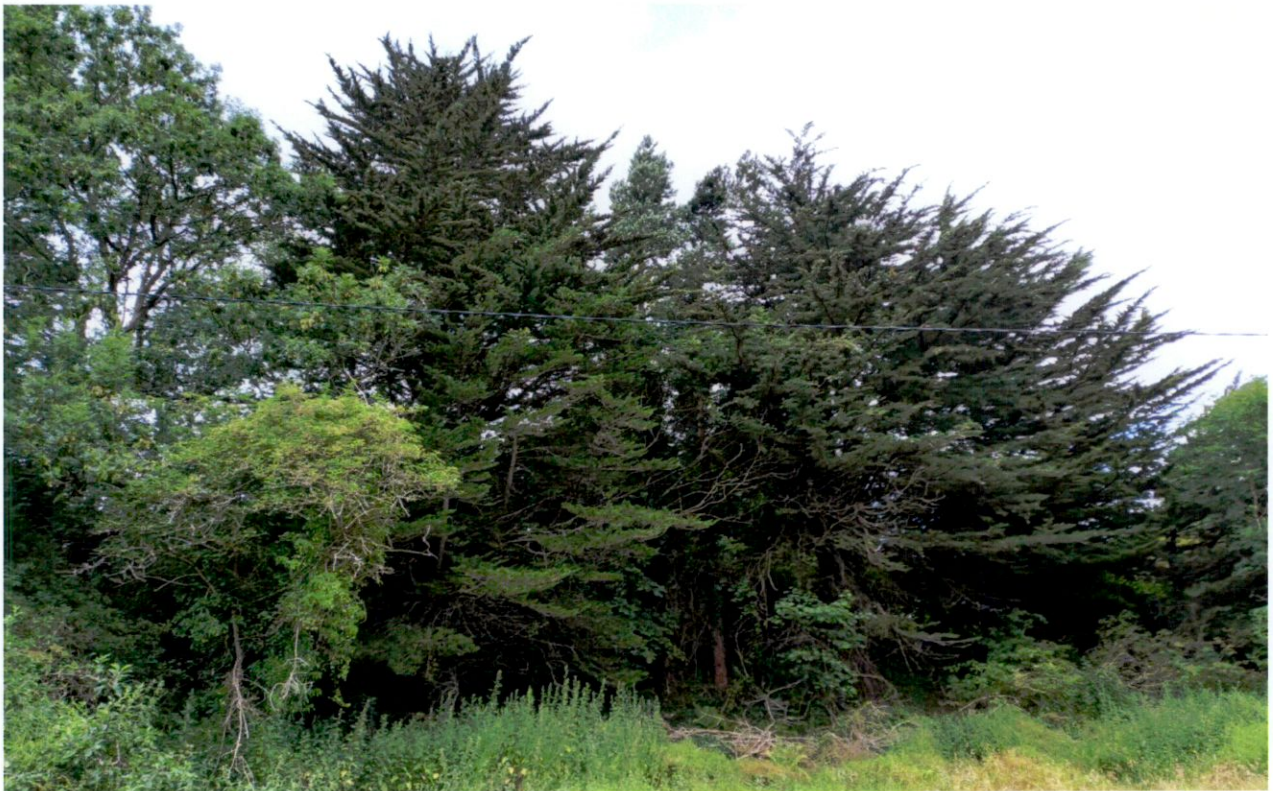
The largest trees within the footprint of the site are located along the western boundary. All the trees are growing from an inclined bank rising to approx. 1 – 1.5m above ground level. The roots of the trees will be spread along the bank but also extending east into the proposed site. The largest root area has a radius of 13m from the centre of its stem. The canopies of the three large Monterey Cypress trees are extending almost 7m out over the site.

FIG 10 – T045 – T053 along western boundary – extended branches of Monterey Cypress trees evident.

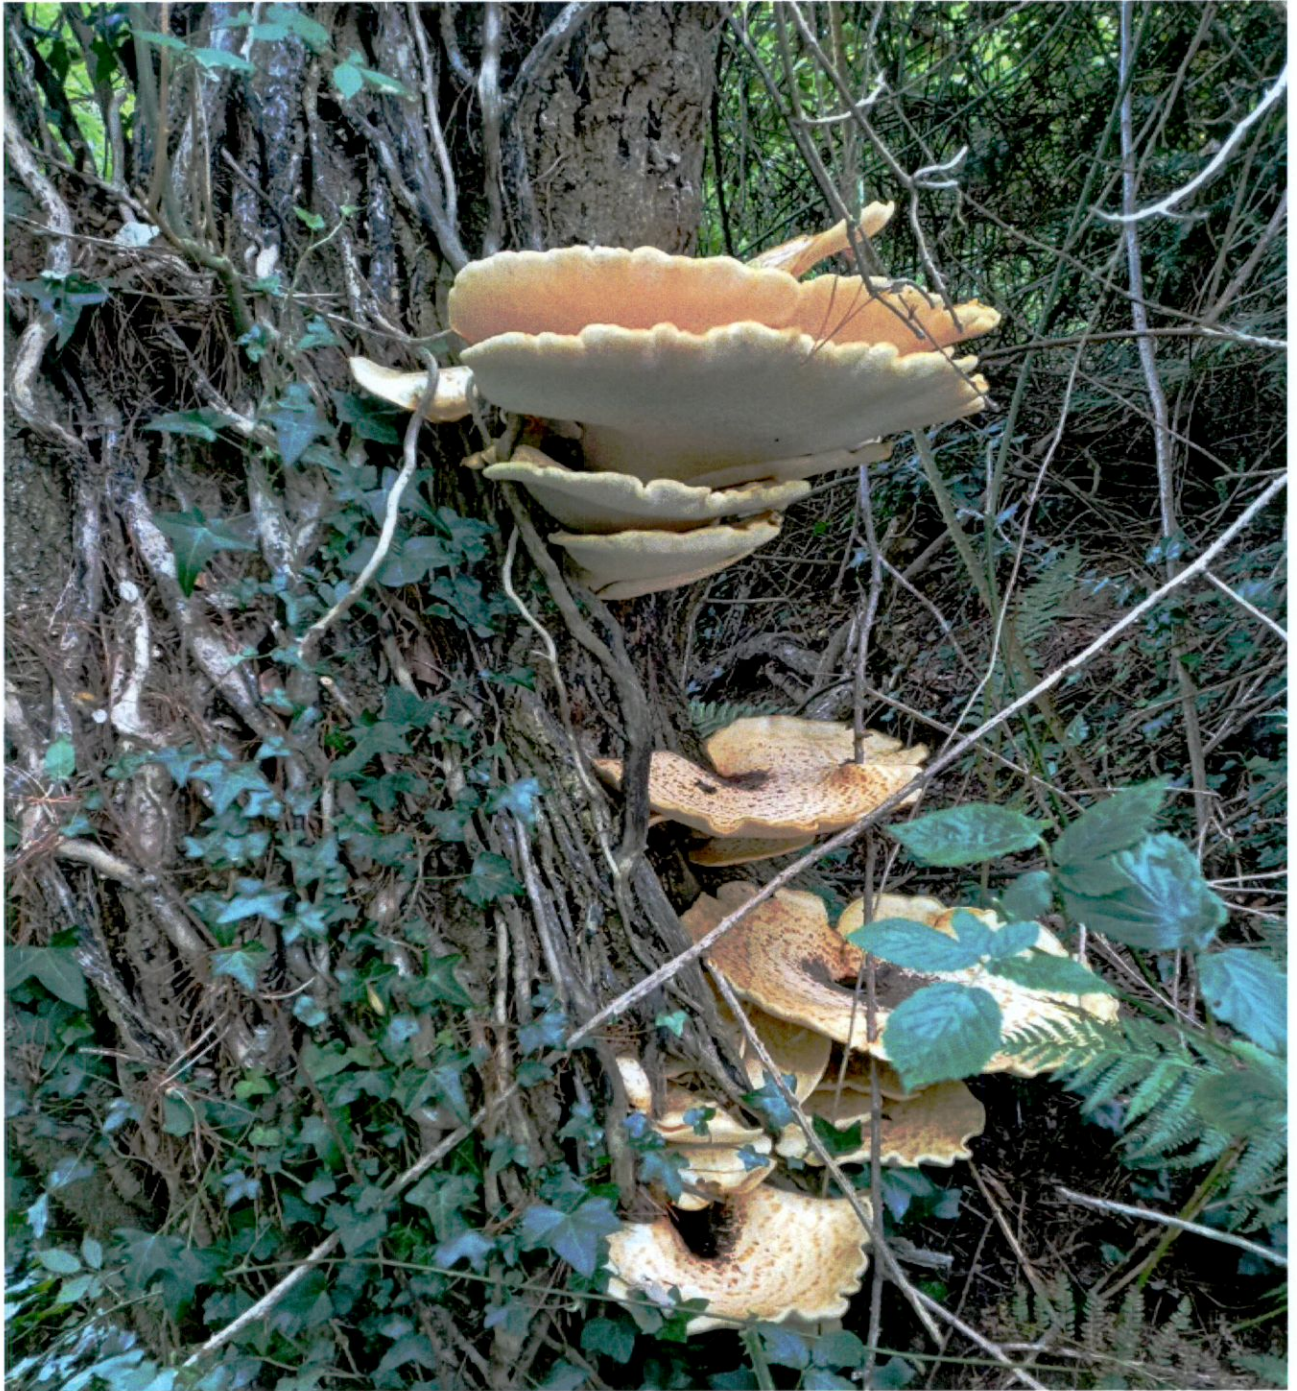
FIG 11 – Decay column on T052 colonised by *Cerioporus squamosus*

TREE NO	SPECIES	AGE	HT	SPREAD	DBH	RPA	CONDITION PHYSIO / STRUCTURAL	COMMENTS	RECOMMENDATIONS	ERC	RC
050	<i>Fraxinus excelsior</i> Ash	E/M	4	N 3 S 0 E 2 W 0	18 15	2.4	POOR / POOR	Extensive dieback & deadwood throughout – Small sparse canopy – tree in a state of Advanced decline	Remove	<10	U
051	<i>Cupressus Macrocarpa</i> Monterey Cypress	M	18	N 5 S 5 E 7 W 2	108	13	GOOD / GOOD	Very large canopy tree – dense branching Structure throughout – extended & weighted Branches to east over site – growing from sloping bank – good form, structure and ext growth – heavily pruned to west in past due to ESB wires – Minor deadwood & broken branches	Crown reduce stem to east by 30% Crown thin smaller diameter Branches only & deadwood	>40	B 1,2
052	<i>Fraxinus excelsior</i> Ash	M	16.5	N 3 S 7 E 8 W 2	73 67	9.9	FAIR / FAIR	Heavily weighted leaning canopy to east over Site – open canopy typical of its species – Large basal cavity at base to west with the Wood decay fungi <i>Cerrioporus squamosus</i> Evident colonizing the area	Remove	20-40	C 1,2
