Arboricultural Assessment

M50 Business Park, Ballymount Road Upper, Ballymount, Dublin 12

Prepared by: -
Ethan Gannon 'TechArborA' and Joe Codd 'B.Agr.Sc. (For.) Dip.Sc. (For.) M.S.I.F. MArborA',
Veon Limited,
1 Leopardstown Business Centre,
Ballyogan Road,
Dublin 18.

20th - October - 2022

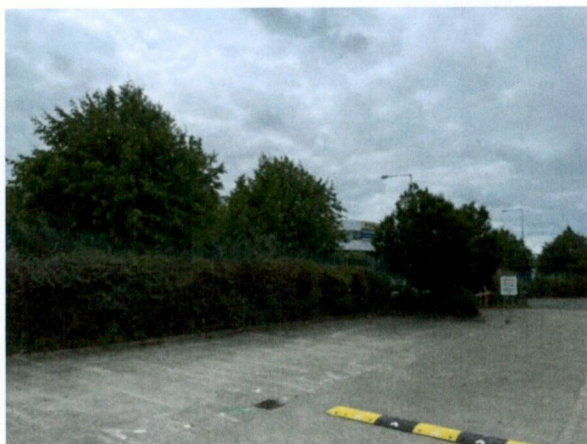
Hedge No.1 along southern boundary with lime trees growing outside the site area

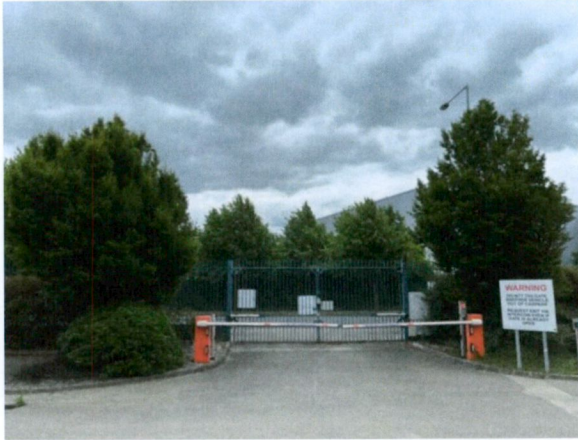
Two upright-hornbeams growing on either side of the secondary entrance gate on the southern boundary.

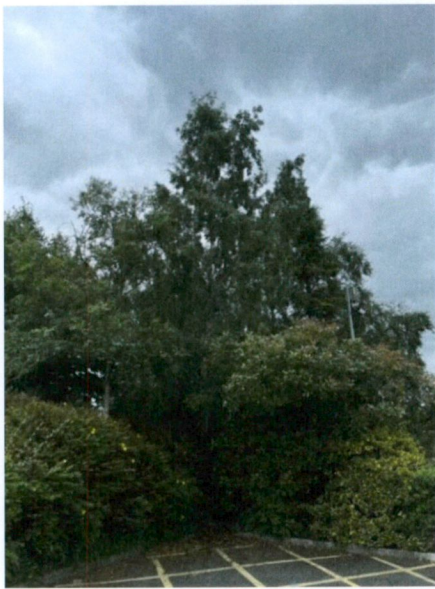
A group of 4 birch and 1 spruce growing in the south-west corner of site area.

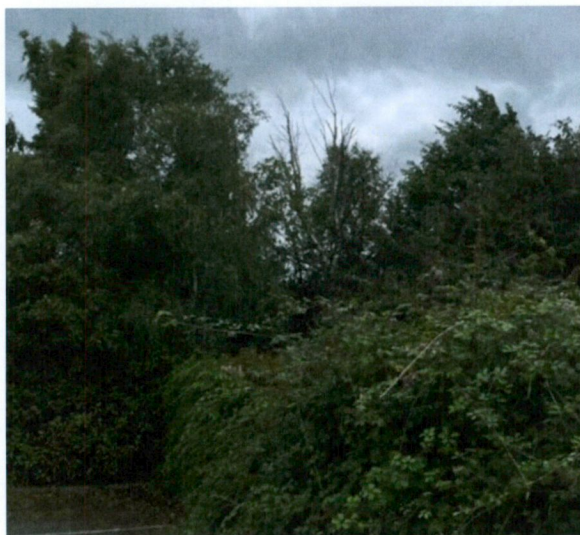
Dead birch at the back of Hedge No.1 in the south-west corner of the site area.

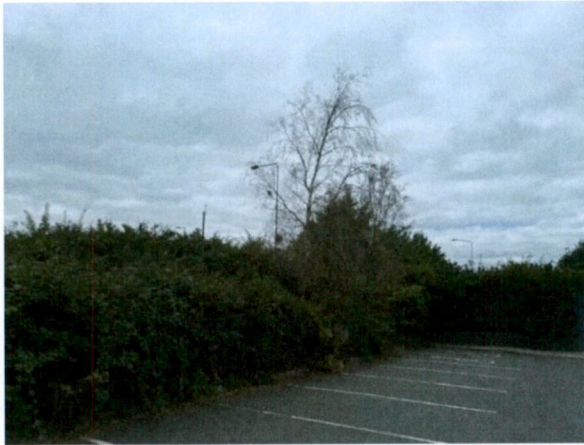
Two birch trees in decline on the western boundary.

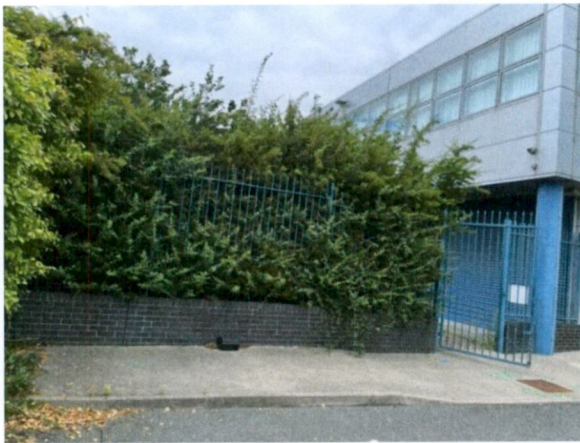
Pyracantha hedge and metal railing create an internal boundary on the western side of the site area.

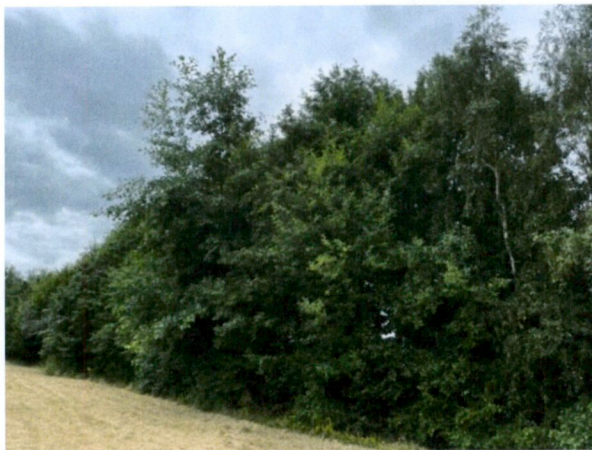
- The northern boundary consists of a semi-mature tree belt of mixed species such as, grey alder (*Alnus incana*), Norway maple (*Acer platanoides*), birch (*Betula pendula*) and upright hornbeam (*Carpinus betulus* 'Fastigiata'). These trees have value as screening and shading along this boundary and have the potential to form the long-term tree cover in this area.

Tree Belt No.1 along the northern boundary.

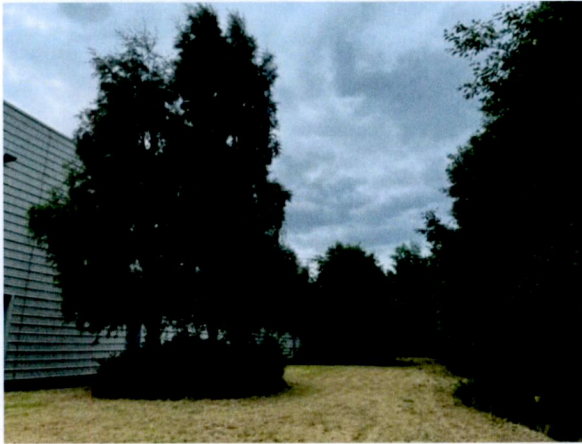
Group of birch and lime trees in the open grass area on northern boundary.

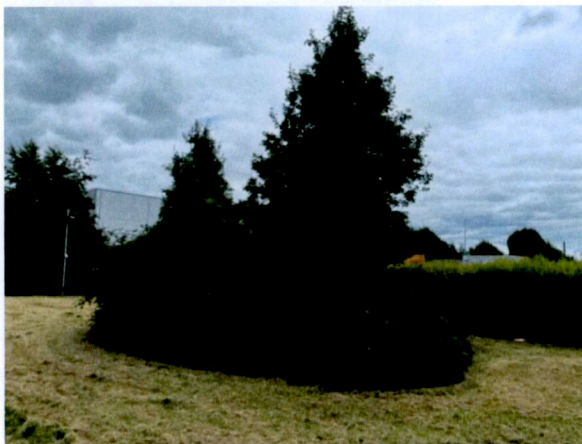
Group of pear trees also along the northern boundary.
