**Oak Lodge, New Road, Clondalkin**

**Architectural Heritage Impact Assessment**

**October 2021**

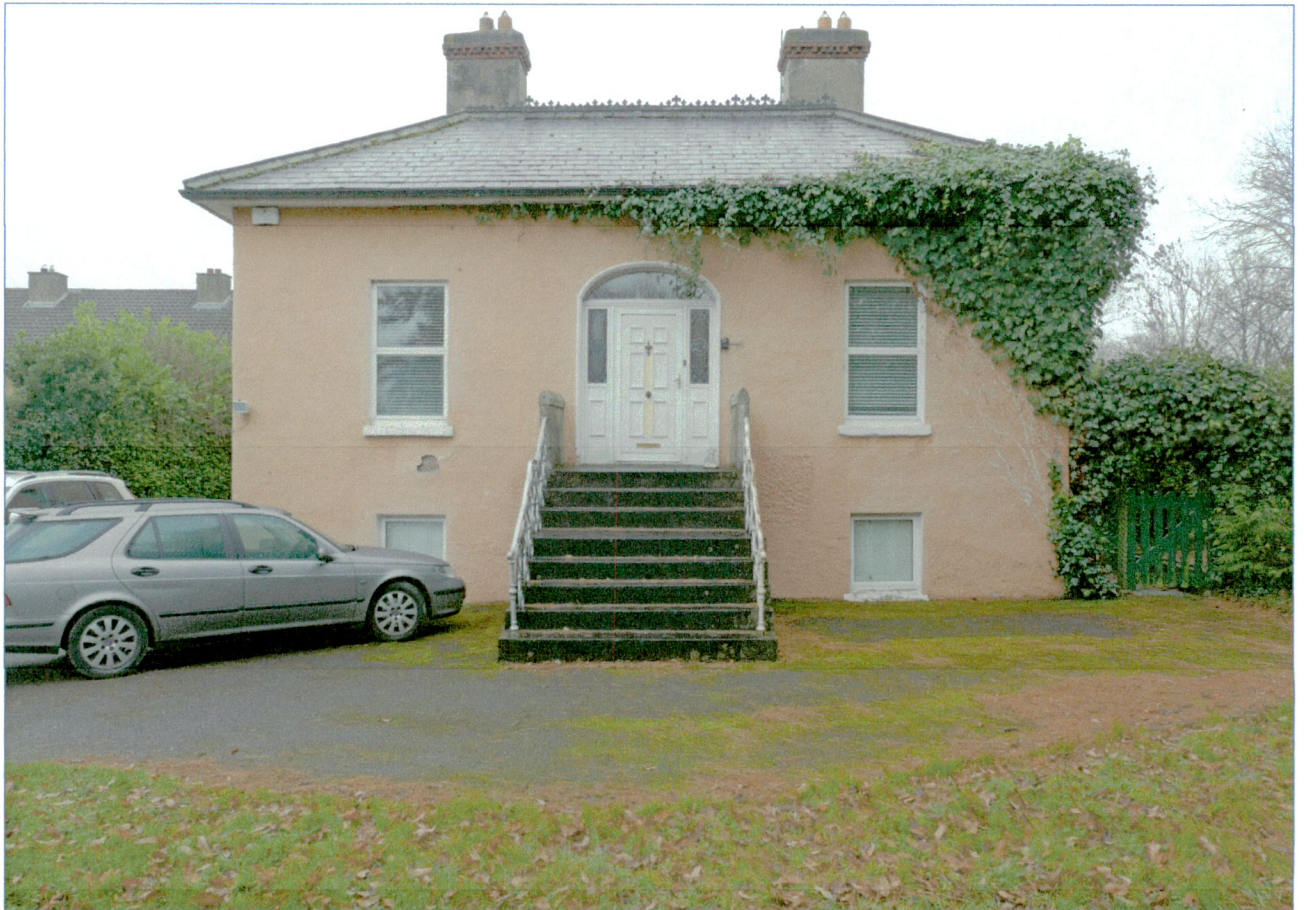
Front (west) facade. It is proposed to replace the existing uPVC windows with timber l-over-l up-and-down sash windows detailed appropriately and to replace the modern door and doorcase with a timber door and doorcase of a design and detail appropriate to the period of the house

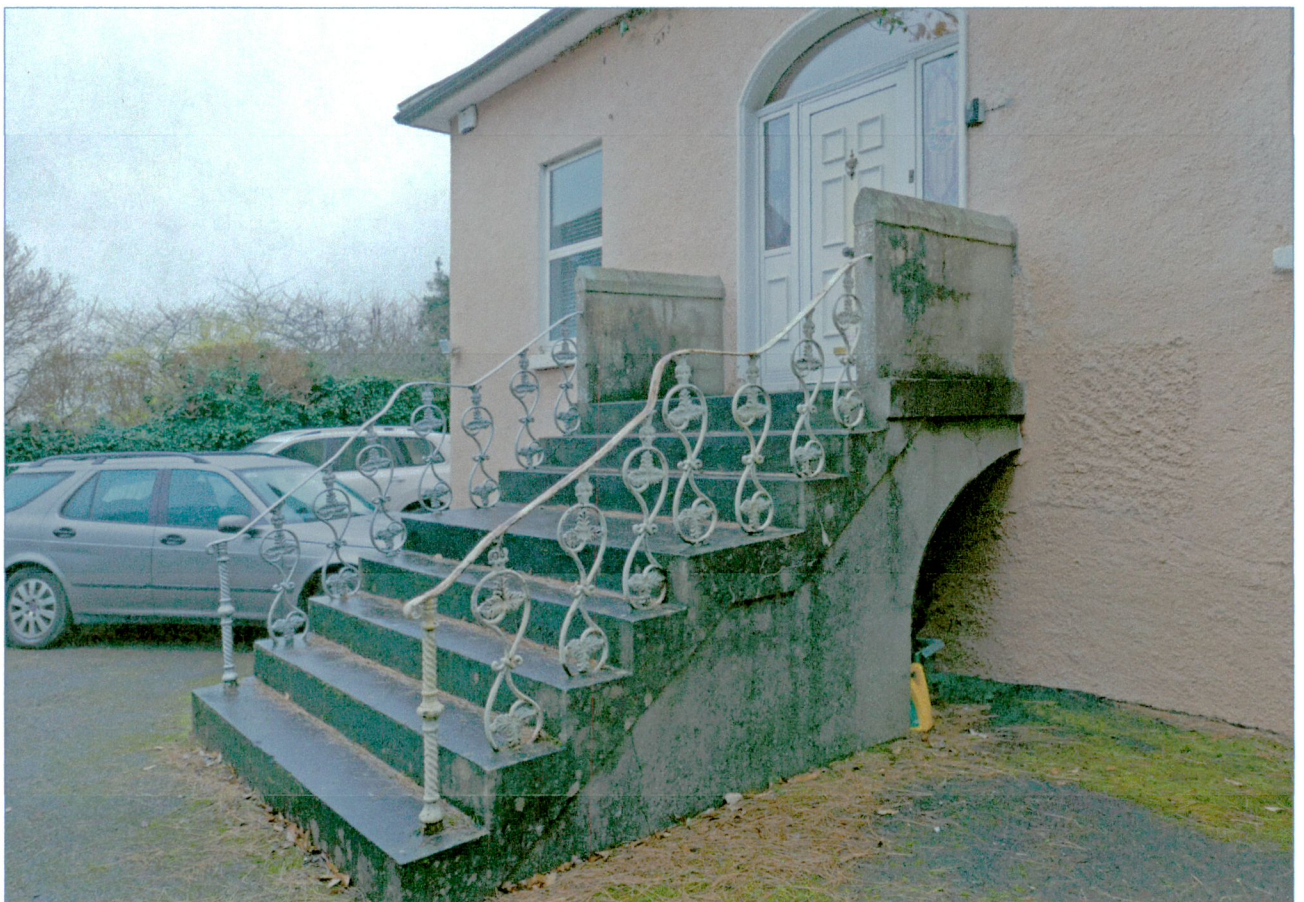
Front Steps. It is proposed to overhaul and repair the front steps where required.

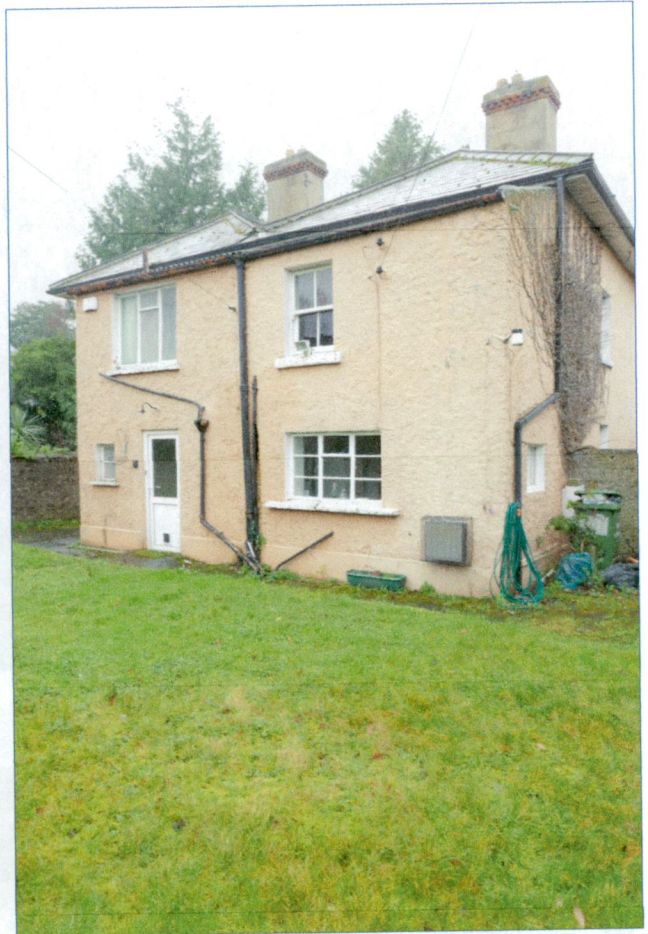
Rear (east side) of house. It is proposed to demolish the modern left half of the return and to refurbish and extend the older section.

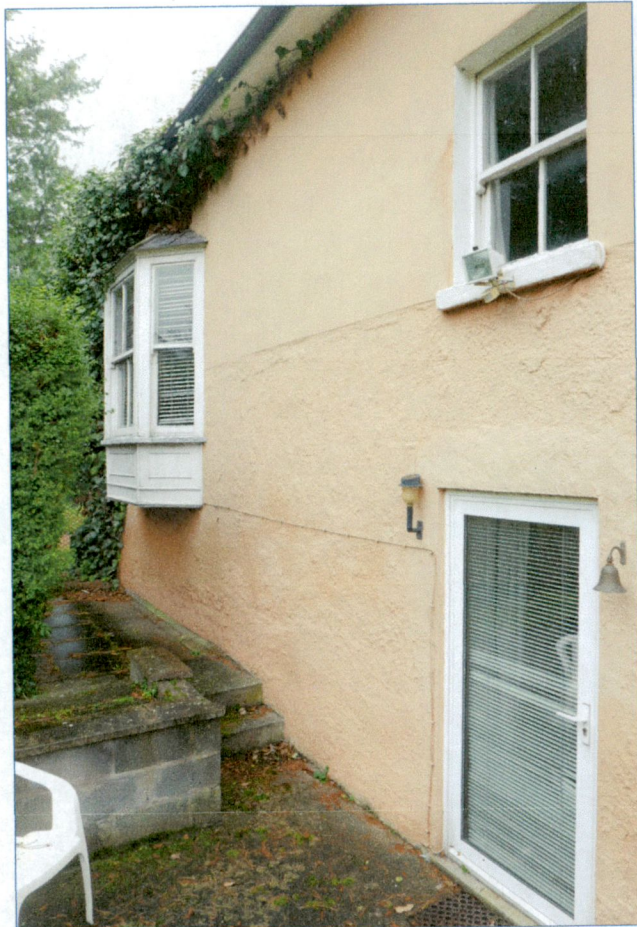
South side of house. A new bay window is proposed at ground level, replacing the door seen on the right.

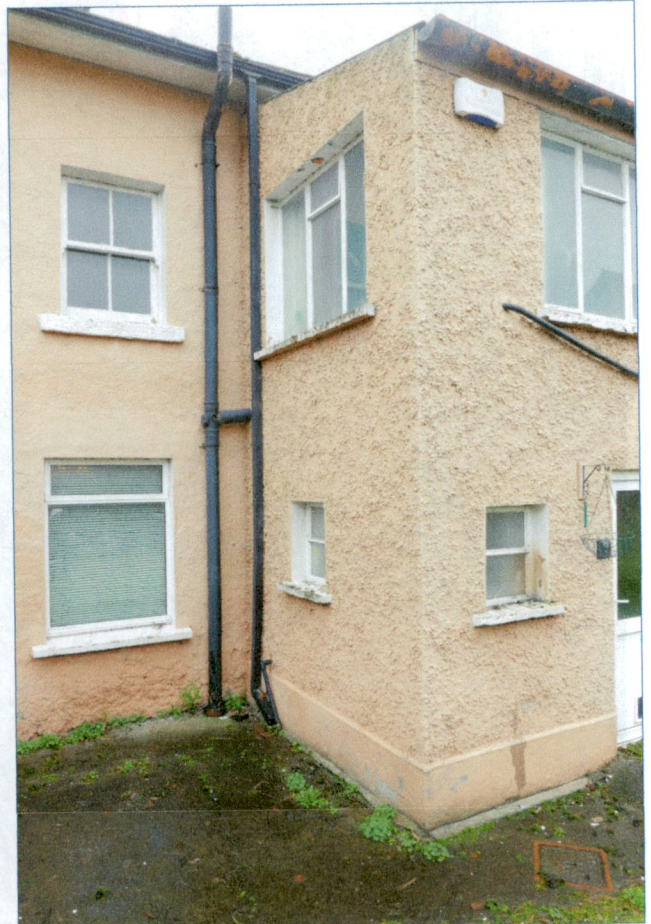
South east corner. A new return is proposed extending across the rear of the house incorporating part of the old.
