TREE & VEGETATION SURVEY, ASSESSMENT, MANAGEMENT & PROTECTION
MEASURES
FOR

Lidl Newcastle

CLIENT: Lidl Ireland GmbH

July 2022

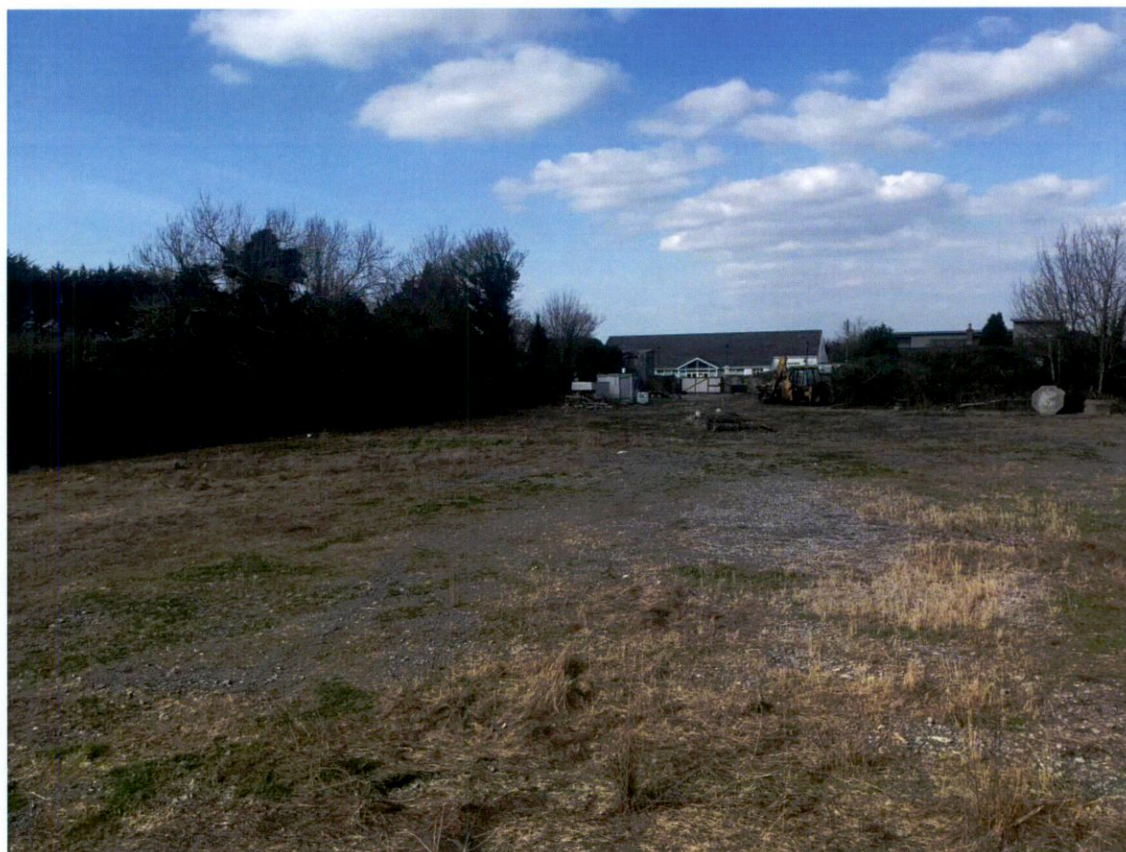
Figure 1: northern part of the site looking north across the yard, the western hedgerow, hedgerow 03 is visible to the right-hand side of the image

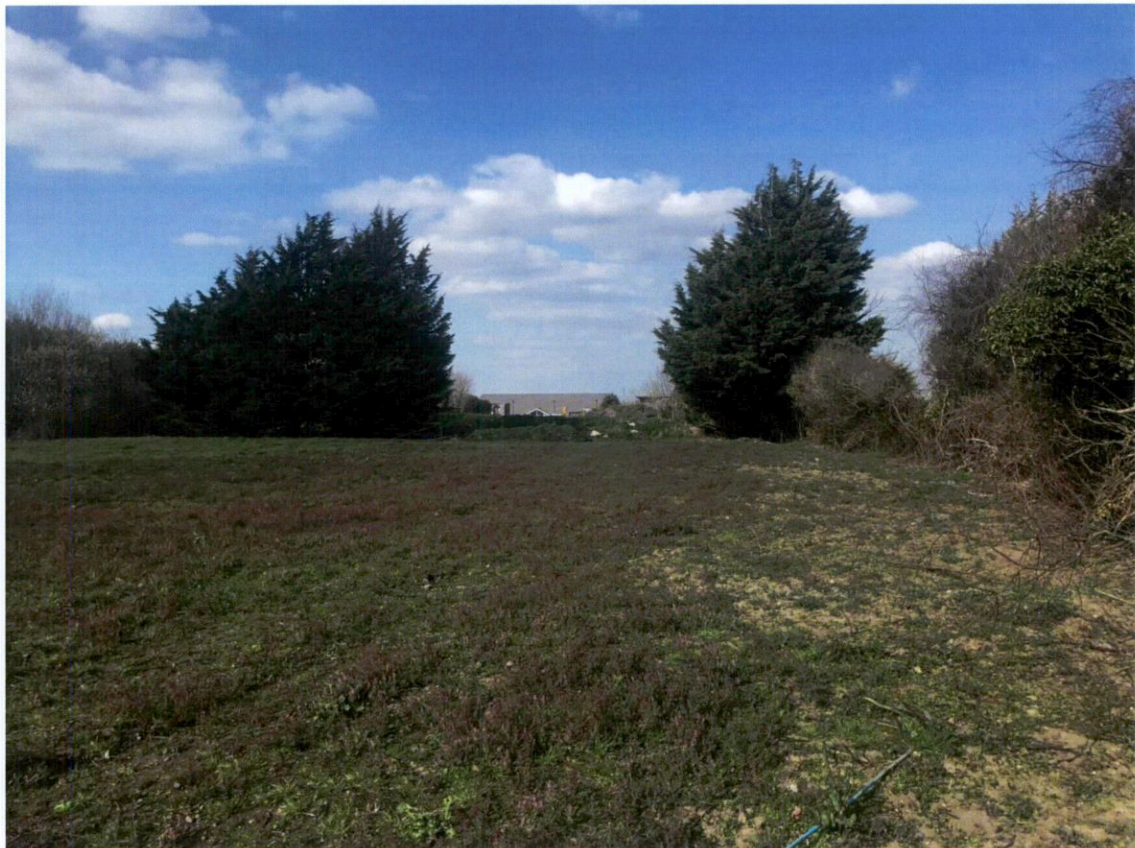
Figure 2: Southern part of the site looking north, Leyland Cypress *X Cuprocyparis* visibly, mound partially visible between the Leyland Cypress *X Cuprocyparis leylandii*

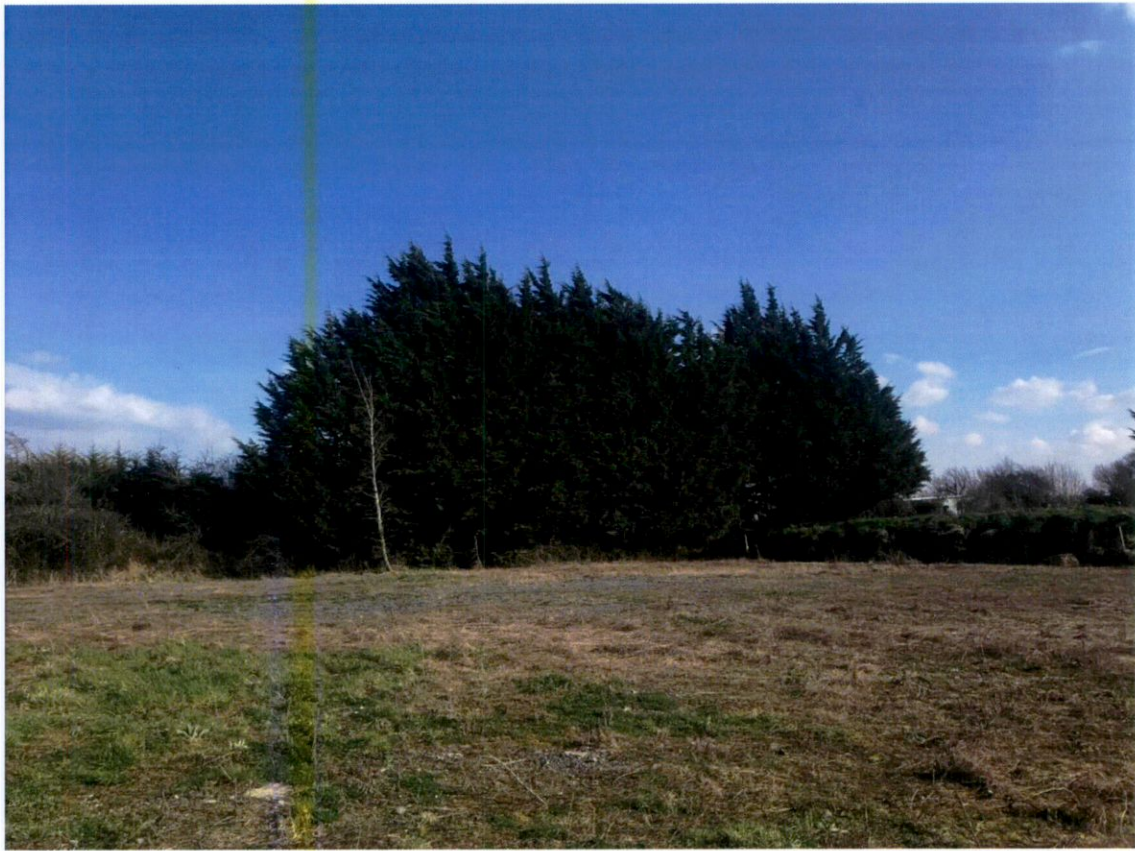
Figure 3: Leyland Cypress X Cuprocyparis Tree Group 01 on the eastern boundary

The eastern boundary of the site, to the northern end is formed by a mish mash of self-seeded planting and Leyland Cypress X *Cuprocyparis leylandii*. To the southern part of this boundary, there is some better hedgerow, hedgerow 03. Though this is quite weak and needs augmentation with suitable native hedgerow species.

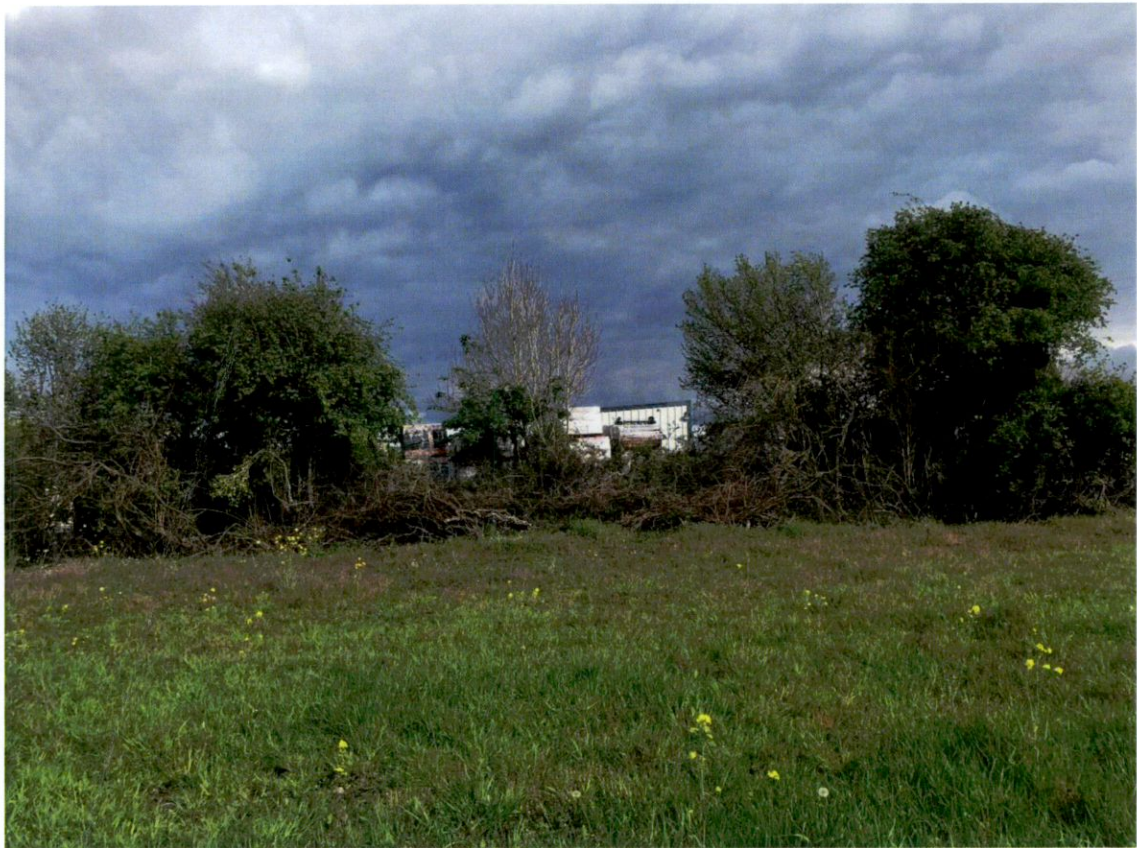
Figure 4: Eastern boundary, southern part, hedgerow 02, this hedgerow is somewhat scraggy with cut brush in the hedgerow, it needs to be cleaned out and augmented with supplementary native planting

Hedgerow 03 is located on the Southern part of the Eastern boundary. Species are *Fraxinus excelsior* Ash and *Crataegus monogyna* Hawthorn and Blackthorn *Prunus spinosa*. The hedge is quite sparse in places and needs augmentation.

- Tree protective fencing will be placed to prohibit access within the RPA of the hedgerow and protect the above and below ground parts of the hedgerow.
- The excavations for building foundations and building construction will be supervised on site by the project Arborist.
- Any local removal of hedging will be supervised by the project Arborist and suitable replacement planting will be planted.
