TREE SURVEY

Proposed Creche & Community Facility,
at Cuil Duin Avenue,
Citywest,
Dublin.

March 2023

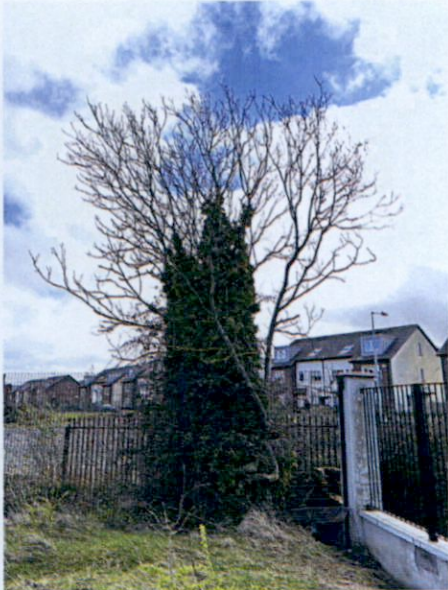
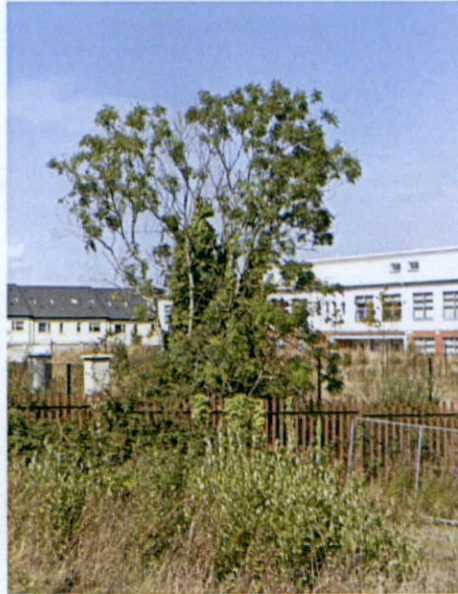
T1- spring

T1- summer (courtesy Google Earth)

2.3. The quality of two inspected trees is poor with both clearly suffering from Ash dieback disease.

Both trees display symptoms of Ash dieback disease. T2 is unsuitable for retention due to its size and extent of infection. T1 is a younger tree with early stage infection and can be retained and monitored for the time being.

The proposed development is compatible with the retention of the tree (T1) located outside the northern site boundary to the north of Boherboy Stream. The location of the tree to the north of the stream suggests a low likelihood of tree roots being present to the south of the stream within the site.

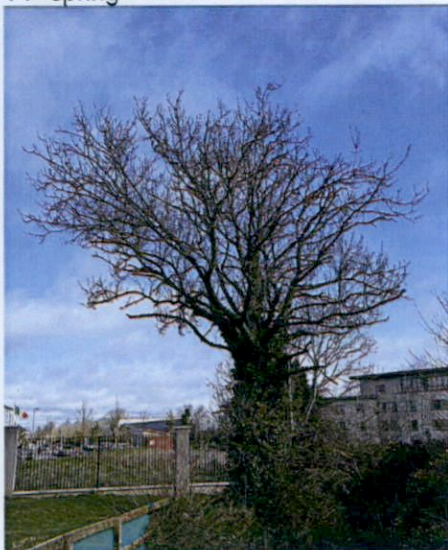
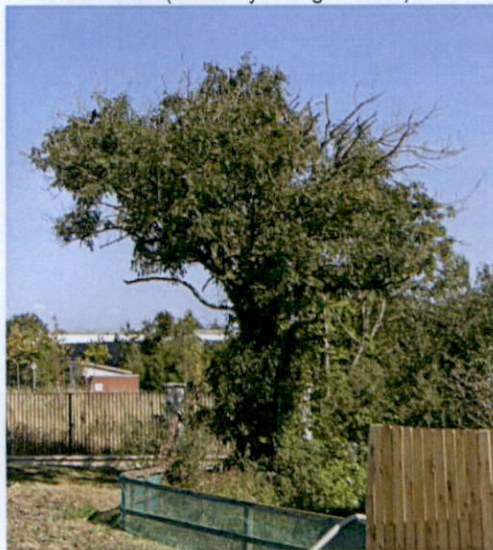
T2 – spring

T2 – summer (courtesy Google Earth)

3.6 T2 being U class is proposed for removal as tree is exhibiting significant signs of Ash Dieback to the crown which is likely to become detrimental to the tree's structural stability.

3.3 Direct loss of trees is limited to the removal of one tree, located in the site premises (T2) along with other areas of early stage regenerative tree and scrub growth from within the site, which is not considered to be of arboricultural significance - particularly in the context of the proposed level of tree planting within the scheme as set out in the Landscape Masterplan.
