Arboricultural Report

Tree Survey,
Arboricultural Impact Assessment &
Arboricultural Method Statement

Esker House
Esker Road
Esker
Co. Dublin

230221-PD-11

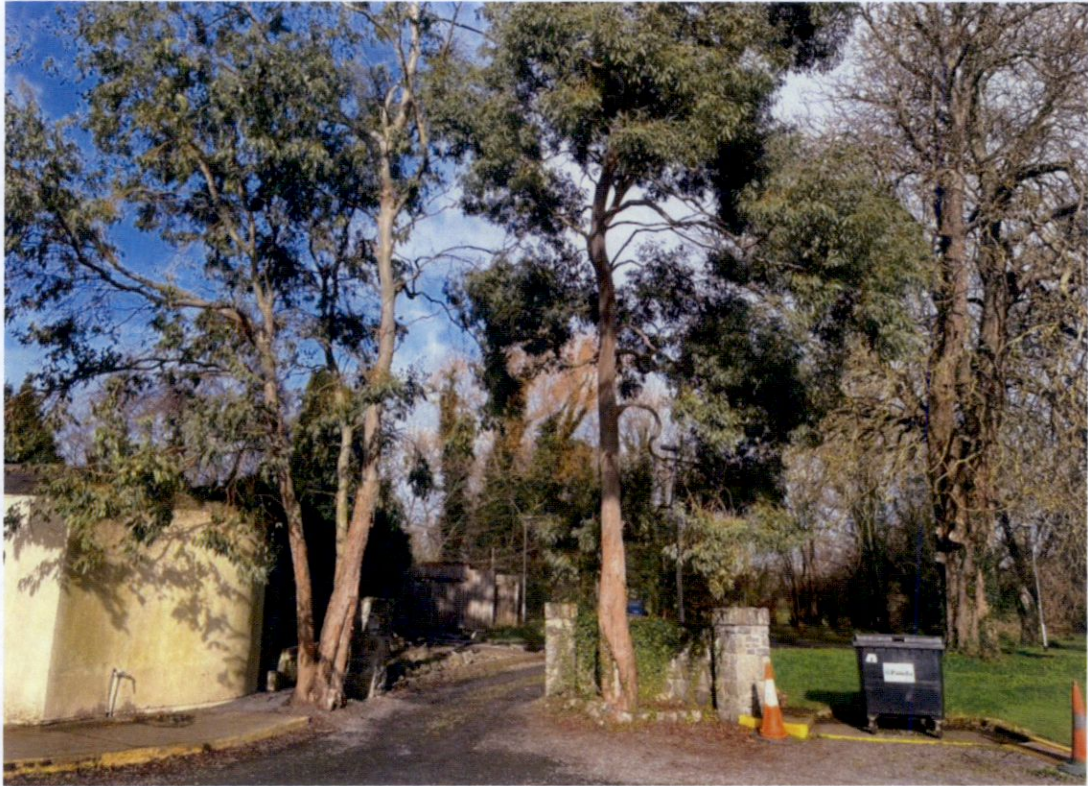
Photo 1: View of the two eucalyptus trees (T984 & T985) located on either side of the access gates to the site location.

T985	1 <i>Eucalyptus sp.</i> Eucalyptus Tree	C2	To facilitate development Lift low canopy - Specified extent. Crown lift to 5m above ground level to allow for construction access.	Proposed
T989	1 <i>Fraxinus excelsior</i> Ash	U	To facilitate development Reduce lateral limb / limbs. Reduce lateral growth to provide clearance for proposed development works.	Proposed
T990	1 <i>Fraxinus excelsior</i> Ash	C2	To facilitate development Reduce lateral limb / limbs. Reduce lateral growth to provide clearance for proposed development works.	Proposed
T991	1 <i>Fraxinus excelsior</i> Ash	C2	To facilitate development Reduce lateral limb / limbs. Reduce lateral growth to provide clearance for proposed development works.	Proposed
T992	1 <i>Fraxinus excelsior</i> Ash	C2	To facilitate development Reduce lateral limb / limbs. Reduce lateral growth to provide clearance for proposed development works.	Proposed
T994	1 <i>Fraxinus excelsior</i> Ash	C2	To facilitate development Reduce lateral limb / limbs. Reduce lateral growth to provide clearance for proposed development works.	Proposed

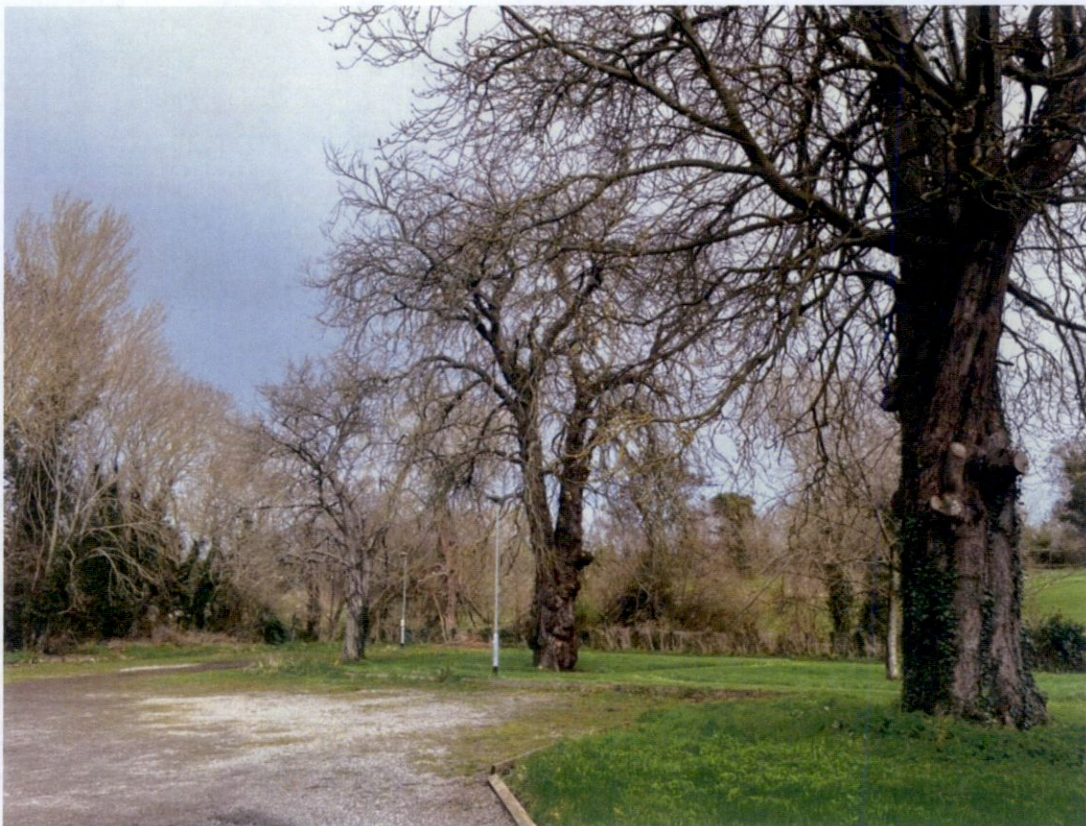
Photo 2: View of the mature cherry (T468) and late-mature horse chestnut trees (T469 & T470) located within the grassed garden area to the east of the proposed tower.

Tree ID	No. Species	Height (m)	Stem diameter (cm)	No. of Stems	CROWN SPREAD (m)								Crown clearance (m)	L.B. (m)	Life stage	Condition Notes	Survey date	RPA (m ²)	RPR (m)	Life expectancy (yrs)	BS Category
					N	NE	E	SE	S	SW	W	NW									
Tree T468	1 Cerasus avium (Wild Cherry)	12.5	67	1	9.0	3.5	6.0	8.5					2.5		Late Mature	Structural condition Poor. Physiological condition Fair. Arboricultural work - Historic. Competition - Adjacent trees. Decay / structural defect - Principal stems. Fungal fruiting body - structural decay suspected. Fork - Weak with included bark. Suppressed crown - Minor. Unbalanced crown - Minor.	24/03/2023	203.1	8.0	10-20	C2
Tree T469	1 Aesculus hippocastanum (Horse Chestnut)	19.0	143	1	7.0	7.5	8.5	5.5					2.5		Ancient / Veteran	Structural condition Poor. Physiological condition Poor. Bark exudation. Die-back - Upper crown. Decay / structural defect - Base. Fork - Weak with included bark. Stag-headed crown. Bleeding canker of horse chestnut.	24/03/2023	706.9	15.0	10-20	B3

Tree T470	1 Aesculus hippocastanum (Horse Chestnut)	25.5	115	1	11.0	8.5	8.0	8.0					2.5		Late Mature	Structural condition Poor. Physiological condition Fair. Bark exudation. Bark wound - Minor. Decay / structural defect in crown limb / limbs - Extensive. Decay / structural defect - Minor. Fork - Weak with included bark. Bleeding canker of horse chestnut.	24/03/2023	598.3	13.8	10-20	B3
Tree T984	1 Eucalyptus sp. (Eucalyptus Tree)	18.5	48 COM	3	4.0	6.5	5.5	5.5					2.5		Early Mature	Structural condition Fair. Physiological condition Poor. Bark wound - Major. Die-back - Throughout crown. Deadwood - Minor. Decay / structural defect - Base. Root environment - Restricted. Structural impact - Potential.	24/03/2023	107.7	5.9	10-20	C2
Tree T985	1 Eucalyptus sp. (Eucalyptus Tree)	15.5	42	1	4.5	8.0	3.5	3.5					2.0		Early Mature	Structural condition Poor. Physiological condition Fair. Bark wound - Major. Deadwood - Minor. Leaning trunk - Major. Root environment - Restricted.	24/03/2023	79.8	5.0	10-20	C2

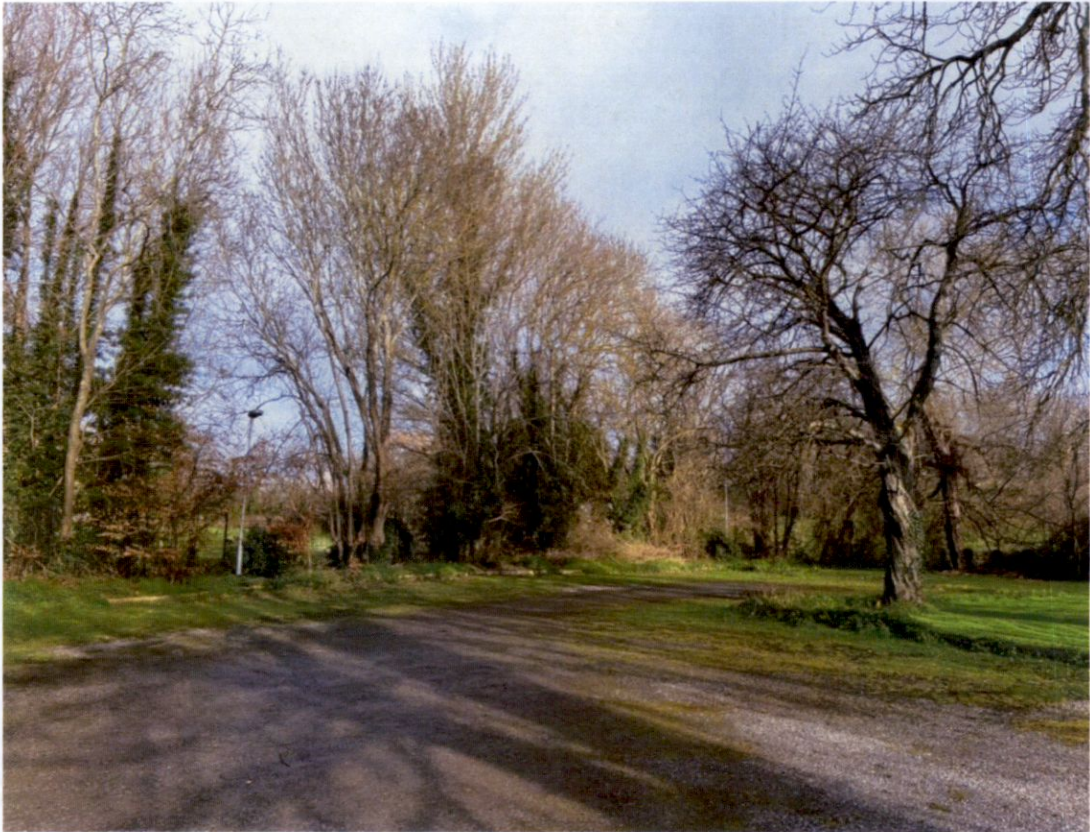
Photo 3: View of the northern boundary tree line and area of existing hard standing located adjacent to the proposed tower.

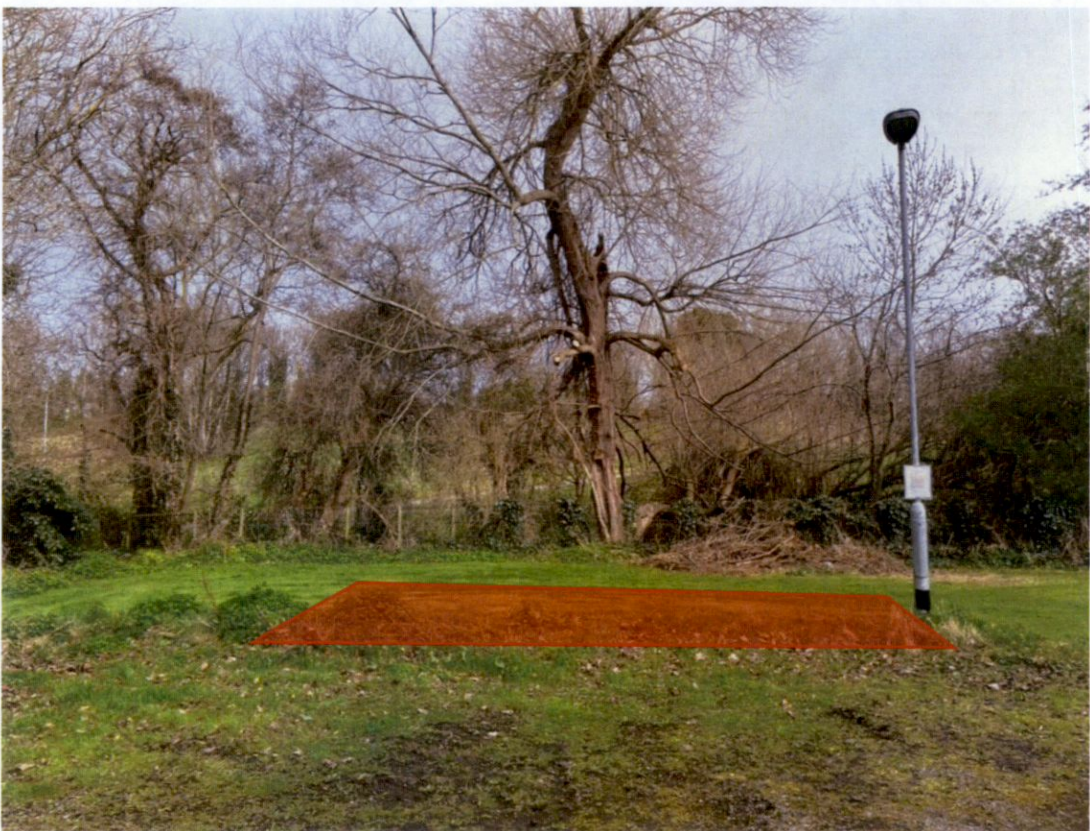
Photo 4: View of the willow T465 located adjacent to the proposed tower. Red area highlights the approximate location of the tower.

- 6.4 **Construction operations** – The proposed location of the tower has been revised to reduce the impact on the surrounding trees following the initial arboricultural survey. Excavation works are still required within the RPA of T465; however, this is only considered to be minor. The level of incursion is 6% of the tree's overall theoretical RPA and is located at the periphery of its rooting area, where significant roots are unlikely to be present. Considering the minor extent of this encroachment, the required excavation works will not have a negative impact on the health or condition of the tree.

- 6.5 As these works are required within the tree's theoretical RPA, it will be necessary to carry them out under arboricultural supervision. Exposed roots will need to be cleanly pruned with the use of a sharp sterile pruning tool to the edge of the excavated trench and a separation member installed between any liquid cement and the soil environment.

ID	No. / Species	BS5837 Category	Purpose of works Recommended works	Status
T465	1 <i>Salix alba</i> White Willow	C2	To facilitate development Reduce lateral limb / limbs. Reduce lateral growth to provide clearance for proposed development works.	Proposed
T468	1 <i>Cerasus avium</i> Wild Cherry	C2	To facilitate development Reduce lateral limb / limbs. Reduce lateral growth to provide clearance for proposed development works. To facilitate development Lift low canopy - Specified extent. Crown lift to 5m above ground level to allow for construction access.	Proposed
T470	1 <i>Aesculus hippocastanum</i> Horse Chestnut	B3	To facilitate development Lift low canopy - Specified extent. Crown lift to 5m above ground level to allow for construction access.	Proposed
T984	1 <i>Eucalyptus sp.</i> Eucalyptus Tree	C2	To facilitate development Lift low canopy - Specified extent. Crown lift to 5m above ground level to allow for construction access.	Proposed
