Independent Tree Surveys Ltd

Tree Survey & Planning Report  
Aderrig Phase 3  
Residential Development  
Adamstown SDZ  
Dublin

October 2022

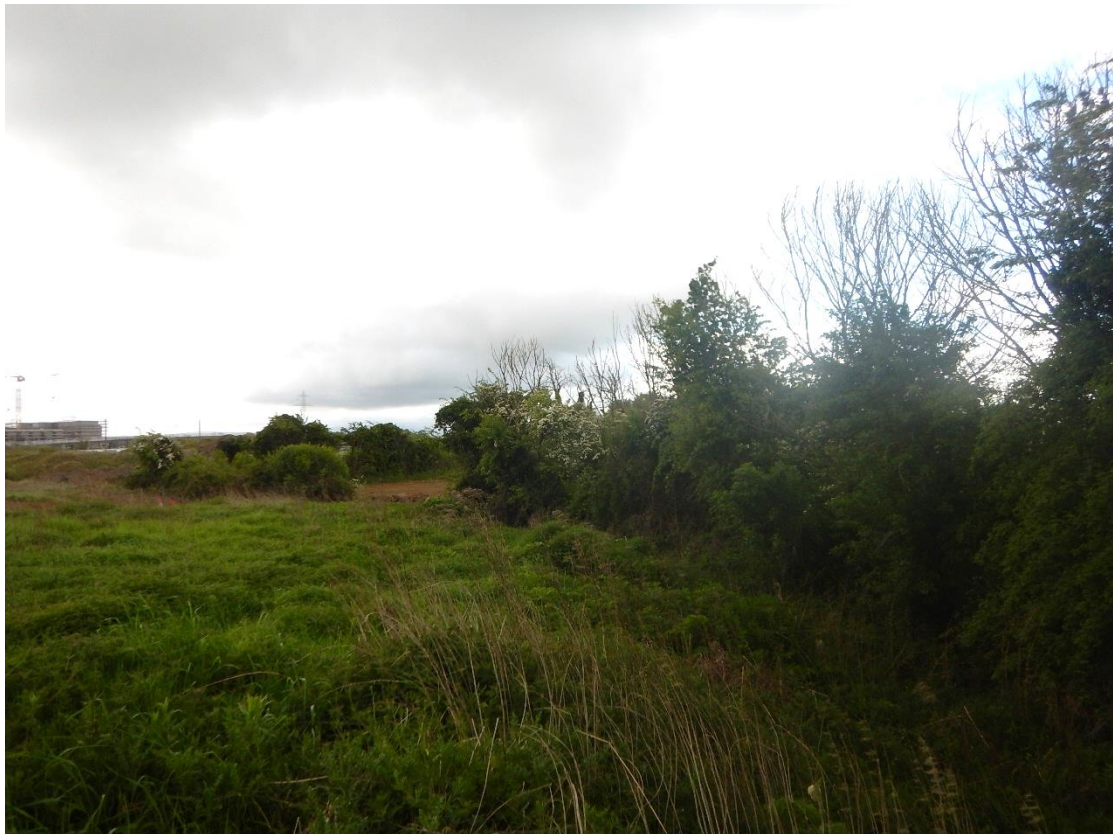
1. Southern end of Hedge H1 viewed from the north

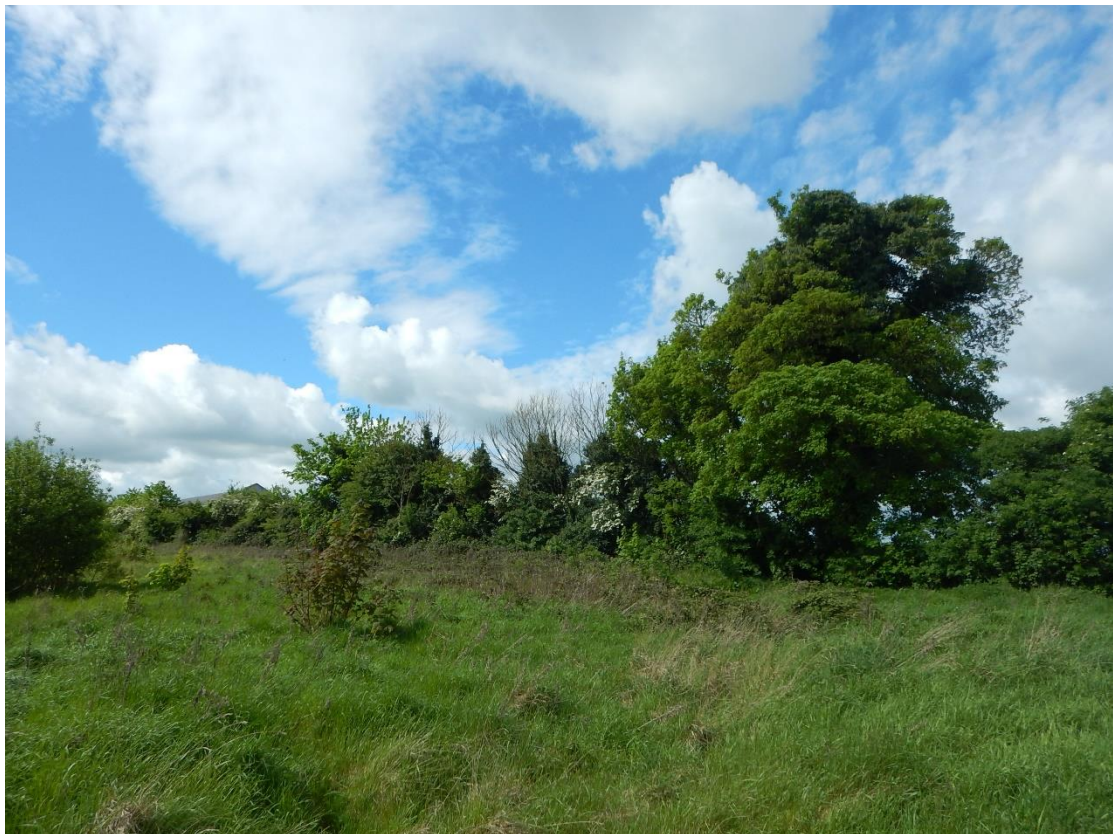
2. Mature Sycamore tree T2 in Hedge H2

T	2	Acer pseudoplatanus (Sycamore)	M	16	950	1	0.5	6.5	7	7	8	10+	Fair	Fair/Poor. Larger hedgerow tree covered by thick Ivy growth which restricts the view of the main stem and branch unions. Wood decay established in extensive old bark wounding to lower stem and stem base; the actual extent of basal decay unclear due to thick Ivy/undergrowth. Excessive Ivy growth in crown.	Cut Ivy around stem base. Review extent of stem decay and crown reduce tree accordingly.	11.4	C2
T	3	Fraxinus excelsior (Ash)	EM	11.5	350	1	0.5	5	5	4	4	10+	Fair	Fair. Growing in hedgerow. Medium sized tree. Thick Ivy growth on tree stem. Ivy restricts view of main branch unions. Epicormic shoots on branching throughout crown.	Monitor tree condition.	4.2	C2
T	4	Ulmus glabra (Wych Elm)	EM	9	400	1						<10	Dead	Bad. Tree standing dead in hedge.	Fell tree.	4.8	U
T	5	Fraxinus excelsior (Ash)	EM	10	566	2	0	5	5	5	5	10	Fair/Poor	Fair. Medium sized tree at end of hedge. Thick Ivy growth restricts view of main branch unions. Unable to inspect stem due to undergrowth. Epicormic shoots consistent with Ash dieback disease (ADB) on branching throughout crown.	Monitor tree condition. Cut Ivy around stem base. Clear undergrowth to allow proper view of tree base.	6.79	C2

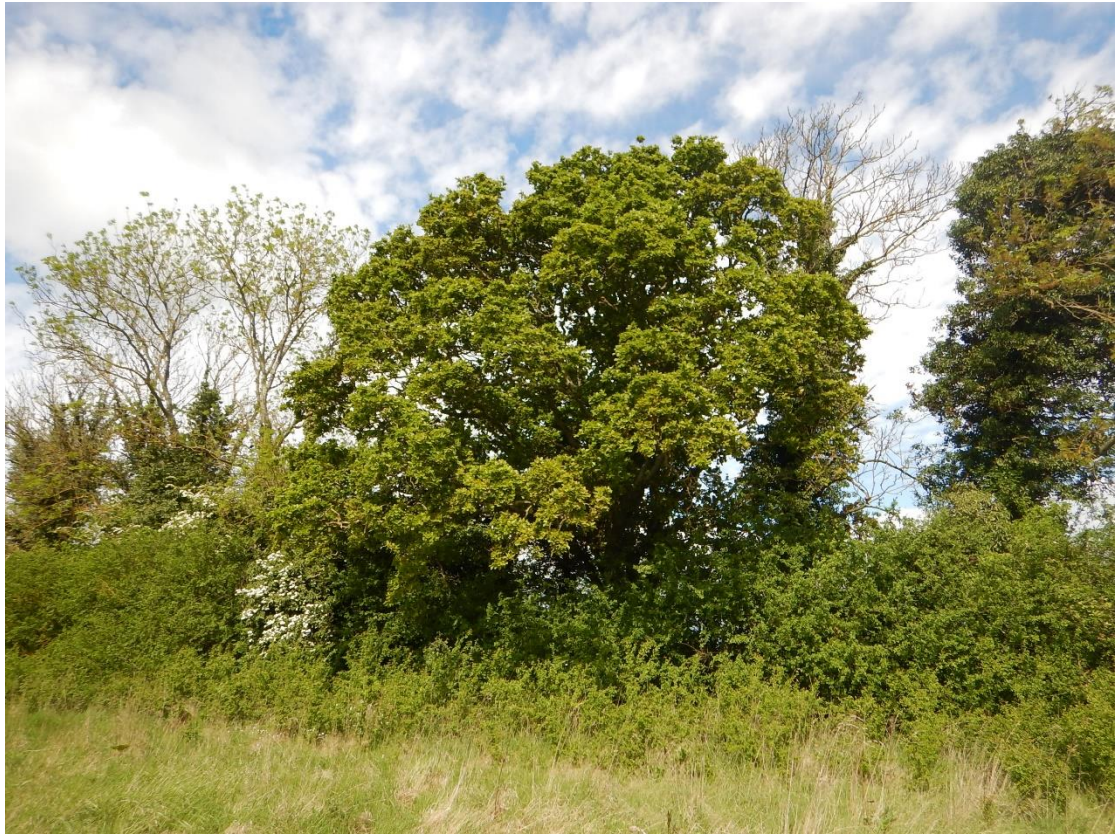
*3. High value mature Oak tree (T16) in Hedge H2 – note poor quality Ash trees on either side*
